**Report on the accident to
BAC One-Eleven, G-BJRT
over Didcot, Oxfordshire
on 10 June 1990**

AIRCRAFT ACCIDENT REPORT 1/92

Air Accidents Investigation Branch

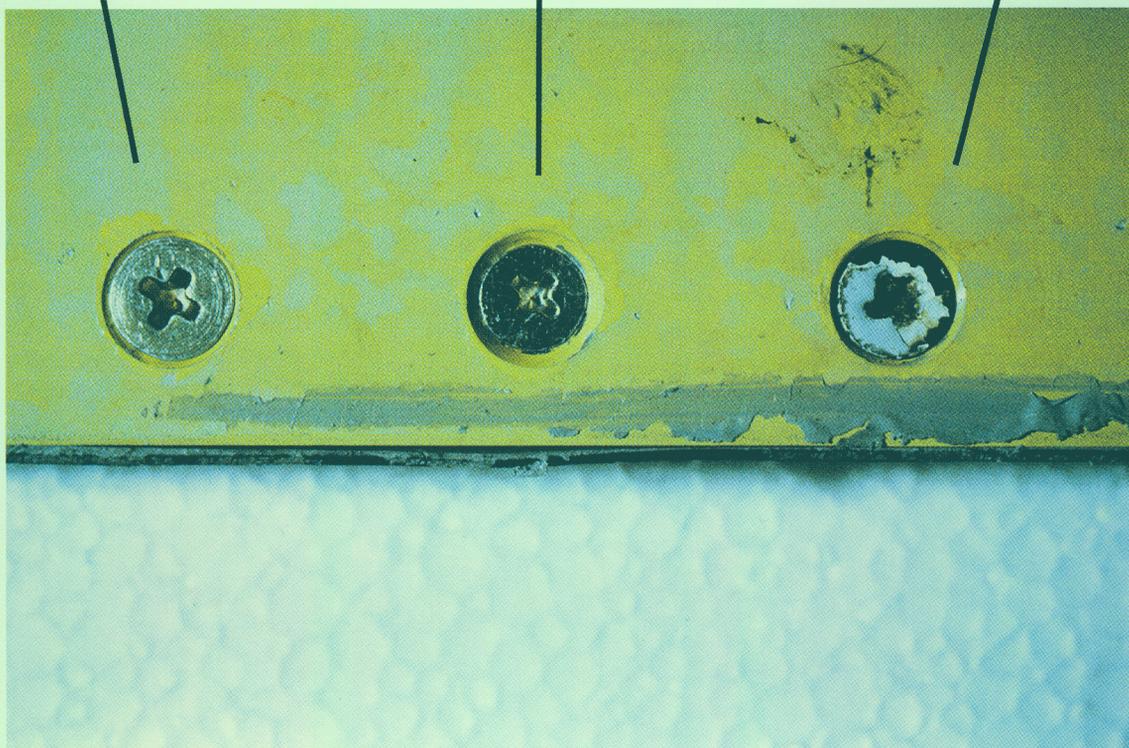
Comparison of bolt heads in countersinks
(shown approximately 1.9 life-size)

The window was finished in primer and had countersunk holes for the bolts; an A211-8C bolt head sits significantly further below the surface of the window, down in the countersink, than does an A211-8D bolt head, leaving an annulus of unfilled countersink which is easily discernable when viewed under good conditions. This excessive annulus of unfilled countersink was not seen.

New 8 UNC

Old 10 UNF
