**NATIONAL TRANSPORTATION
SAFETY BOARD
WASHINGTON, D.C. 20594**

AIRCRAFT ACCIDENT REPORT

**IN-FLIGHT ENGINE SEPARATION
JAPAN AIRLINES, INC., FLIGHT 46E
BOEING 747-121, N473EV
ANCHORAGE, ALASKA
MARCH 31, 1993**

**Adopted: October 13, 1993
Notation 6081A**

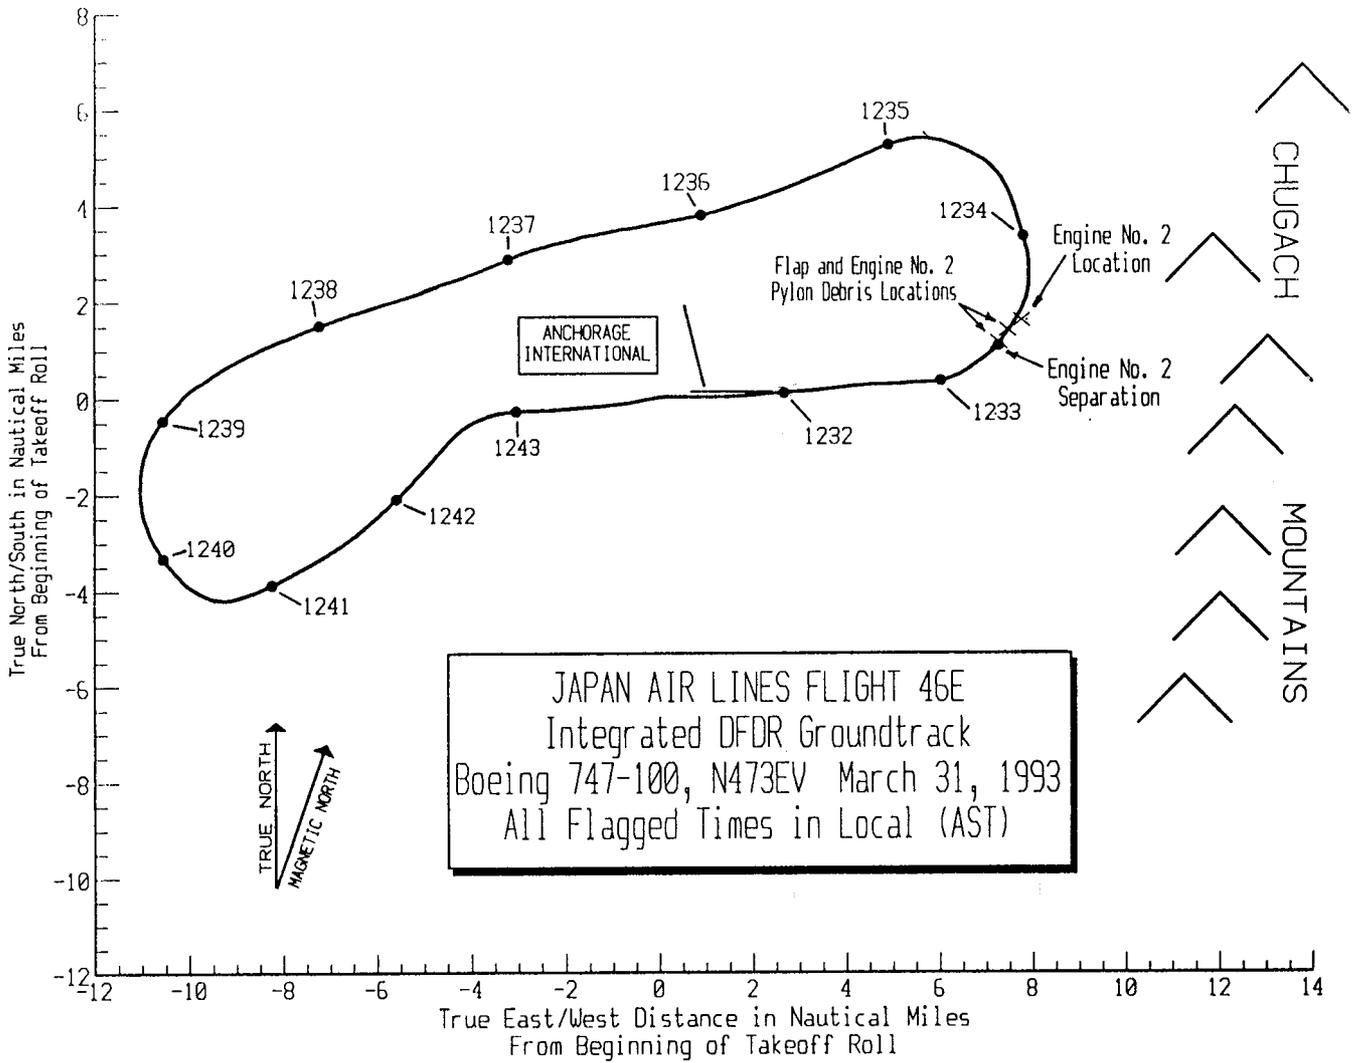
Figure 1.--Flightpath and wreckage location.

Several private dwellings, automobiles, and landscaping were damaged by the impact of the No. 2 engine and various parts of the engine pylon and wing LEDs. Figure 1 is a diagram of the airplane's flightpath and the wreckage location.

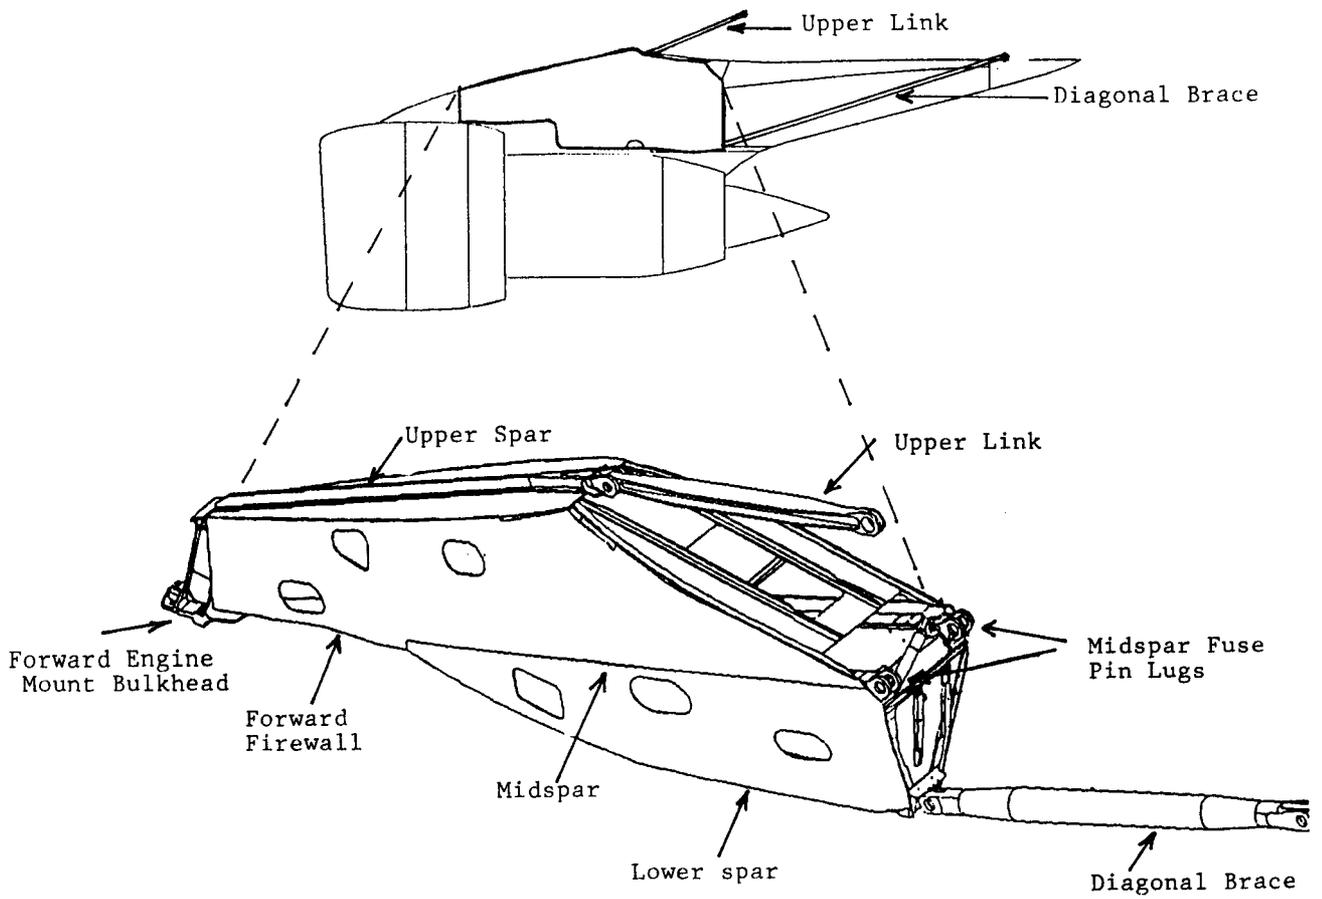
Figure 2.--Pylon structure.

The No. 2 engine pylon was separated into four pieces as a result of three principal fracture areas. These fractures were located just aft of the forward engine mount bulkhead, along a jagged vertical plane aft of the rear engine mount bulkhead, and around the inboard midspar fuse pin fitting. The two forward pieces of the pylon remained attached to the engine through the forward and rear engine mounts. Examination of the fractures around the perimeter of the break aft of the forward engine mount bulkhead revealed features typical of overstress separations, with the exception of a small, flat fracture region in the firewall web.

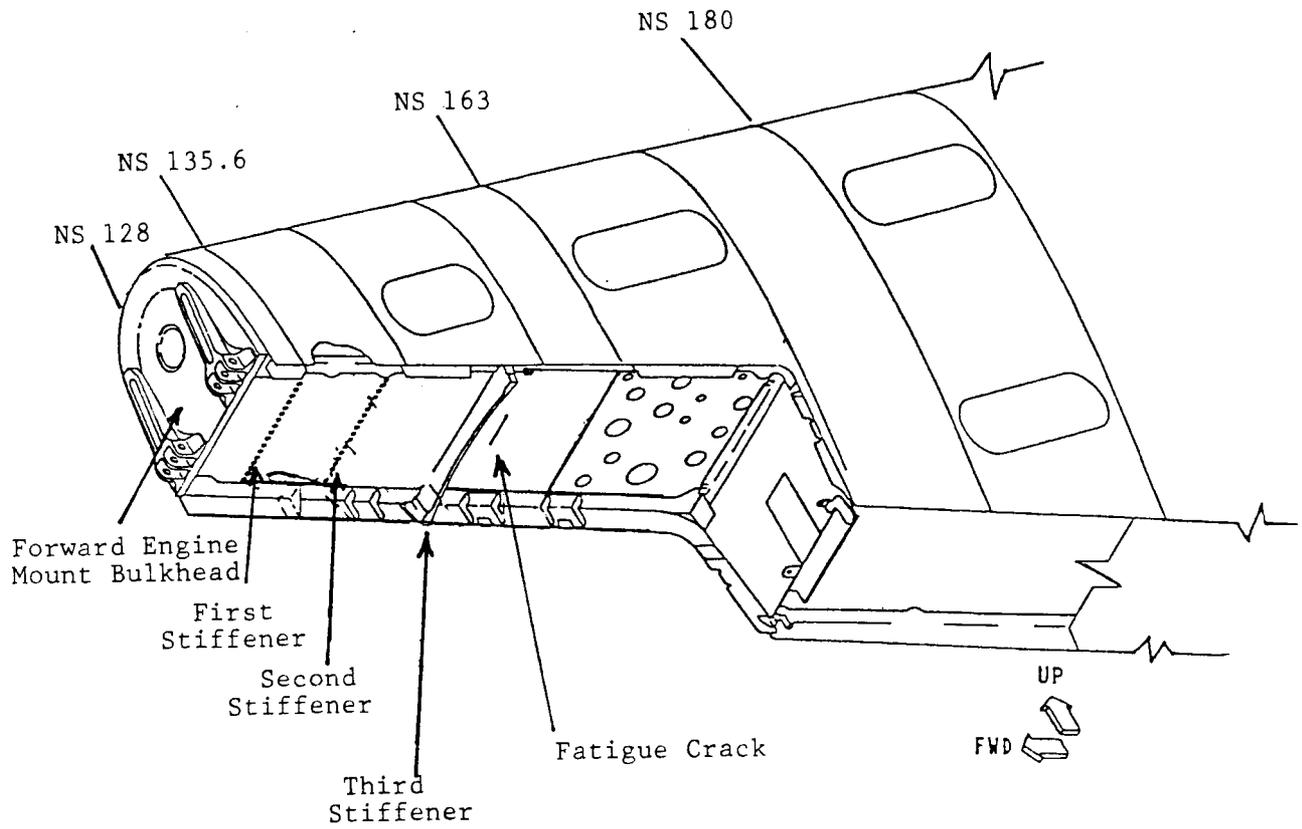
Figure 3.--Flat fracture area.

The flat fracture area was approximately in the middle of the web, on the outboard side of the web centerline. The fracture was a lateral fracture about 2 inches long through the thickness of the web and was aft of the third transverse stiffener behind the forward engine mount bulkhead. The location of this fracture area is indicated in figure 3. Investigators cut the flat fracture area from the remainder of the firewall and examined it in detail with a bench binocular microscope and a scanning electron microscope. The mating fracture faces had been heavily rubbed. Despite the rubbing, isolated areas of fatigue striations, indicative of through-the-thickness propagation, were noted. Compression buckling of the firewall web extended from the fatigue crack area forward to the outboard side of the pylon at the second transverse stiffener. Inspection of the other three pylons on the airplane found no similar cracks.

The two fatigue cracks that were found in the No. 2 engine pylon structure were subjected to metallurgical examinations. One of the fatigue cracks was a lateral fracture about 2 inches long and was in the web of the pylon forward firewall, just aft of the third transverse stiffener behind the forward engine mount bulkhead. This fatigue crack was lateral to the web. Although most of the features of this crack had been obliterated by rubbing, a few isolated areas of fatigue striations were found. The orientation of the striations indicated that the cracking propagated through the thickness of the web. The web material (nickel alloy) and construction appeared to comply with specification requirements. There was no evidence of damage or defects that may have contributed to initiation of the fatigue cracking.

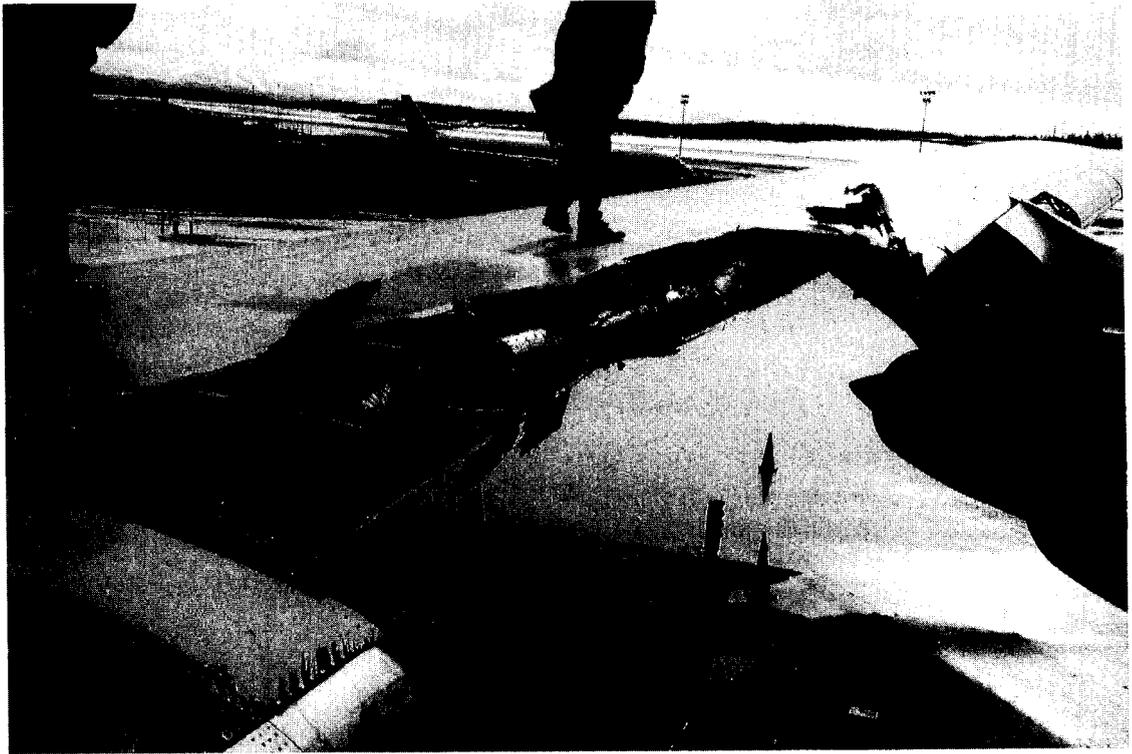
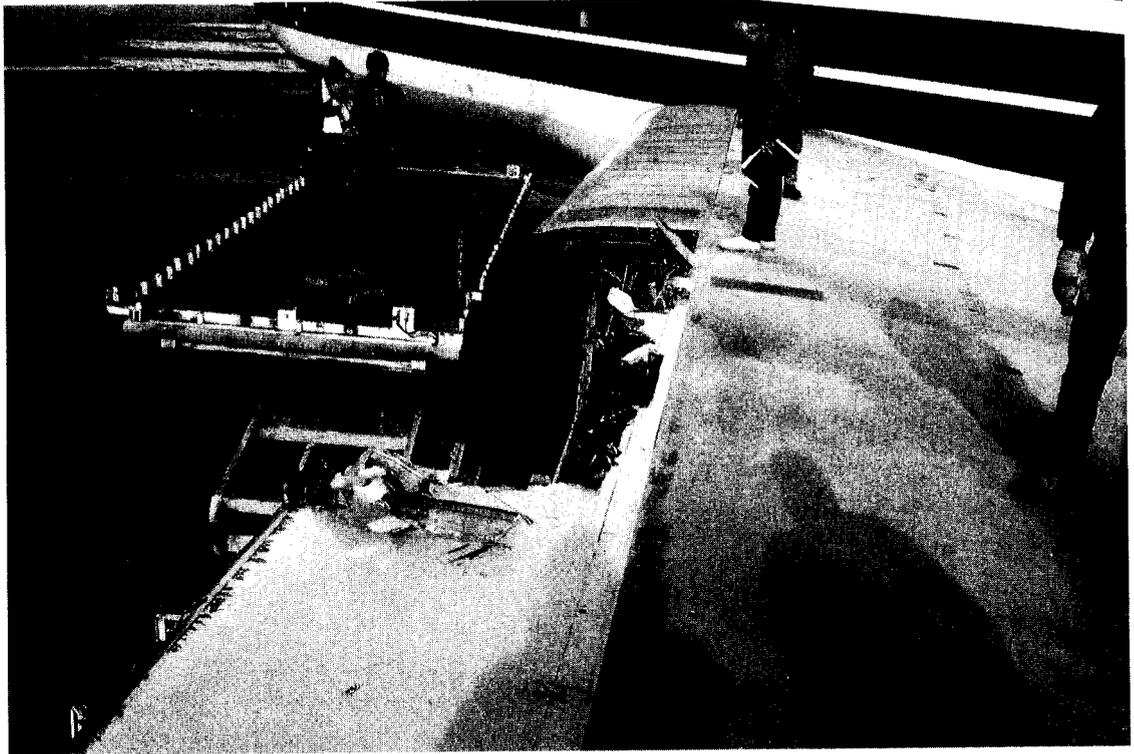
Figure 4.--Left wing damage.

All of the entire upper surface fixed leading edge panels from approximately inboard leading edge station (ILES) 695 to ILES 930 on the left wing were missing (see figure 4). The wing leading edge "D" beam and thermal anti-ice duct from ILES 695 to ILES 930 on the left wing were missing. The leading edge variable camber (VC) flaps Nos. 7, 8, 9, and 10, including their drive motors, torque tubes, and 50 percent of all the linkage had been torn from the wing. Additionally, all of the leading edge flap support ribs were either missing or partially missing in this area.

The D beam and thermal anti-ice duct portions, as well as many of the VC flap folding nose sections, were crushed and appear to have been struck by a large, heavy object. The recovered VC flap portions were split in the spanwise direction. The leading edge flap support ribs were broken near the front spar's upper chord attachment and the rib post lug tension tube attachment. The appearance of these fractures and the position of the rib portions that were still attached to the front spar were consistent with an upward and outboard motion of the object that impacted the structure. The VC flap linkage parts that were recovered exhibited compression and torsion damage that was also consistent with this motion. Some parts of the wing's upper surface fixed leading edge honeycomb panels smelled of fuel. A puncture in the No. 4 spoiler was consistent with an object that entered on the upper surface and exited on the lower surface, when the spoiler was deployed. The remaining punctures, gouges, and dents were typical of impact with small objects.

Other damage was found on the wing's trailing edge outboard fore, mid, and aft flaps, inboard aft flap outboard corner, spoiler No. 4, the lower fixed trailing edge panel aft of the "sailboat" fairing, and the left side of the lower rudder. This damage consisted of punctures and tears. Dents, scrapes, and scratches were found on the left wing upper and lower skin panels as well as on the left stabilizer leading edge. Figure 4 shows the damage to the leading edge of the wing.
