**CIVIL  
AVIATION  
ADMINISTRATION  
OF CHINA**

**AIRCRAFT ACCIDENT REPORT**

**Controlled Flight Into Terrain  
KOREAN AIR FLIGHT KE6316  
MD-11F, HL7373  
SHANGHAI, PEOPLE'S REPUBLIC OF CHINA  
APRIL 15, 1999**

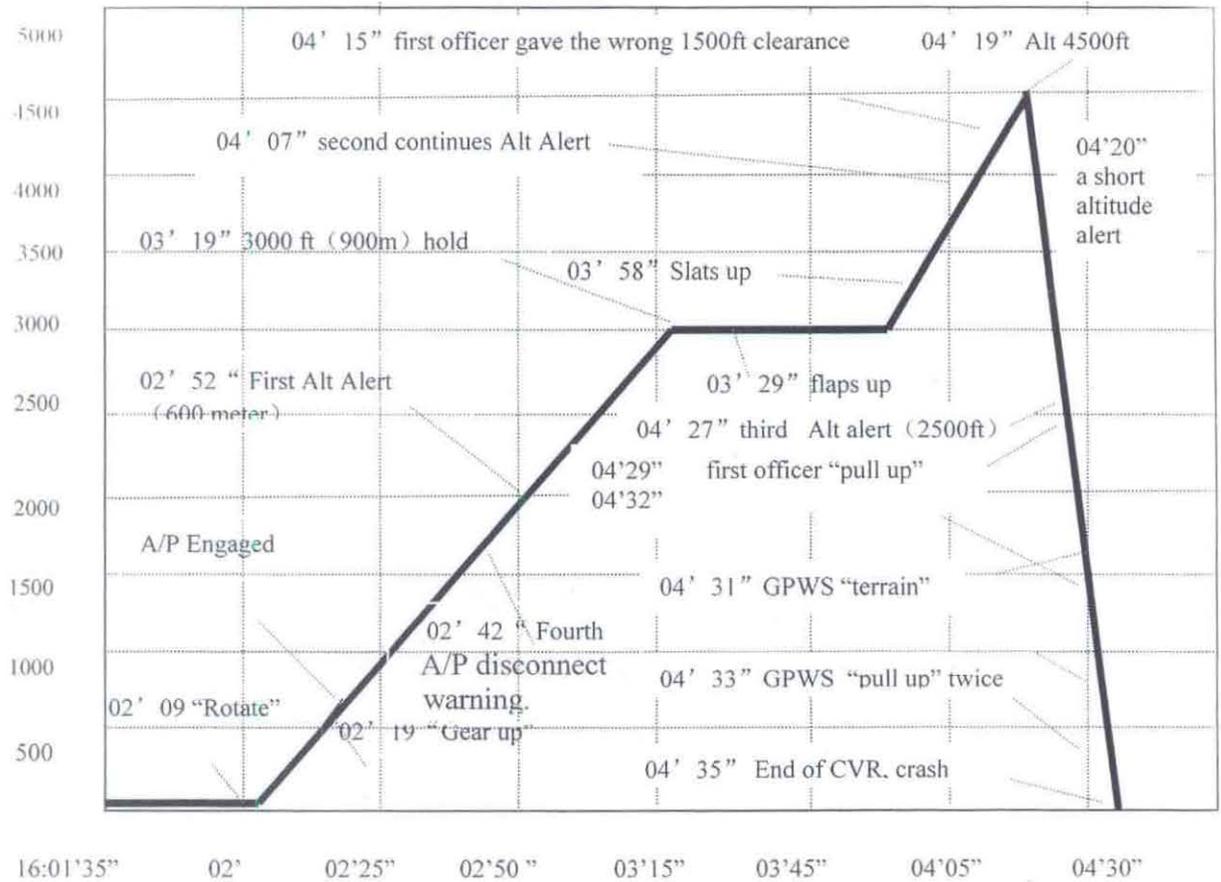
## 2.7 Accident Flight profile

The investigative team found that the accident airplane had climbed to approximately 1,370 meters (4,500 feet) at its last recorded radar data point prior to impact, and the elapsed time from the last recorded radar data point to ground impact was approximately 16 seconds. The average descent rate required to travel from 1,370 meters (4,500 feet) to ground level (approximately 10 feet MSL) in 16 seconds is approximately 16,875 ft/minute.

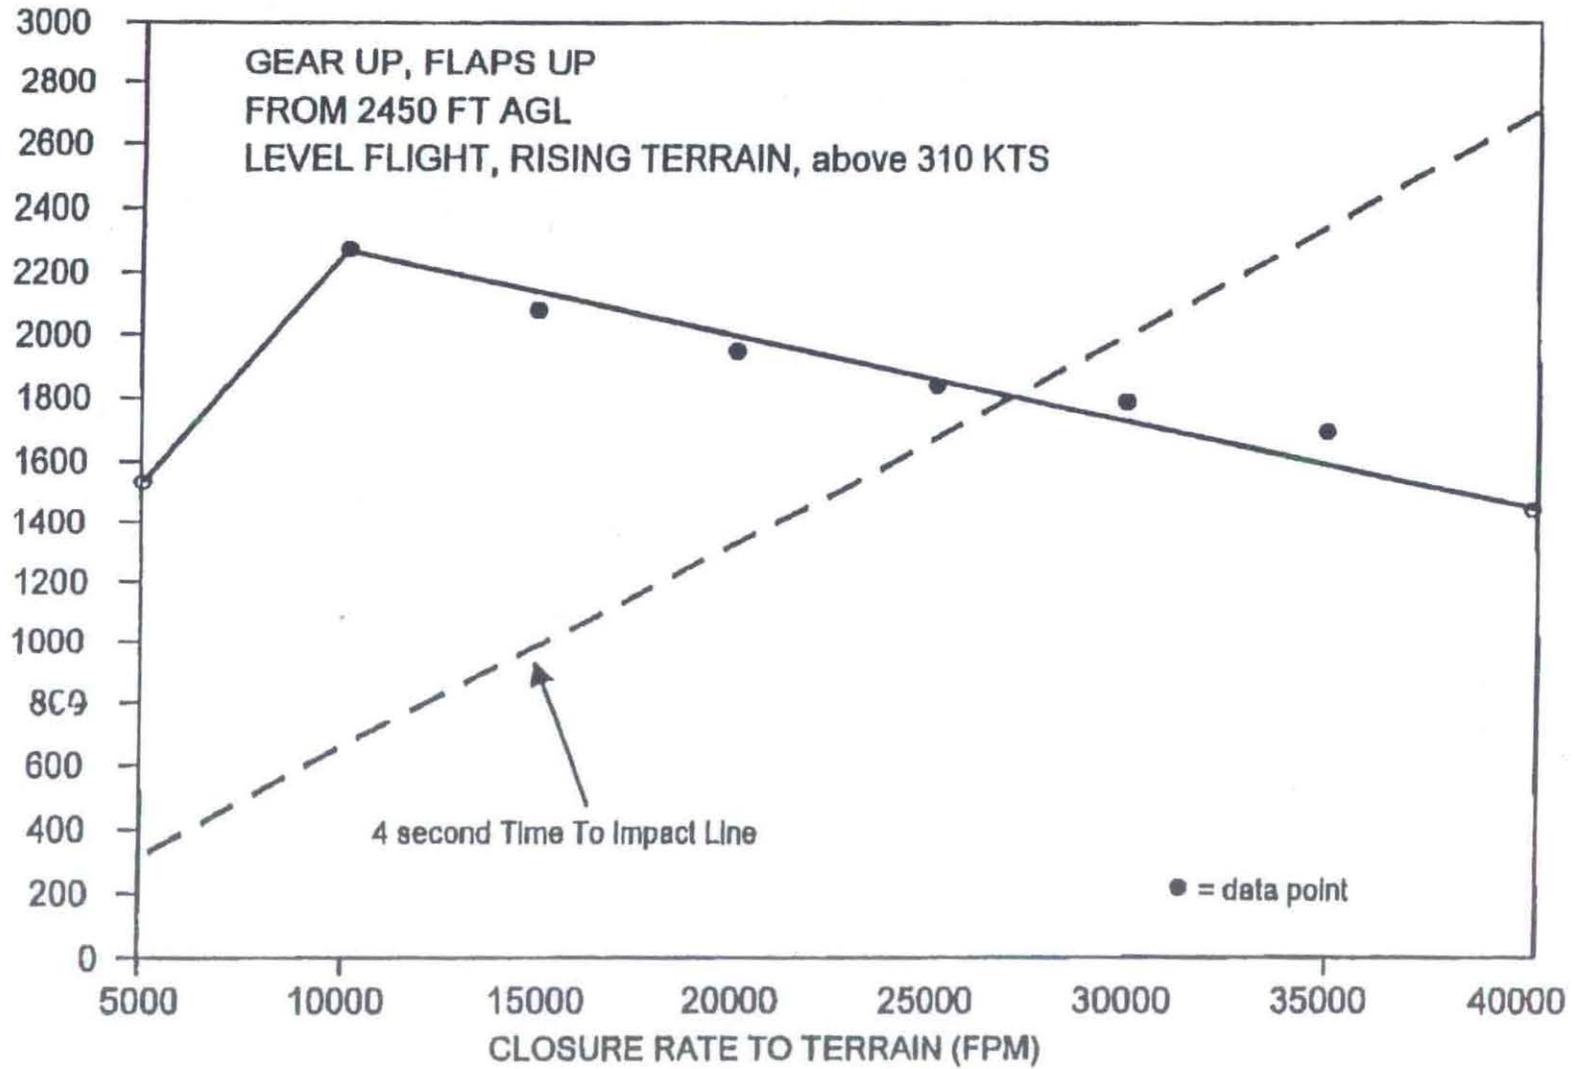
**MODE 2 DYNAMIC CURVE (level unaccelerated flight towards terrain)**

Time (roughly in seconds)	CAWS	pilot	GPWS
0	MOTION		
1	TONE		
2	ALTITUDE		
3		TRAYA?	
4		TRAYA?	
5		TRAYA?	
6	(GLIDESLOPE?)	TERA-TERA?	TERRAIN-TERRAIN
7		TERA-UH	WHOOOP-WHOOOP
8	(MANIFOLD?)	UNABLE CONTROL	PULL-UP
9		AIRPLANE	WHOOOP-WHOOOP
10			PULL-UP

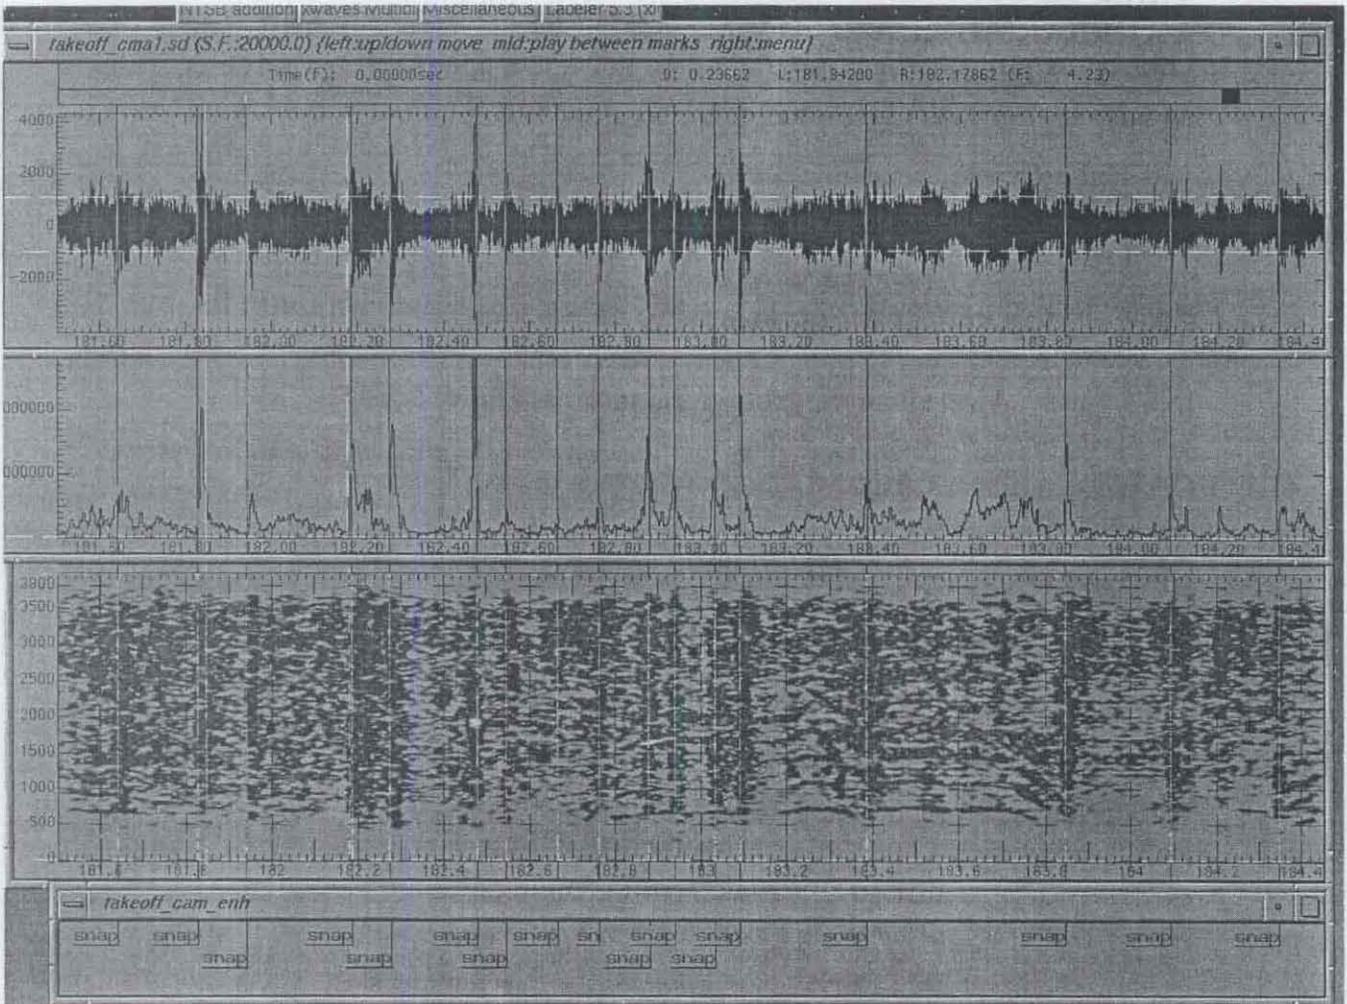
# CHART 1

Chart 1 depicts this segment as recorded on the cockpit area microphone channel of the CVR recording. The top trace in the chart is the representation of the waveform of the signal. In this top trace, time in seconds, is along the horizontal axis and amplitude is depicted along the vertical axis. The middle trace is a depiction of the total energy of the signal shown in the top trace. Again time in seconds is along the horizontal axis and total energy is along the vertical axis. The bottom trace is a "voice print" or a spectrograph representation of the signal shown in the top trace. The spectrograph is a frequency representation of the signal where frequency in hertz is shown along the vertical axis. Intensity or amount of energy in a particular frequency is depicted by the various colors of the chart. Red being the highest energy followed by yellow and blue. The last trace is a text annotation of the various snap sounds that make up the rattling noise noted on the CVR transcript. It should be noted that the time shown on Chart 1 is an arbitrary CVR elapse time in seconds. For example, the voice signature noted at chart time 183 corresponds to the statement on the CVR transcript at time 0804:46.

It can be seen that the rattling noise consists for the most part of a repeating pattern of two snaps. The pairs of snaps are repeating at approximately a 10-Hertz rate over the 5-second period. This rate does not correspond to the stick shaker stall-warning rate, but it is more representative of a rattling dash or glare shield panel in the cockpit of the aircraft.
