**Statens haverikommission**  
Swedish Accident Investigation Board

***Report RL 2010:01e***

**Accident to aircraft SE-IVF at the northern basin of  
Falsterbo canal, Skåne County, on 26 October 2006**

Case L-27/06

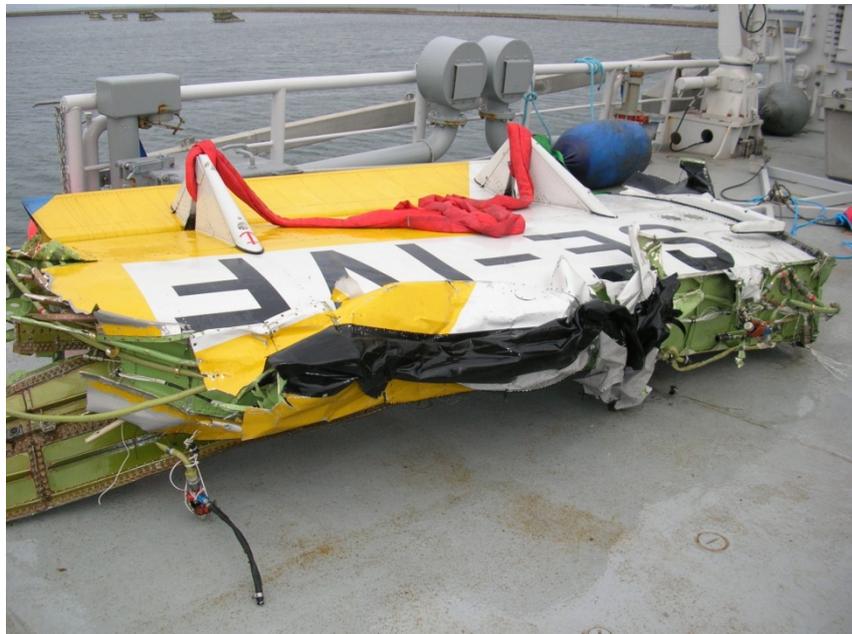
The entire left wing with its engine had separated from the aircraft while in flight and impacted with the water, leading to major damage. The left engine with its propeller had broken free from the wing.

Figure 14. Left wing

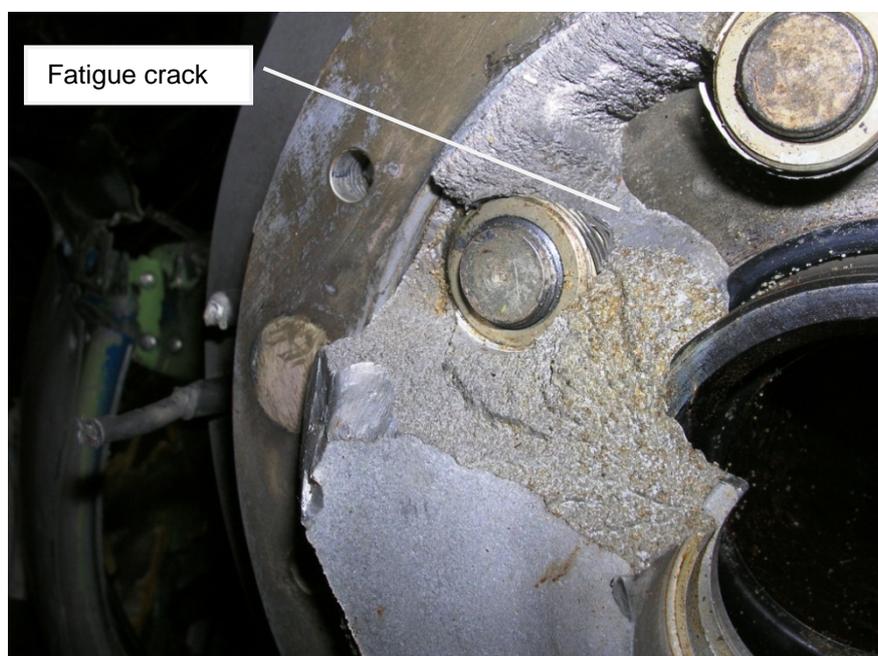
In the fracture surface of the left propeller hub one of the bolt holes had a fatigue crack measuring approximately 10 x 5 mm. (See also Section 1.6.12.)

Figure 16. Left propeller hub

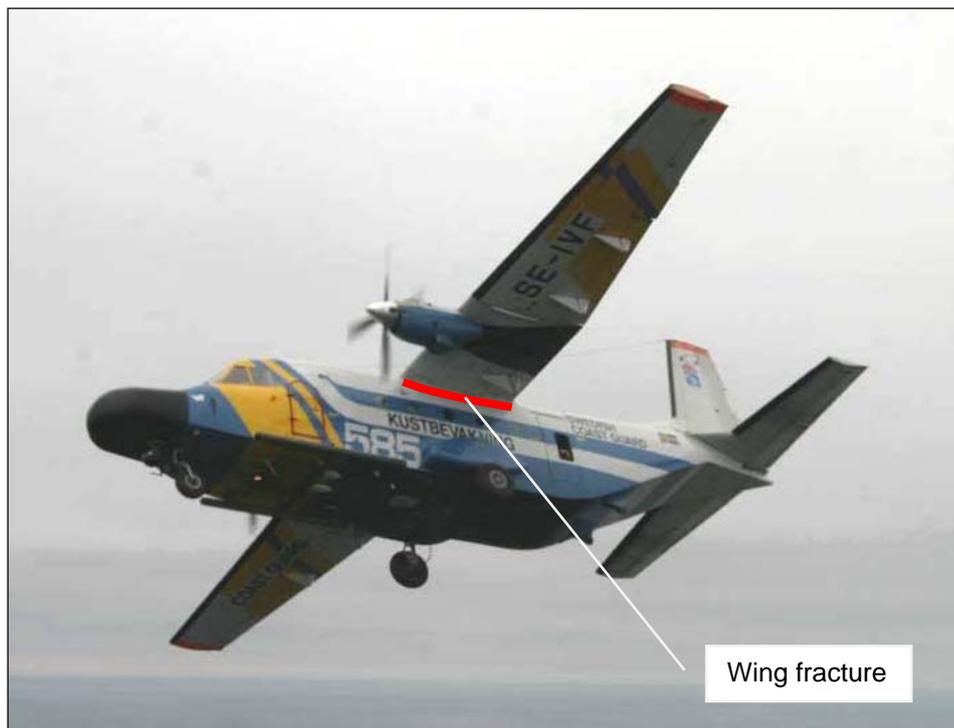
The left wing broke off at the wing root during the accident flight. The fracture occurred at the central wing box adjacent to the fuselage. Damage to the upper part of the wing structure shows that the wing, while separating from the aircraft, bent upwards.

Figure 17. Location of the fatigue cracking

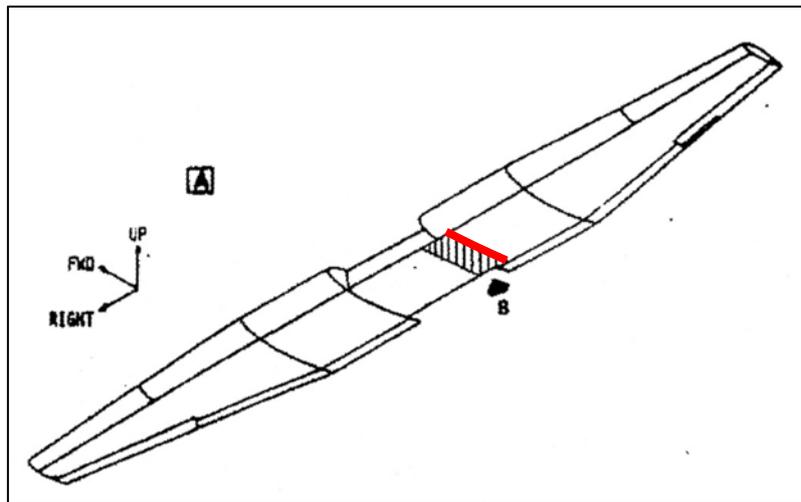
An approximately 840 mm long fatigue crack that led to the wing fracture was found in the lower supporting wing skin between the wing spars. The crack was localised in the longitudinal plane of the wing, along the outermost row of rivets (rivet row # 1 closest to the wing tip) in the riveted attachment for the lower doubler, that at the same time forms the riveted attachment for the angle bracket to which the fairing is screwed (Station 1030). Within the same length 6 longerons and both wing spars had fatigue cracks which had penetrated between 5 and 95 % of their cross-sections.

Figure 18. Location of the cracks in the underside wing skin

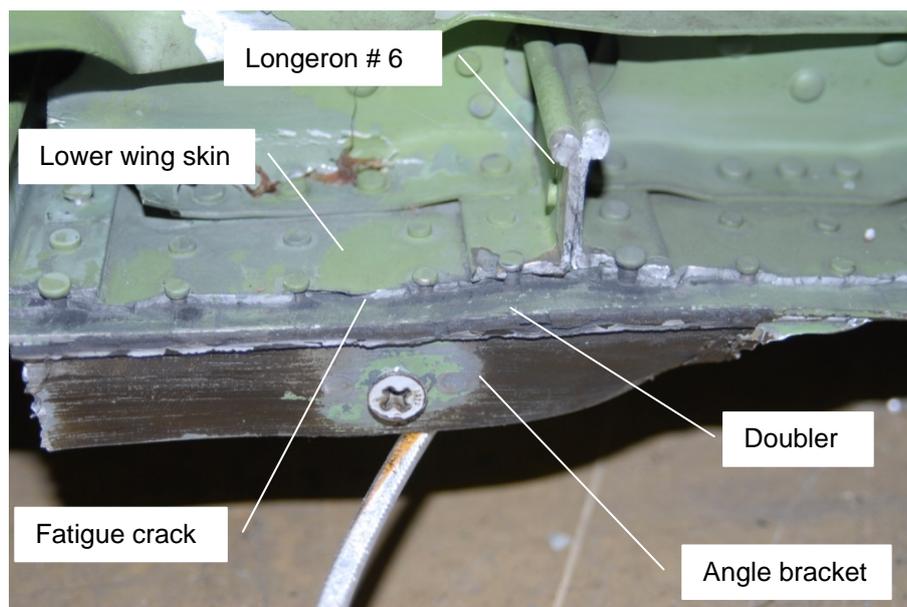
During the examination colour changes were noted in the primer on the inside of the wing, which could indicate that the anti-corrosion treatment had been applied at different times.

Figure 19. Part of the fatigue cracking in the left wing.

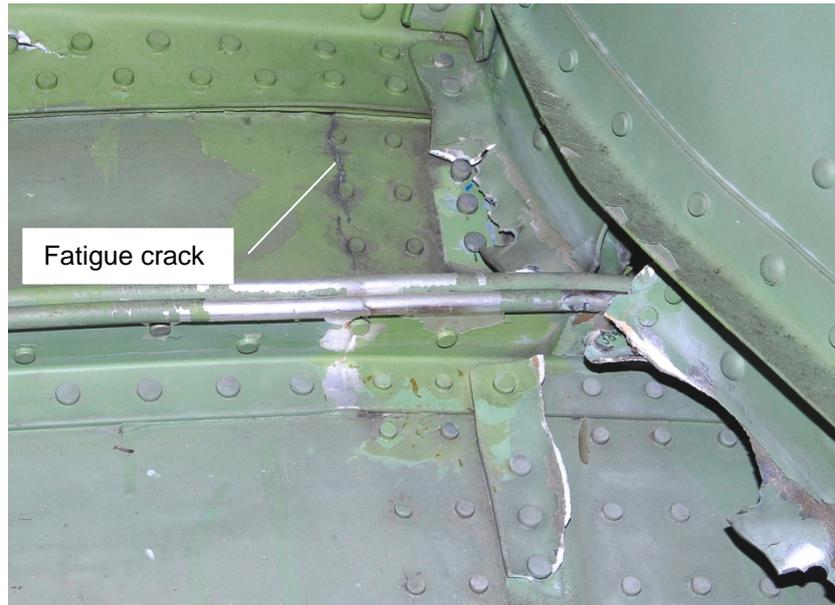
crack length was estimated as being about 200 mm. Concerning the emergence of the fatigue cracks, see below.

Figure 20. Fatigue cracks seen from the inside of the right wing

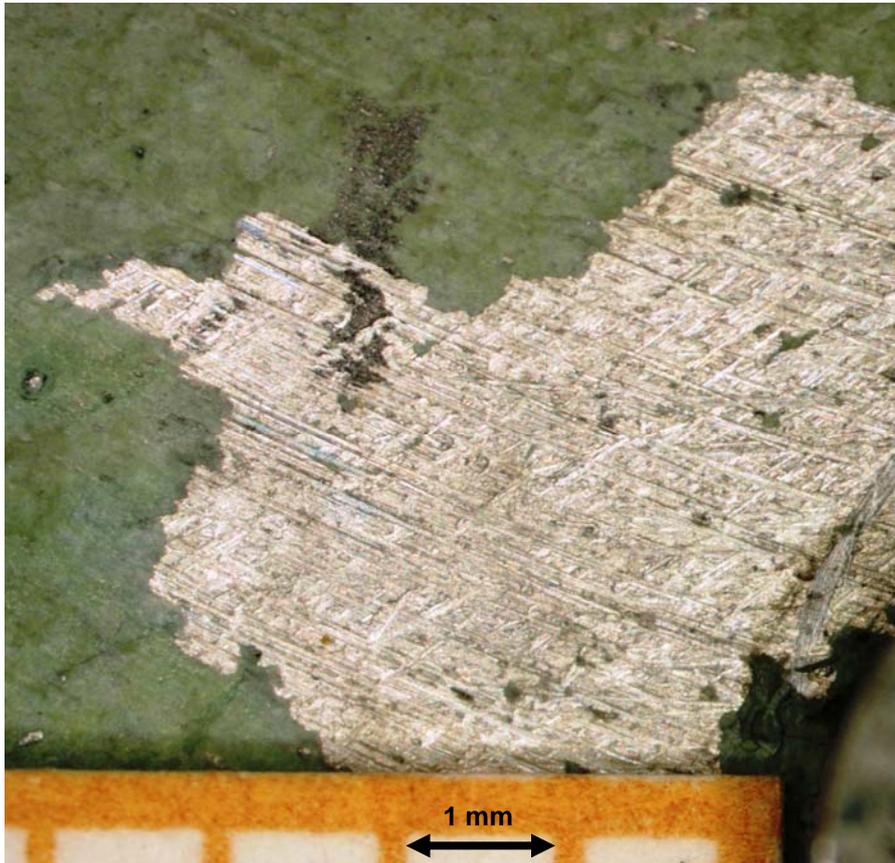
Figure 21. Finishing marks between rivet holes

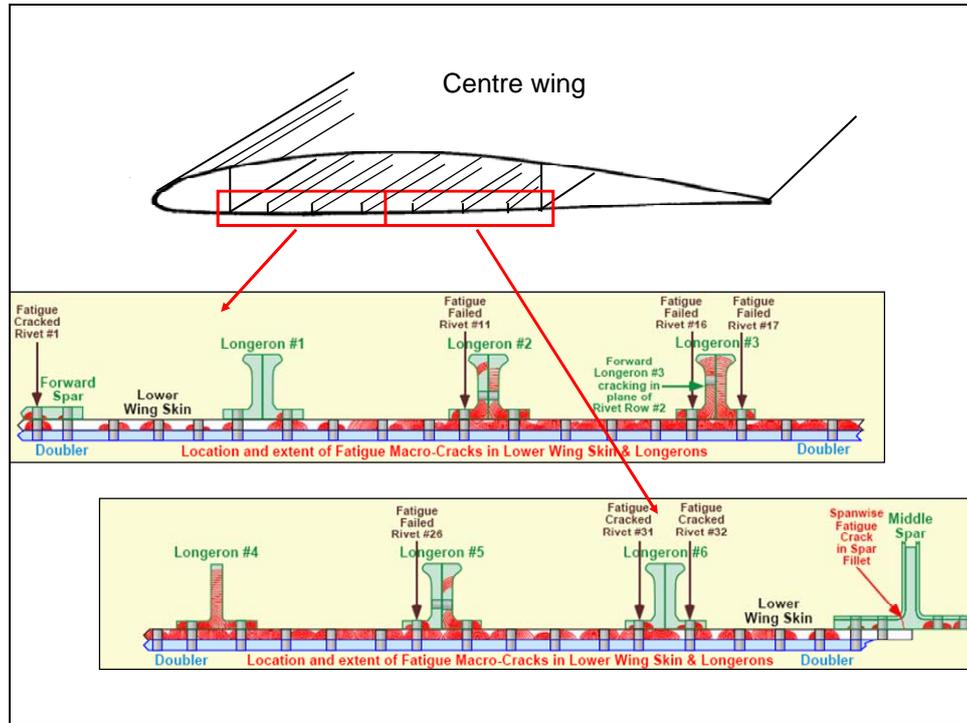
*Phase V* – When the major fatigue crack had reach a length of about 840 mm the wing ruptured. See the following sketch.

Figure 22. Fracture, with fatigue cracks marked in red

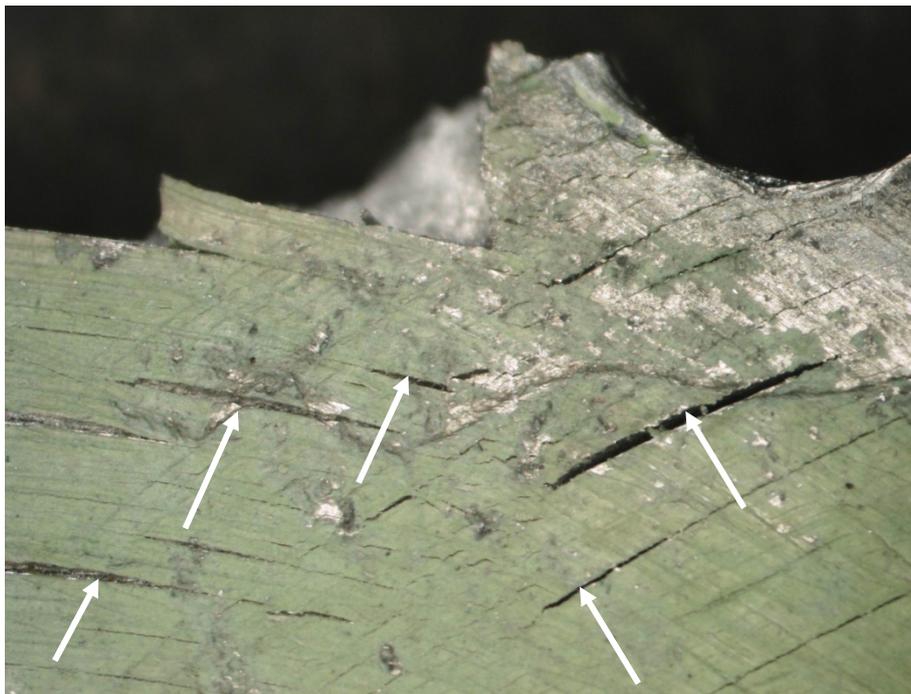
In a band that extends about 4 mm inside to 12 mm outside the centre line of the rivet row, hundreds of micro-cracks were found on the underside of the skin. Some of these were only 0.1 mm deep and 1 mm long, and could not be seen by the bare eye or with any of the usual NDT methods. Such cracks only become apparent during visual inspection with magnifying glass (x 10) or when the sheet is bent.

Figure 23. Example of micro-cracks in the finishing

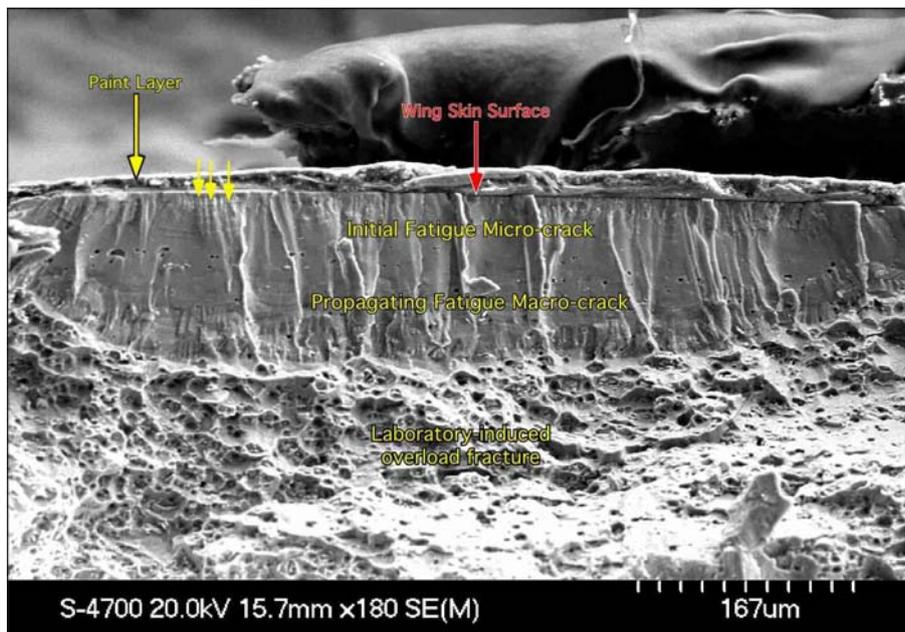
The fracture surfaces of many of the micro-cracks show no sign of mechanical fretting against the opposing fracture surfaces. (See the illustration below, taken using a sweep electron microscope.) This may be because there was internal stress in the material or that the normal forces that arose in the wing during flight tended to hold the cracks “open”.

Figure 24. Undamaged fracture surface in micro-crack

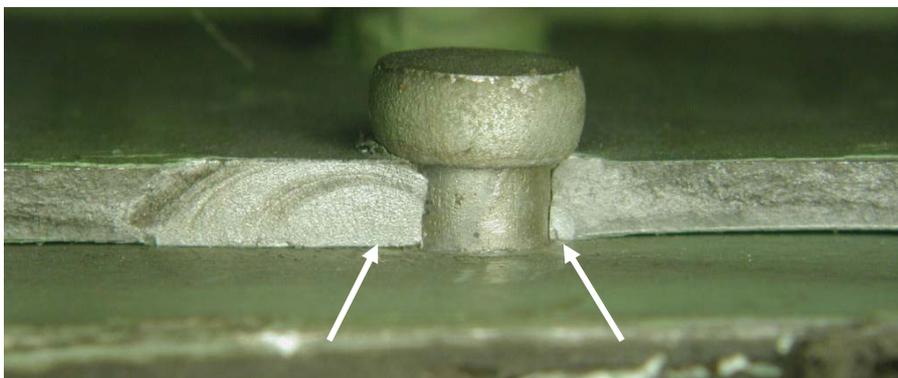
Fatigue cracks have grown from the many initiation points along the rivet row. The arrow at the left in the illustration below shows how a crack has grown from a starting point between the rivet holes. On the surface of the crack can be seen typical curved beach lines. The arrow at the right indicates a starting point from the corner of a rivet hole.

Figure 25. Fatigue cracks in the left wing skin.

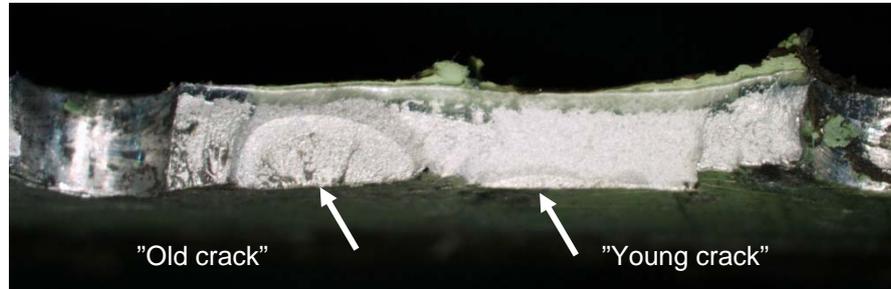
The picture below shows different stages in the growth of fatigue cracks that have started from micro-cracks between the rivet holes, seen in a cross-section of the skin.

Figure 26. Growth of micro-cracks

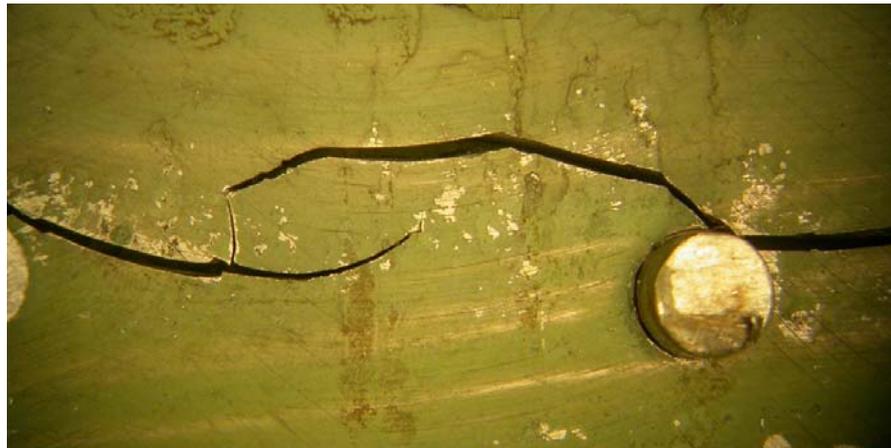
In many cases a crack has “jumped over” to another crack that has thereby been lengthened. (See the picture below.)

Figure 27. Example of crack growth by “jumping”

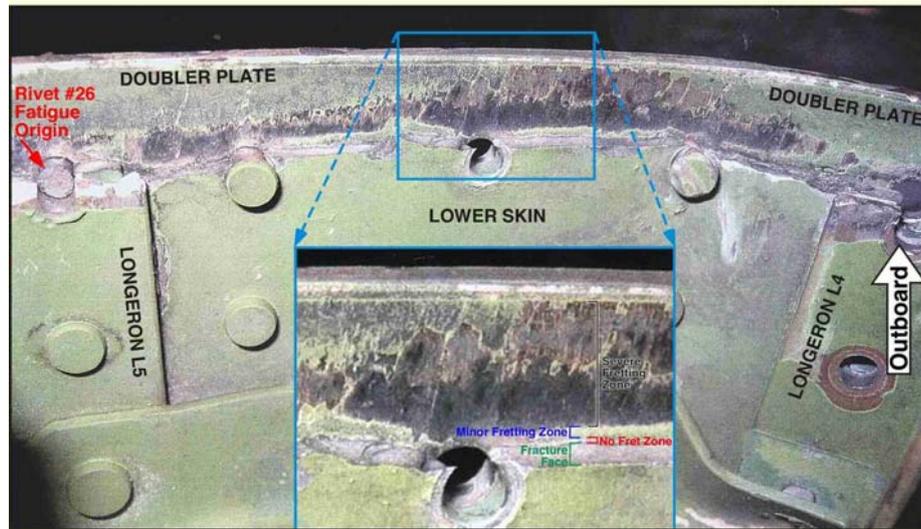
Figure 28. Fretting damage at the doubler

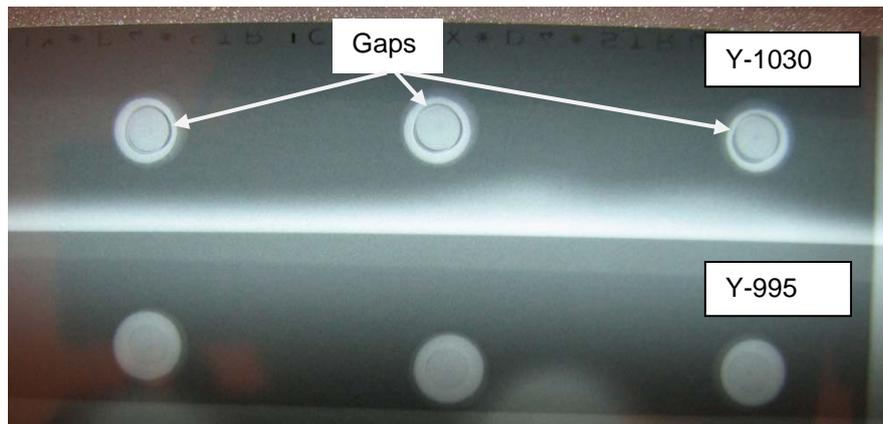
It was further noted that gaps were mainly only present in joints that connected loaded elements such as ribs, longerons, angle brackets, etc. The illustration below shows a section of the rivet joint on the sister aircraft, S/N 343, where rivet row Y-1030 (rivet row # 1) also secures the angle bracket, while rivet row Y-995 only secures the doubler.

Figure 29. X-ray image showing examples of gaps between rivets and rivet holes (*Aircraft S/N 343*)

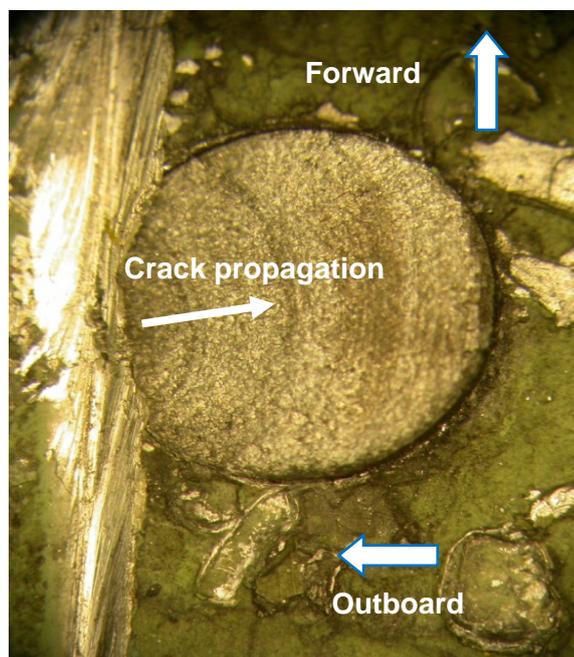
On the right wing there were two broken rivets caused by 100 % fatigue. These were located on each side of the rear wing spar. The cracks had initiated from the side that faced out to the wing tip and propagated “inwards”. (See the illustration below.)

Figure 30. Fatigue fracture in a rivet shank

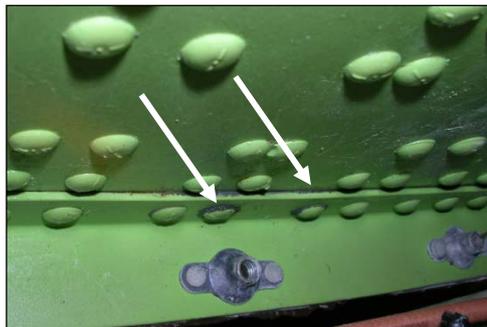
Signs that axial movement had occurred in the joint in question were also present on the sister aircraft, S/N 343, where black aluminium oxide had leaked out from some rivets. So far, rivets have been found to be missing on two other aircraft individuals in operation.

Figure 31. Signs of movement in a riveted joint, in aircraft S/N 343

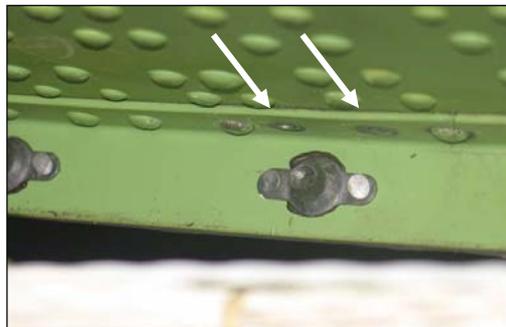
Figure 32. Missing rivets in a Spanish-registered operational aircraft  
(Manufacturer's picture)

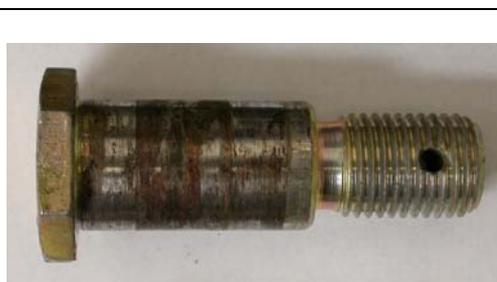
The wear damage consisted of a type of fretting and the beginning of cutting. Also purely mechanical deformation was present. The two front bolts were more worn than that at the rear, but no great difference in wear was apparent between the left and right sides. The wear was fairly evenly spread around the circumference but not so great that a gap was present in the attachment.

Figure 33. Wing bolt from the accident aircraft S/N 346, right front position

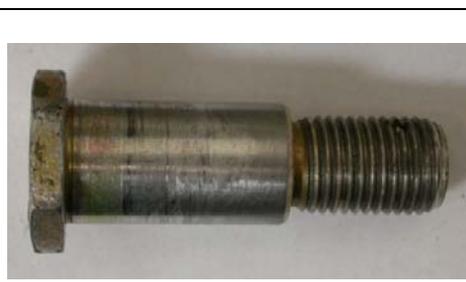
Figure 34. Wing bolt from sister aircraft S/N 343, unknown position

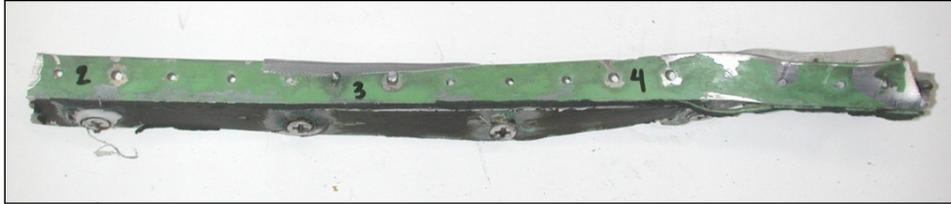
Four of the rivets that secured the angle bracket to the doubler and the wing underside skin had broken. The fracture surfaces of two of these rivets, those that also secured the angle bracket to longeron # 3, showed that the fractures had been preceded by fatigue cracks. In the rivet hole in the angle bracket for one of these two rivets, two fatigue cracks were found.

Figure 35. Part of the angle bracket from the left wing.

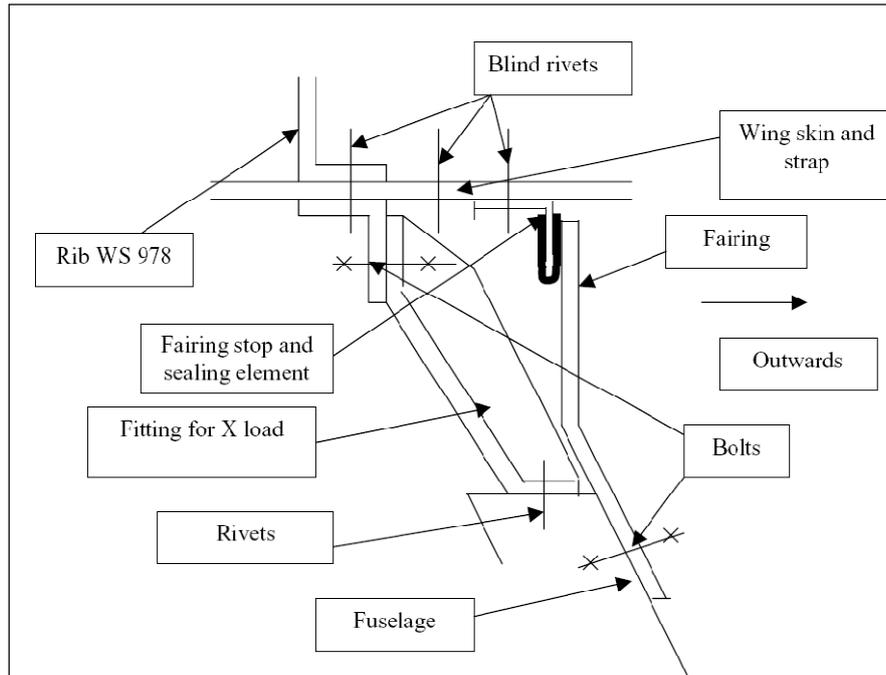
Figure 38. Modified wing attachment according to manufacturers drawing (Compare with Figure 6)

This modification has been incorporated on aircraft S/N 343 in accordance with Service Bulletin (SB) 212-57-40 as a test. With the issue of new inspection requirements the manufacture does not consider it necessary to implement this modification on other CASA C-212 aircraft in operation.
