**AIRCRAFT ACCIDENT INVESTIGATION COMMITTEE
MINISTRY OF TRANSPORT, THAILAND**

AIRCRAFT ACCIDENT FINAL REPORT

**ONE TWO GO AIRLINES COMPANY LIMITED
MCDONNELL DOUGLAS DC-9-82 (MD-82)
HS-OMG**

**PHUKET INTERNATIONAL AIRPORT
THAILAND**

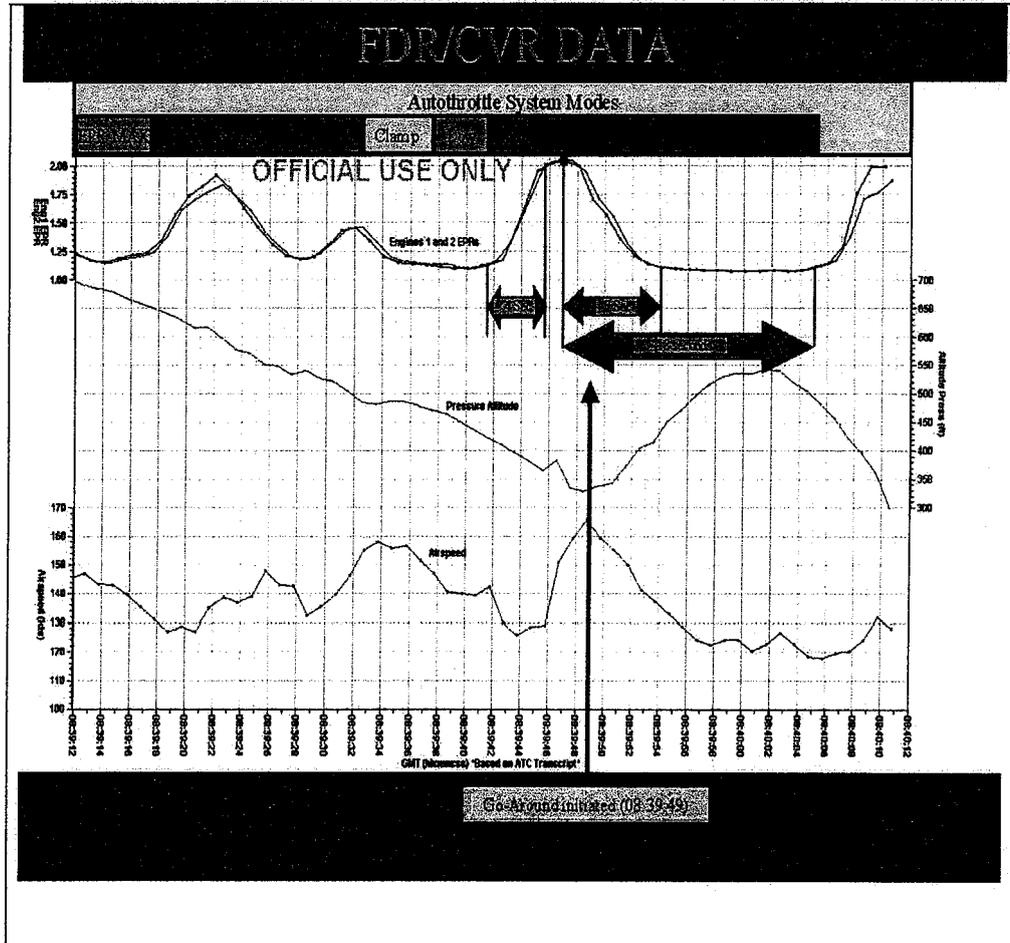
Figure 1 Autothrottle System Modes

At about 08:39:47, with the aircraft in the SPD mode, at about 50 feet (RA), airplane HS-OMG experienced an automatic reduction of all engine thrust from about 2.0 EPR to about 1.1 EPR because the retard (RETD) mode function of the autothrottle system automatically activated. Both engine's EPR remained at about 1.1 for approximately 13 seconds allowing the airspeed to drop below 120 kts. According to Boeing, the RETD mode is automatically activated as a function of radio altitude and landing flap configuration when the autothrottle is not in the EPR G/A mode. With the approach slat/flap logic applied to the autothrottle system, the flaps positioned to at least 20 degrees and the radio altitude less than or equal to 50 feet, the retard mode of operation is automatically established. The FDR data indicates the RETD mode activated when the flaps were positioned at 40 degrees and the aircraft descended below the 50-foot autothrottle retard altitude. Once activated, the FMA displays "RETD" and both throttles are driven to the aft stop at a rate dependant on the radio altitude. The autothrottle retard mode is independent of the autopilot or flight director-operating mode.

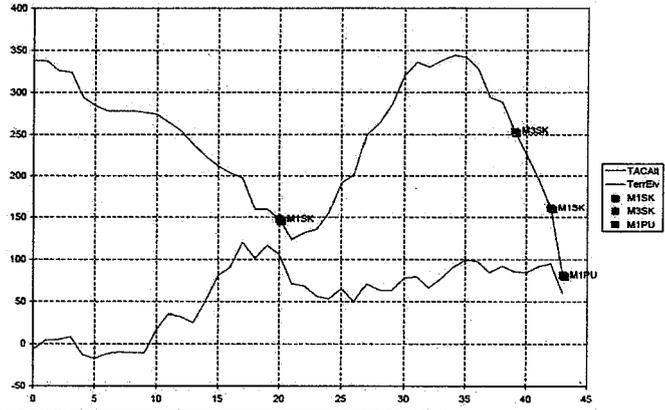
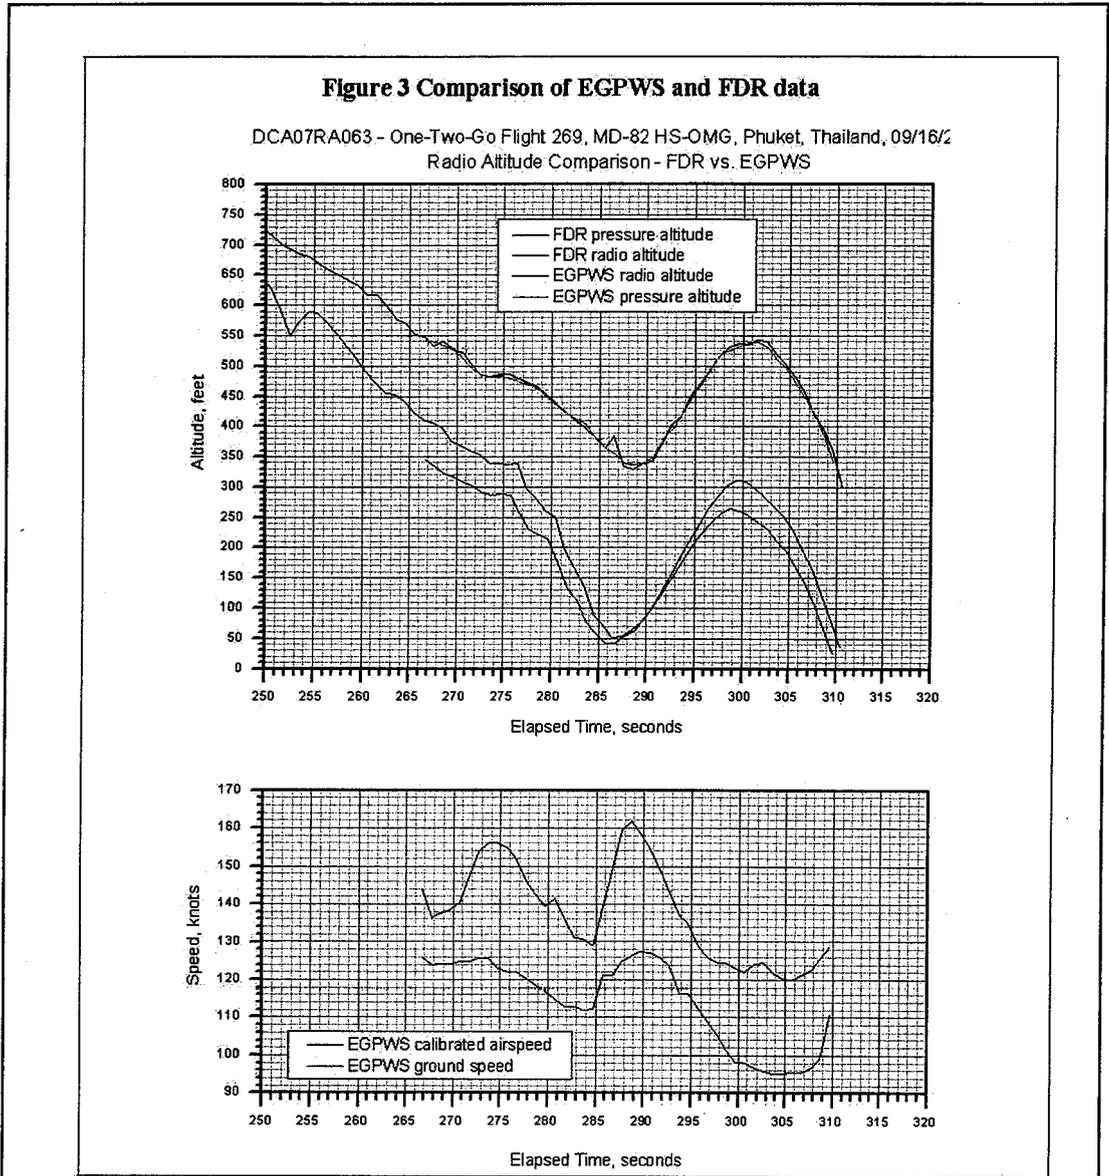
Figure 2 EGPWS Alerts

¹¹ As mentioned previously, an accurate conversion for radio altitude data recorded on the FDR could not be determined. The FDR radio altitude presented in Figure 3 is based on one of the conversions that was evaluated and is included to show the trend of the data compared to the radio altitude recorded on the EGPWS.

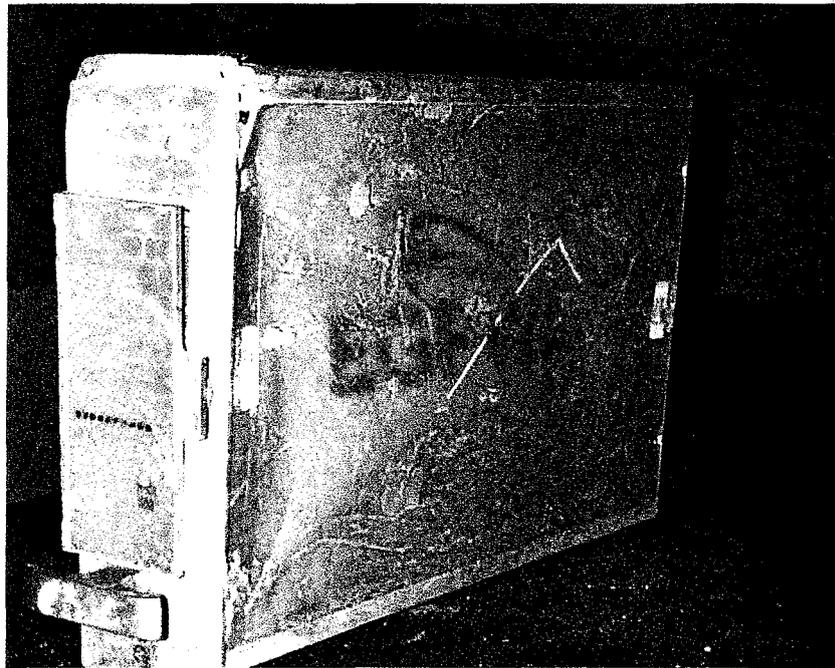
PHOTO 2

Unit removed from aircraft rack

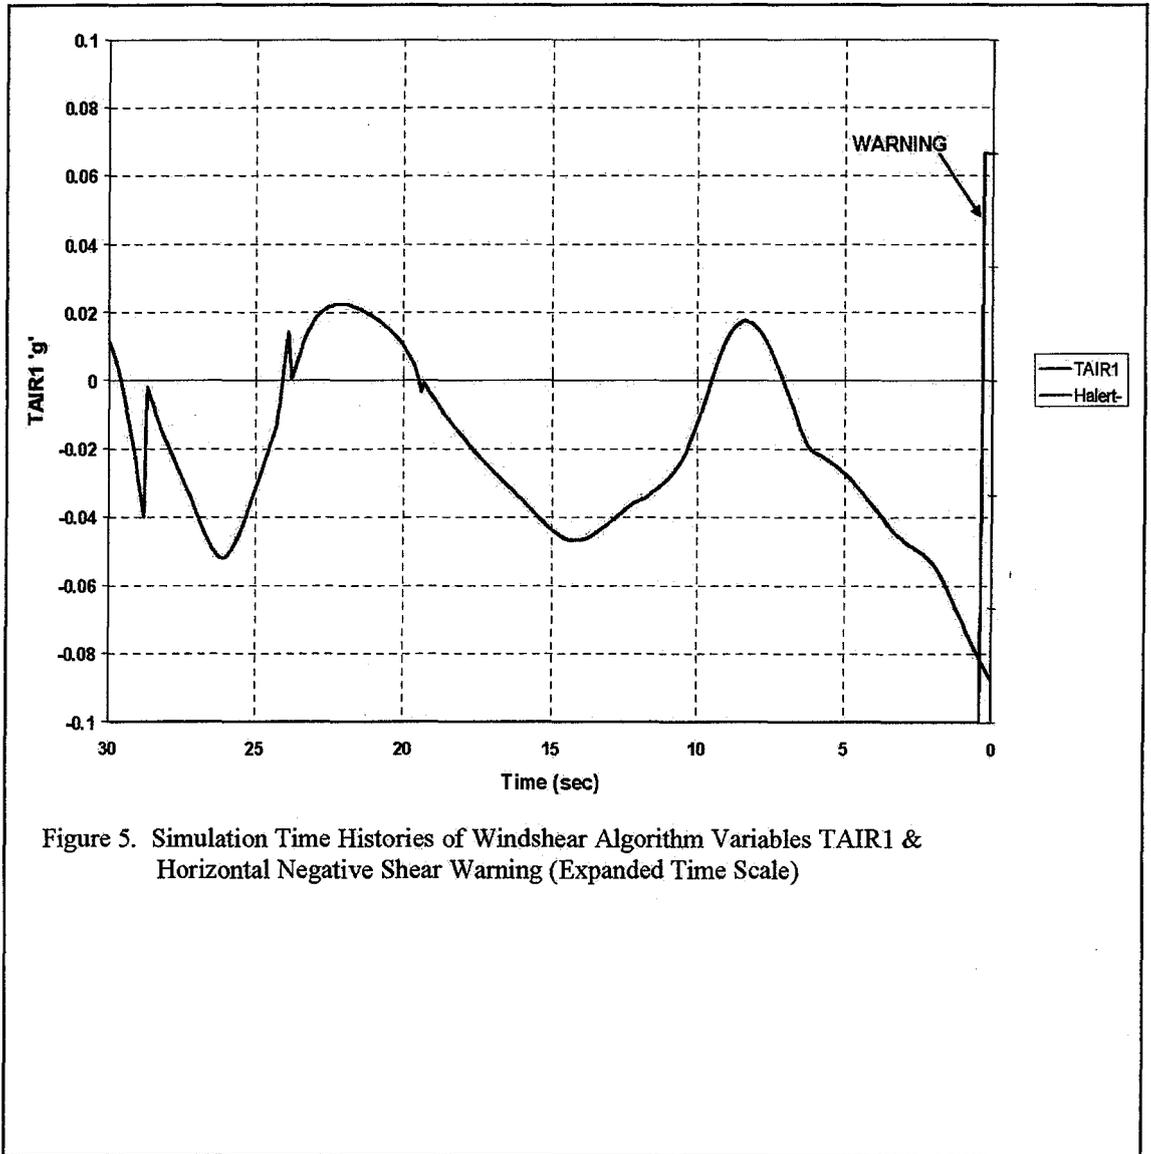
Figure 5. Simulation Time Histories of Windshear Algorithm Variables TAIR1 & Horizontal Negative Shear Warning (Expanded Time Scale)

The variables within the legacy Honeywell algorithm which are most responsive to horizontal shear are the variables TAIR1, TWIND1 and the 'wind vector rotation' variable TVIV. Plots of these variables against time from the simulation are shown in Figure 4. It is the variable TAIR1 which finally exceeds the threshold and causes an alert, as shown in Figure 5.

From the simulation data and accident data, the preliminary conclusion is that the legacy windshear detection system performed its function as intended, and that the performance was compatible with the requirements of FAA TSO-C117.
