AIRCRAFT ACCIDENT REPORT

DANA/2012/06/03/F

Accident Investigation Bureau

**Report on the Accident to
DANA AIRLINES NIGERIA LIMITED
Boeing MD-83 aircraft with registration 5N-RAM
which occurred at Iju-Ishaga Area of Lagos State,
Nigeria
On 3rd June 2012**

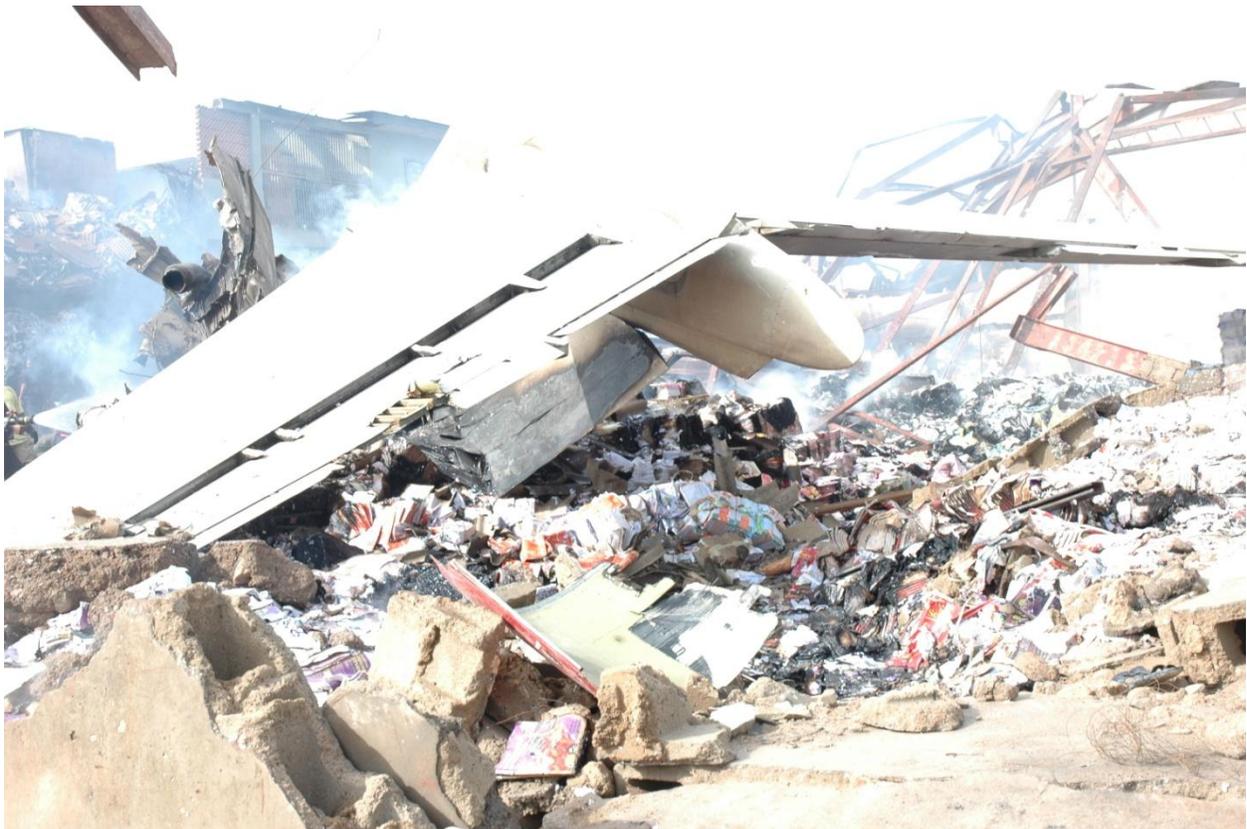
The Aircraft was destroyed. See Figures 1, 2 and 3.

FIGURE 1: TAIL PLANE OF THE AIRCRAFT AT THE CRASH SITE

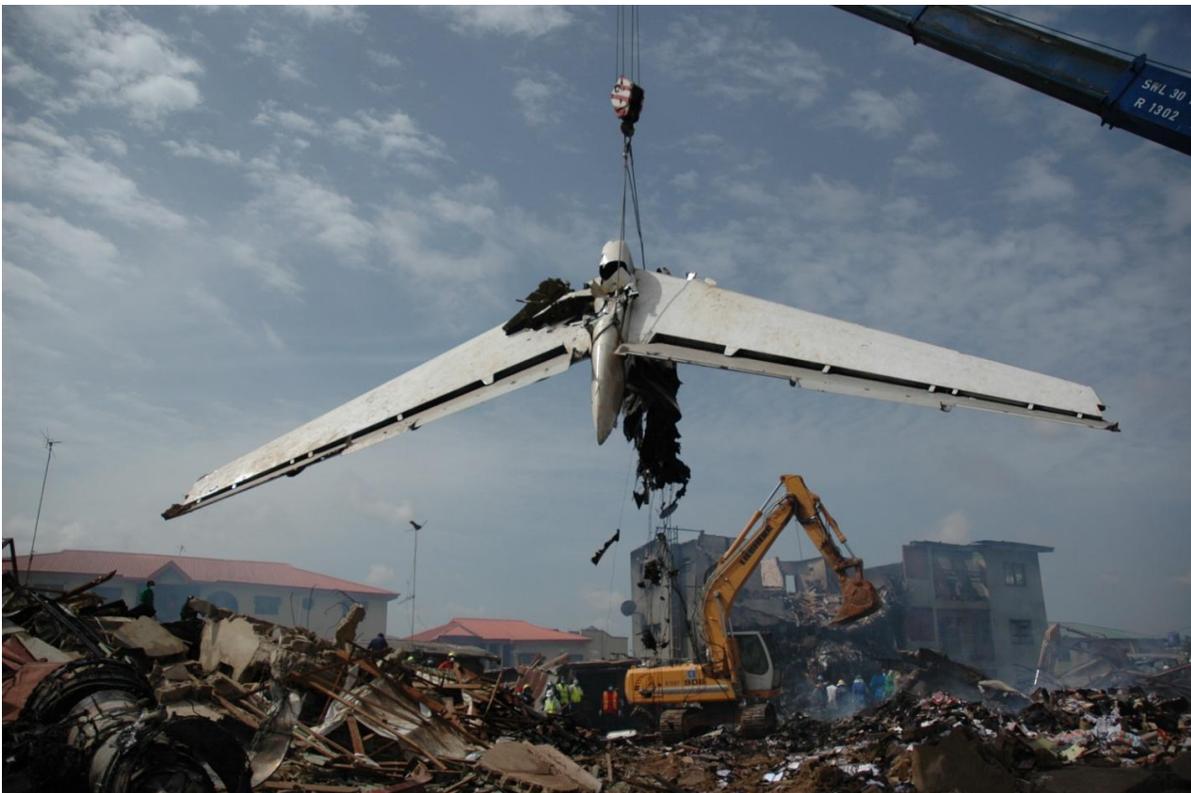
FIGURE 3: THE TAIL PLANE BEING REMOVED FROM THE CRASH SITE

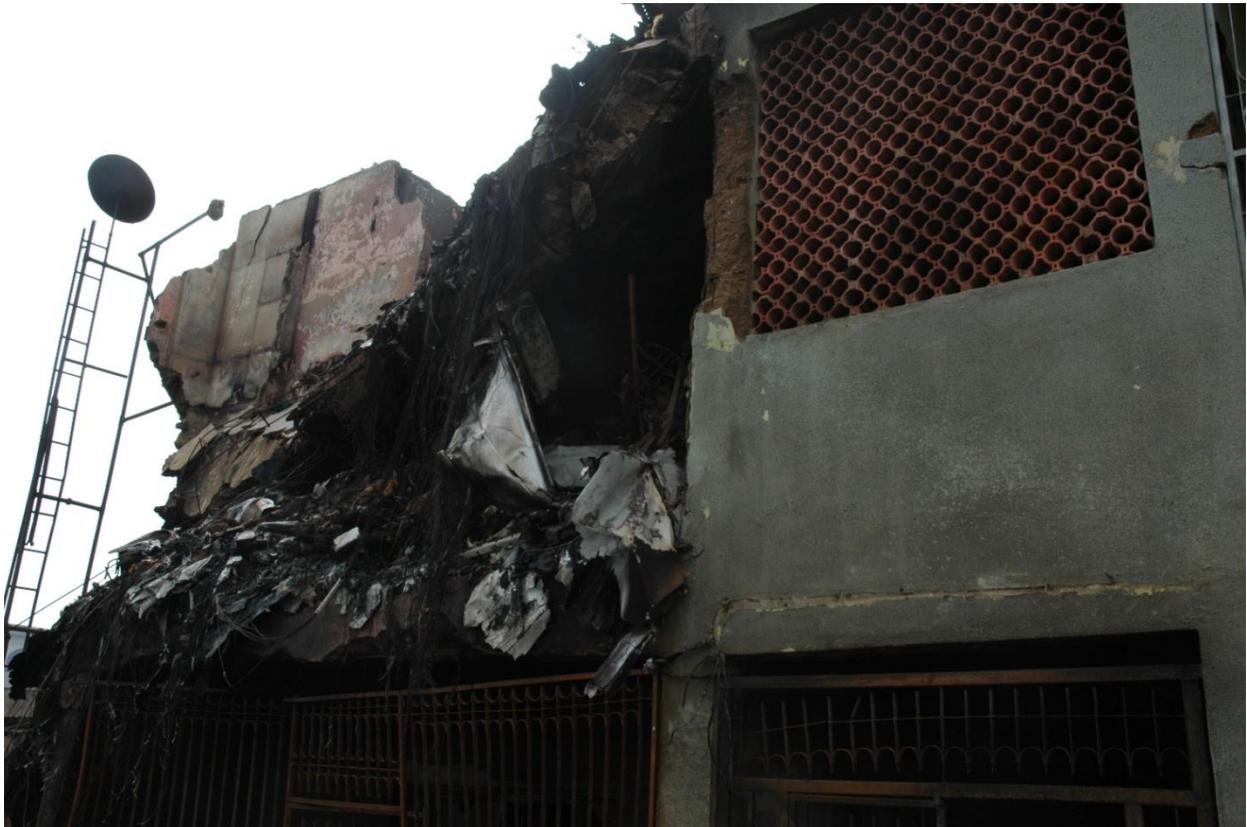
A storey building, one 2-storey building, Power Holding Company of Nigeria (PHCN) electric poles/cables and a warehouse/printing press were completely burnt and destroyed. See Figures 4 and 5.

FIGURE 4: THE 2-STOREY BUILDING THE AIRCRAFT CRASHED INTO

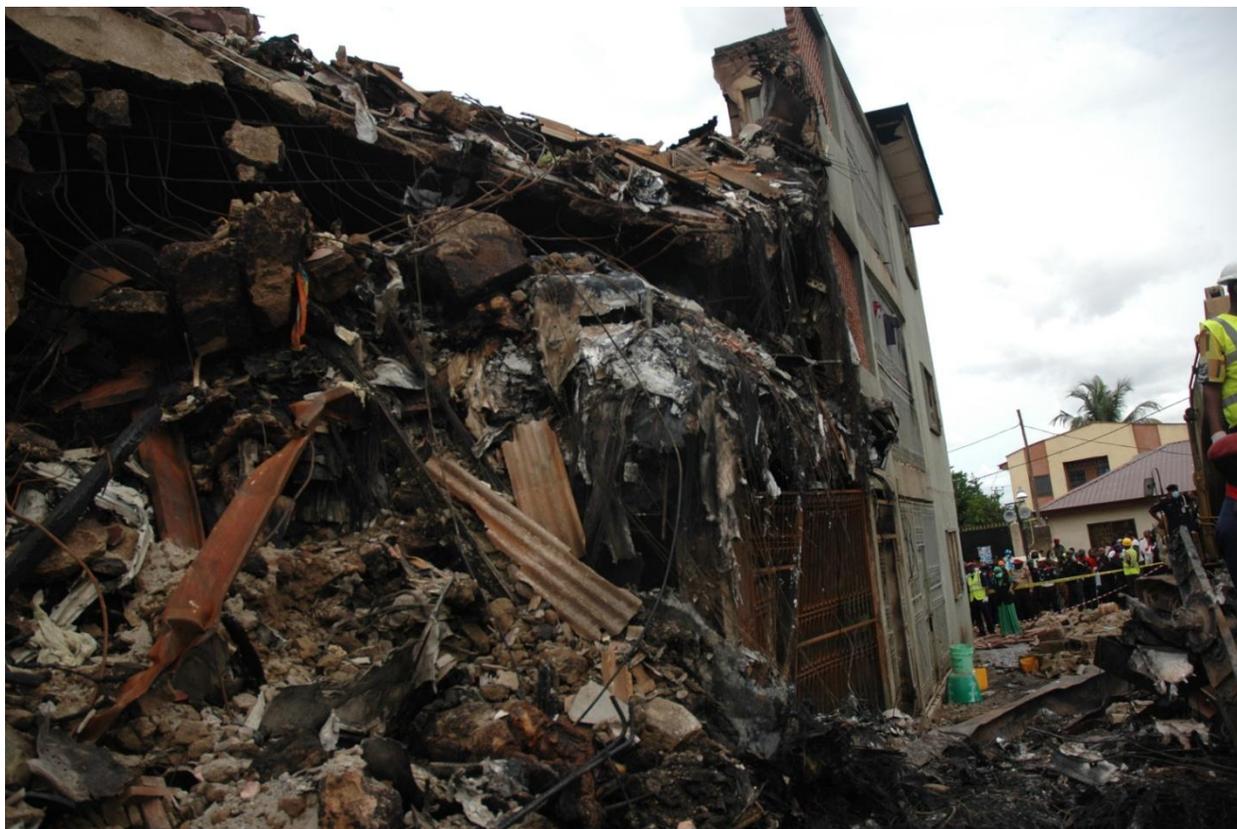
FIGURE 5: THE DAMAGED 2-STOREY BUILDING

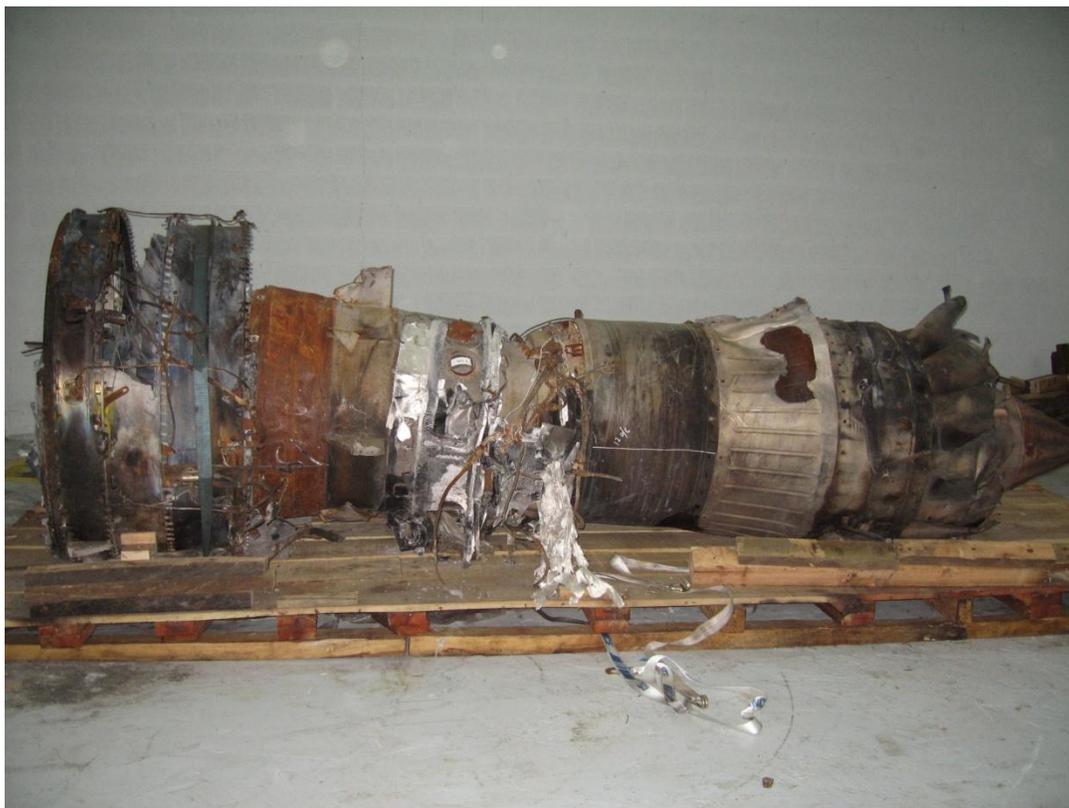
exhaust ducting was missing from the "D"-flange (aft flange of the rear fan case) aft except for a section of the front compressor fan duct that was still attached to the D-flange and ranged from 9 to 13-inches axially and approximately 100° circumferentially.

FIGURE 10: TOP VIEW OF THE NO. 1 ENGINE S/N 718142

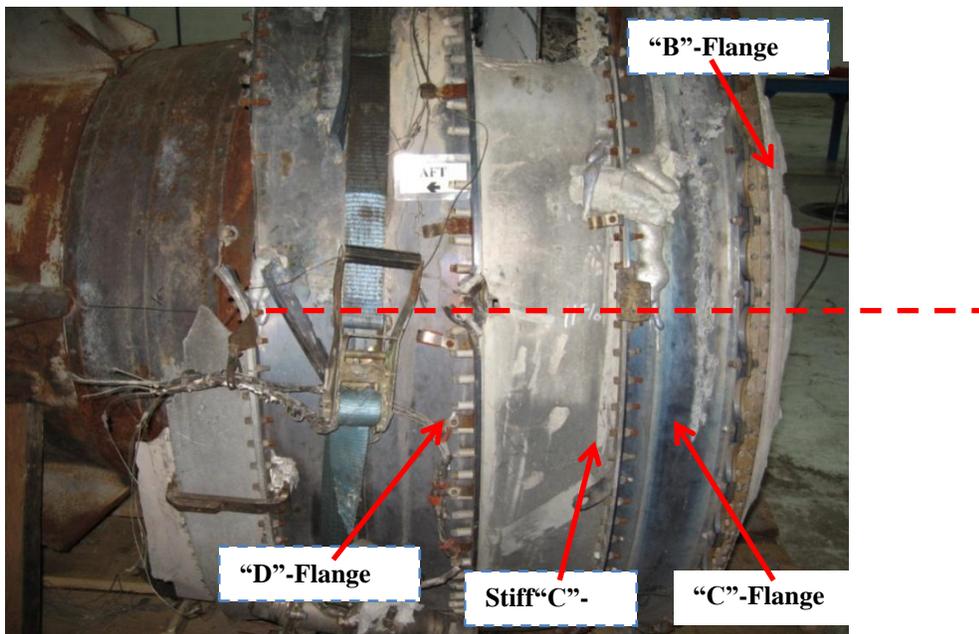
The inlet case, and the rear fan case were intact but the front fan case was missing material from the 5:00 to 10:00 o'clock position. The part of the front fan case that remained exhibited signs of thermal distress and melted material. The inlet case and the front fan case did not exhibit any significant distortion; however, the rear fan case exhibited inward distortion/deformation at the 7:30 o'clock position and also at the 11:00 o'clock position with part of the "D"-flange (approximately 5 bolt holes in length) missing. The "C"-flange (front flange of the rear fan case) was fractured at approximately the 11:00 o'clock position, which was in-line axially with the rear fan case stiffening rib and "D"-flange fractures. All the flange fractures were deformed in the aft direction (**FIGURE 11**).

**FIGURE 11: DAMAGED TO THE FRONT AND REAR FAN CASES
AT THE 11:00 O’CLOCK POSITION**

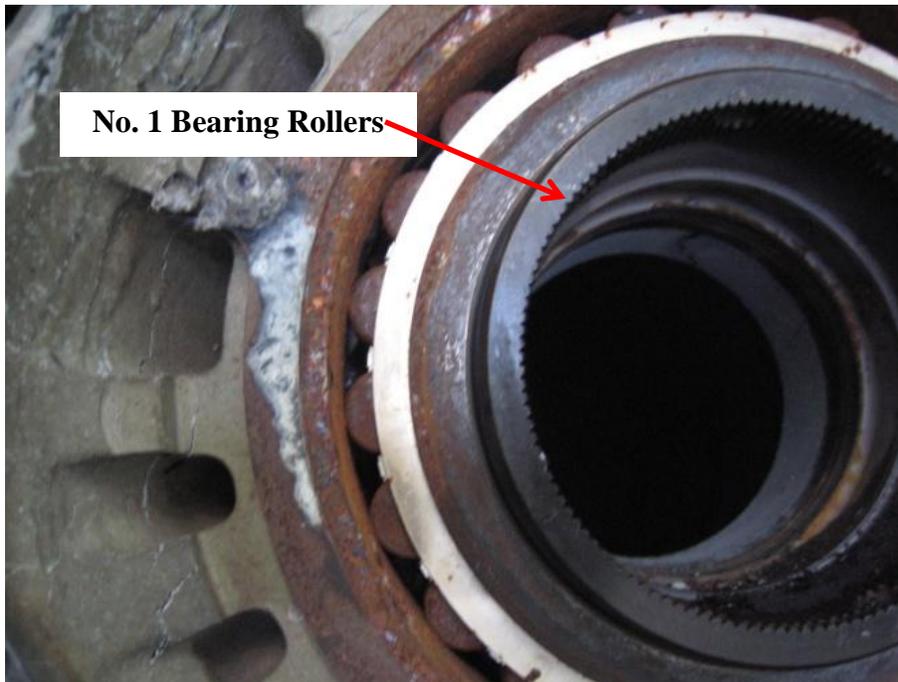
The nose bullet and the front accessory drive cover were both missing, exposing the No. 1 bearing and N1 tachometer (tacho) drive gear. Molten material was observed in the area of the front accessory drive attachment flange. All the No. 1 bearing rollers were present and appeared cylindrical but were covered in rust.¹ The cage was shiny and appeared to be intact (**FIGURE 12**). The N1 tacho drive was intact and undamaged but also covered in rust. The inlet guide vanes (IGVs) were all fractured at their inner diameter (centre body location) with three of the IGVs missing. The IGVs that remained were bent in the direction of rotation (clockwise) at their ID relative to their OD, many were buckled at their outer diameter attachment point, and none exhibited any significant impact damage (**FIGURE 13**). Based on the location of the 6:00 strut, where the No. 1 bearing oil tubes are located, the outer ring of the inlet case with the IGVs still attached was rotated approximately 120° clockwise from the matching centre body strut location.

FIGURE 12: NO. 1 ROLLER BEARING INTACT AND COVERED IN RUST

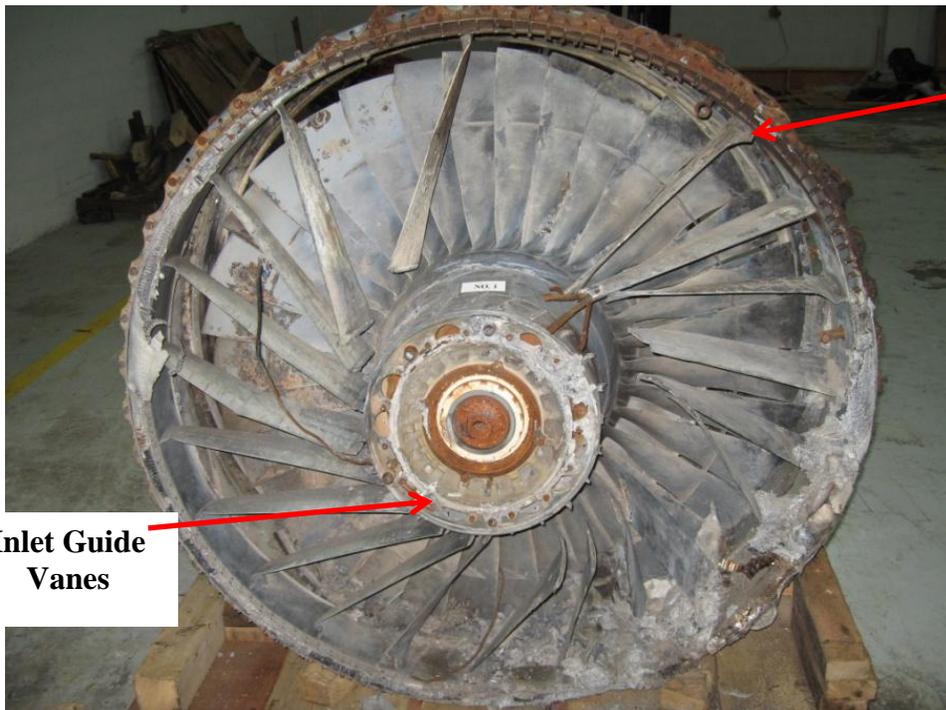
FIGURE 13: INLET CASE WITH FRACTURED AND DAMAGED INLET GUIDE VANES

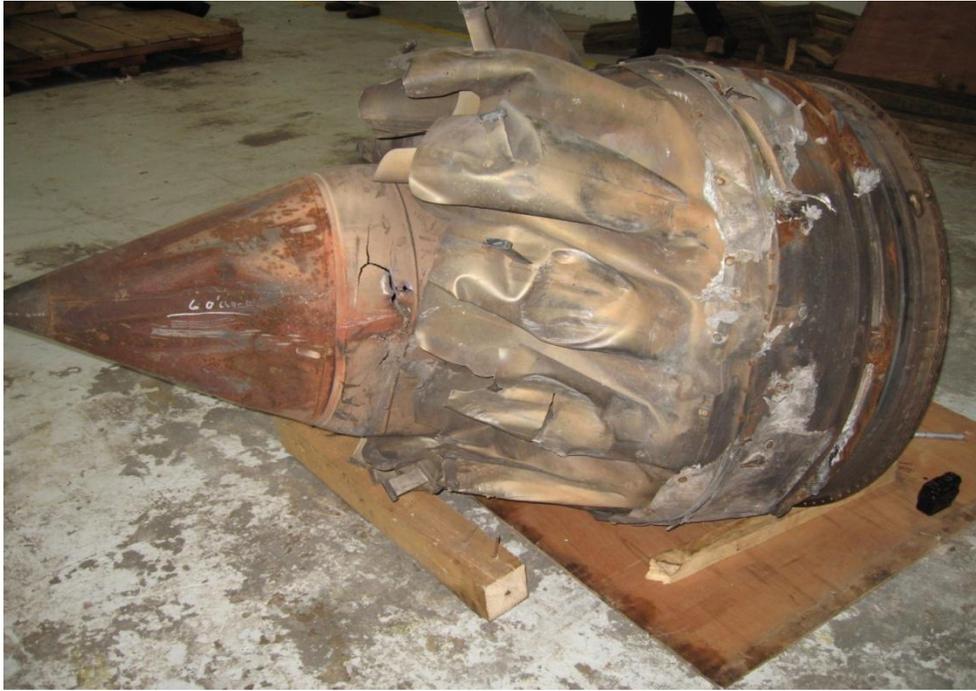
Seven of the tangential fan exhaust duct strut rods that connect the turbine exhaust case to the exhaust duct were still secured to the turbine exhaust case at their inner ends. Five were fractured at their inner end (turbine exhaust case mount rail location), two were almost entirely intact (one at the 2:00 o'clock and one at the 10:00 o'clock position) and fractured at their outer end; the eighth rod was missing. The exhaust mixer remained attached to the turbine exhaust case. At the 6:00 o'clock position, exhaust mixer was deformed inwards with longitudinal/axial scrape marks. The majority of the remainder of the mixer was pushed/buckled inwards and forward. The turbine exhaust inner duct and tail cone were still attached to the turbine exhaust case centre body (No. 6 bearing housing). The turbine exhaust duct was dented and cracked at the 6:00 o'clock position, in-line with inward deformation of the tail cone. The deformed area of the tail cone also exhibited axial scrape marks (**FIGURE 14**). No other significant damage was noted on the exhaust duct or tail cone.

FIGURE 14: EXHAUST CASE, INNER DUCT, CONE AND MIXER DAMAGE AT THE 6:00 O'CLOCK POSITION

The exhaust mixer lobes exhibited crushing damage both radially inward and forward from the 6:00 to 9:00 o'clock positions. The tail cone and inner exhaust duct were both present and undamaged (**FIGURE 14**). There was no distress noted in the exhaust duct mount rails.

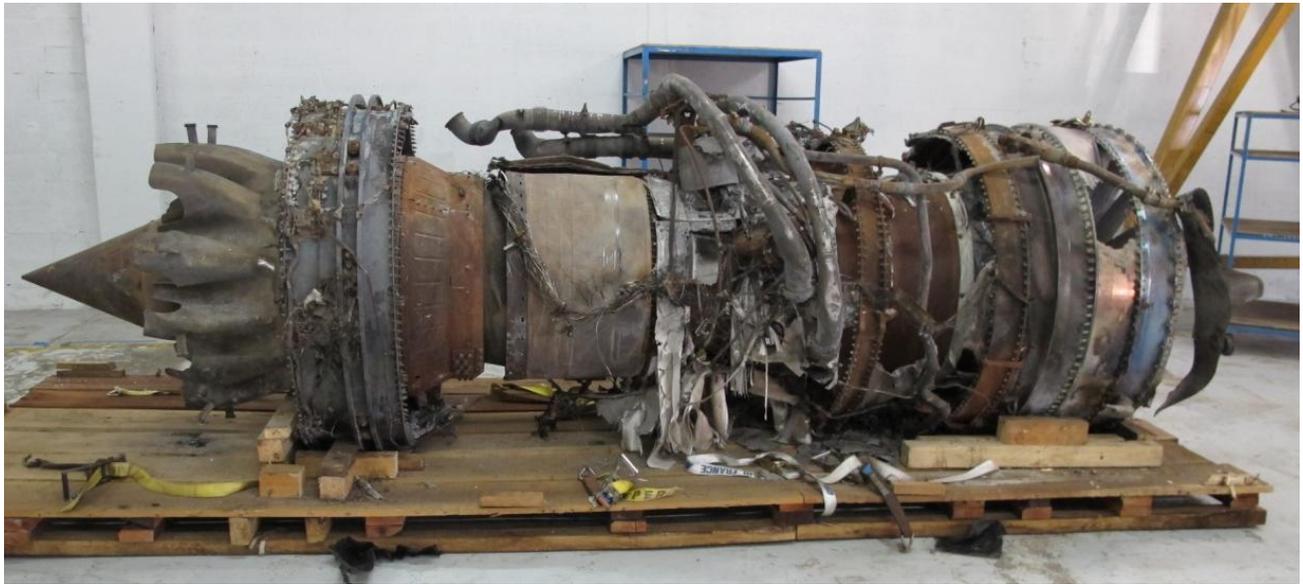
The engine was un-crated and placed on pallets for examination and disassembly (**FIGURE 16**). The engine was intact from the nose bullet aft to the exhaust tail cone with all major modules in place. Engine cases appeared round and did not exhibit signs of structural deformation or case breach. Fan and exhaust ducting was missing from the "E"-flange (aft flange of the fan exit guide vane (FEGV) Outer Case) aft to the "F"-flange (forward flange intermediate case outer diameter ring) and from the "G"-flange (aft flange of the intermediate case outer diameter ring) to the "K"-flange (forward flange of the turbine case outer diameter ring). Some wiring, and pneumatic and oil system plumbing along with crash debris were removed to facilitate teardown (**FIGURE 17**).

FIGURE 16: RIGHT-HAND SIDE OF THE NO. 2 ENGINE S/N 728113

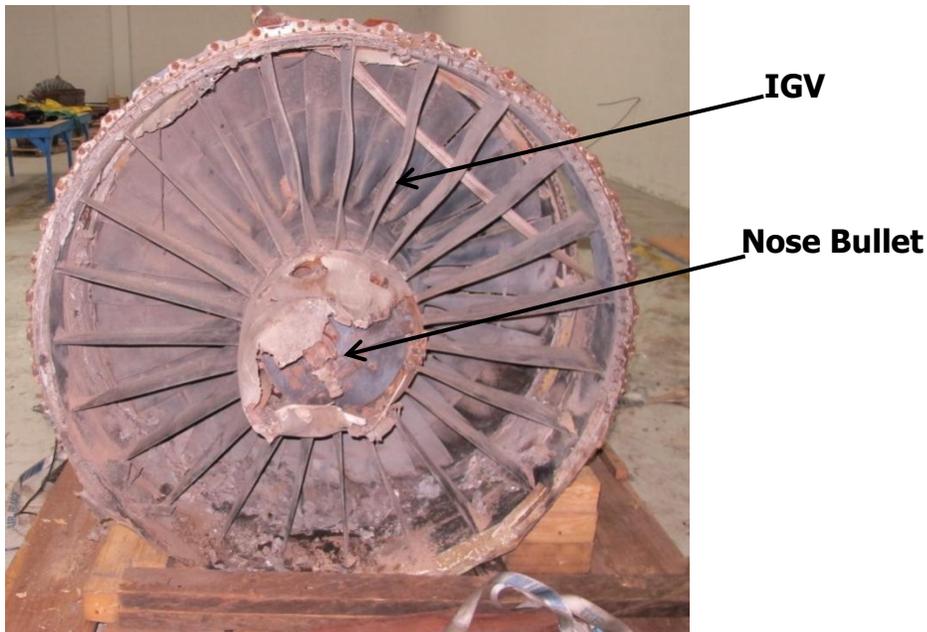
The inlet area was inspected and it was noted that the inlet nose bullet was partially melted exposing the front accessory drive cover. All the IGV's were in place and secure with five vanes, located between the 10:00 o'clock and 12:00 o'clock positions, buckled at the mid-span (**FIGURE 18**). No significant leading edge impact damage was noted.

FIGURE 18: ENGINE INLET

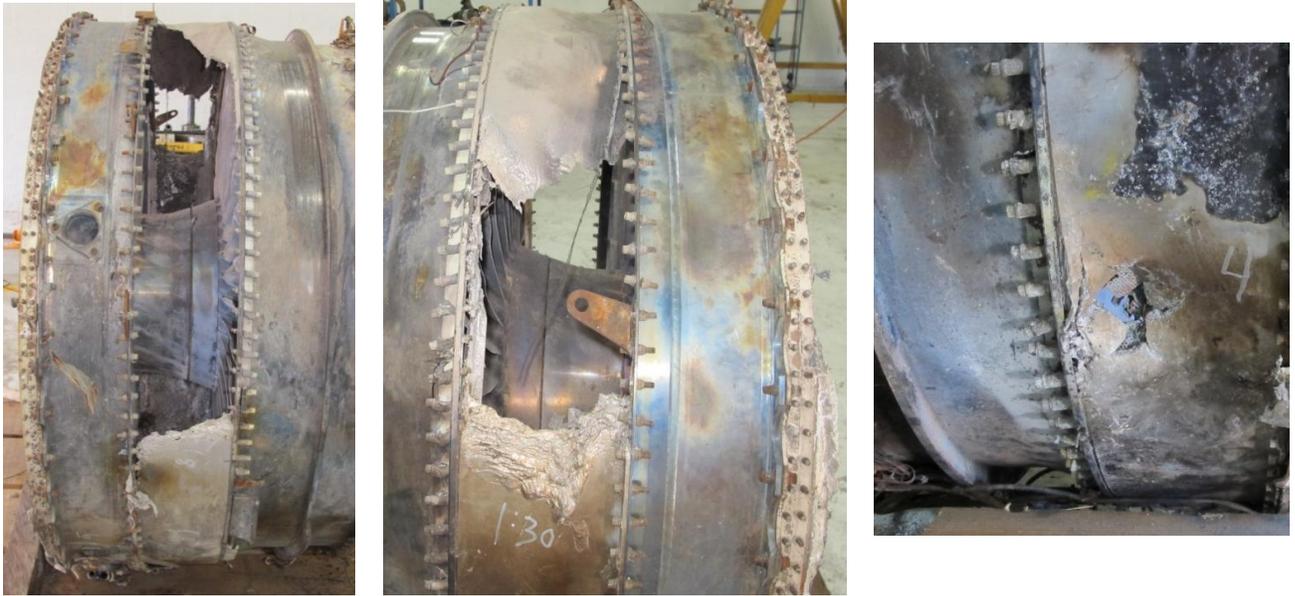
The forward fan case exhibited damage in three locations. Case material was missing circumferentially from the 12:00 to 1:30 positions and from the 8:00 to 11:00 o'clock positions, the edges of these holes exhibited thermal distress and indications of melting. An inward puncture with associated case deformation was present at the 4:00 o'clock position, approximately 4 inches in diameter with indications of melting around the fracture surfaces (**FIGURE 19**).

FIGURE 19: FORWARD FAN CASE THERMAL AND IMPACT DAMAGE

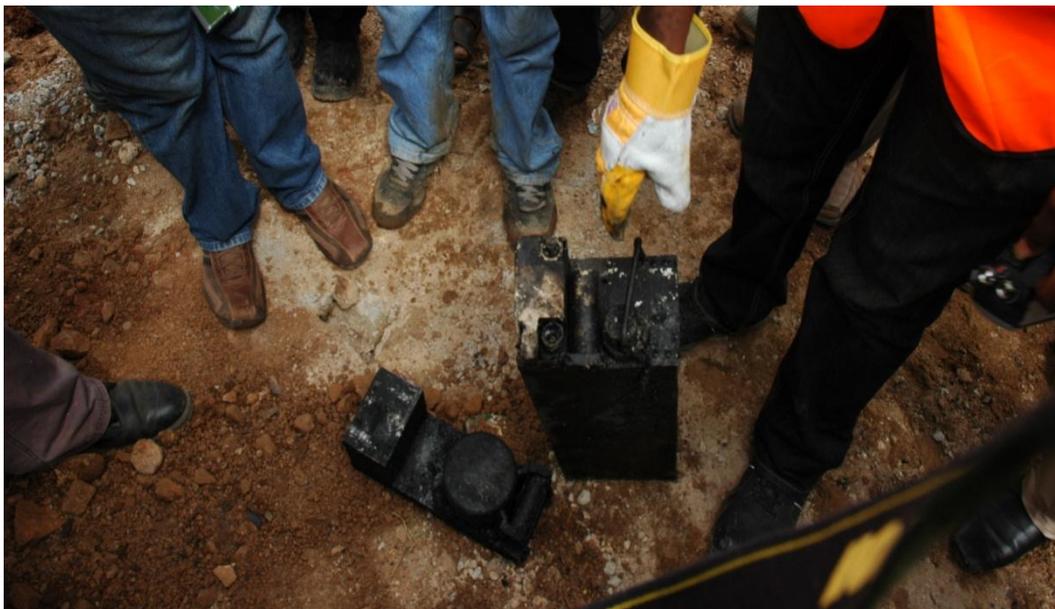
FIGURE 27: PICTURE OF THE SEVERELY BURNT FLIGHT RECORDERS

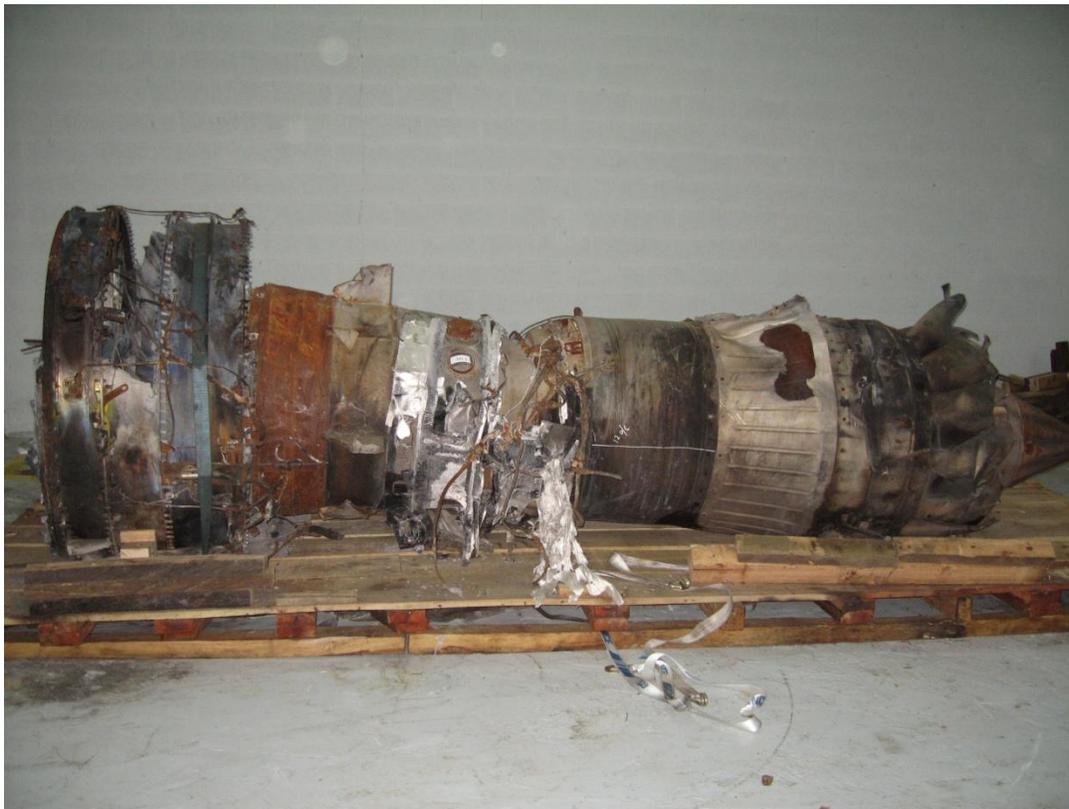
The engine was un-crated and placed on pallets for examination and disassembly (**PHOTO 1**). The inlet case, and the front and rear fan cases were attached as a unit, but were no longer attached to the rest of the engine. This unit was clocked approximately 120° clockwise direction relative to the core of the engine. The fan and exhaust ducting was missing from the "D"-flange (aft flange of the rear fan case) aft except for a section of the front compressor fan duct that was still attached to the D-flange and ranged from 9 to 13-inches axially and approximately 100° circumferentially.

PHOTO 1: TOP VIEW OF THE NO. 1 ENGINE SN 718142

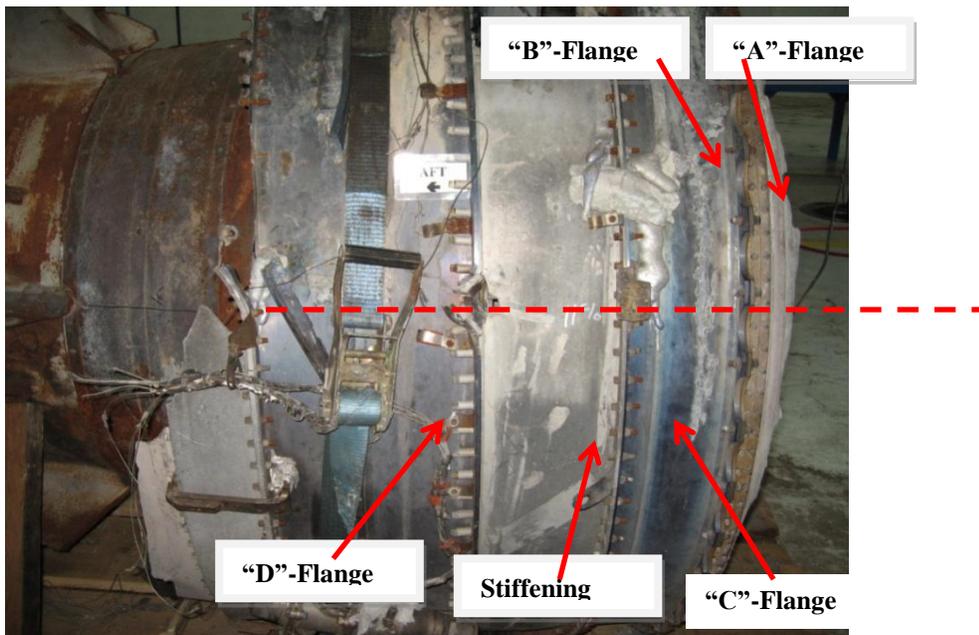
The inlet case, and the rear fan case were intact but the front fan case was missing material from the 5:00 to 10:00 o'clock position. The part of the front fan case that remained exhibited signs of thermal distress and melted material. The inlet case and the front fan case did not exhibit any significant distortion; however, the rear fan case exhibited inward distortion/deformation at the 7:30 o'clock position and also at the 11:00 o'clock position with part of the "D"-flange (approximately 5 bolt holes in length) missing. The "C"-flange (front flange of the rear fan case) was fractured at approximately the 11:00 o'clock position, which was in-line axially with the rear fan case stiffening rib and "D"-flange fractures. All the flange fractures were deformed in the aft direction (**PHOTO 2**).

PHOTO 2: DAMAGED TO THE FRONT AND REAR FAN CASES AT THE 11:00 O'CLOCK POSITION

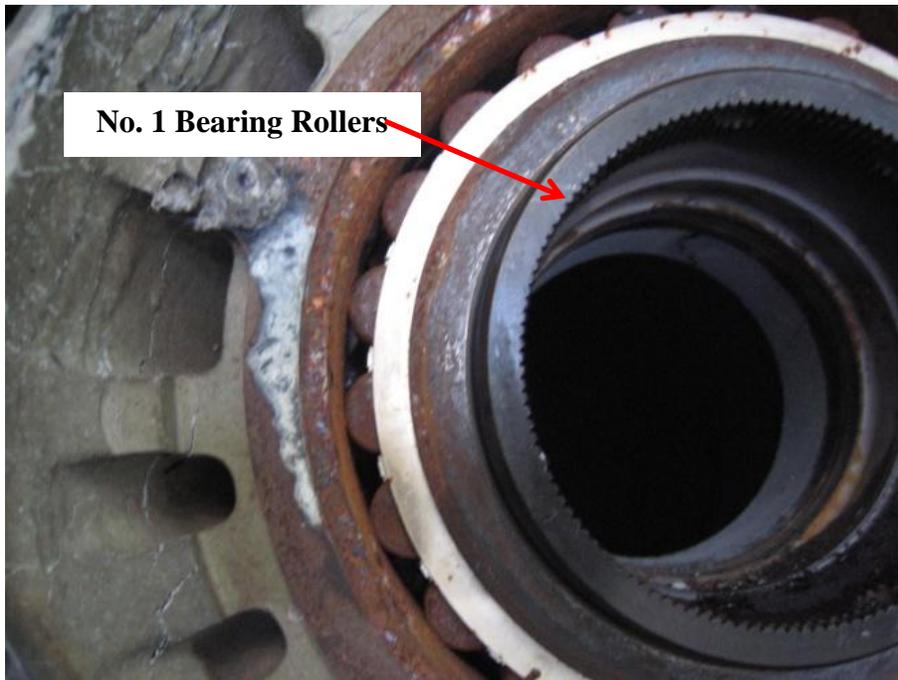
undamaged but also covered in rust. The inlet guide vanes (IGVs) were all fractured at their inner diameter (center body location) with three of the IGVs missing. The IGVs that remained were bent in the direction of rotation (clockwise) at their ID relative to their OD, many were buckled at their outer diameter attachment point, and none exhibited any significant impact damage (**PHOTO 4**). Based on the location of the 6:00 strut, where the No. 1 bearing oil tubes are located, the outer ring of the inlet case with the IGVs still attached was rotated approximately 120° clockwise from the matching center body strut location.

PHOTO 3: NO. 1 ROLLER BEARING INTACT AND COVERED IN RUST

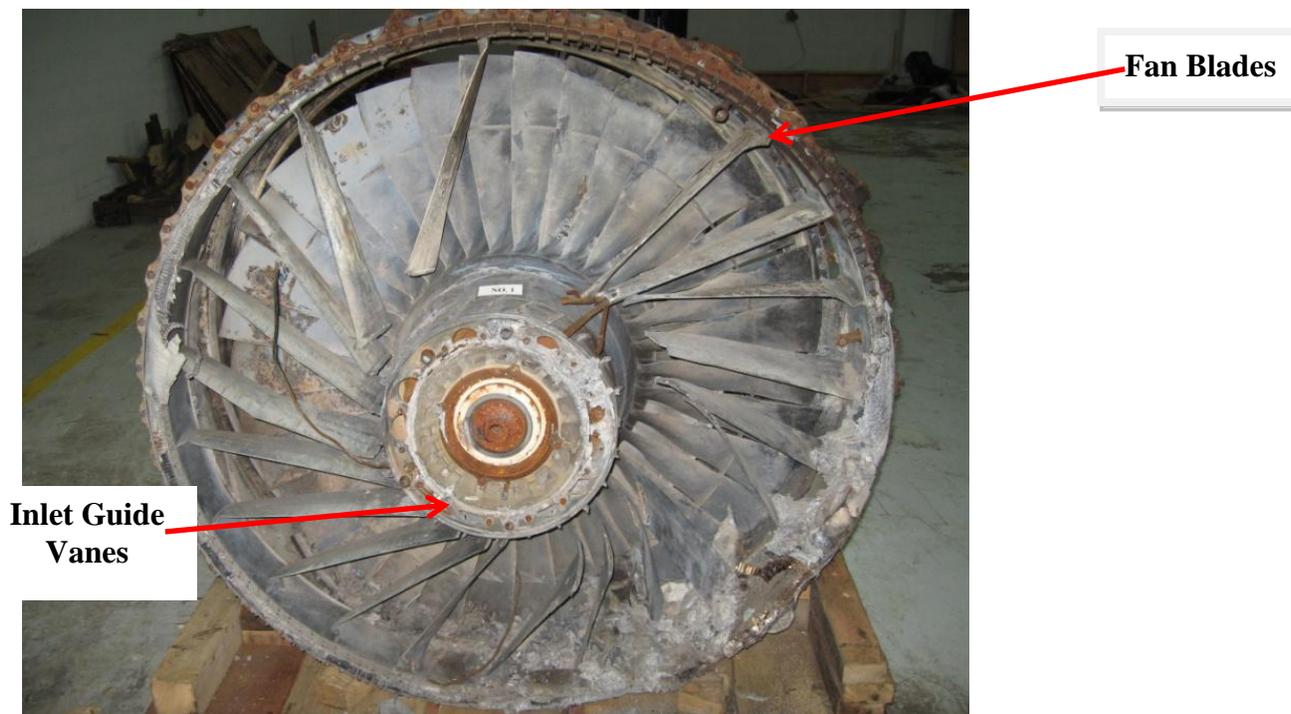
PHOTO 4: INLET CASE WITH FRACTURED AND DAMAGED INLET GUIDE VANES

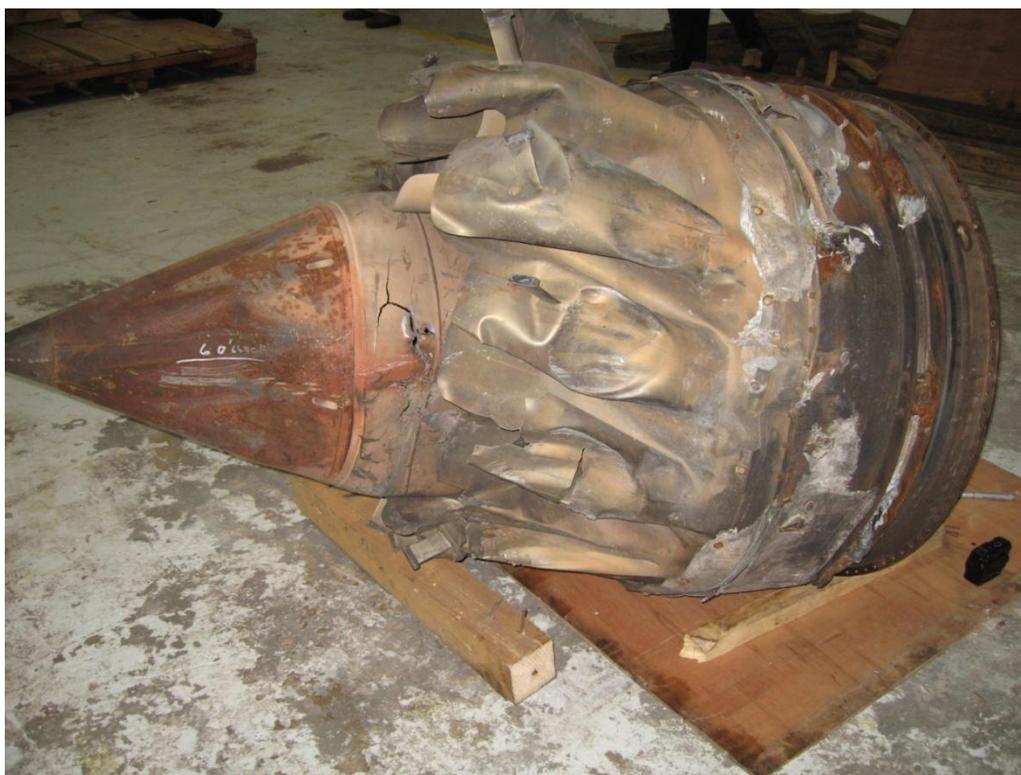
Seven of the tangential fan exhaust duct strut rods that connect the turbine exhaust case to the exhaust duct were still secured to the turbine exhaust case at their inner ends. Five were fractured at their inner end (turbine exhaust case mount rail location), two were almost entirely intact (one at the 2:00 o'clock and one at the 10:00 o'clock position) and fractured at their outer end; the eighth rod was missing. The exhaust mixer remained attached to the turbine exhaust case. At the 6:00 o'clock position, exhaust mixer was deformed inwards with longitudinal/axial scrape marks. The majority of the remainder of the mixer was pushed/buckled inwards and forward. The turbine exhaust inner duct and tail cone were still attached to the turbine exhaust case center body (No. 6 bearing housing). The turbine exhaust duct was dented and cracked at the 6:00 o'clock position, in-line with inward deformation of the tail cone. The deformed area of the tail cone also exhibited axial scrape marks (**PHOTO 5**). No other significant damage was noted on the exhaust duct or tail cone.

PHOTO 5: EXHAUST CASE, INNER DUCT, CONE AND MIXER DAMAGE AT THE 6:00 O'CLOCK POSITION

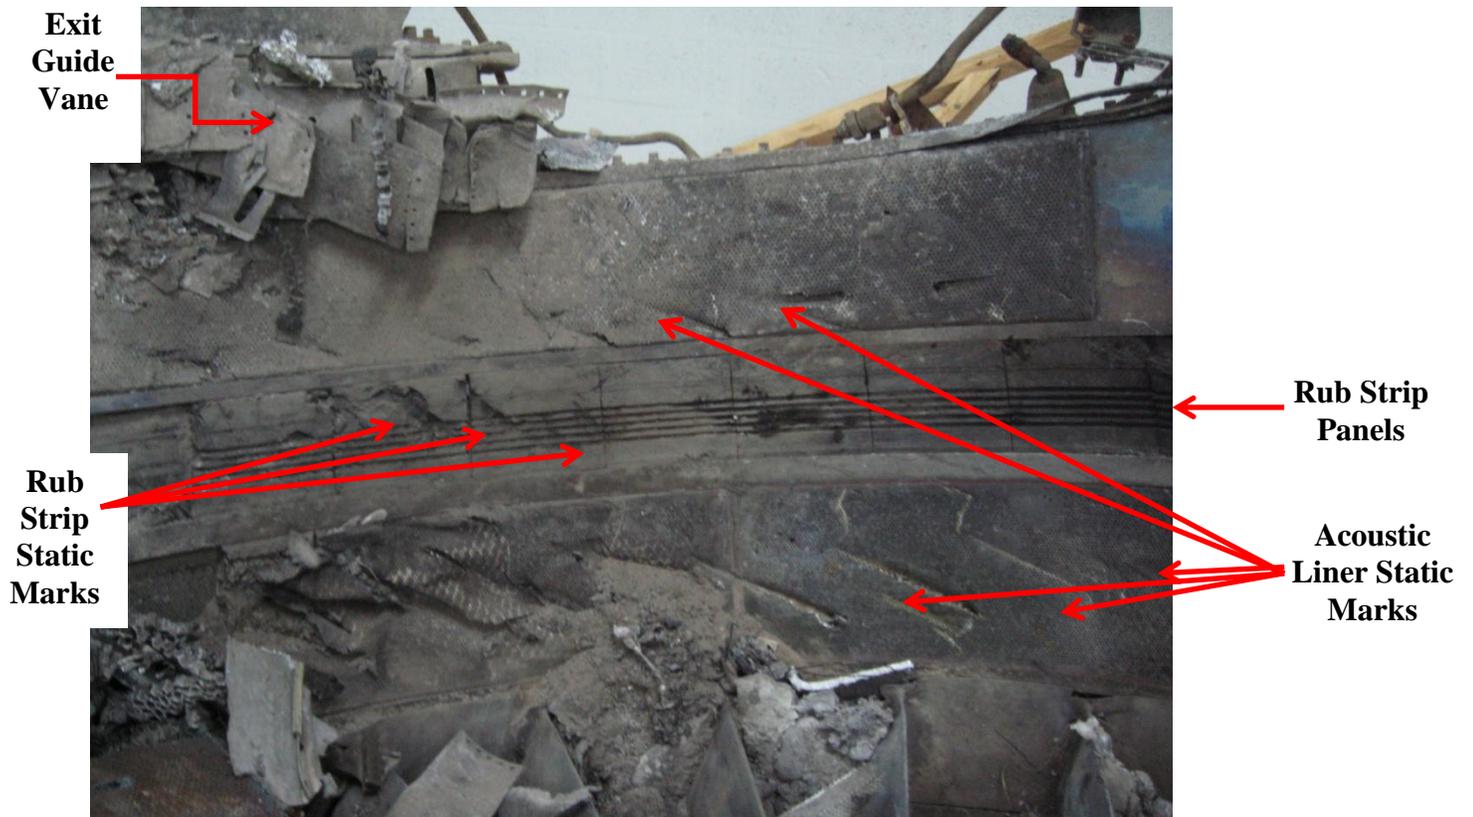
The inlet case, and the front and rear fan cases were cut at approximately the 5:00 and 12:00 o'clock positions to facilitate removal from the fan module (front compressor module). The right-hand section (12:00 to 5:00 o'clock) had no fan rub strip material present and all the exit guide vanes were missing. The left-hand side (5:00 to 12:00 o'clock) had 7 ½ fan rub strip panels present – from approximately the 2 to 5 o'clock position. No circumferential rubbing or gouging was observed; however, a couple of panels located at approximately the 3 o'clock position exhibited what appeared to be longitudinal static marks at angles and spacing not consistent (tighter) with typical fan blade static marks. These panels also exhibited more physical and thermal distress than the other panels still present. The acoustic liners located forward and aft of the fan blade running position exhibited slicing and gouging marks more consistent with typical fan blade static marks. The impact marks in the forward acoustic liner were approximately 5-inches forward of the normal fan blade running position and the impact marks in the aft acoustic liner were approximately 7-inches aft the fan blade normal running position. Ten exit guide vanes, around the 2:00 to 3:00 o'clock position, remained attached to the outer ring and all the vanes were bent over in the direction of rotation (clockwise) at their ID relative to their OD (**PHOTO 6**).

PHOTO 6: FAN CASE DAMAGE

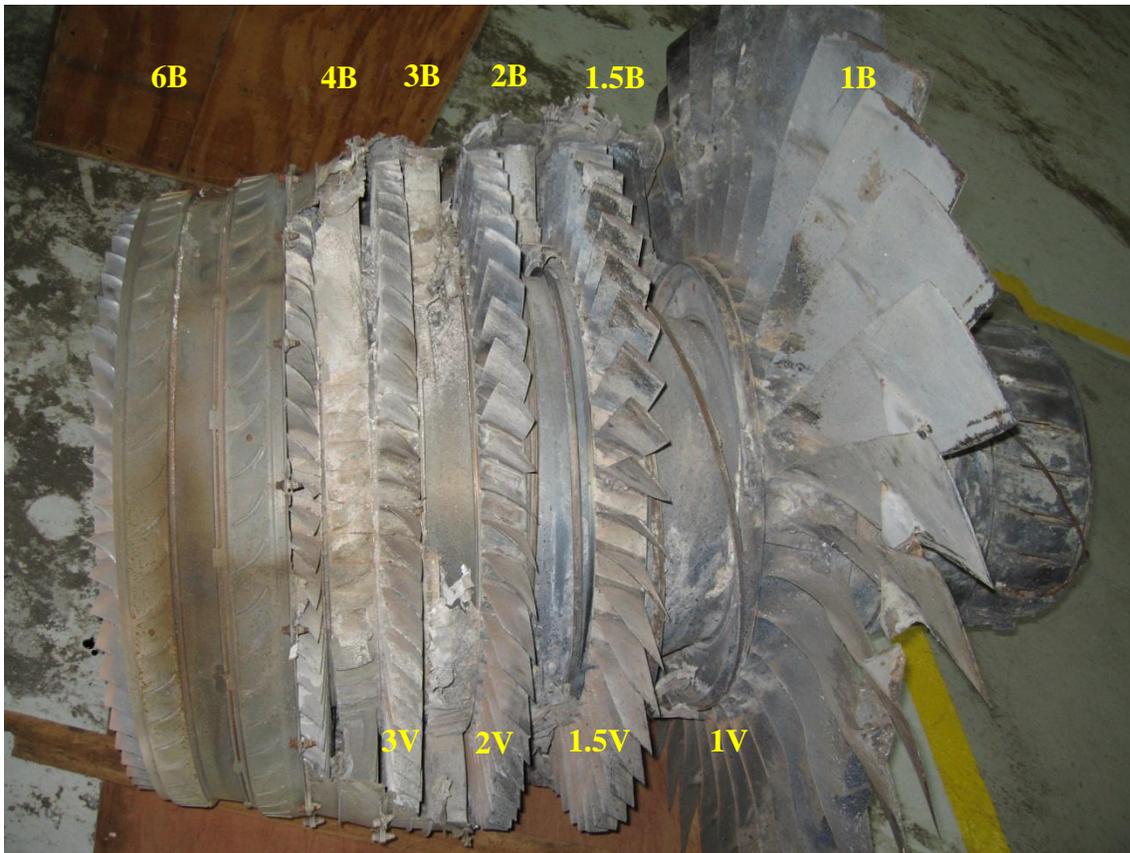
damage. The melted front outer compressor cases stages 1 through 3 also exposed the stators as follows: 1) stage 1, vanes missing from the 3:00 to 10:00 o'clock position, 2) stage 1.5, vanes missing from the 3:00 to 9:00 o'clock position, 3) stage 2, vanes missing from the 4:00 to 8:00 o'clock position and 4) stage 3, vanes missing from 5:00 to 7:00 o'clock position. In each of these stages, the vanes that remained exhibited thermal distress and melting. In stage 4, vanes were visible from approximately the 4:00 to 7:00 o'clock position looking through the stage 4 blades and in stage 5 all the vanes were visible looking through the stage 6 rotor blades. In general, the stage 4 and 5 vanes were present, in good condition and did not exhibit airfoil damage. The stage 4 and 5 outer shroud rings were intact and did not exhibit thermal distress.

PHOTO 7: FRONT COMPRESSOR ROTOR AND STATOR BLADE, VANE, AND OUTER CASE DAMAGE

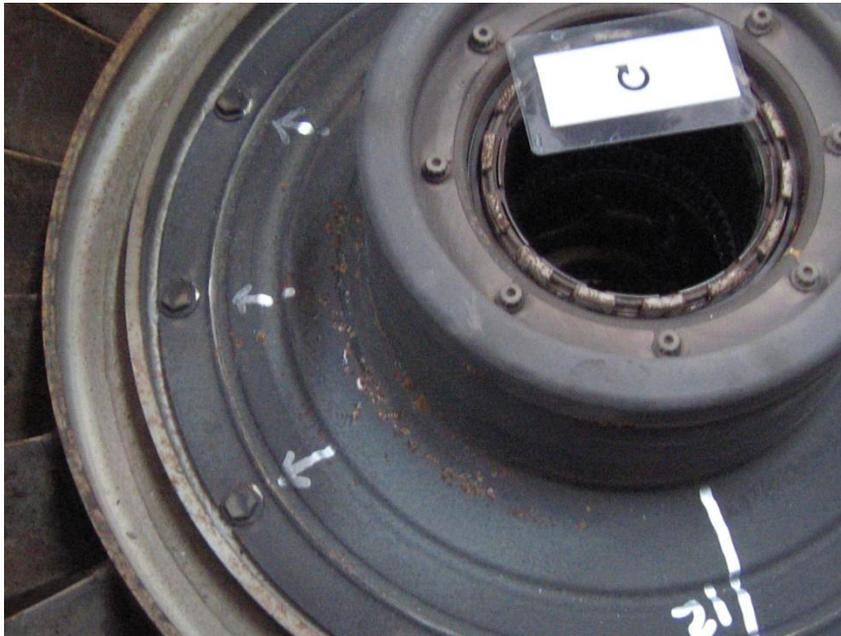
The No. 3 bearing spun freely and smoothly when turned by hand. The oil from the No. 2/3 compartment was dark in color but did not exhibit an acrid odor. The No. 3 bearing housing aft cover exhibited light 360° circumferential scoring with the heaviest located between the 3:00 and 6:00 o'clock positions. In this area, the washers underneath the aft cover attachment bolts at 3 locations were also rubbed (**PHOTO 10**). Reviewing the engine cross-section, the washer and aft housing cover rub was in-line with the forward end of the HPC tie-rods.

PHOTO 10: No. 3 BEARING HOUSING AFT COVER CONTACT RUB

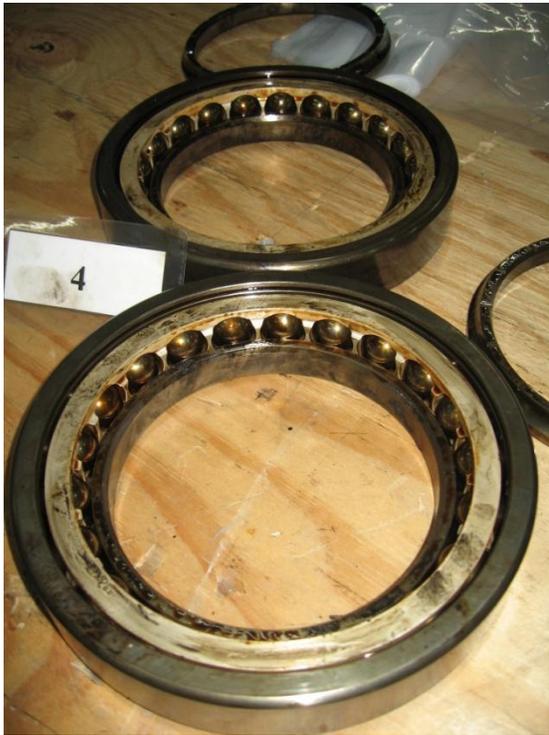
The No. 4 duplex ball bearing spun freely and smoothly when turned by hand. All balls were present, shiny, oil-wetted, and secured in their cages which were also intact (**PHOTO 11**). The inner races were shiny, oil wetted, and in good condition.

PHOTO 11: NO. 4 BEARING - GOOD CONDITION

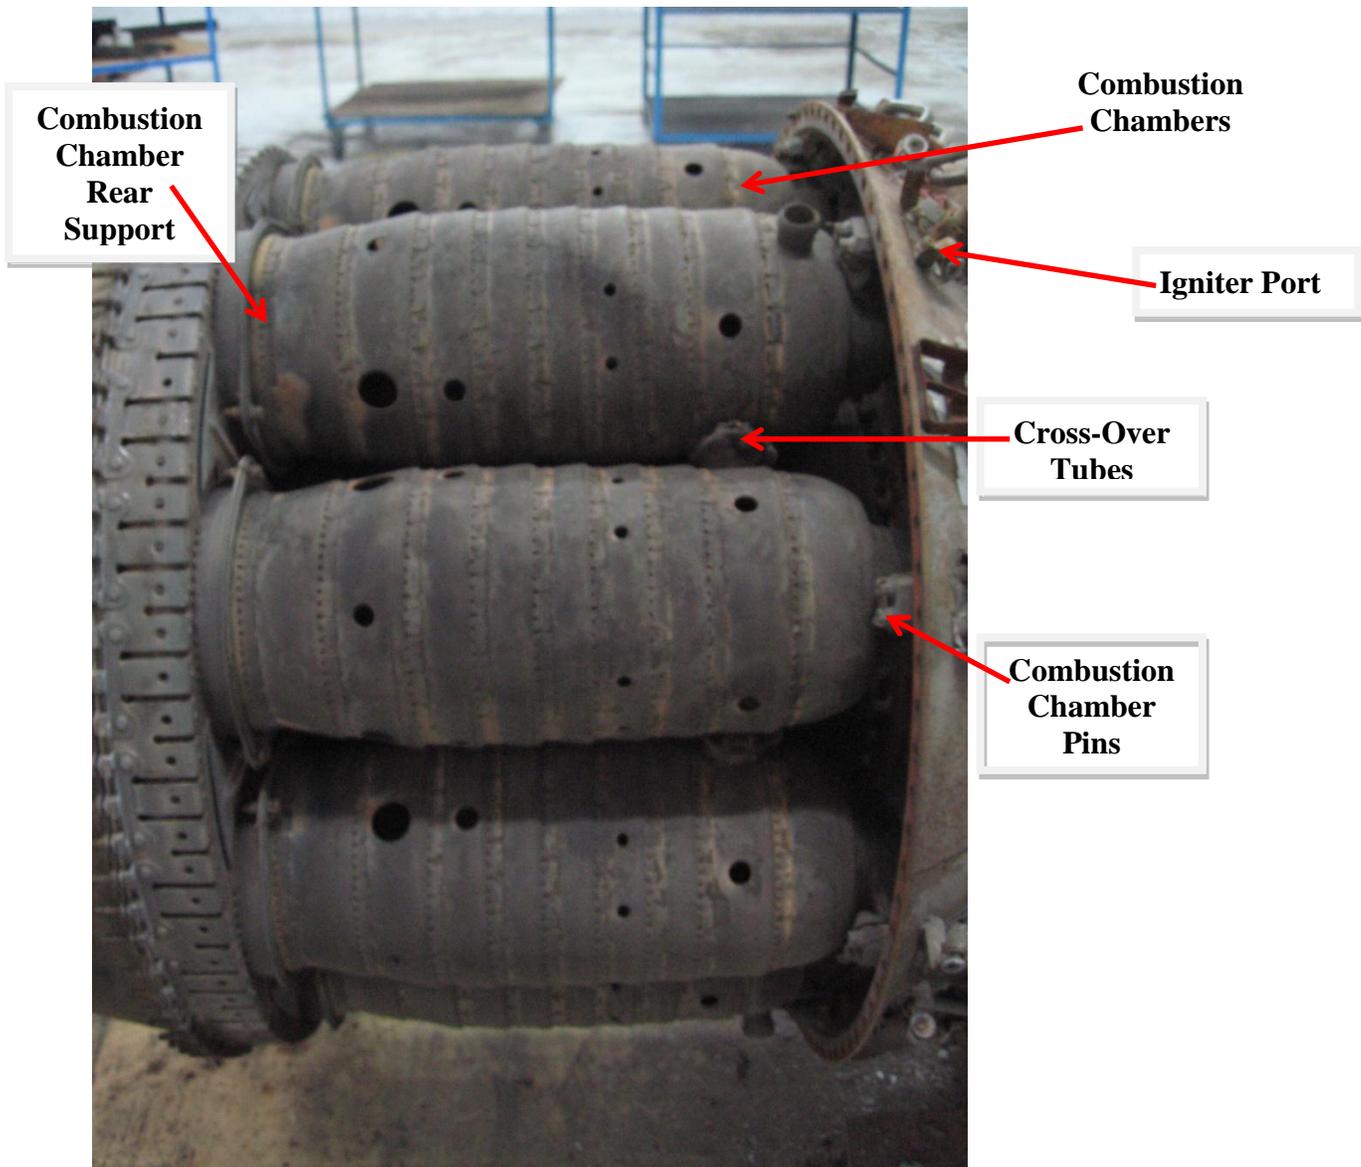
Nine one piece combustion chambers (or burner cans) are located between the combustion chamber outer cases and the combustion chamber inner case in a can-annular arrangement. All nine combustion chambers were present, secure, intact, and exhibited no thermal distress (burn-through or erosion), cracking in the louvers or dilution holes, burn-through, or impact damage (**PHOTO 12**). All nine combustion chambers were secured at the front by positioning pins that were intact and safety wired. The aft ends of the combustion chambers were secured into the front of the combustion chamber rear support assembly. All the interconnecting cross-over tubes were present, secured, and lockwired. The combustion chambers were removed to expose the interior of the chambers and the fuel nozzles. All nine combustion chambers exhibited a similar condition: 1) no thermal distress (burn-through or erosion), 2) no localized sooting, or evidence of nozzle streaking in the ID of the chambers, 3) some minor flaking/chipping of the thermal barrier coating on the ID of the chambers, 4) no significant contact wear on the pin support, fuel nozzle port, cross-over tubes, or rear skirt, and 5) no significant cracking of the dilution holes or louvers. Some of the combustion chambers exhibited a white fibrous growth on the ID of the chambers. Tactilely the growth lacked structure and felt soft. All the combustion chamber support pins were intact and no appreciable wear was noted. The combustion chamber rear support assembly was in good condition and no wear or thermal distress was noted on the combustion chamber supports.

PHOTO 12: COMBUSTION CHAMBERS STILL INSTALLED IN THE ENGINE - NO VISIBLE THERMAL DISTRESS
