AIRCRAFT ACCIDENT REPORT

DANA/2012/06/03/F

Accident Investigation Bureau

**Report on the Accident to
DANA AIRLINES NIGERIA LIMITED
Boeing MD-83 aircraft with registration 5N-RAM
which occurred at Iju-Ishaga Area of Lagos State,
Nigeria
On 3rd June 2012**

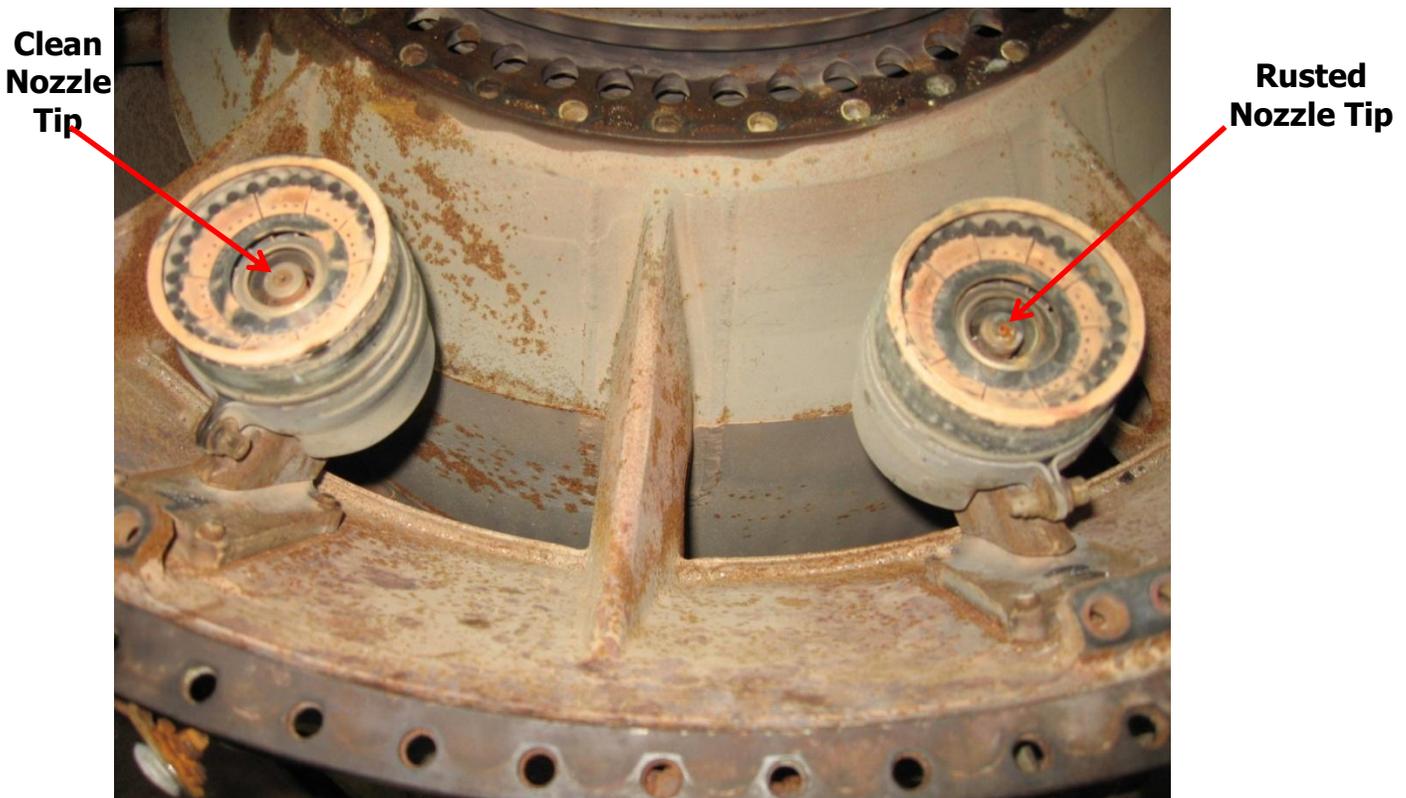
All the fuel nozzles were intact and secure in the diffuser case (**PHOTO 13**). No wear or thermal distress was noted on any of the fuel nozzle shields and all the air flow holes were unobstructed. None of the nozzle tips appeared blocked but varied in appearance - some were clean, some exhibited rust, while others were black in appearance. In general all the fuel nozzles were coated in a light brown residue that was easily removed by hand. Removal of the fuel nozzles from the diffuser case revealed that most of the nozzles exhibited rust on the swirler vanes and that some of the nozzles exhibited rust and or debris in the fuel passages (primary and secondary); however, no significant blockage was observed.

PHOTO 13: FUEL NOZZLES INSTALLED AND SECURE IN THE DIFFUSER CASE

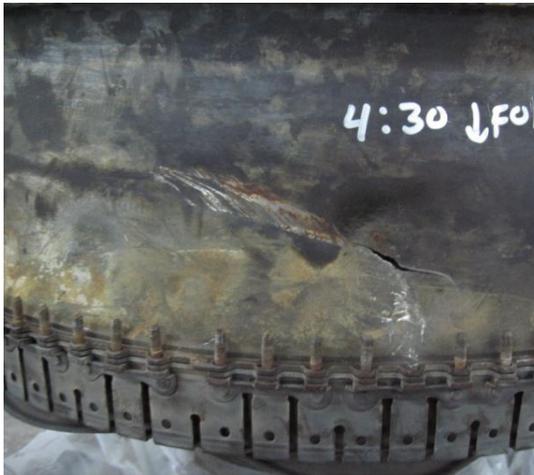
The HPT case exhibited an inward impact mark and associated case puncture at the 4:00 to 4:30 o'clock location (**PHOTO 14**). All the HPT stage 1 vanes were present, intact, and secure. No signs of thermal distress, no leading edge erosion, and no trailing edge cracks were observed. The thermal barrier coating on the nozzles was in good condition. All the HPT stage 1 blades were present, full length, and no signs of thermal distress were observed. The tip shrouds exhibited a light 360° circumferential rub (**PHOTO 15**). The HPT outer air seal ring exhibited a 360° circumferential rub of the honeycomb that was dull and matted consistent with normal engine break-in, as well as a fresh shiny thin light 360° circumferential rub consistent with a more recent contact. The shiny rub was more distinctive around the bottom of the engine. On the aft side of the HPT disk, a light 360° circumferential rub was noted on the stage 1 vane inner rotating air seal land. The HPT shaft did not exhibit any circumferential contact rub.

PHOTO 14: PUNCTURED HPT CASE

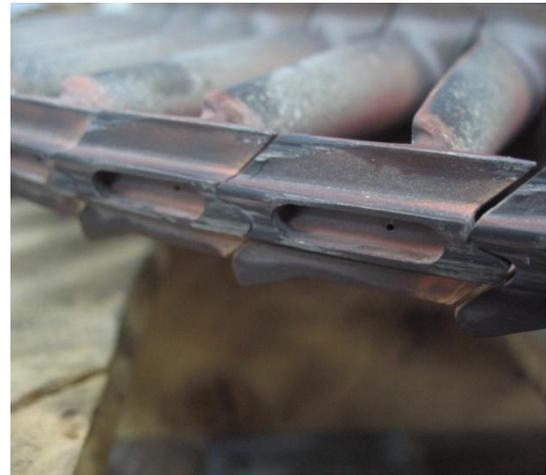
PHOTO 15: HPT BLADE TIP RUB

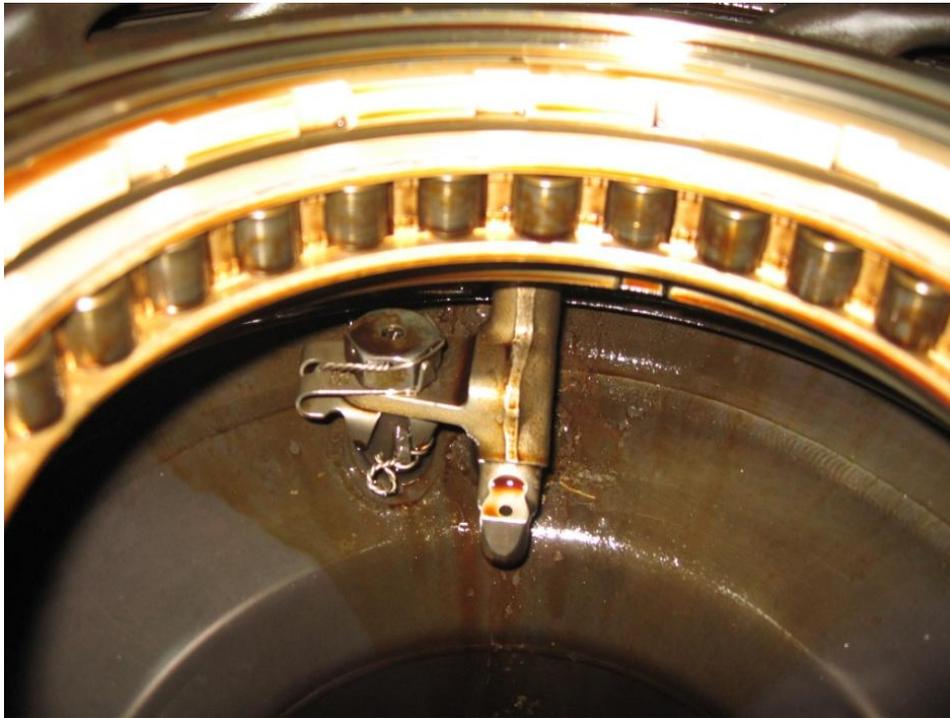
All the No. 5 bearing rollers were present, shiny, oil wetted, and secured in their cage which was also intact. The No. 5 bearing spun freely and smoothly when turned by hand. The No. 5 bearing inner race was shiny and in good condition (**PHOTO 16**). The oil from the No. 5 bearing compartment was dark brown in color with no acrid smell. Coke build-up was noted on the ID of the No. 5 bearing compartment on the top half.

PHOTO 16: No. 5 ROLLER BEARING AND OIL JET IN GOOD CONDITION

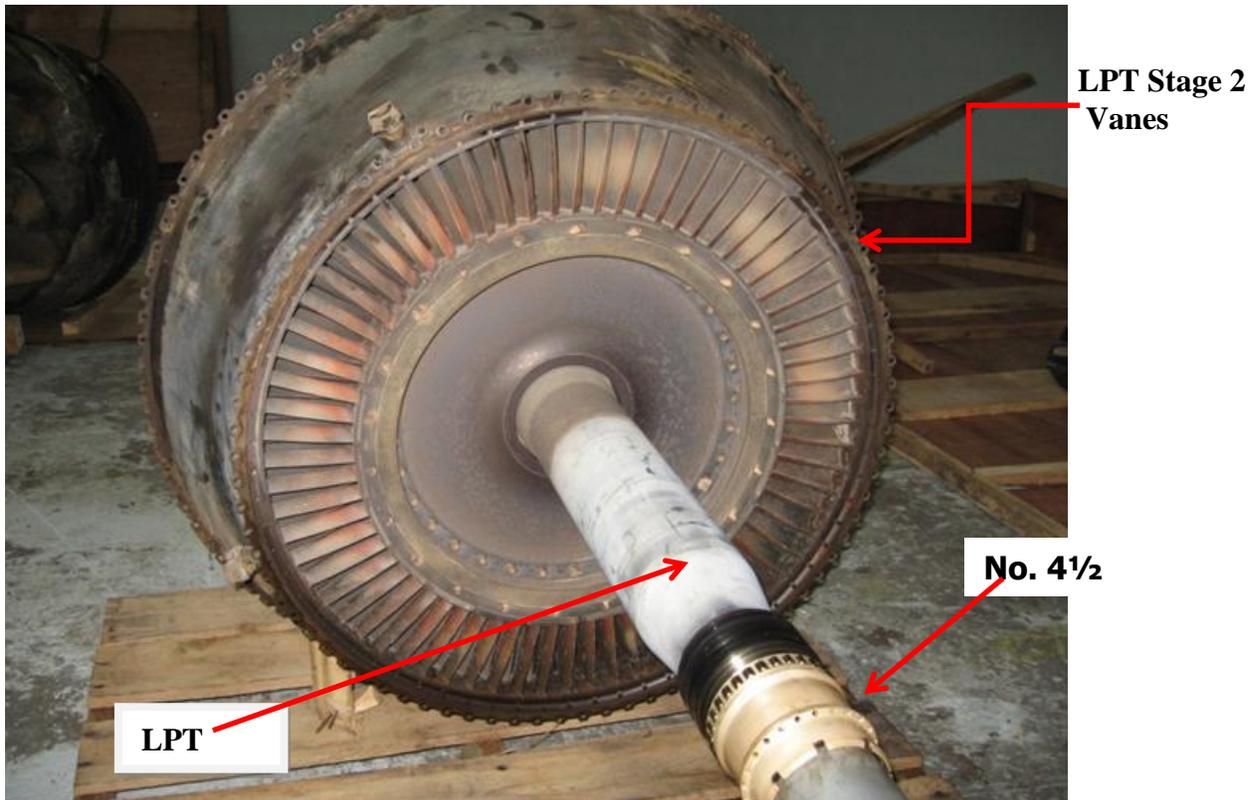
intact. The LPT stage 2 vanes were all present, in good condition, and no leading edge damage was noted (**PHOTO 17**). Looking through the LPT stage 2 vanes, the stage 2 turbine blades were visible. All the stage 2 turbine blades were present and appeared undamaged and straight. The LPT stage 4 blades were all present, straight, in good condition, and no trailing edge damage was noted (**PHOTO 18**). No visible wear or trenching of the honeycomb was noted on the LPT stage 4 outer air seal ring. Looking through the LPT stage 4 blades, the stage 4 vanes were visible. All the stage 4 turbine vanes were present and appeared undamaged. There were no indications of rub on the LPT stage 4 blade outer air seal. All the No. 6 bearing rollers were present, shiny, and secured in their cage which was also intact. The No. 6 bearing spun freely and smoothly when turned by hand (**PHOTO 19**). The No. 6 bearing carbon seal was present and intact. All the LPT disk tie-rods were present, and the tie-rods were secure.

PHOTO 17: LPT STAGE 2 VANES IN GOOD CONDITION AND NO LPT SHAFT CIRCUMFERENTIAL SCORING

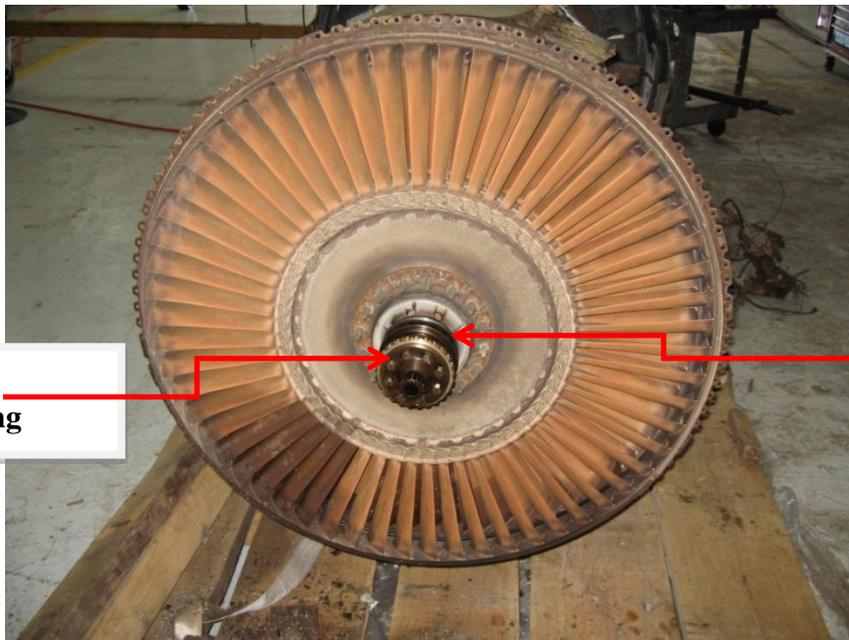
PHOTO 18: ALL THE LPT STAGE 4 BLADES FULL LENGTH AND UN DAMAGED AND ALL TIE-RODS SECURE

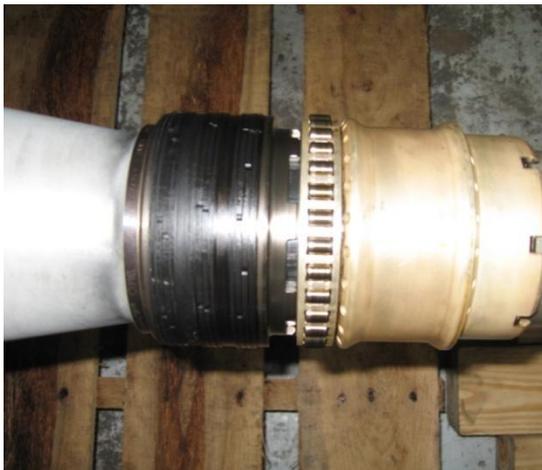
PHOTO 19: No. 4 1/2 BEARING, CARBON SEAL AND INNER RACE LOCK NUT

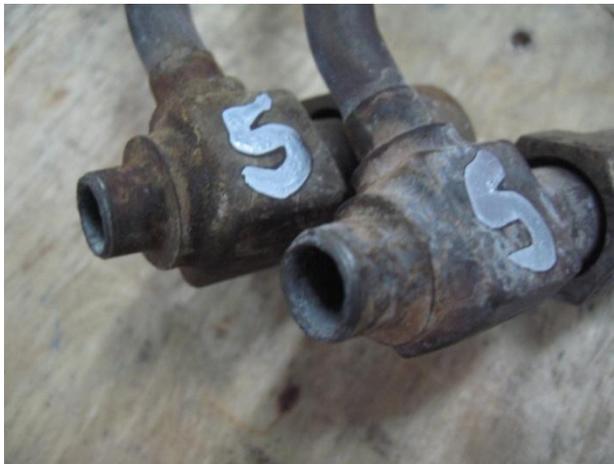
reduction/crushing in the primary manifold near the nozzle No. 2 fitting. The fuel-feeder lines that attach to the No. 5 fitting were both (primary and secondary) fractured flush with the No. 5 fitting and a piece of the fuel-feeder tubes remained within the No. 5 fittings in both manifolds (**PHOTO 21**). These fractured fuel-feeder tubes both exhibited shear lips. The left-hand manifold exhibited the following damage and observations: 1) heavily sooted at fuel nozzle fitting Nos. 8, 9 and 1, 2) the primary fuel transfer tube was pinched almost closed at the No. 8 fuel nozzle fitting (**PHOTO 22**), and 3) the primary fuel transfer tube diameter was reduced at the No. 7 fuel nozzle fitting,. The fuel-feeder lines that attach to the No. 6 fitting were both fractured at the No. 6 fitting with an appreciable piece of the secondary feeder tube was still attached and twisted/crimped (**PHOTO 23**).

PHOTO 21: RIGHT-HAND FUEL MANIFOLD WITH FRACTURED FEEDER TUBE

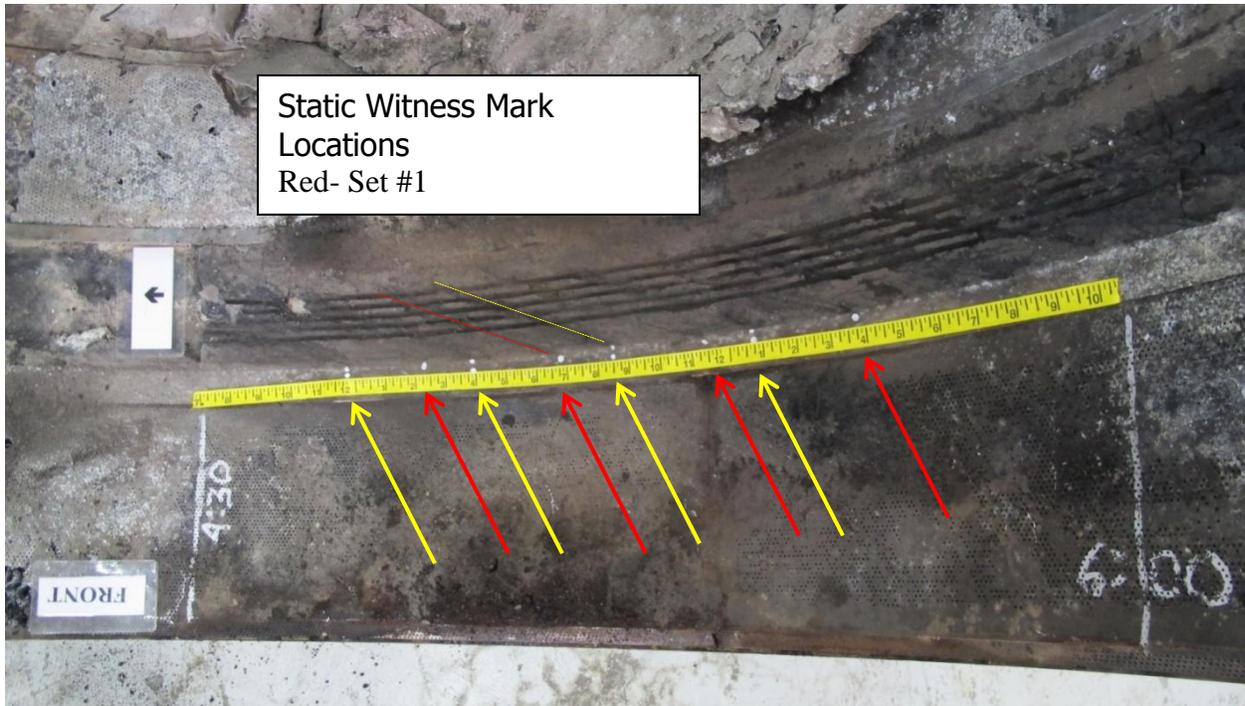
PHOTO 31-FAN RUB STRIP STATIC WITNESS MARKS

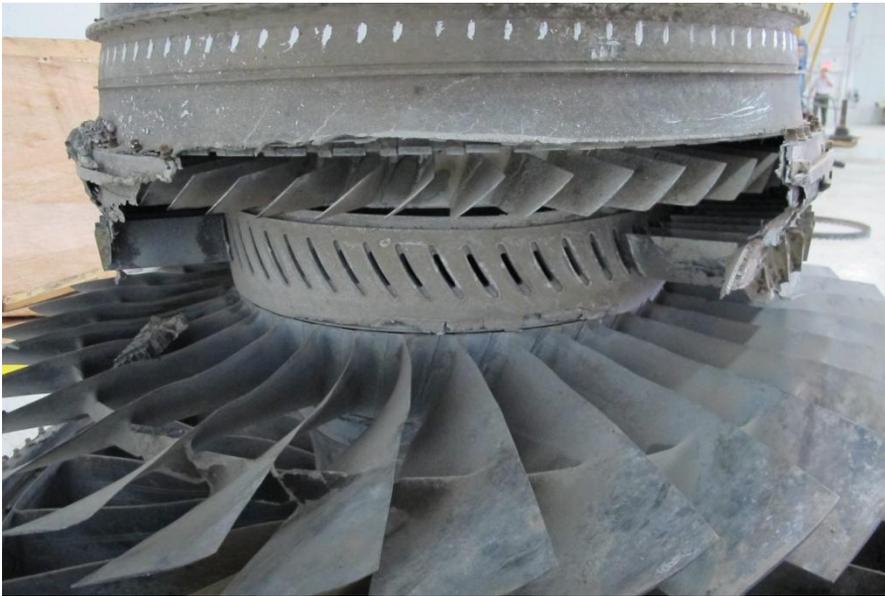
PHOTO 32-LPC Stage 1 Stator Case Melted and Missing Vanes

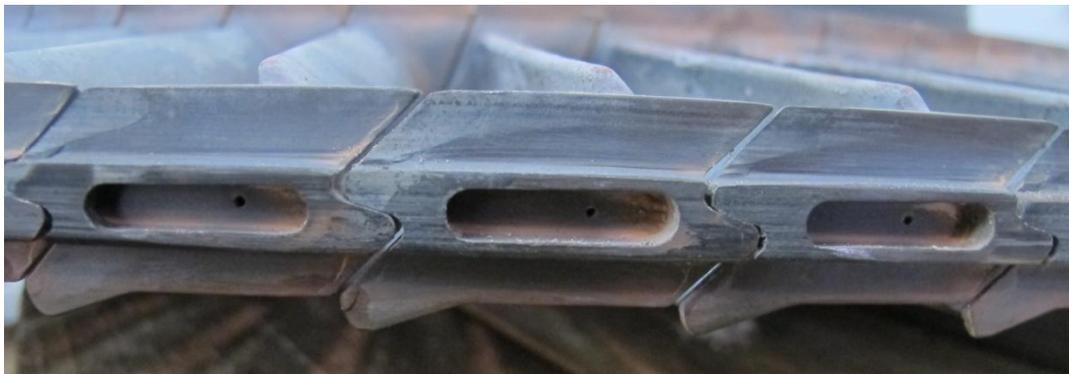
PHOTO 38-HPT STAGE 1 BLADE TIP RUB

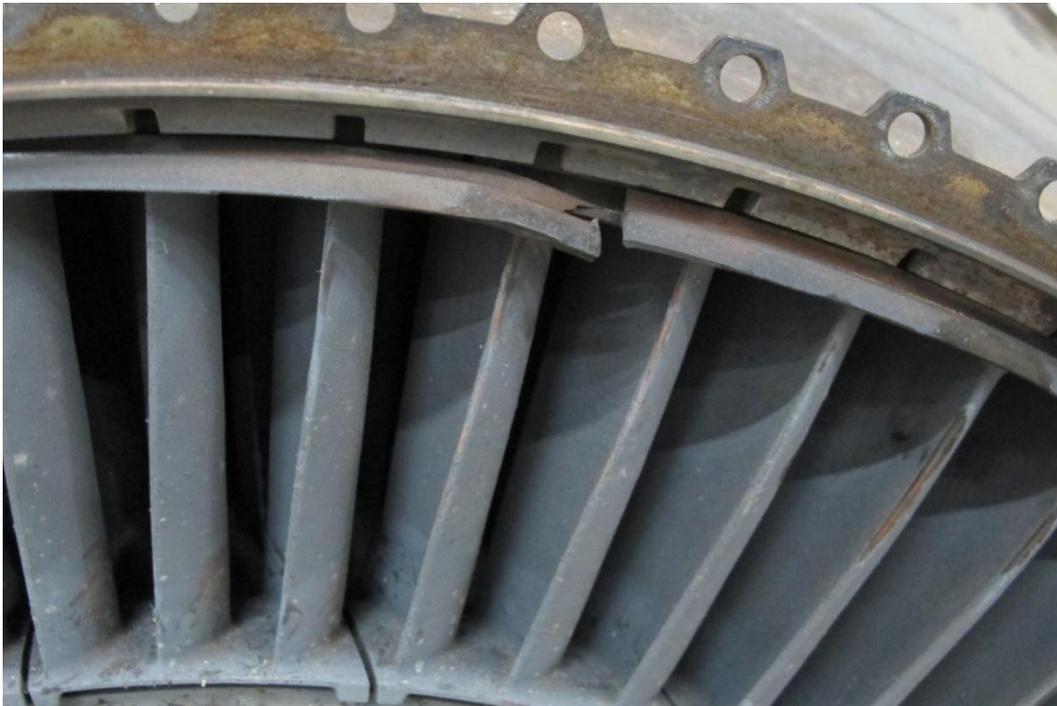
PHOTO 42-STAGE 2 OUTER AIR SEALING RING SPACER FRACTURE

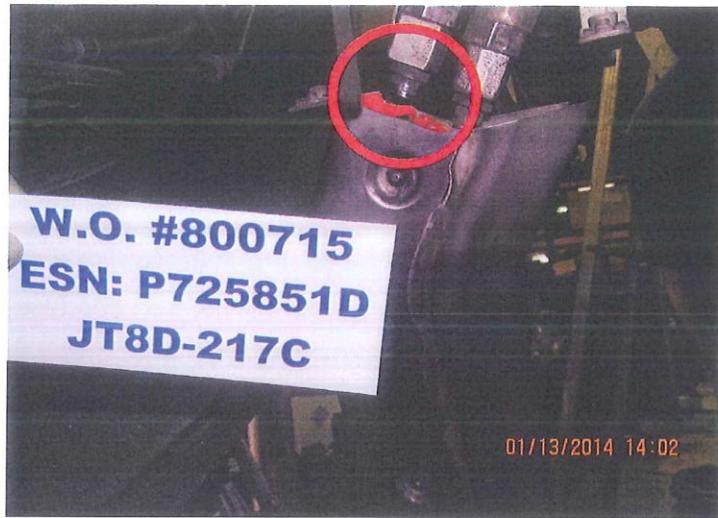
Image 3: R/H fuel manifold assembly shows a fracture on the secondary fuel inlet tube

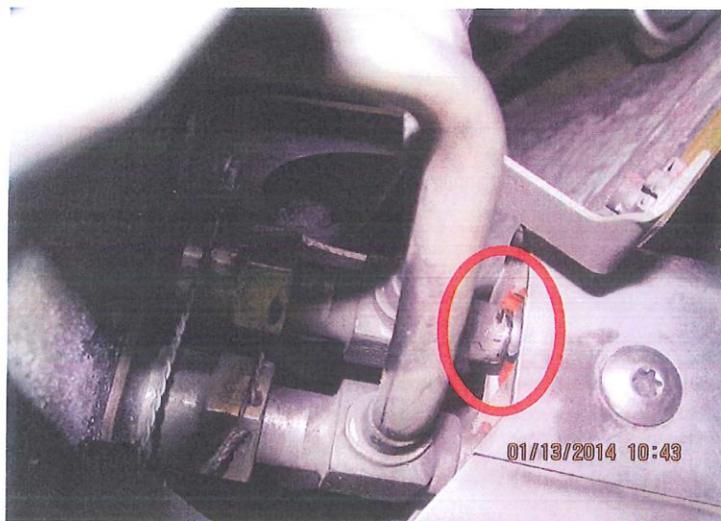
Image 4: R/H fuel manifold assembly, fracture of secondary fuel inlet tube

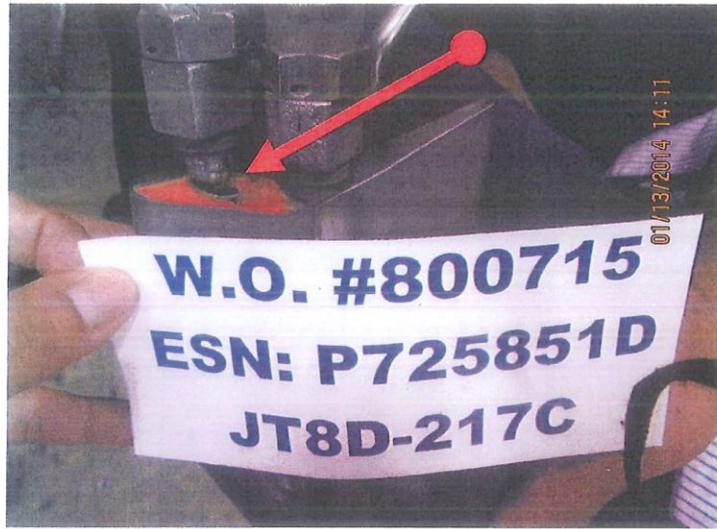
Image 5: Fracture on the secondary fuel inlet tube

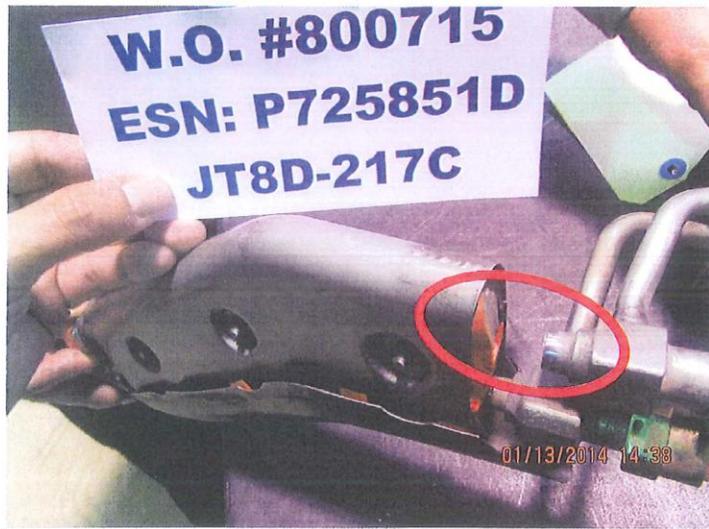
Image 6: Note liberation of manifold and fuel inlet tube

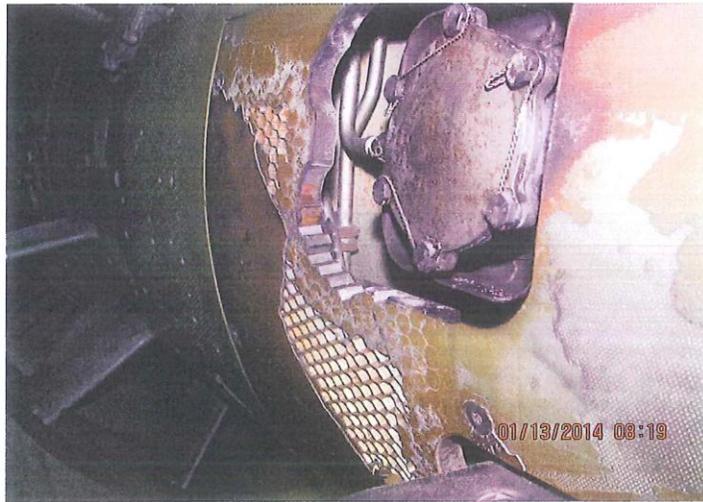
Image 18: Diffuser liner segment at 9 o'clock position exhibit heat related damage due to hot air leak

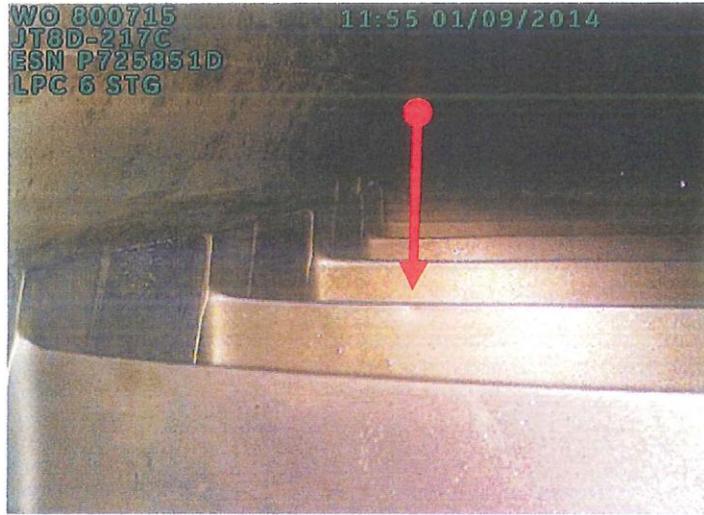
Image 19: C-6 blade T/E impact damage

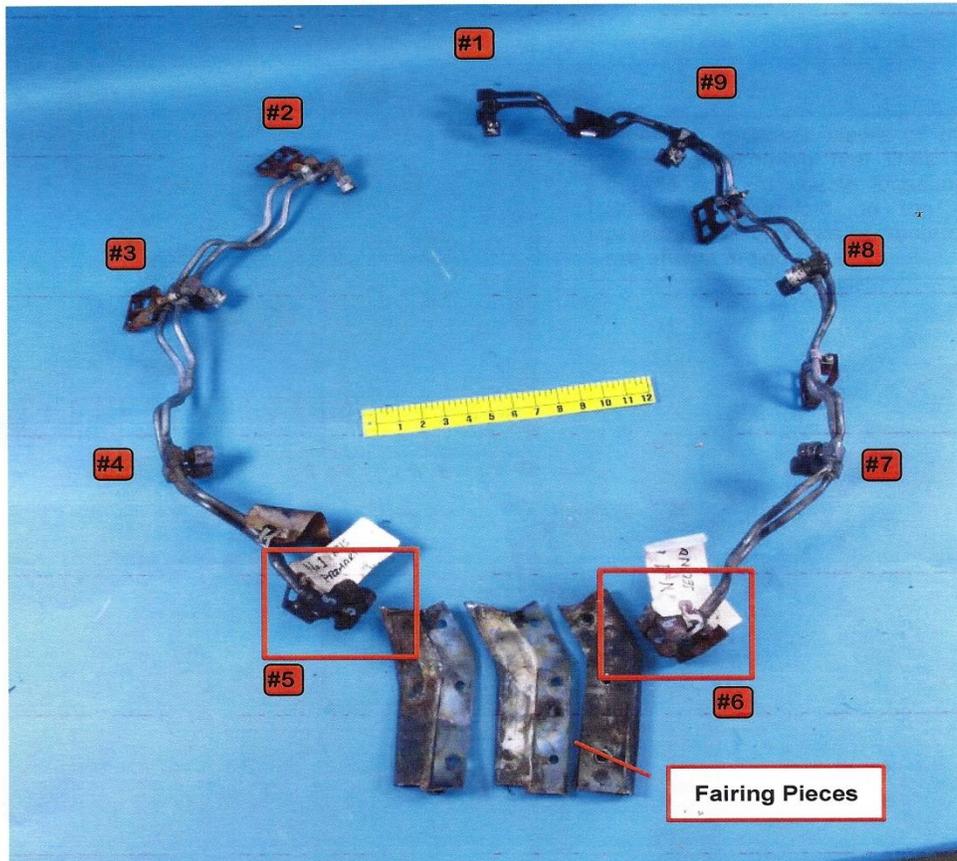
Figure 1. An overall view of the fuel manifold segments, viewed from the front looking aft. Fractured incoming lines are denoted by the red boxes and shown in figure 2. Nozzles numbered from engine top.

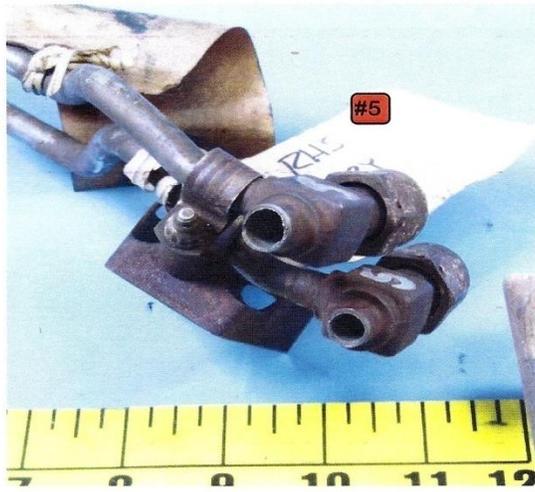
Figure 2. Closer views of the fractured incoming fuel lines at the #5 and #6 nozzle locations. Secondary manifold on top of primary. Closer views of fractures are shown in figure 3.

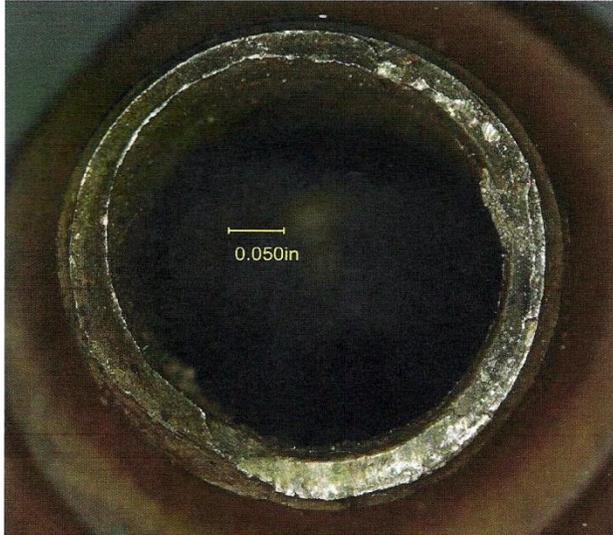
Figure 3. Magnified views of the fuel line fractures at the #5 nozzles with features indicative of bending overstress fractures. Upper fracture from secondary manifold segment and primary manifold below.

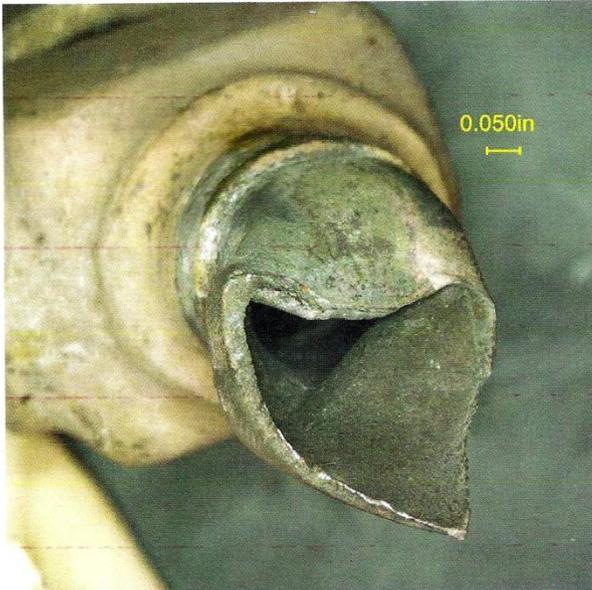
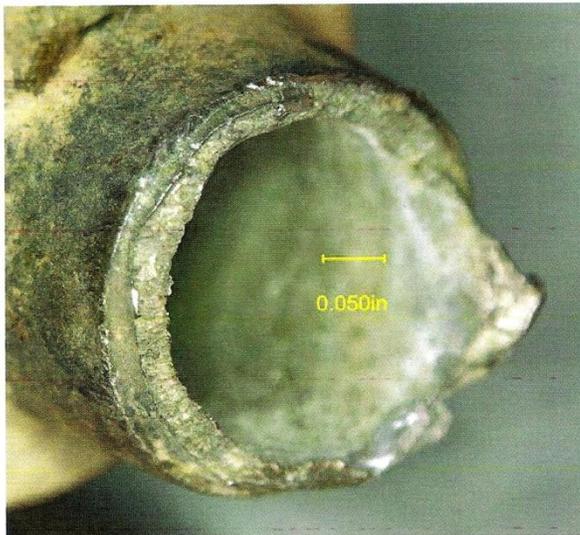
Figure 4. Magnified views of the fuel line fractures at the #6 nozzles with features indicative of bending overstress fractures. Upper fracture from secondary manifold segment and primary manifold below.
