# Air Accident Investigation Sector

AAIS Case N° AIFN/0015/2016

## Failure of the Left Wing Landing Gear to Extend

Make and Model: Airbus A380-861

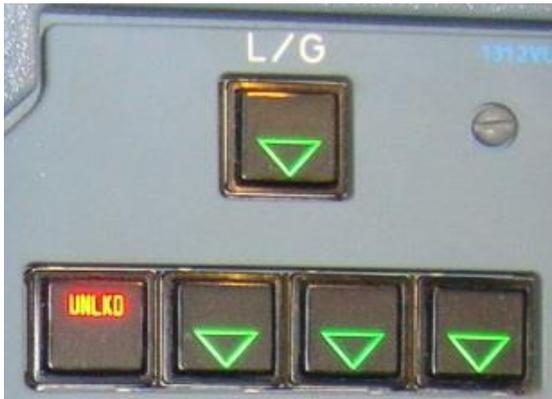
Figure 5. Left wing landing gear not down and locked

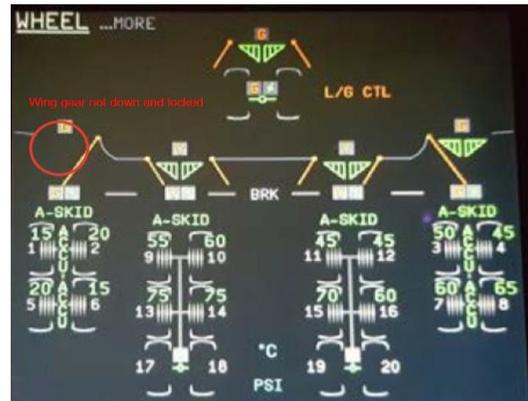
Figure 6. SD Wheel page showing left wing landing gear condition

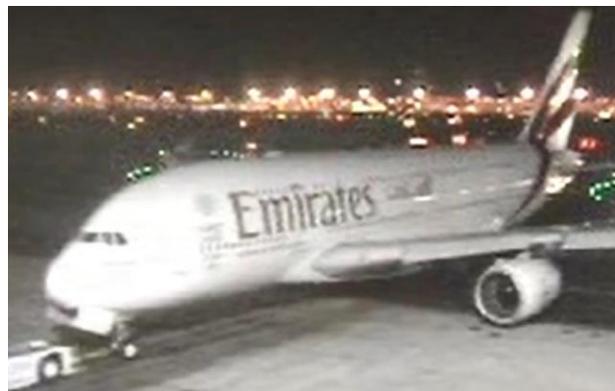
After it was confirmed that the smoke had dissipated, and was not associated with fire, the airside operations controller instructed the tug operator to connect the tug and to start towing the Aircraft to the assigned stand. The tug followed the airside operations controller vehicle to stand F20, where company engineers informed the Commander that the left wing landing gear was in the retracted position.

Figure 7. Aircraft arrival at passenger stand

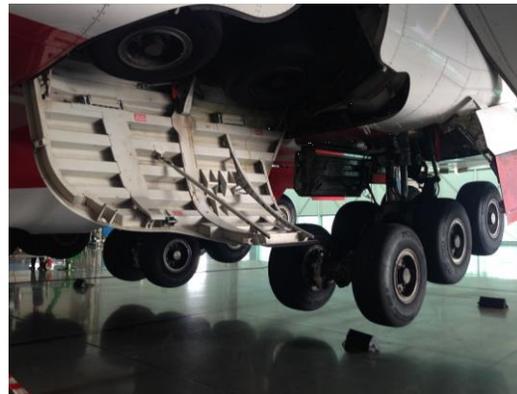
Initial visual inspections did not reveal any damage. The Aircraft was then raised on jacks to test the emergency free fall extension (figure 8). After the Aircraft weight-on-wheel systems were reset, the left wing landing gear was extended successfully. A number of system tests and detailed visual inspections were conducted.

Figure 8. Left wing landing gear retracted

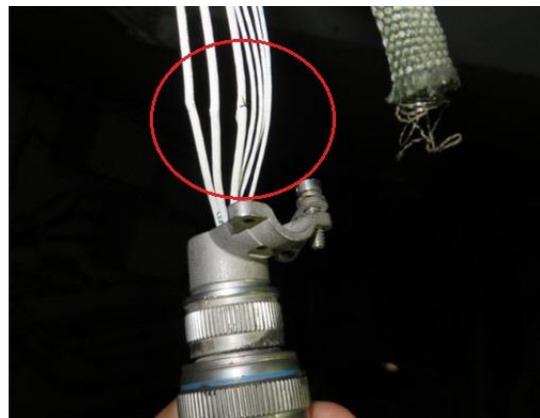
The inspections identified broken wires in the left wing landing gear harness for the free fall system connectors to channel A and channel B EUA (figure 9). Inspections of the other landing gear looms identified similar damage to channel B EUA wires on the right wing landing gear uplock assembly.

The initial inspection revealed fractures of the three command wires to the EUA of channel A loom and channel B loom. The deformation of the wire strands indicated a repetitive mechanical load. Signs of arcing between the wire ends were evident. (Figure 9).

Figure 9. Left wing landing gear retracted

The final tomographic examination confirmed the initial results and determined that the wires failed due to flexure endurance fatigue, which occurred when the wire loom was subjected to frequent movements (figure 10). The manufacturer determined that: “These repetitive aerodynamic [movements] of the harness are most likely the root cause of the damage we observe on these wires and result in rupturing conductor’s strands. Once ruptured, arcing is generated between both sides of the ruptured strands that leads to degradation of the insulation.”<sup>1</sup>

The left wing uplock assembly, and the two free fall control modules, were replaced and the damaged wires were repaired. A subsequent emergency free fall extension test was successfully conducted.

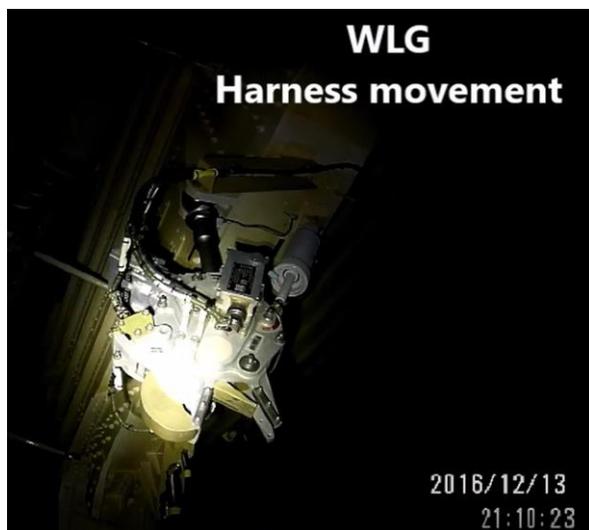
These tests confirmed that wiring loom movements due to aerodynamic effects were present at the wing landing gear positions, while the body landing gear and nose landing gear looms showed minimal or no movement. (Figures 11 and 12).

Figure 11. WLG flight test [Source: Airbus]

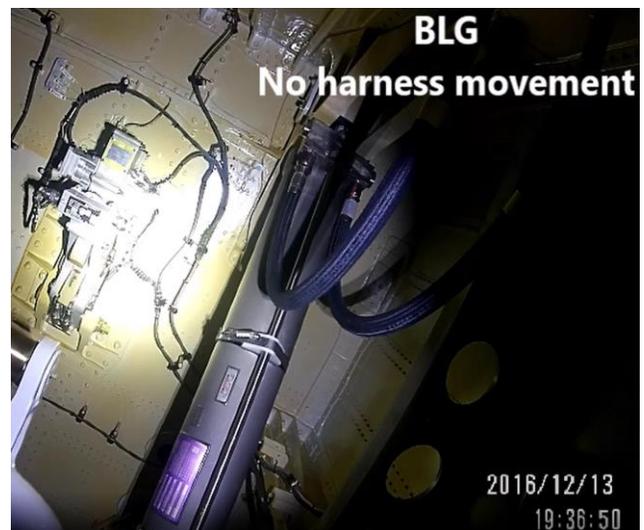
Figure 12. BLG flight test [Source: Airbus]
