KNKT.07.11.27.04

**NATIONAL
TRANSPORTATION
SAFETY
COMMITTEE**

**Aircraft Accident Investigation Report
BOEING AIRCRAFT COMPANY B737-200
PK-RIL
ABDURRACHMAN SALEH AIRPORT,
MALANG
EAST JAVA
REPUBLIC OF INDONESIA**

1 NOVEMBER 2007

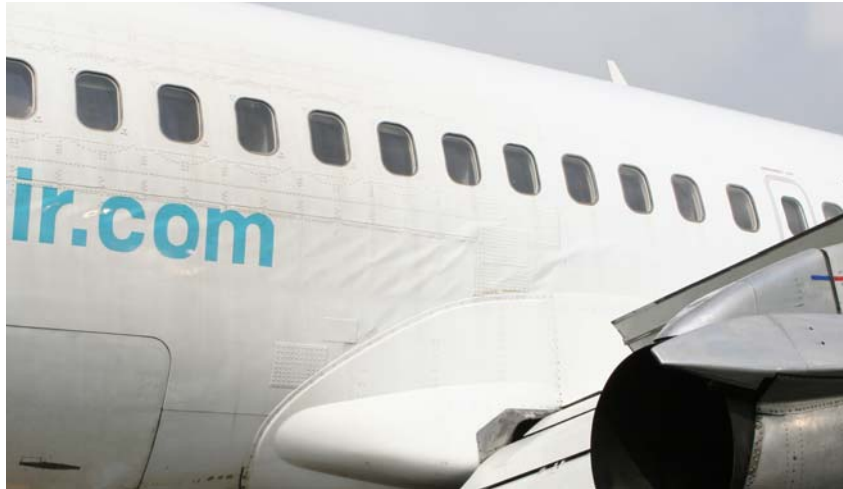
The right centre fuselage section aft of the right wing was wrinkled, and the right inboard wing section was deformed.

The skin of that section of the wing was also wrinkled, and it was 'oil canned'⁴. The left engine cowling was damaged due to impact with the runway, and there was oil leakage from the left engine accessory gearbox.

Figure 2: Wrinkling on the right centre fuselage section

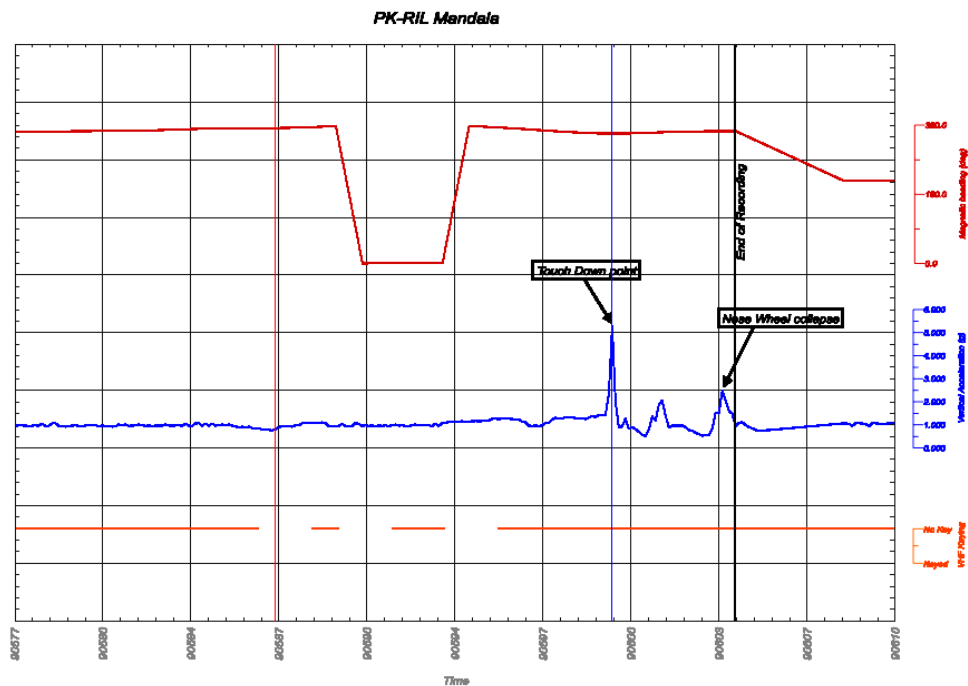
The assessment and verification of the FDR data tables also revealed that during the 22 seconds before the severe hard landing initial touchdown, the aircraft's average derived ROD had been about 1,750 feet / minute. That therefore represented an unstabilized approach.¹⁴

Derivation of the FDR data also revealed that the aircraft bounced to a height of about 20 feet after the initial severe hard landing.

Figure 3: Recorded flight data plots
