CIVIL AERONAUTICS BOARD
AIRCRAFT ACCIDENT REPORT

AMERICAN AIRLINES, INC., DOUGLAS DC -3,
NEAR TRAMMEL, KENTUCKY, JULY 28, 1943.

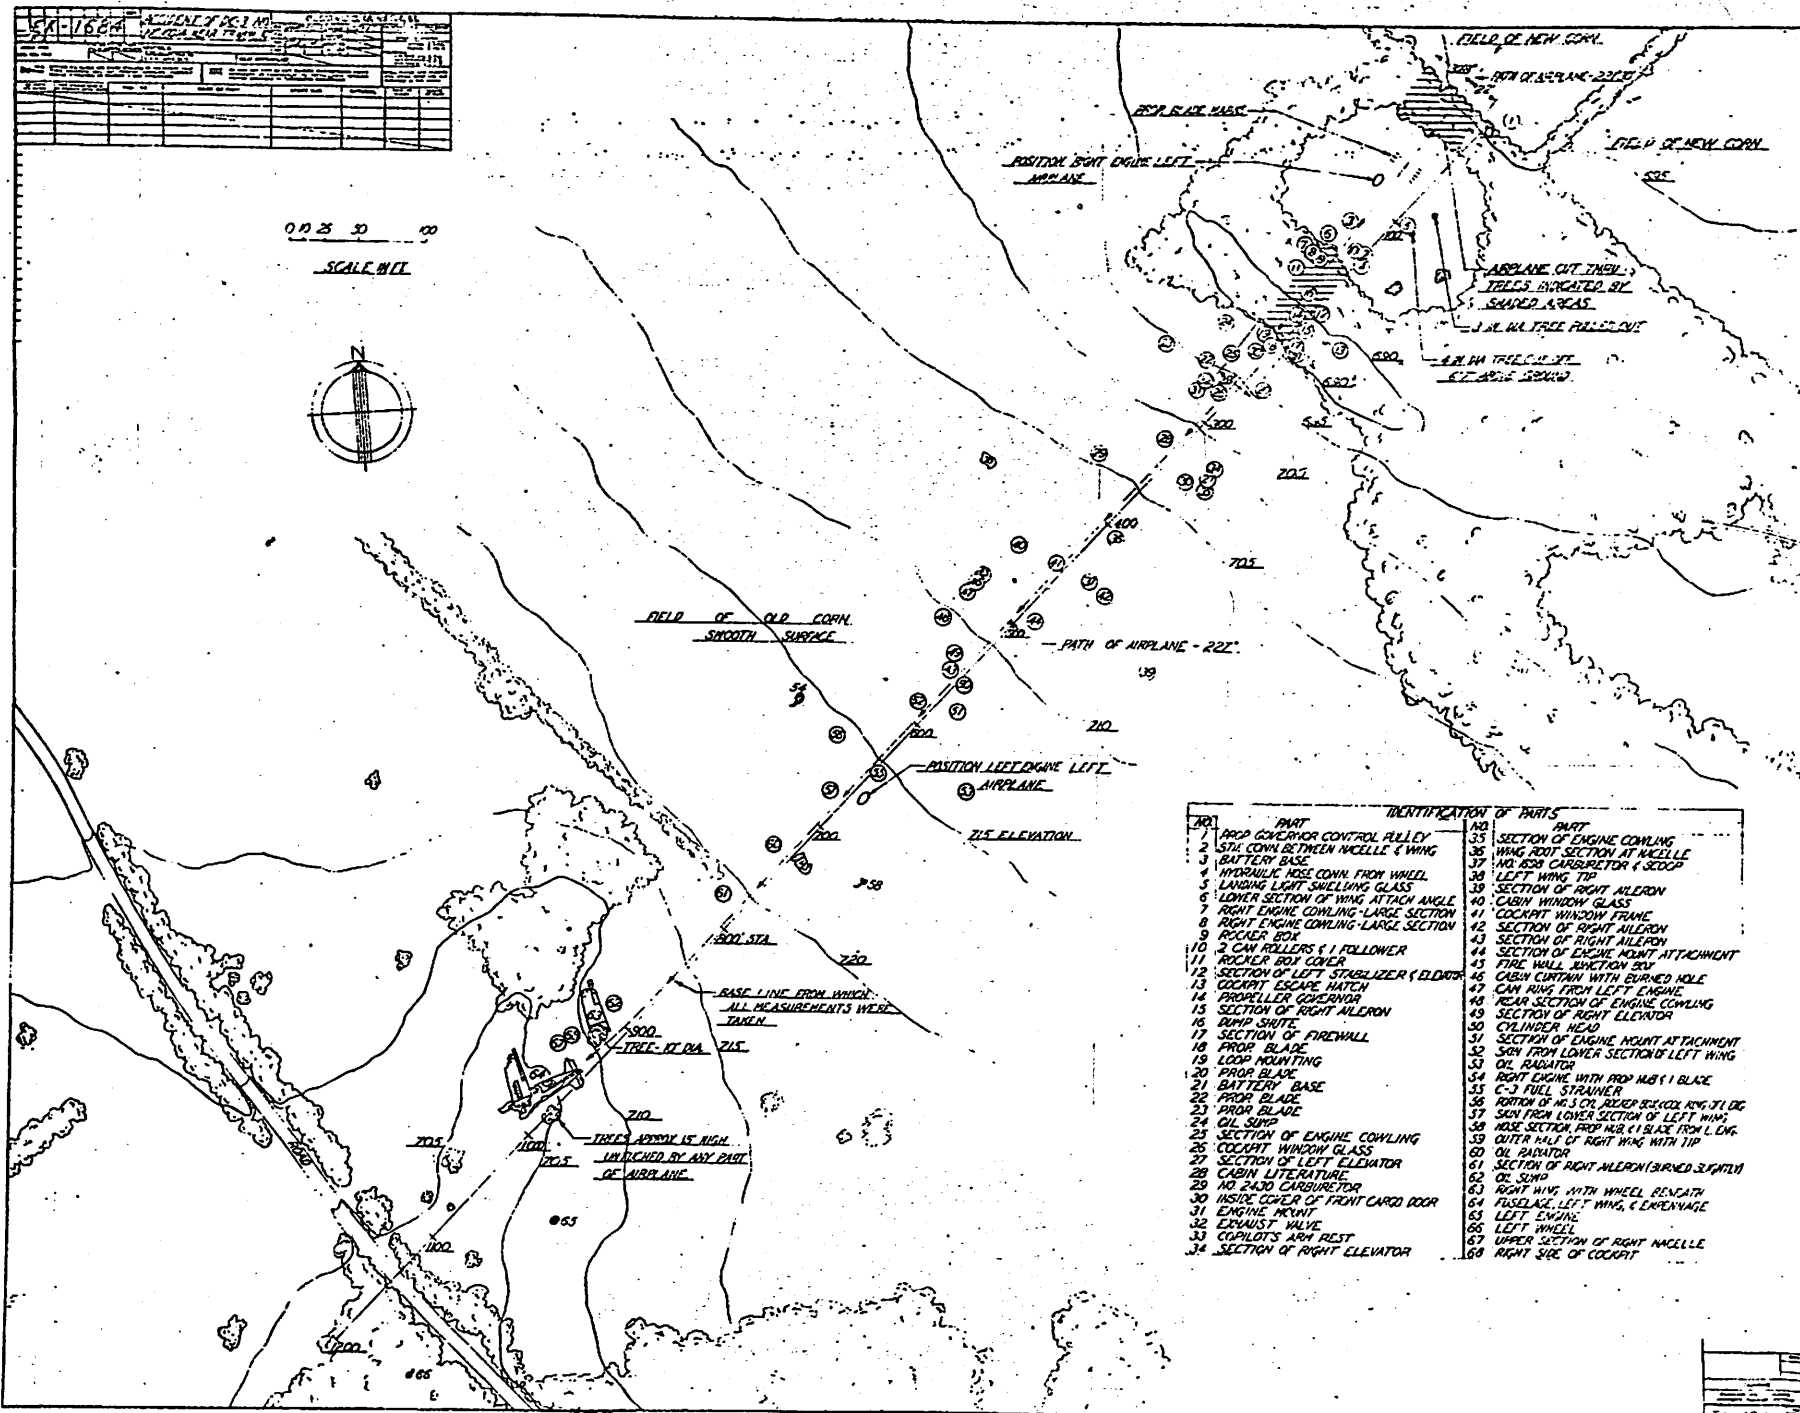
of the propellers disclosed settings of $23\frac{1}{2}^{\circ}$ on the left propeller and 24° on the right. It appears probable that these settings were indicative of the settings immediately prior to impact. The wreckage was found on the airway less than 2 miles from the "on course" signal of the Smiths Grove Radio Range. The rolling terrain of the locale varies from 695 to 720 feet above sea level. Examination of the wreckage and of marks and cuts on the ground and trees revealed that the aircraft, while level laterally and descending about 11° from horizontal, initially struck and cut a path through a small grove of trees, 35 feet in depth about 16 feet above the ground. It struck the ground approximately 85 feet beyond the point of first contact with the trees, continued on an almost straight course (221°) through another small clump of trees, then across an open field and stopped in an upright position among several larger trees, about 1000 feet beyond the point of first impact. Just prior to coming to rest, the right wing was sheared from the fuselage by impact with a large tree and it was found approximately 25 feet behind the fuselage. The left wing, minus the tip, with portions of the center section, had been bent upward and over and was found lying across the top of the fuselage. Pieces of the wreckage, including the left wing tip, were scattered over the entire distance, indicating that the airplane disintegrated all along its path from impact with trees and the ground. The right engine struck the ground around 90 feet beyond the point of first impact of the aircraft with the trees, tore loose and rolled forward about 500 feet. The left engine struck the ground approximately 650 feet beyond the point of impact with the trees, tore loose and rolled forward about 375 feet, coming to rest some 25 feet beyond the wrecked fuselage. The left wheel was found still farther forward and across a road, almost 1200 feet beyond the point where the aircraft first struck the trees. There was no indication that fire had started on the aircraft before the initial impact, as all parts of the wreckage which gave indication of fire were found at or near the final resting place of the fuselage and the two wings. (See sketch, opposite page, prepared by engineers of American in collaboration with investigators of the Board.)
