CIVIL AERONAUTICS BOARD

ACCIDENT INVESTIGATION REPORT

EASTERN AIR LINES—NEAR BAINBRIDGE, MD., MAY 30, 1947

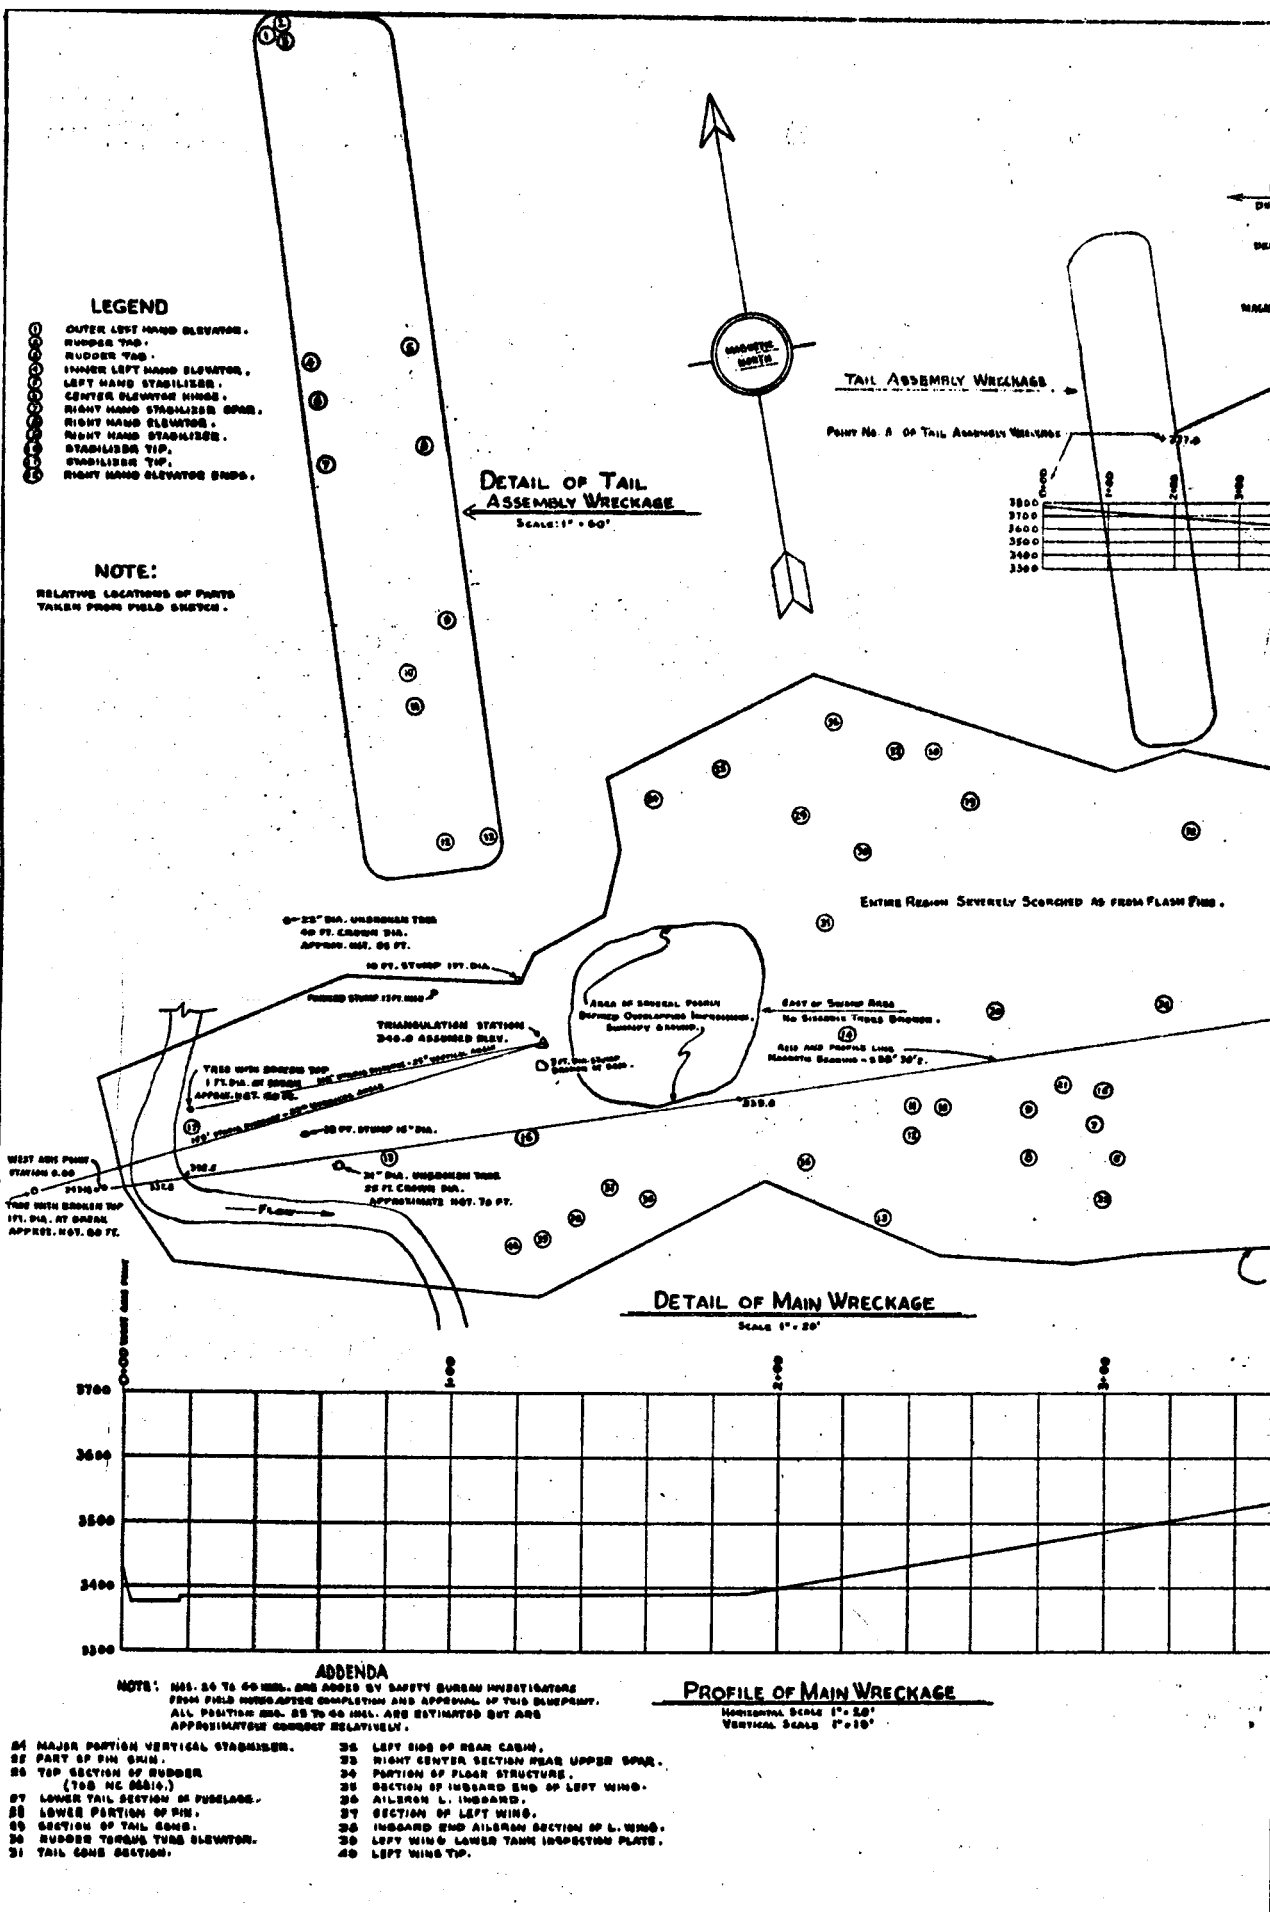
WRECKAGE DISTRIBUTION
of
CRASH OF EAL-C54B-DC-NC68614
NEAR BAINBRIDGE, MD. ON MAY 30, 1947

Impact with the ground was about 2 miles east of Bainbridge, on Amber 7 Airway, in a moderately to densely wooded area with trees 60-70 feet high. The aircraft broke up into a large number of pieces which were strewn irregularly over an area roughly 500 feet long and 150 feet wide with the explosive-like violence common to high-speed crashes. The direction of the long axis of this area, from the initial impact end, was about 90° or nearly east, and opposite to the flight's original westerly course. A quite clear-cut path of trees, broken at decreasing heights, indicated that the plane came through them at an angle of 28°-30° below the horizontal. Near both sides of this line of broken trees were closely-spaced unbroken trees. Examination of the wreckage indicated that the plane was inverted at impact with its left wing low. A flash fire which followed burned leaves and foliage and scorched tree trunks throughout the wreckage-strewn area; there was no sustained or concentrated fire. (A detailed sketch of the crash site is attached.)

All major portions of the horizontal tail surfaces were found in a similarly heavily wooded region some 300 yards west of the crash site. These pieces were concentrated in a comparatively small area under the path of final inverted approach.

A study of the distribution of the wreckage indicates that parts of the empennage left the aircraft at about the same time, and at low altitude, otherwise their resting places would have been far more scattered. No part of the aircraft was found anywhere except in the areas of the main wreckage or of the tail wreckage.
