C I V I L A E R O N A U T I C S B O A R D
AIRCRAFT ACCIDENT REPORT

Adopted: December 17, 1962

TRANS WORLD AIRLINES, INC., LOCKHEED CONSTELLATION, MODEL 049,
N 86511, MIDWAY AIRPORT, CHICAGO, ILLINOIS
SEPTEMBER 1, 1961

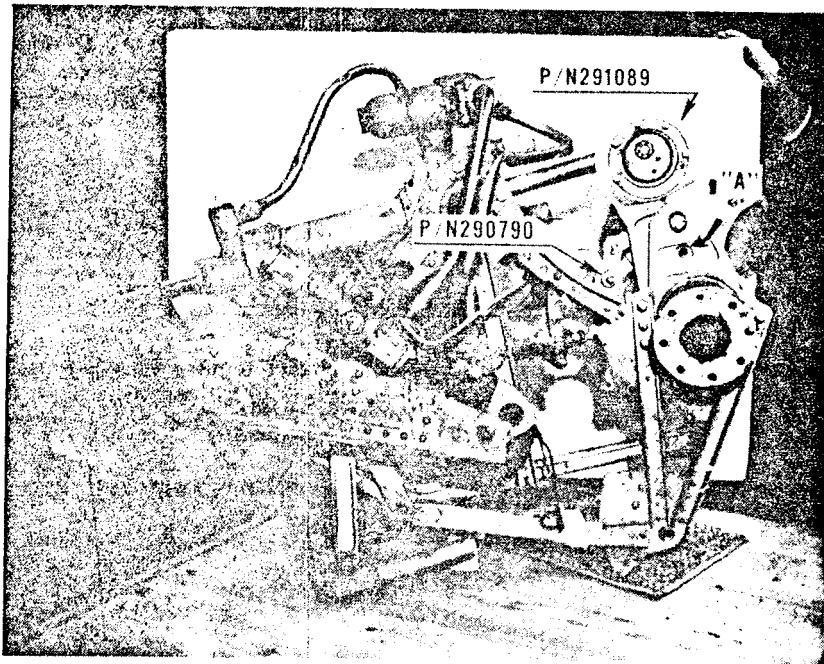
Examination of the parallelogram linkage of the elevator boost located in the extreme aft section of the fuselage revealed a 5/16th-inch AN-175-21 nickel steel bolt to be missing. (See Appendix A, Fig. 1.) This parallelogram linkage connects the pilot elevator input to the control valve of the elevator boost system. The bolt was not found in the wreckage despite a thorough search, including sifting of earth in the wreckage area.

The arm assemblies, part No. 291089L, part No. 291089R, and link assembly, part No. 290790 (See Appendix A, Fig. 1), were examined to determine if the bolt was in place at time of impact. This bolt, when in its proper position, passes through the press-fit bushings of P/N 291089 arm assemblies and the P/N 290790 link assembly. The head of the bolt is installed against the outboard face of arm assembly P/N 291089L. On the outboard face of the bushing, which is flush with the face of the forged arm, there were two deposits of old thick grease having the consistency of modeling clay and 0.01 inch or more deep.

FIG. 1. Elevator boost package. Bushing where bolt should have been is indicated by arrow "A".

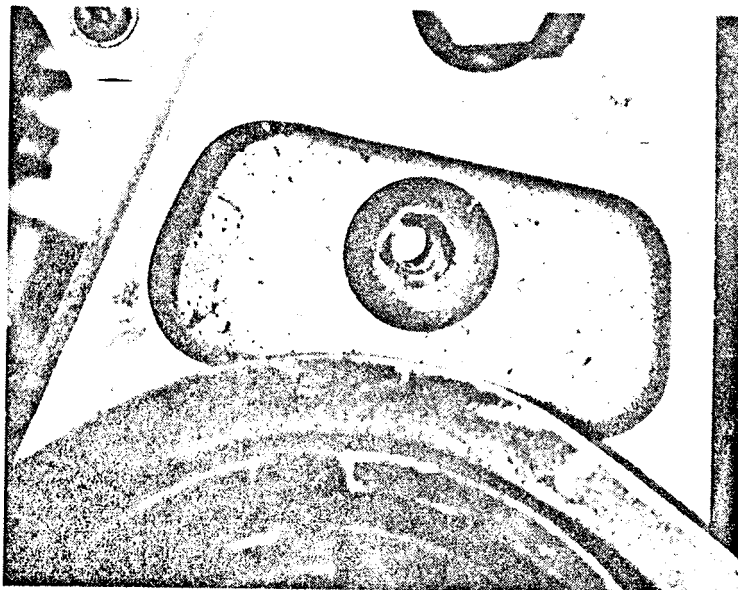
(See Appendix A, Fig. 2.) The larger of the two grease deposits covered an arc of 120 degrees from the 11:00 to the 3:00 o'clock positions, $\frac{2}{3}$ and averaged $\frac{3}{32}$ inch in width. The inner edge of this deposit was common with the inner circumference of the bushing, whereas the outer edge was, in places, slightly beyond the bushing's outer circumference; however, a slight outline of two sides of the bolt's hex-head was visible around its outer perimeter of the deposit. (See Appendix A, Fig. 2.)

The smaller deposit covered an arc of 60 degrees between the 7:00 and 9:00 o'clock positions and, like the larger deposit, the inner edge was common with the bushing's inner circumference and was about $\frac{3}{32}$ inch wide.

There were many scuff marks across the faces of both deposits, but neither had received any compressive loads sufficient to flatten their top surfaces. Those portions of the bushing which had no heavy grease buildup showed a film of grease of the same consistency.

FIG. 2. Close-up view before disassembly of bushing against which head of bolt should have been.

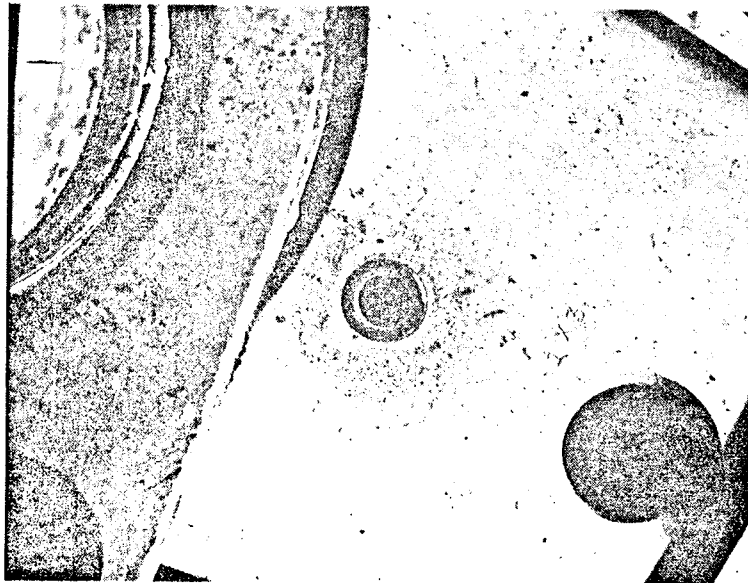
The nut of the missing bolt is normally installed against the outboard face of right arm assembly P/N 291089R. There was no deposit of grease on the outboard face of the bushing of the right arm, nor was there on the surface of this arm the heavy splatter of grease and dirt such as appeared on the left arm. Some grease was present, but only as a film. The outboard face of this bushing was unscarred except for slight concentric scratches. The outline of a washer could be seen on the face of the forging, but sufficient pressure had not been applied to remove the zinc chromate. The outboard one-third of the bushing's bore showed heavier corrosion than the other two-thirds and contained some irregular scoring. There were several threadlike score marks on the bore's

inboard one-third from 9:00 through 3:00 o'clock. At several places near the 12:00 o'clock position these scorings were polished and flattened. The inboard face of the bushing was clean and a concentric impression of the link bearing was visible. There was a thin drag mark at the bushing's inner circumference at 9:00 o'clock, 0.005 inch wide by 0.10 inch long, parallel to the arm centerline. At the outer circumference of the bushing's inboard face at the 1:00 o'clock position there was a curved brinell mark 0.125 inch long by 0.015 inch wide. When viewed under magnification, another brinelling could be seen superimposed within the first one. The curvature of these marks, opposite in arc to the circumference of the bushing, exactly matched that of the circular end of the P/N 290790 link assembly. The flow of metal showed that both brinellings had been formed in a direction away from the bushing center. No elongation of the bushing hole could be found.

FIG. 4. Close-up of bushing against which nut should have been. Taken after disassembly, but before cleaning.

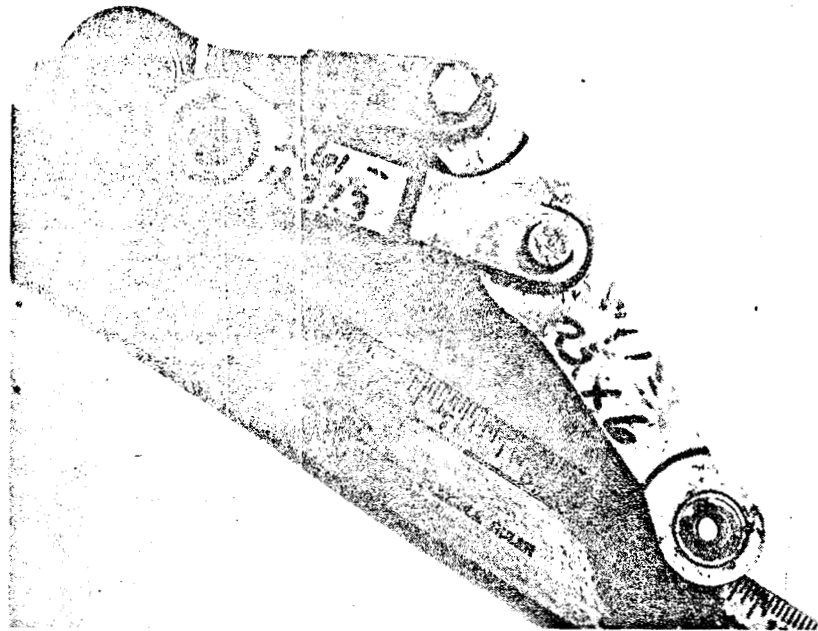
Prior to the Civil Aeronautics Board public hearing there existed a question of how the grease deposit showed the hexagonal outline of a bolt head when Lockheed Aircraft Corp. drawing No. 209835 calls for two washers, one at the head of the bolt and one at the nut. It was evident that a washer had been present at one time because one had left its impression on the lever arm and could be seen after the grease was cleaned away. If the installation were made according to the LAC drawing, the hexagonal pattern could not have been present since an AN-960-516 washer has a greater diameter than the head of an AN-175 bolt. This apparent anomaly was cleared at the hearing when a TWA mechanic testified that because of tolerance variations, it was not always possible to secure the nut if a washer is installed under the bolt head. In such cases the washer is removed and the installation made without it. The Board does not suggest that this is an unsafe practice, but it does explain how the shape of a bolt head could be seen in the grease pattern. It is clear that a washer was used at this point on at least one previous parallelogram installation, but not on the one installed in November 1960.

FIG. 5. Parallelogram, removed from boost assembly but reoriented to its position before removal. Note grease ring at arrow, made by bushing face.

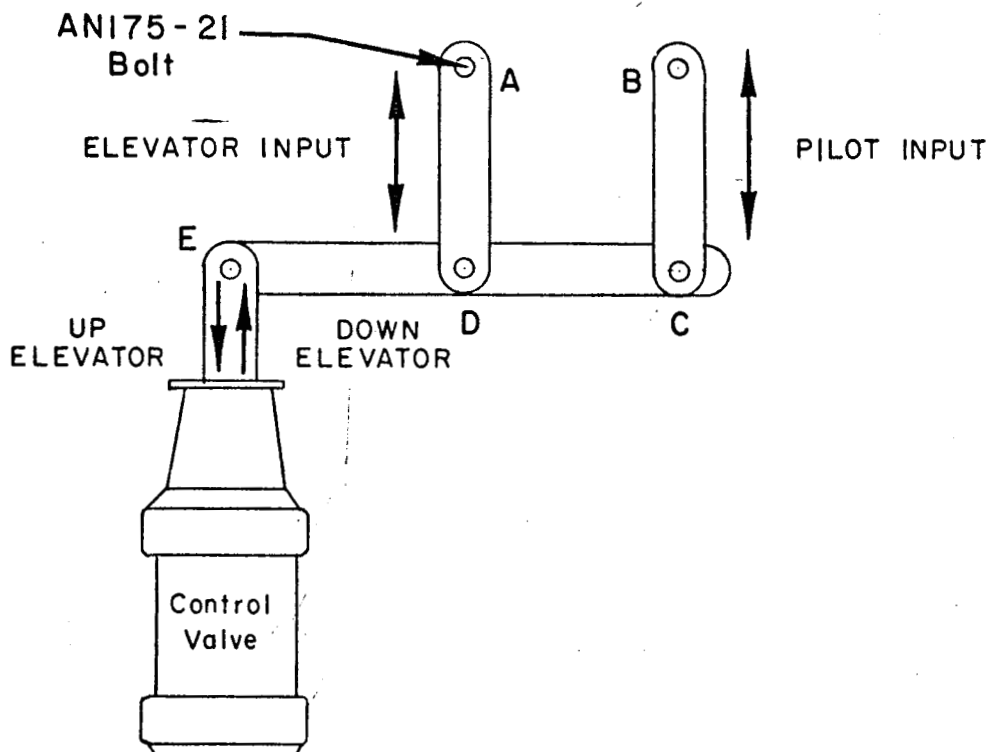
FIG. 6. Schematic diagram of parallelogram linkage and valve of elevator boost package.

With reference to Appendix A, Fig. 6, it can be seen that pilot input moves link BC up or down which pivots link EDC as a walking beam about point D, causing point E to move down or up. This positions the control valve spool which is connected at point E. Elevator input moves link AD up or down which, in turn, pivots link EDC about point C. This action also positions the control valve spool. It should be noted that pilot and elevator inputs in the same direction are subtractive and inputs in opposite directions are additive to the valve spool.

If the AN-175-21 bolt at point A be removed, no support for the parallelogram is provided by link AD, and link EDC is free to pivot about point C. Since the valve is mounted in a near-vertical position, the weight of links AD and EDC and the weight of the spool are applied in the direction to move the spool toward up-elevator, to be resisted only by the friction in the valve and at points C and E, the total of which is negligible. Any friction above the normal would be overcome by vibration.

Further reference to the sketch shows that there can be no pilot input to the valve to counteract the action since the parallelogram can no longer pivot at point D. Input applied by the pilot is only carried through the mechanical linkage. The mechanical advantage of the system is far too low to be effective against the full pressure in the boost actuator. In a study ^{5/} of the Constellation boost systems, it was pointed out that the systems will develop approximately 8.5 times more hinge moment with boost on than with boost off. This factor is even greater with the above-described malfunction because the pilot does not have the added mechanical advantage gained by shifting to manual position.

On November 22, 1961, the Board recommended to the Administrator of the Federal Aviation Agency that the mechanism for shift-to-manual in the Constellation control boost system be modified so that the actions would be sequential rather than simultaneous. Specifically, under the recommended change, the shifting action by the pilot would remain one continuous motion of a handle but would, first, open the bypass valve; second, close the hydraulic shutoff valve and, third, shift the mechanical linkage. With such an arrangement, all hydraulic pressure in the boost package would be relieved prior to the mechanical shift action and would thus allow the complete shift-to-manual without restriction regardless of pilot-applied control forces.
