# AIRCRAFT ACCIDENT REPORT

**EASTERN AIR LINES, INC.**

**DC-7B, N849D**

**February 8, 1965**

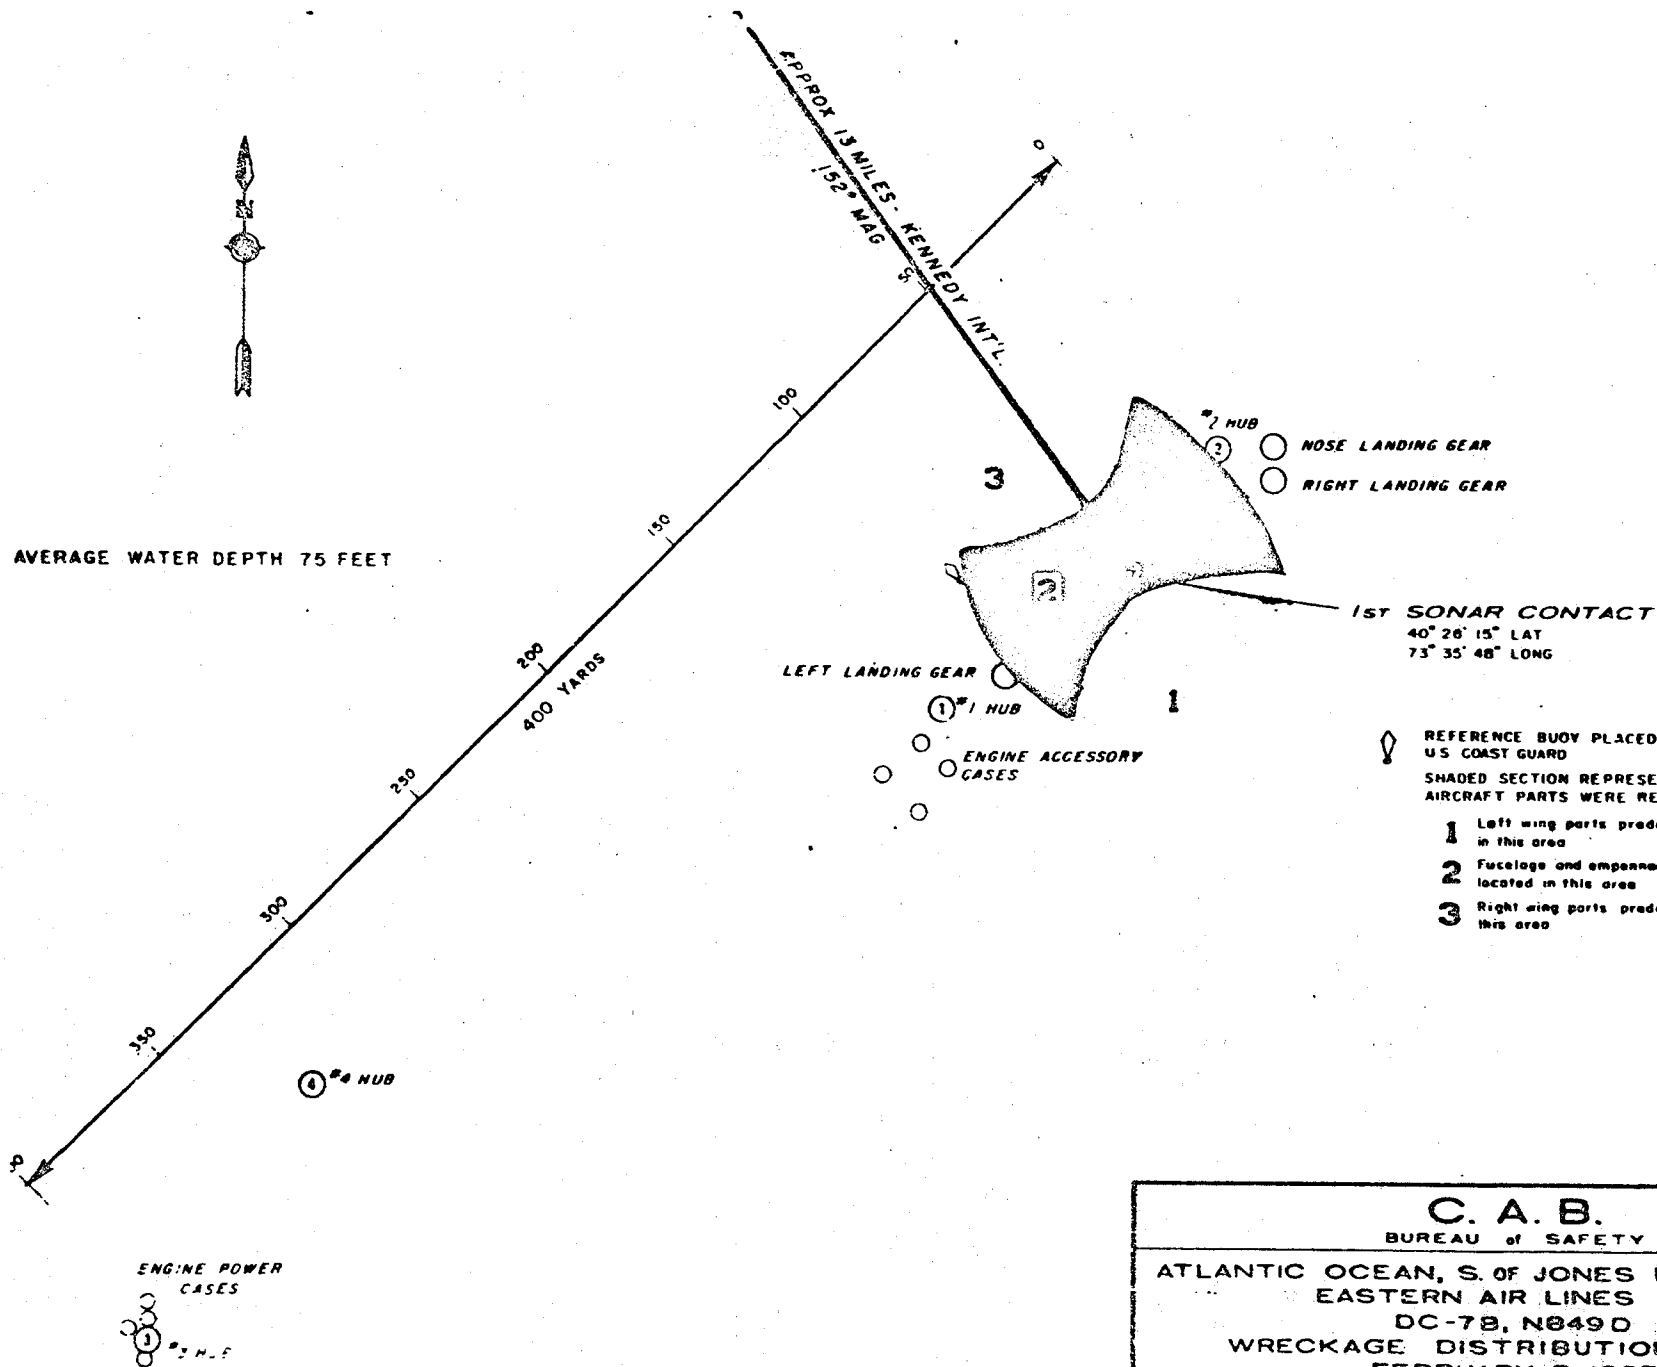
<b>C. A. B.</b> BUREAU of SAFETY		
ATLANTIC OCEAN, S. OF JONES INLET, L.I., N.Y. EASTERN AIR LINES INC. DC-7B, N849D WRECKAGE DISTRIBUTION CHART FEBRUARY 8, 1965		
DRAWN BY WILLIAM LEWIS 4/2/65	SCALE 1 inch = 20 Yards	STRUCTURES GROUP J. T. CHILDS, BO Chairman, 8 96

Over 60 percent of the aircraft was recovered, including portions of all major components. The investigation revealed no evidence which would indicate failure or malfunction of the aircraft's powerplants, systems, or structural components prior to impact.

All the control surfaces including trim tabs were recovered, damaged but with no indication of pre-impact malfunction or failure. All of the control cables recovered exhibited complete separation and all strands were necked down at the separation points.
