Report on the Accident to
Britannia G - ANCG at Manston Aerodrome
on 20th April, 1967

Accident Report No.EW/E/04

Aircraft: Bristol Britannia Series 308 G-ANCG Engines: 4 Proteus 75

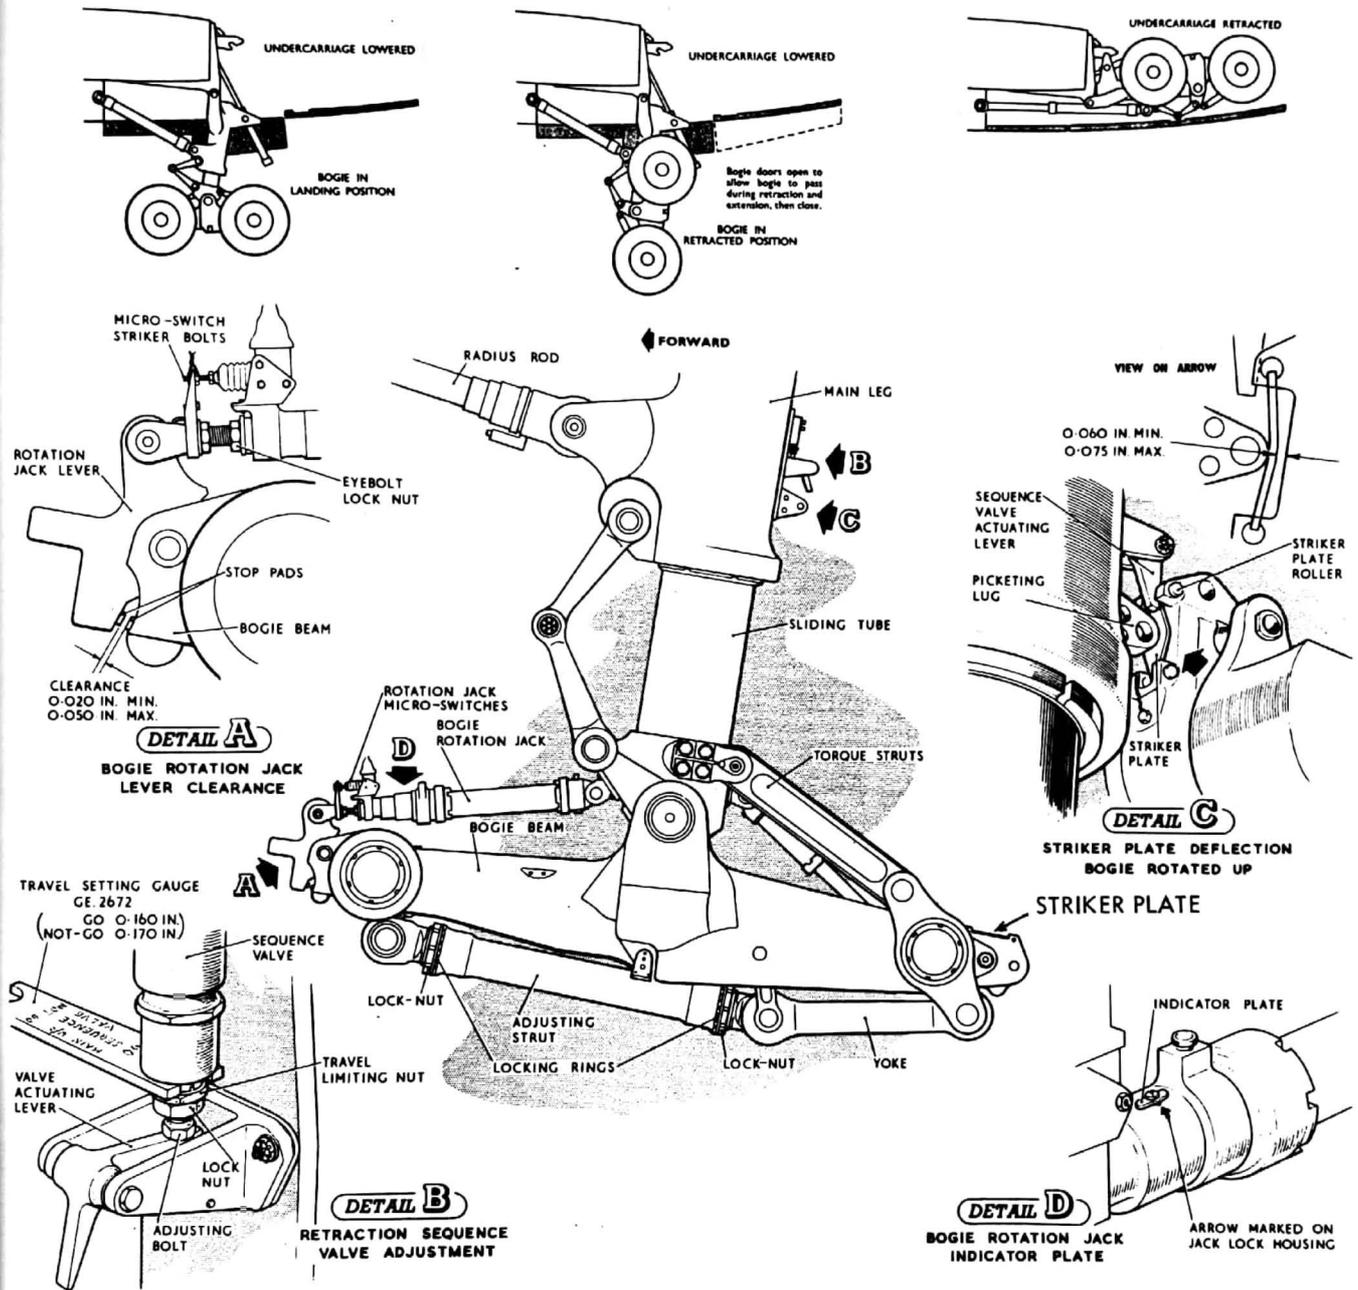
BRITANNIA MAIN LANDING GEAR

- (a) the bogie rotation jack being fully extended and locked;
- (b) the striker plate on the bogie being deflected by the picketing lug and producing a clearance between the plate and the adjacent face of the bogie beam of 0.060 to 0.075 inches (see Appendix 2).

A check revealed that the clearance was in excess of 0.140 inches; this resulted in the striker plate roller imparting insufficient movement to the sequence valve actuating lever which in turn led to incorrect setting of the overtravel dimension of the sequence valve. This incorrect setting would have been detected if the sequence valve setting had been checked with the bogie horizontal as required by the Britannia Series 300 Maintenance Manual, Section 3, Chapter 5, paragraph 51(3) and (4).
