ACCIDENTS INVESTIGATION BRANCH
Department of Trade and Industry

Hawker Siddeley HS 748 Series 2
aircraft G-A TEK and G-A TEH
of Channel Airways
Report on the accidents at Portsmouth Airport,
Portsmouth, Hampshire on 15 August 1967

Civil Accident Combined Report Nos EW/C/0179 and EW/C/0180

Aircraft: Hawker Siddeley HS 748, Series 2, G-ATEK and G-ATEH

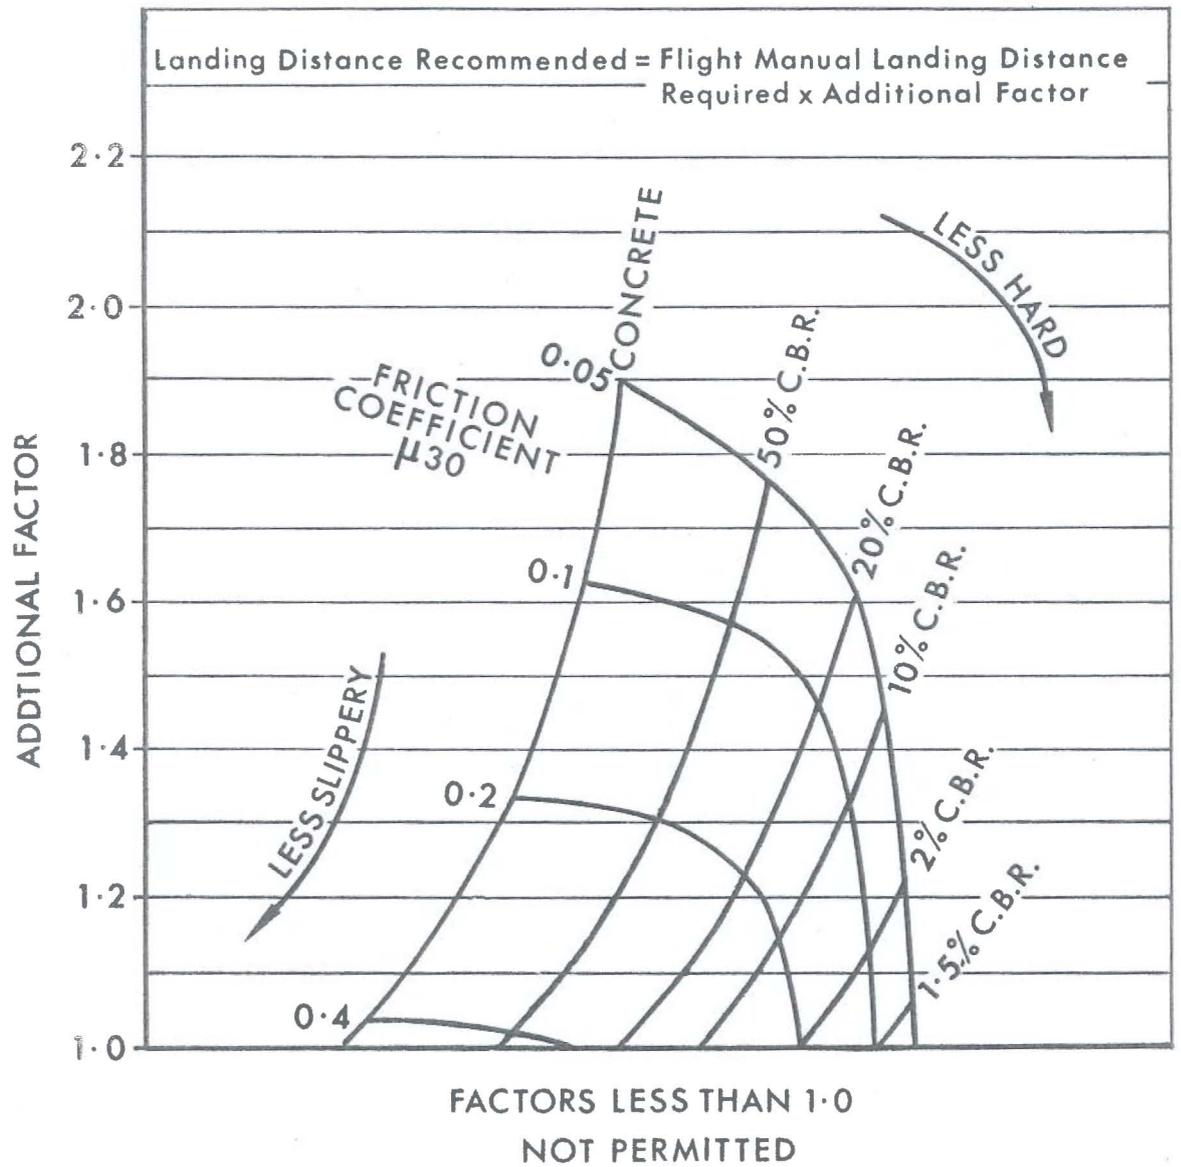
FIGURE 1

Figure 1 has been constructed on the basis of the tests results to show the additional factor recommended. Surface friction and hardness are expressed in the way they were measured during the tests, i.e., friction coefficient at 30 m.p.h., μ 30, and hardness as California Bearing Ratio (CBR) at a depth of 3 ins. The conditions covered in the tests, and the estimated conditions applying at the time of the two incidents, are listed in the following tables :—

It will be noted that the only conditions likely to require an additional factor on the landing distance are a combination of a hard surface and a very low friction coefficient, e.g. an ice covered paved runway or an unpaved runway with very hard sub-soil and a thin slippery layer on top. On such surfaces the high drag from the discing propellers and the large flaps rapidly reduces the aircraft speed from touchdown to about 40 knots. By this speed the propeller drag has fallen to a low value and changes to a small thrust as the speed approaches zero. This characteristic, common to all Dart engine/propeller combinations, causes the final part of the ground run to increase considerably on the slippery surface.
