Report on the Accident
to Comet Series 4B G-ARCO
which occurred in the Mediterranean near Rhodes
on 12th October 1967

Civil Accident Report No. EW/A/0102

Aircraft: de Havilland Comet Series 4B G-ARCO *Engines:* Four Rolls Royce Avon 524

Date and Time: 12th October 1967 at about 0325 hrs.

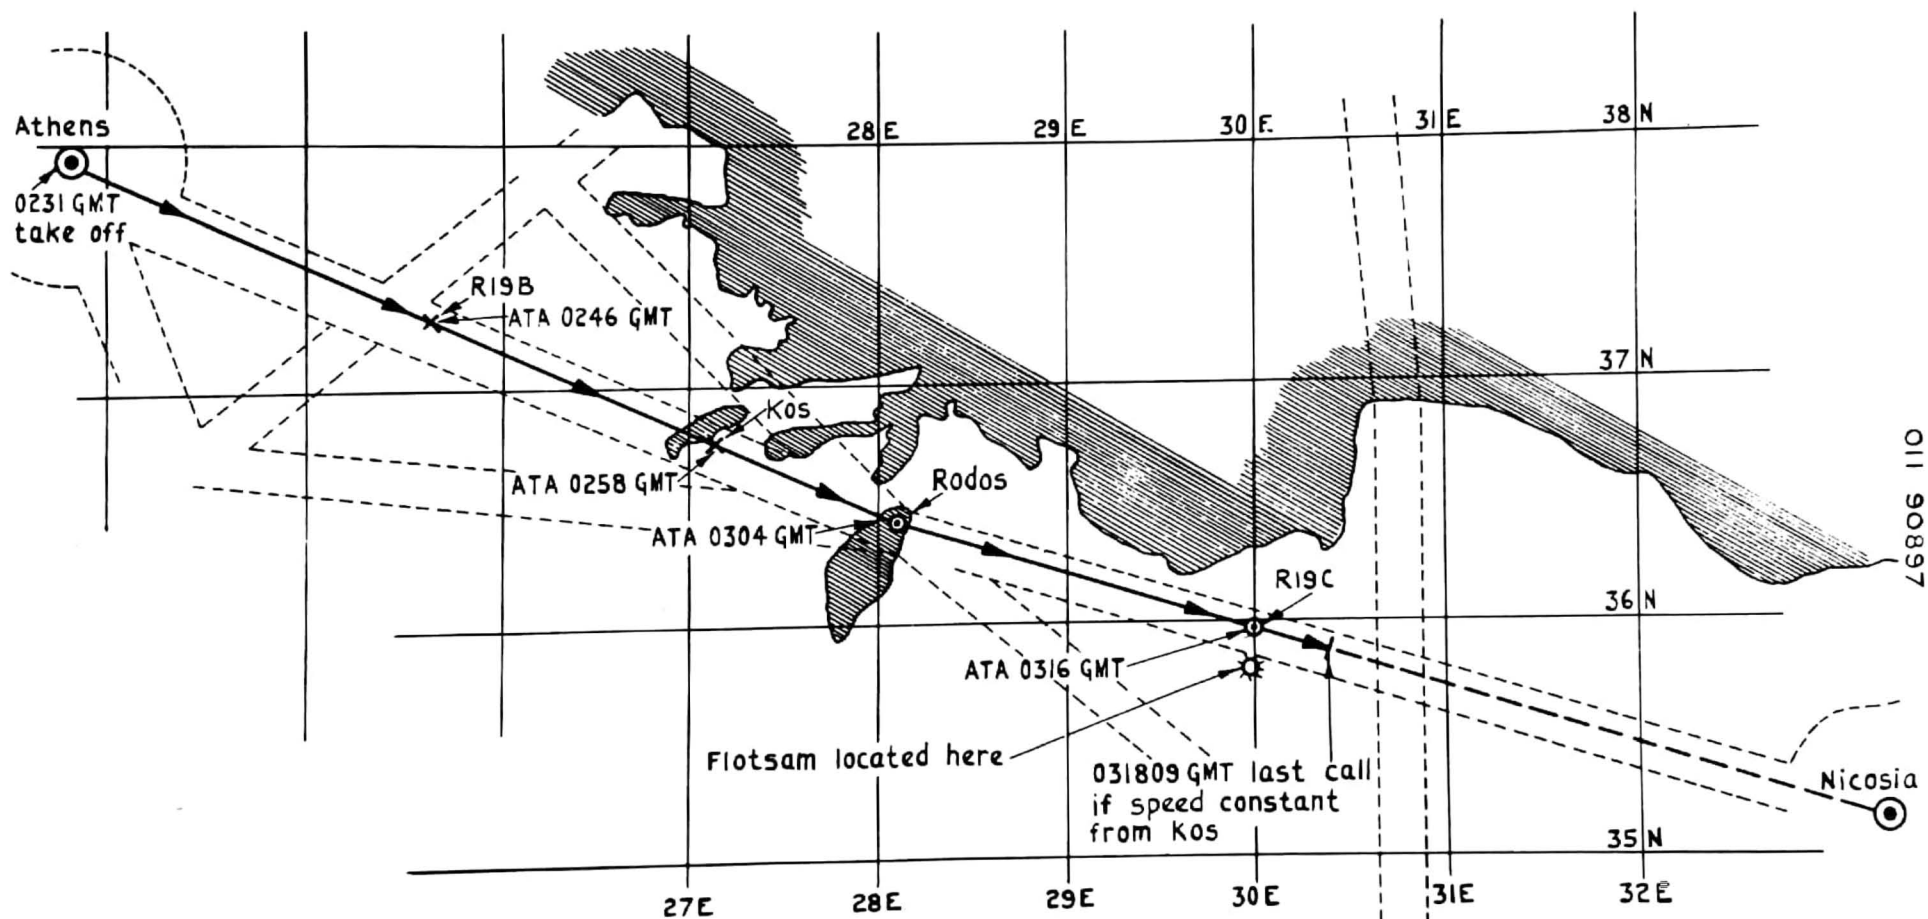
to the aircraft with an instruction to go ahead with its message but no further transmission was heard. Nicosia continued to try to contact the aircraft but without result and overdue action was therefore taken. At 0440 hrs. R.A.F. Search and Rescue aircraft took off from Akrotiri; at 0625 hrs. wreckage from G-ARCO was sighted in the vicinity of R19C, the last reported position. The aircraft's estimated track from Athens to the crash position is shown in fig. 1.

Fig. 1 Times and positions of aircraft along track

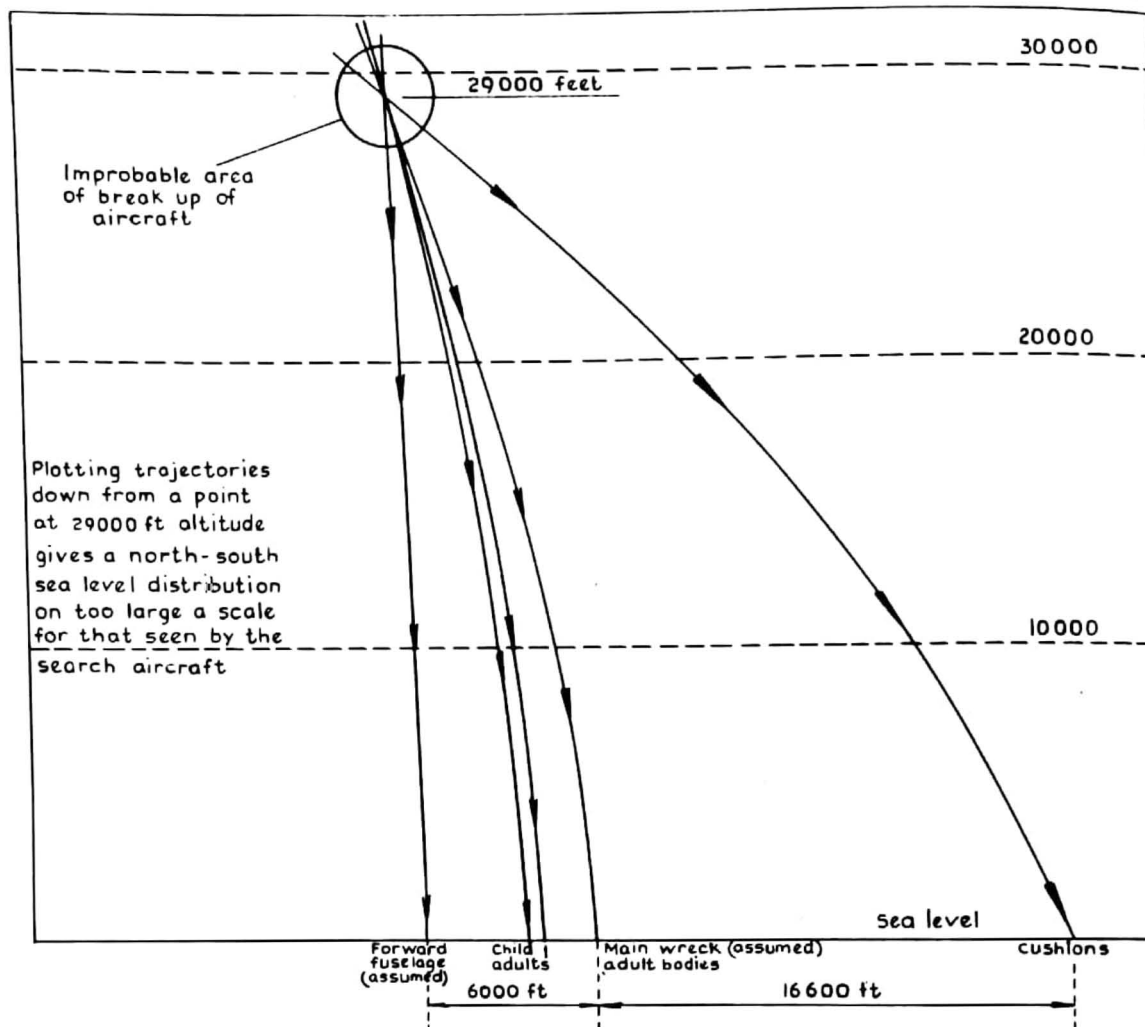
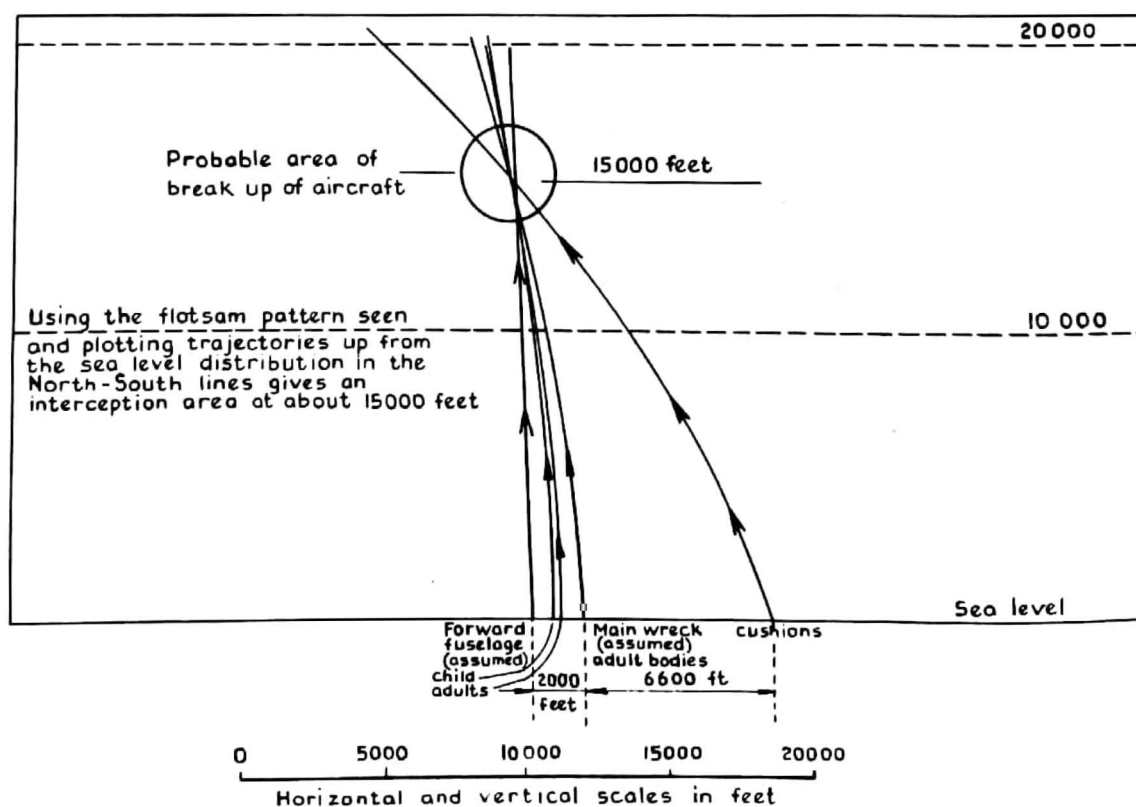
Fig. 2 shows the results of the calculations. Plots were first made from a specific point at 29,000 feet altitude, and the resulting scatter of flotsam and bodies, at sea level, noted. This distribution was too large to be reconciled with that seen by the search aircraft. Trajectories were then plotted from sea level upwards, from the general positions for items, as suggested by charts and maps from the search aircraft. A very close interception area of plots was found at about 15,000 feet altitude but this figure must be regarded only as an approximation and treated with caution owing to the imprecise information of the relative position of the flotsam and bodies at sea level. It was concluded that the aircraft had not broken up at its cruise altitude, but at the lower altitude, to produce the general pattern in the sea of flotsam and bodies, and the damage and injury pattern to bodies. A similar conclusion was reached by the pathologists, basing their argument purely on the medical evidence.

Fig. 2 Trajectory plots

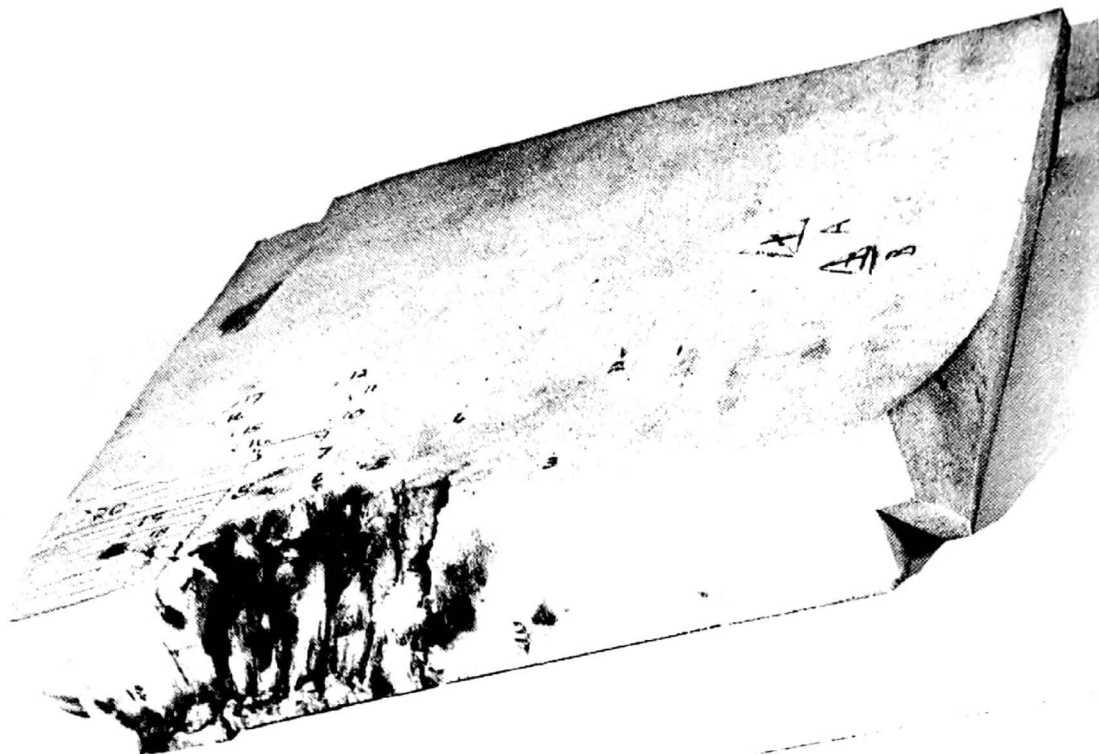
- (a) The physical damage to the cushion included blackening of the surfaces, superficial damage and perforations (fig. 3). Microscopic examination, X-ray and electron diffraction and fluorescence confirmed that the blackening was substantially due to amorphous carbon and identical to that produced by a high explosive. All these characteristics were reproduced in laboratory trials on similar cushions using a military high explosive. There was no evidence of fire.

FIG. 3. DAMAGED SEAT CUSHION

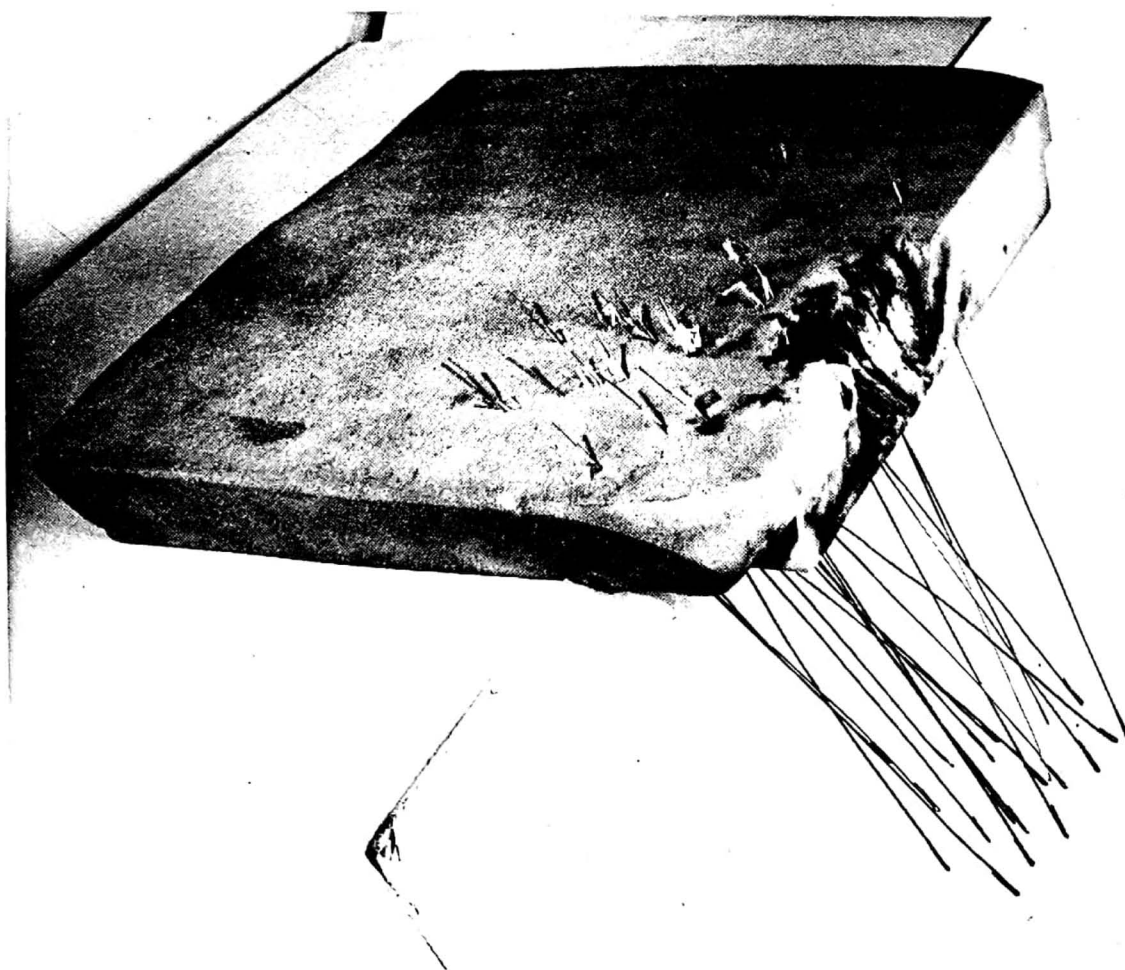
- (a) The trajectories of the larger particles which perforated the cushion and those which produced the major area of damage were explored by the use of wire probes (fig. 4). This suggests an origin of limited volume some 12 inches below the seat roughly in the vertical plane to the rear edge of the cushion and about 3 inches from the line of the port edge of the cushion. The trajectories delineated by the entry paths of the small particles embedded in the cushion confirm this position.

FIG. 4. SEAT CUSHION WITH WIRES SHOWING TRAJECTORIES.

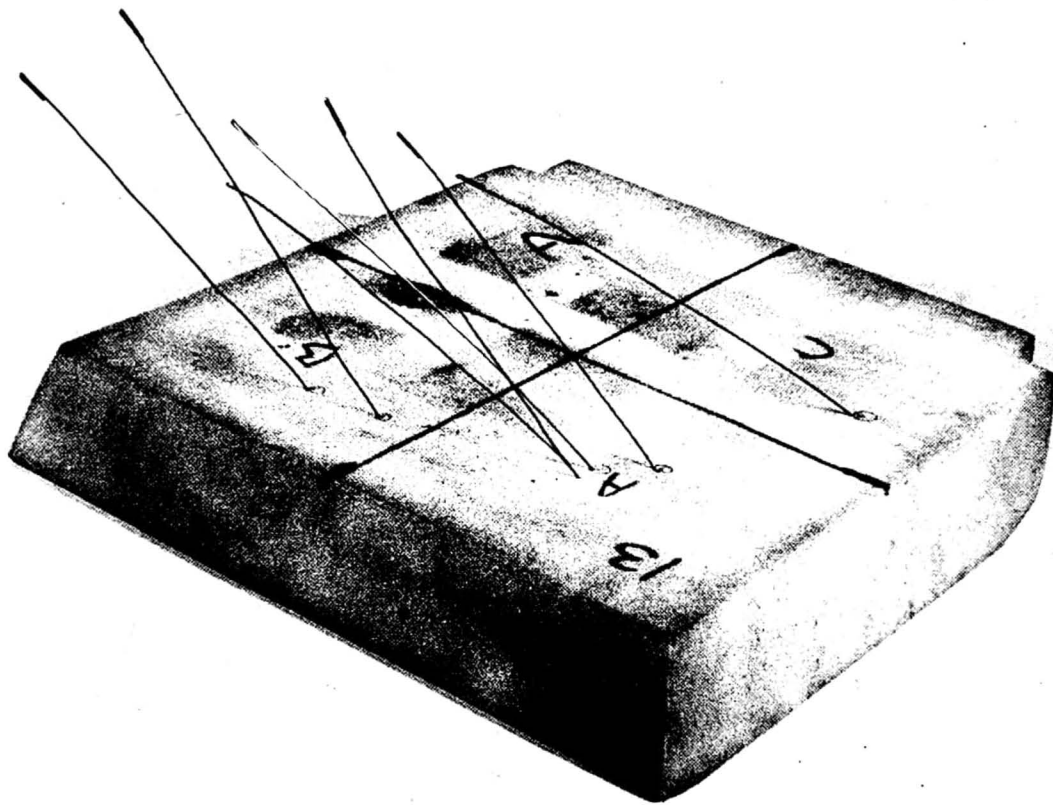
FIG. 5. SECOND SEAT CUSHION WITH WIRES SHOWING TRAJECTORIES.
