CIVIL AVIATION DEPARTMENT

**CIVIL AIRCRAFT ACCIDENT**

Convair 880M VR-HFX

at Hong Kong International Airport

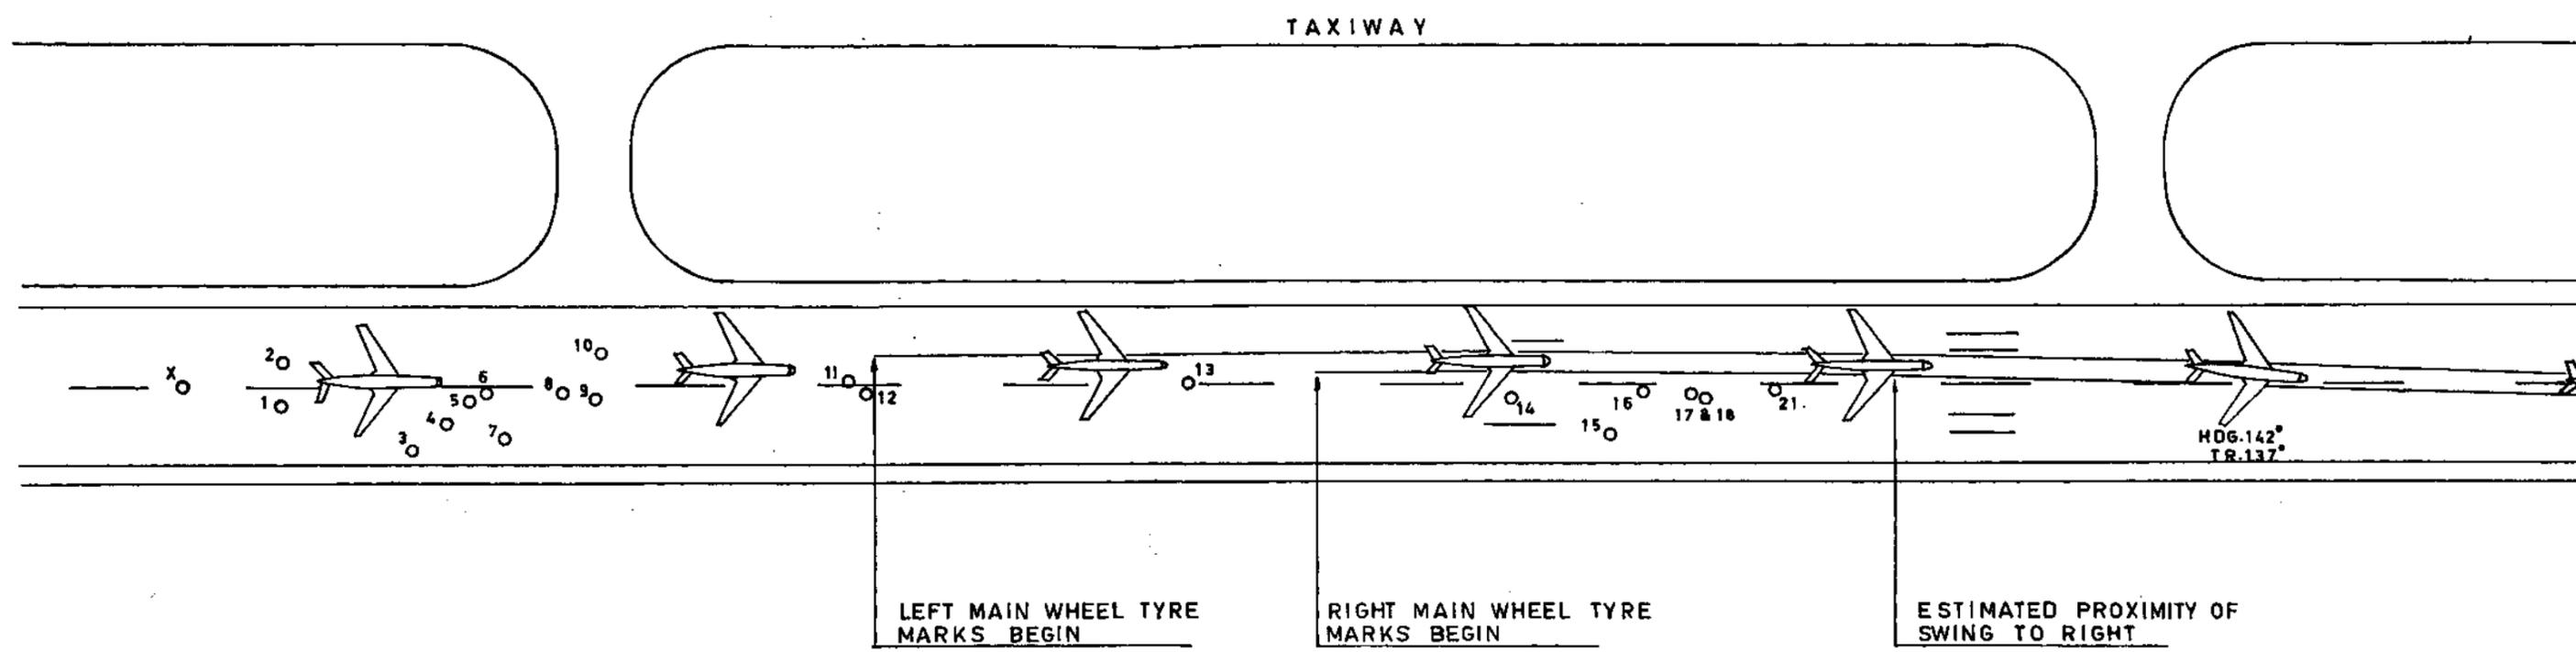
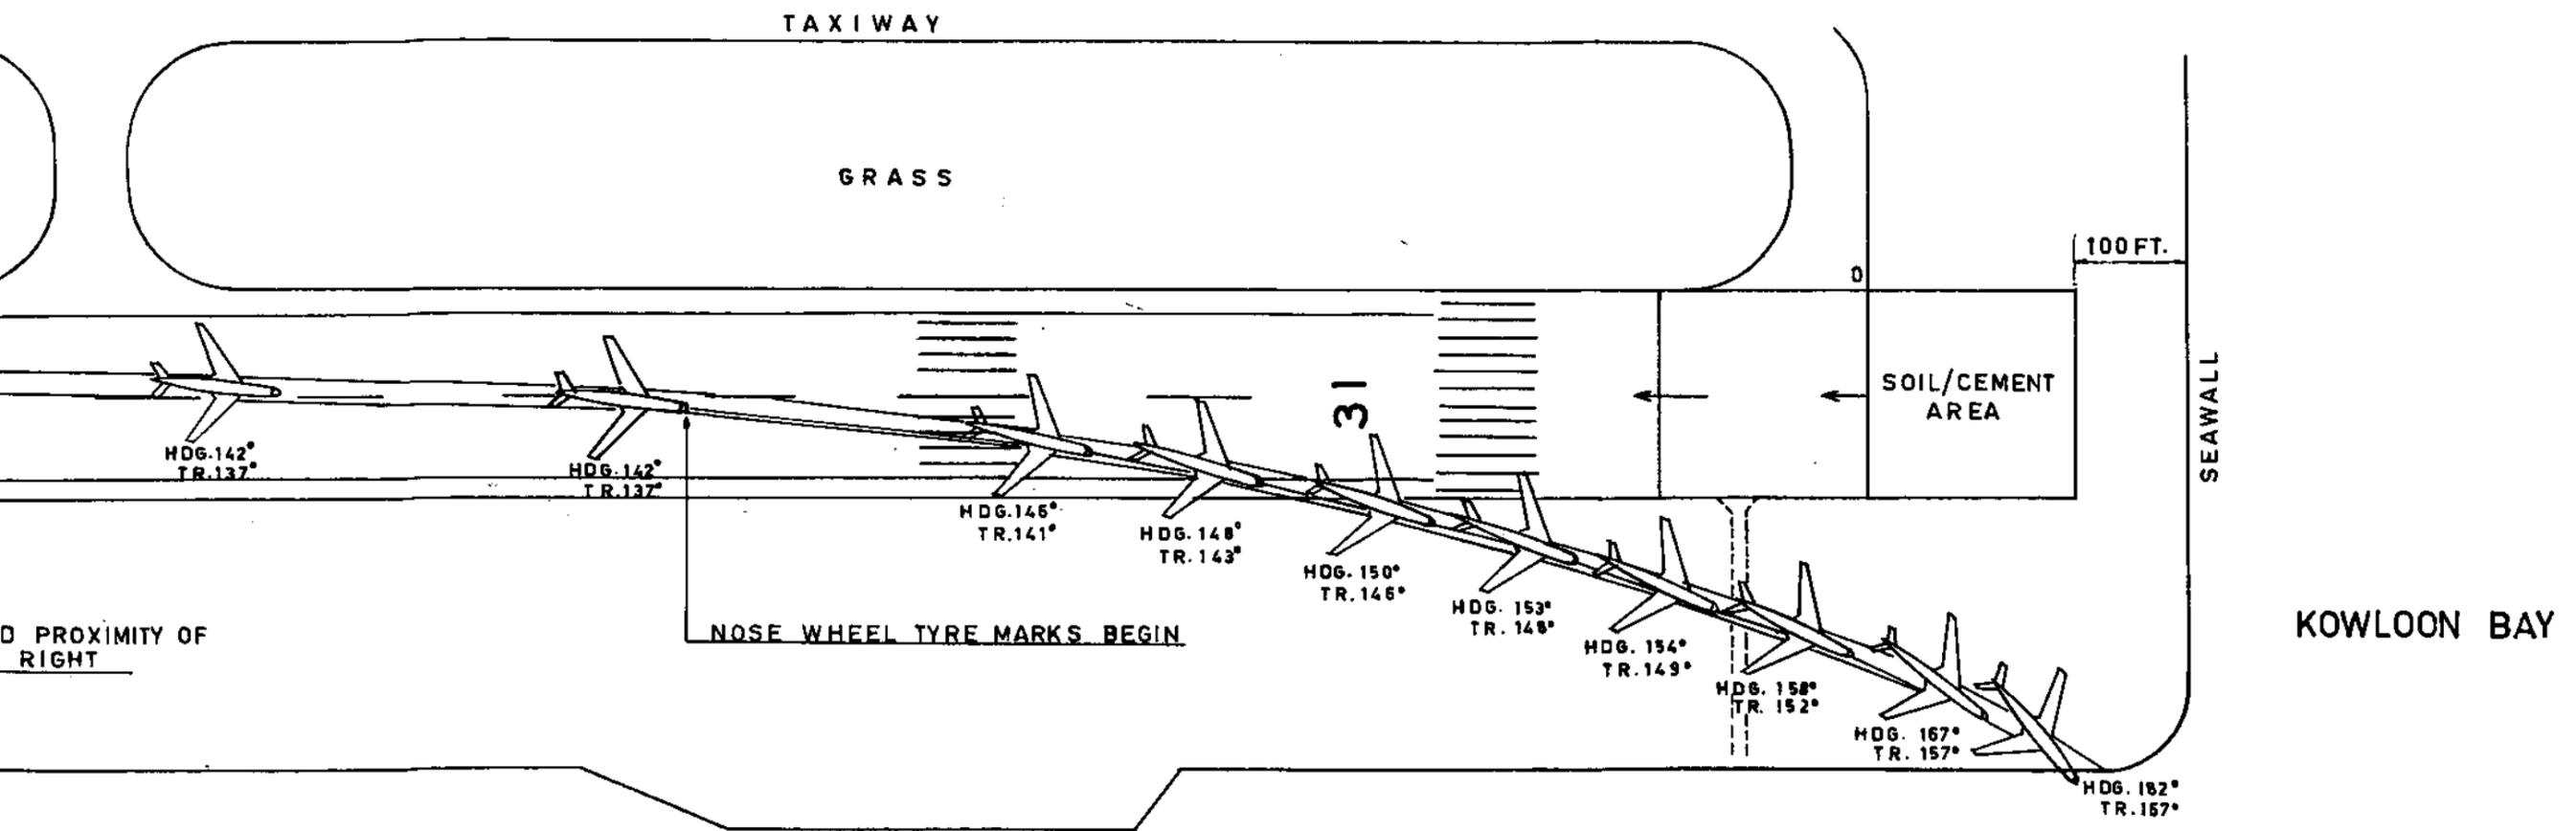
WHEEL MARKS & AIRCRAFT ATTITUDE

The correlation of the pieces of rubber and the tyre marks found on the runway were plotted and are shown at Appendix 'B'. The first shedding of rubber occurred around 4,580 feet from the beginning of the runway, and tyre marks resulting from application of the left hand wheel brakes first appear some 710 feet further down the runway, i.e. approximately three

seconds later in terms of the aircraft's speed. The major shedding of rubber in this period occurred approximately 1 second after the initial separation and would bring a heavy increase in vibration. In this context the examination of the damaged nose-wheel tyre confirmed that the first two pieces of thrown tread were those marked X and 1 and this would indicate that the pattern of pieces of rubber found on the runway generally followed the sequence of separation, even though the pieces of tread would have been thrown off during various phases of the tyre's rotation and would have been subject to varying forces, such as those imparted by the aircraft's momentum, centrifugal force of the wheel and the engines' jet blast.

A second major shedding of rubber took place some 6,080 feet down the runway and because of the 'tied' nose-wheel system this caused a progressive "down-hill" castoring of the nose-wheels which initiated the swing to the right. Some 790 feet after this commenced, the nose-wheel tyres began to leave marks on the runway for the first time but by this point the aircraft had a pronounced crab to the left with heavy side loads on the wheels and it is considered that it was this force rather than braking effects which caused the impressions to be left.

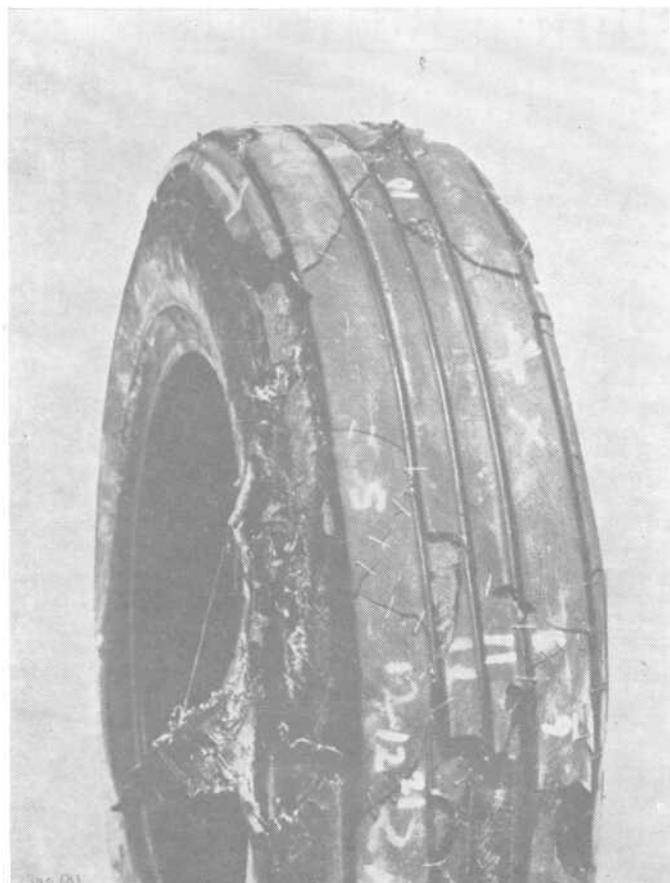
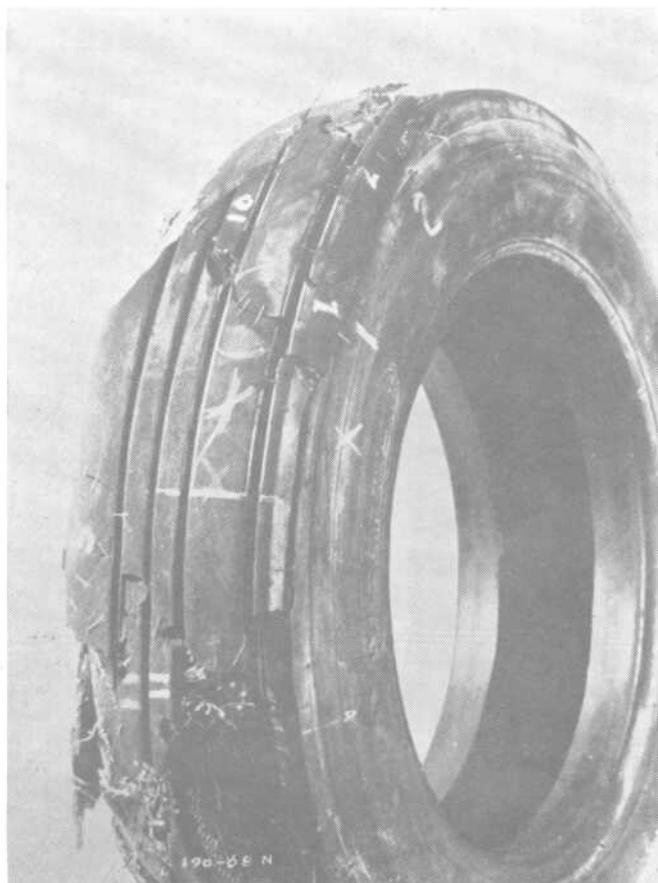
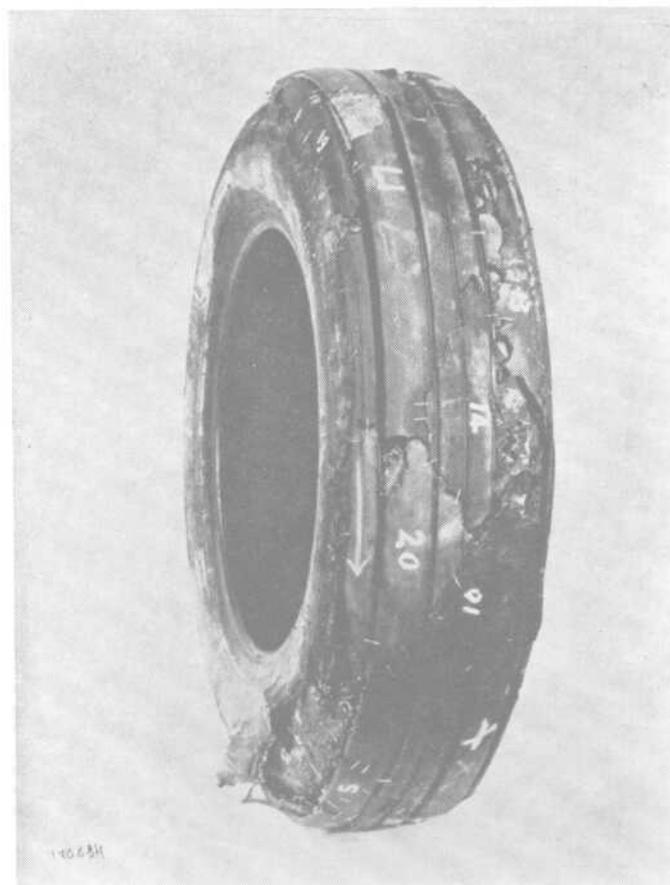
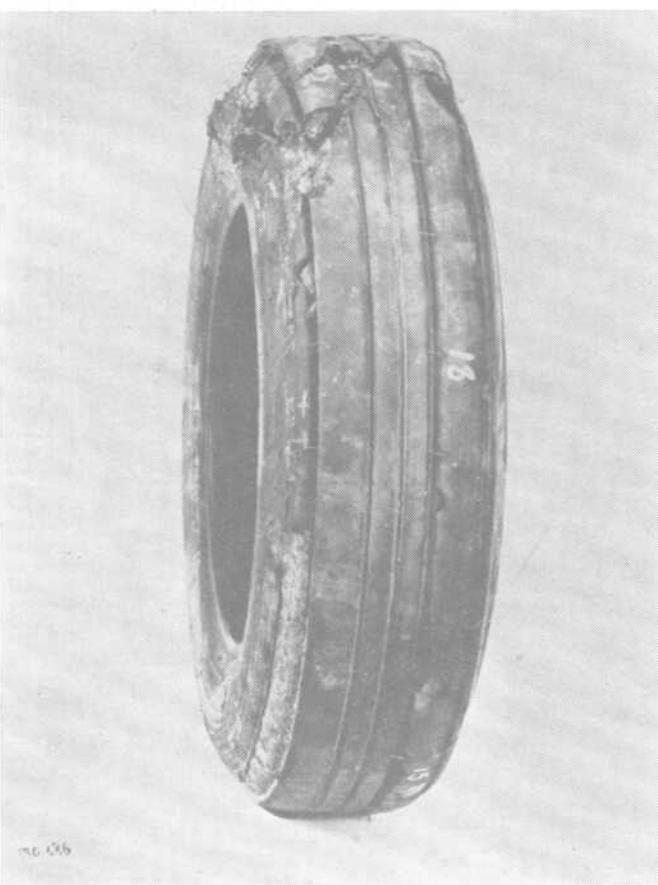
ACCIDENT TO CONVAIR 880M VRHFX  
HONG KONG ON 5TH NOVEMBER, 1967  
PHOTOGRAPHS OF FAILED NOSE-WHEEL TYRE

Examination of the nose landing gear revealed that the right hand tyre had stripped a considerable portion of its tread (Appendix 'C'). The left hand tyre showed signs of rather more than normal wear as well as signs of sideways scuffing. Both tyres were found to be inflated to approximately the correct pressure when checked subsequent to the accident. Both tyres had been retreaded.

Nose Tyres. Both nose tyres, together with the numbered pieces of tread recovered from the runway, were despatched to Messrs. Goodyear Tyre Company, who had originally manufactured the tyres and who had sub-contracted the last re-tread on the failed tyre, for an expert opinion as to the reason for the tread separation. Messrs. Goodyear carried out a detailed examination and submitted a comprehensive report, relevant sections being that: the differential between the two nose-wheel tyres was 0.19" and was well within the normal limits for tyre matching; the beads, innerliner and carcass of the stripped tyre were sound and had lost approximately 60 - 70% of the tread; separation of the tread had developed directly underneath tyre piece No. 10 (Appendix C, photograph 190-68E); there was a further evidence that a separation developed in the wide outboard rib of the area circled between X and 10 (Appendix 'C', photograph 190-68N).

- i) Separation developed in the retreaded tyre at one point in the shoulder and possibly at two points on the sidewall.
- ii) These separations could have been in the retread prior to take-off or developed during take-off.
- iii) There was no evidence of a defect in the tyre or retread which might have led to such separations.
- iv) In their opinion, the separations were initiated by impact, such as may result from hitting runway markers or edges, foreign objects on the runway, etc.
- v) Although portions of the tyre tread were missing from one tyre, both tyres were still capable of retaining air and carrying a load.

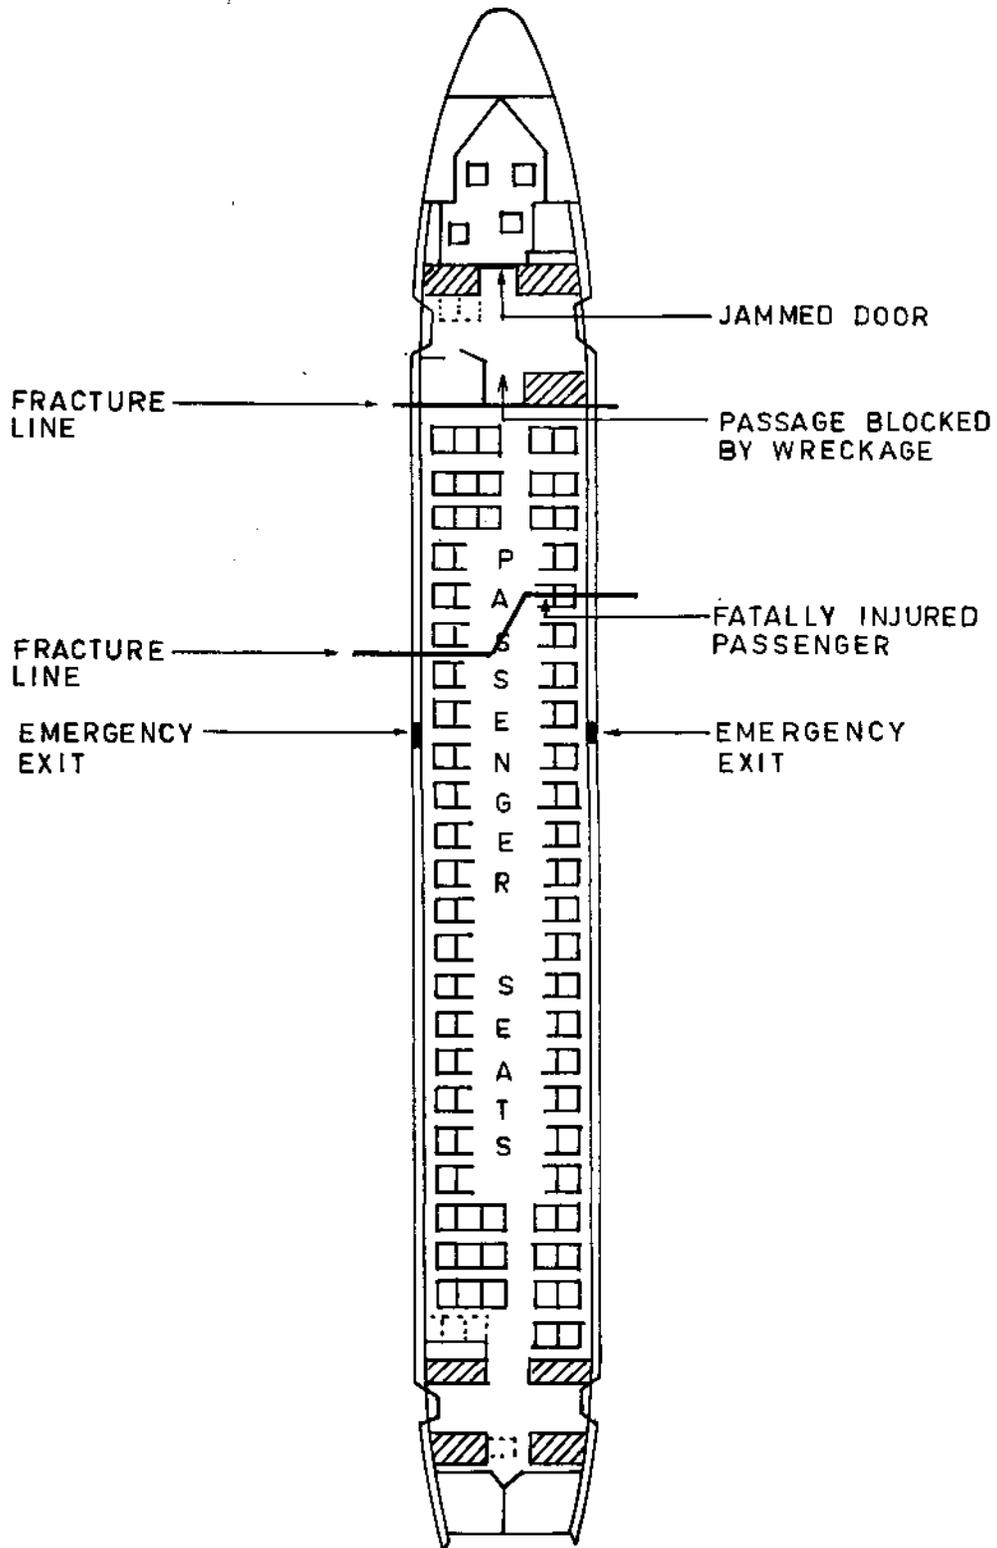
EMERGENCY EXITS & FUSELAGE FRACTURES

The nose section forward of the leading edges of the mainplanes had separated at Station 622 at the top and bottom and left side and on the right side at Station 565. The nose section had itself broken into two sections around Station 429. There were indications that this section had broken away from the main body as the result of an impact from the left as well as from the front. The crew compartment itself had suffered very little internal damage, the major damage being located between Stations 622 and 429.

All seats aft of the wing leading edges were relatively intact and secured to the floor but those forward of the mainplane were generally extensively damaged due to the fuselage damage between stations 429 and 622.
