## CIVIL AIRCRAFT ACCIDENT

Report on the Accident  
to Ambassador AS.57 Series 2 G - AMAD  
at Heathrow Airport, London  
on 3rd July 1968

Accident Report No. EW/C/0214

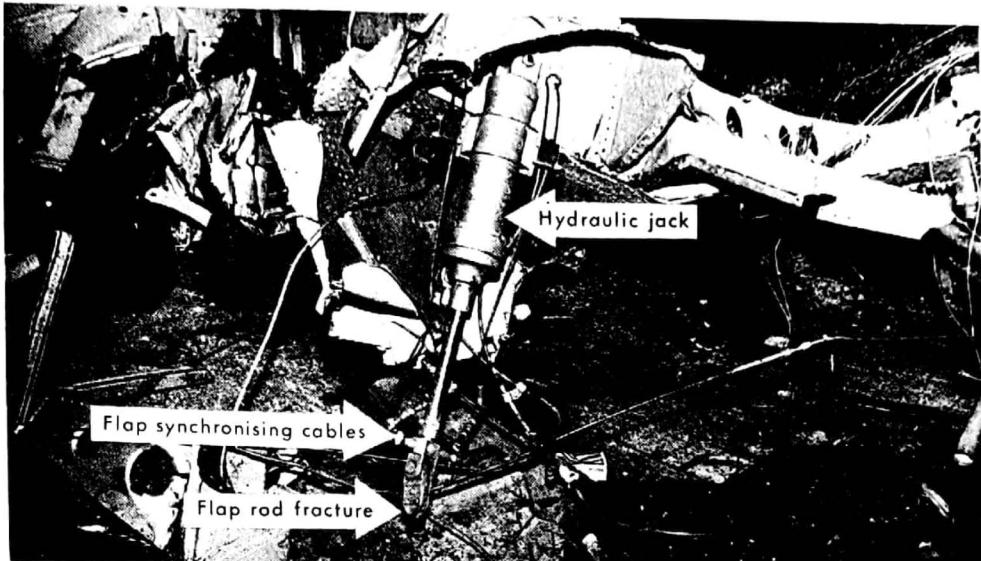
During the examination of the wreckage at the accident site, the flap operating rods were located. Examination of the rods revealed a fracture on the port rod just outboard of its connection to the flap jack piston rod. These components were removed for detailed laboratory examination. This examination revealed that the port operating rod had failed due to fatigue. (See Appendix A). There was no evidence of incorrect assembly or corrosion. There was no failure or fatigue on the starboard operating rod.

PORt FLAP JACK AND FRACTURED FLAP ROD

Prior to the accident there was no laid down fatigue life for the flap operating rods. However, immediately following the accident the Air Registration Board, in conjunction with Hawker Siddeley Aviation Limited, introduced a scheme to reinforce the rods with steel plates. Tests with these

strengthened rods has confirmed a safe fatigue life of 37,000 flying hours. In addition, a design re-appraisal has led to the introduction of a safe fatigue life for other parts of the flap system, and additional mandatory inspections of certain items has now been incorporated in aircraft operators' approved maintenance schedules.

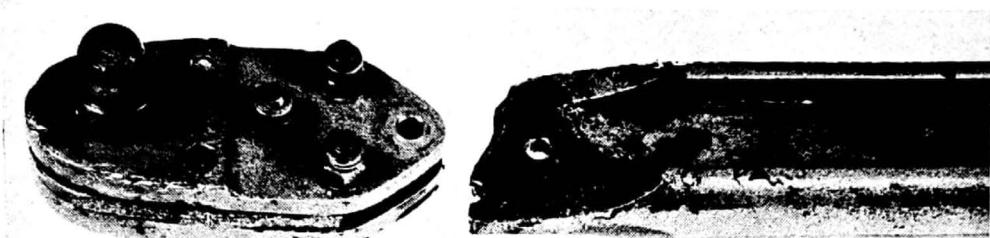
FRACTURED PORT FLAP ROD

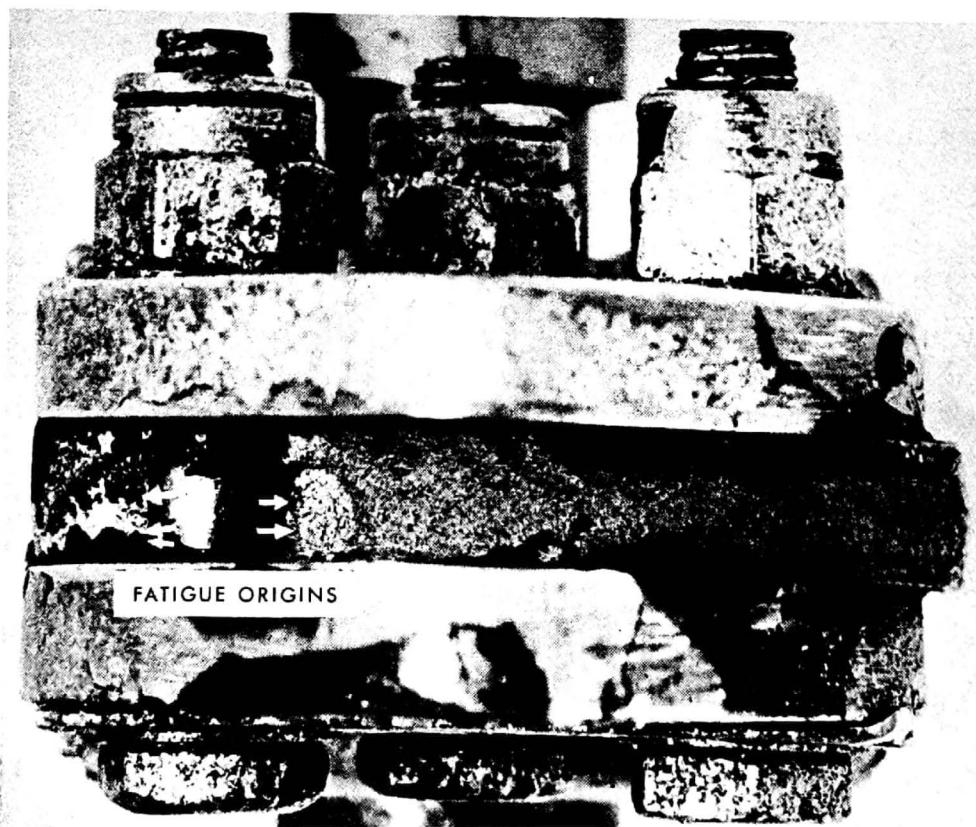
A number of rods removed from other Ambassador aircraft, including those which had achieved lives greater than 13,000 hours were also examined and tested. The examination revealed fatigue cracks emanating from the 2 BA bolt holes in a number of these rods. In this respect, the appearance and position of the fatigue cracks was similar to that of the rod in the accident aircraft. When tested in a tensile machine the position and mode of failure also proved to be similar.

Failure of the port flap operating rod by fatigue permitted the port flaps to retract. This resulted in a rolling moment to port which could not be controlled.

ENLARGED VIEW SHOWING FATIGUE FRACTURE
