REPORT ON THE CATASTROPHY OF AVIOGENEX AIRCRAFT

TU - 134 A, YU-AHZ

AIRPORT "RIJEKA", YUGOSLAVIA

23 May 1971

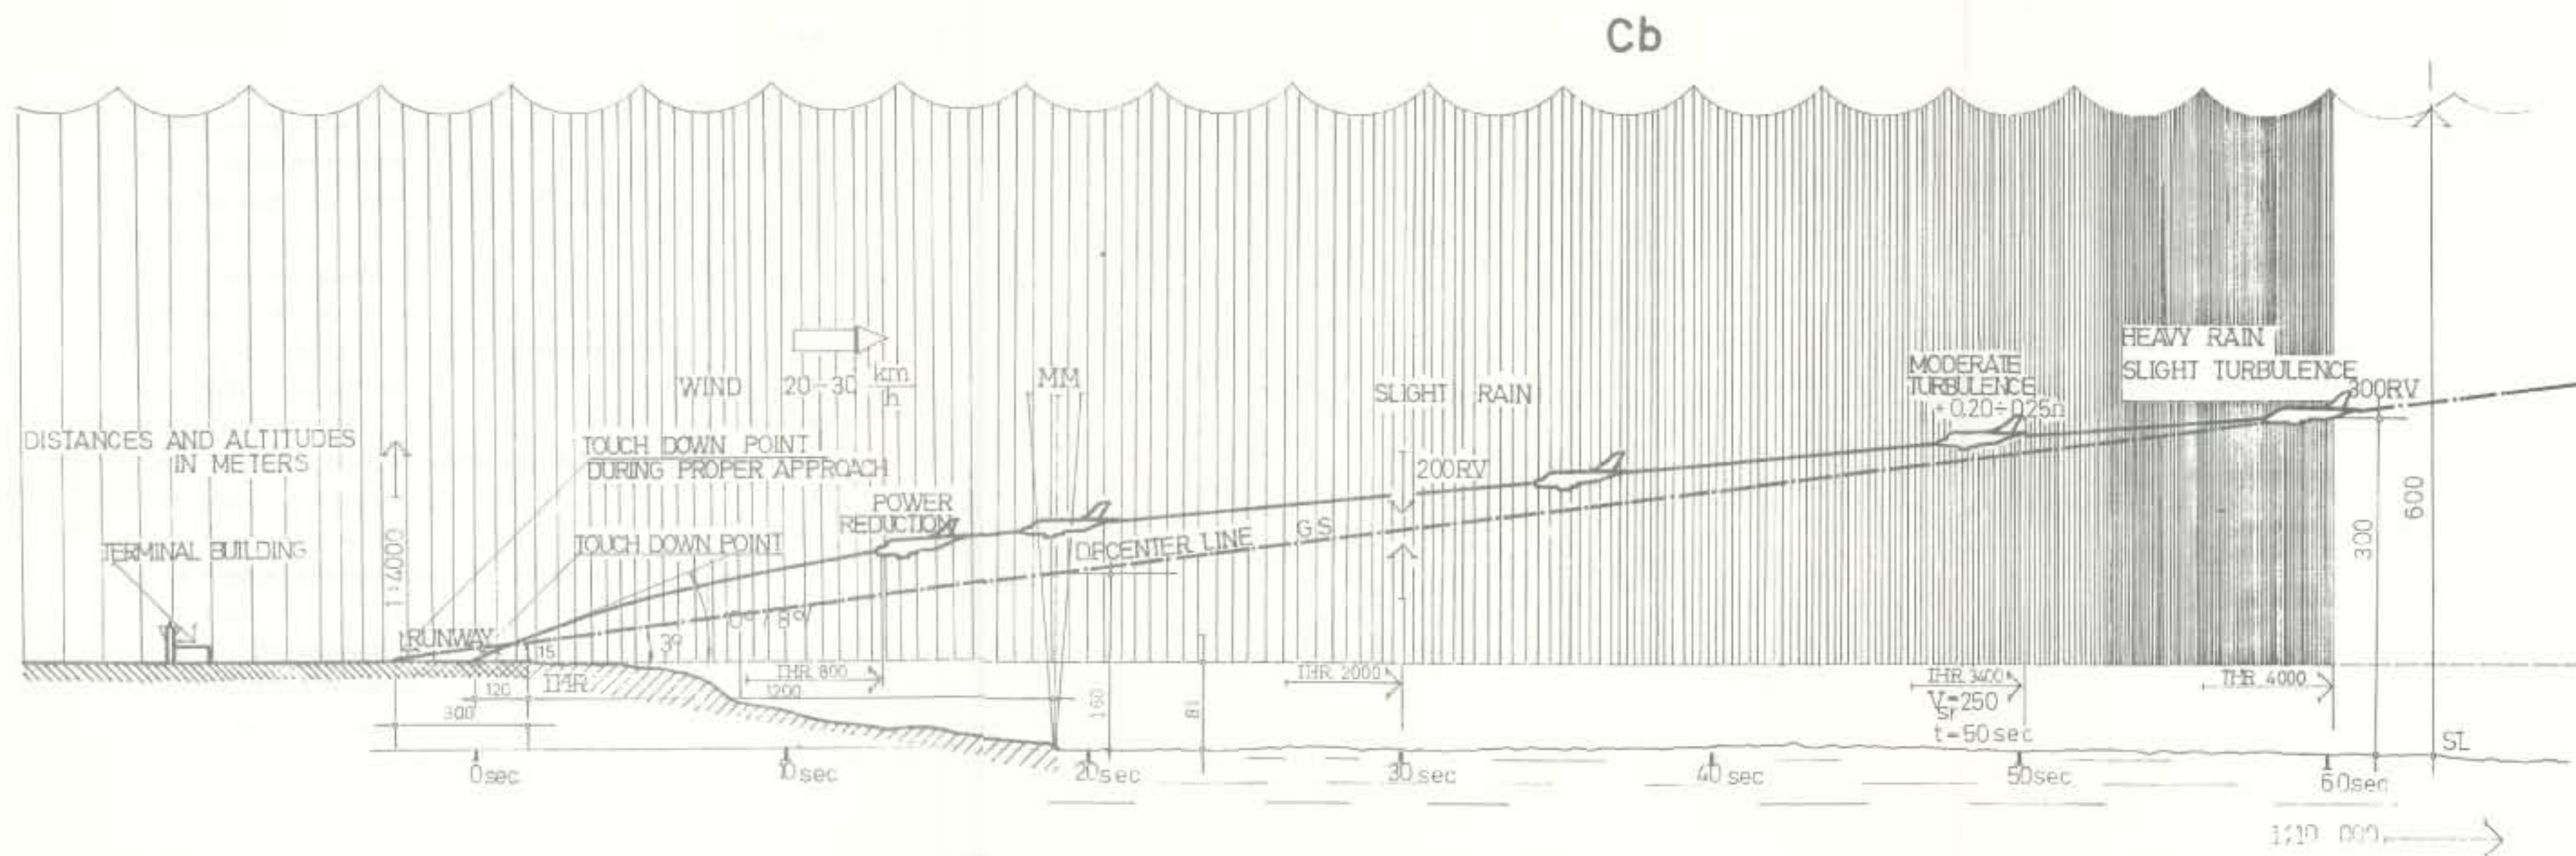
SKETCH No. 1.

The subsequent flightpath of the aircraft was characterized by the reduction of speed and a steeper and steeper angle of descent (Figure No. 1)

this was to be expected with the reduced power and due to the aerodynamic features of the aircraft. From the statements of the crew it was apparent that due to an optical illusion they thought that they were closer to the runway and at a greater height above it than was in fact the case.

# PROBABLE FLIGHT PATH OF THE AIRCRAFT YU-AHZ

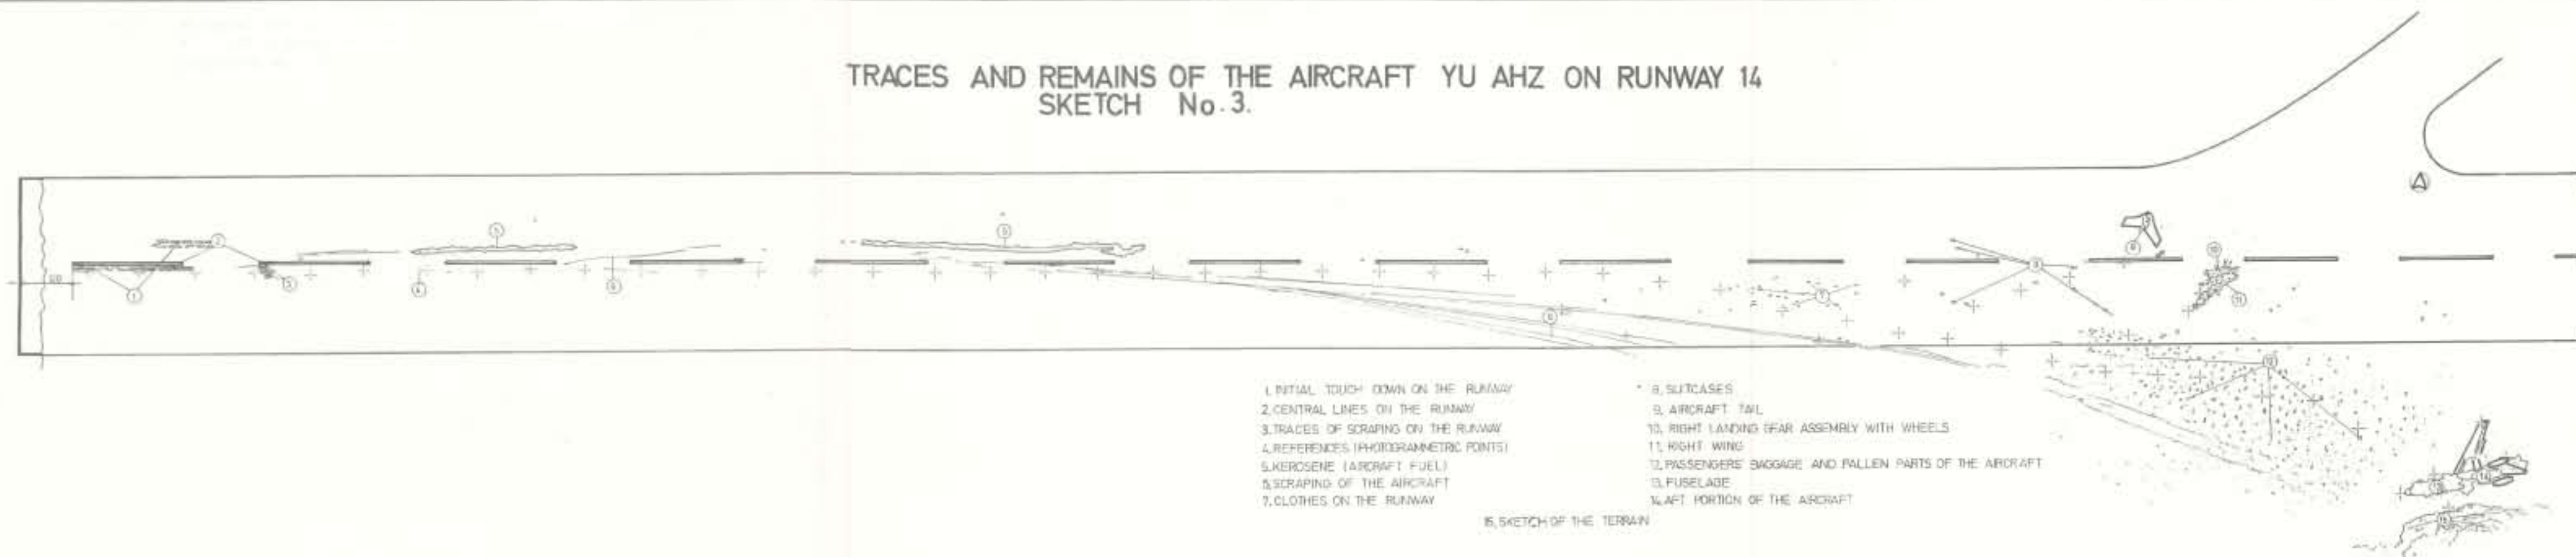
# TRACES AND REMAINS OF THE AIRCRAFT YU AHZ ON RUNWAY 14 SKETCH No. 3.

A survey of the accident site is presented on Figure 3. The survey has been made on the basis of stereophotogrametric photography.

The wreckage of the right wing and the wreckage and deformation on other parts of the aircraft were re-constructed during the investigation and photography, and the following was found out:

- the initial failure occurred in the right wing between the sixth and seventh rib because of the combined loads on the attachment point of the landing gear to the wing.

- deformation - bending and traces of scraping the runway were found on the root of the right wing the remains of which bent over and blocked the access to the emergency exits.

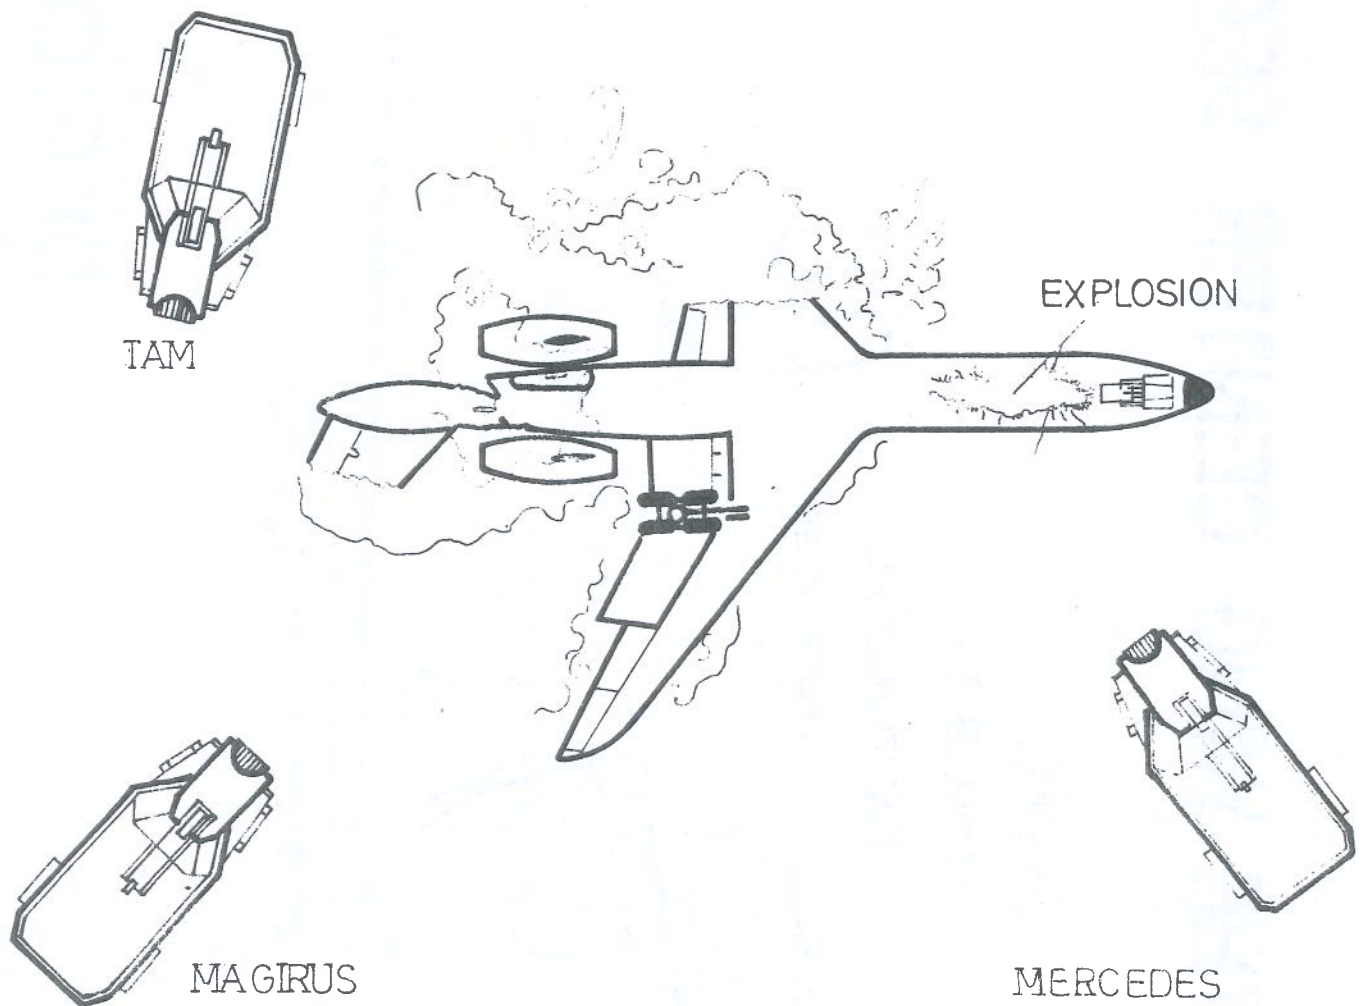
SKETCH №4.

- In the first minute after the aircraft had stopped, the fire broke out under and around the left wing and with less intensity in the tail, behind the right engine and in the remaining parts of the right wing (Figure No. 4).

After the impact, breakup and ground slide the aircraft stopped on the right side of the runway near the terminal building on its back and with the tail in the direction of landing, Figure No. 4.

# FIRE YU-AHZ

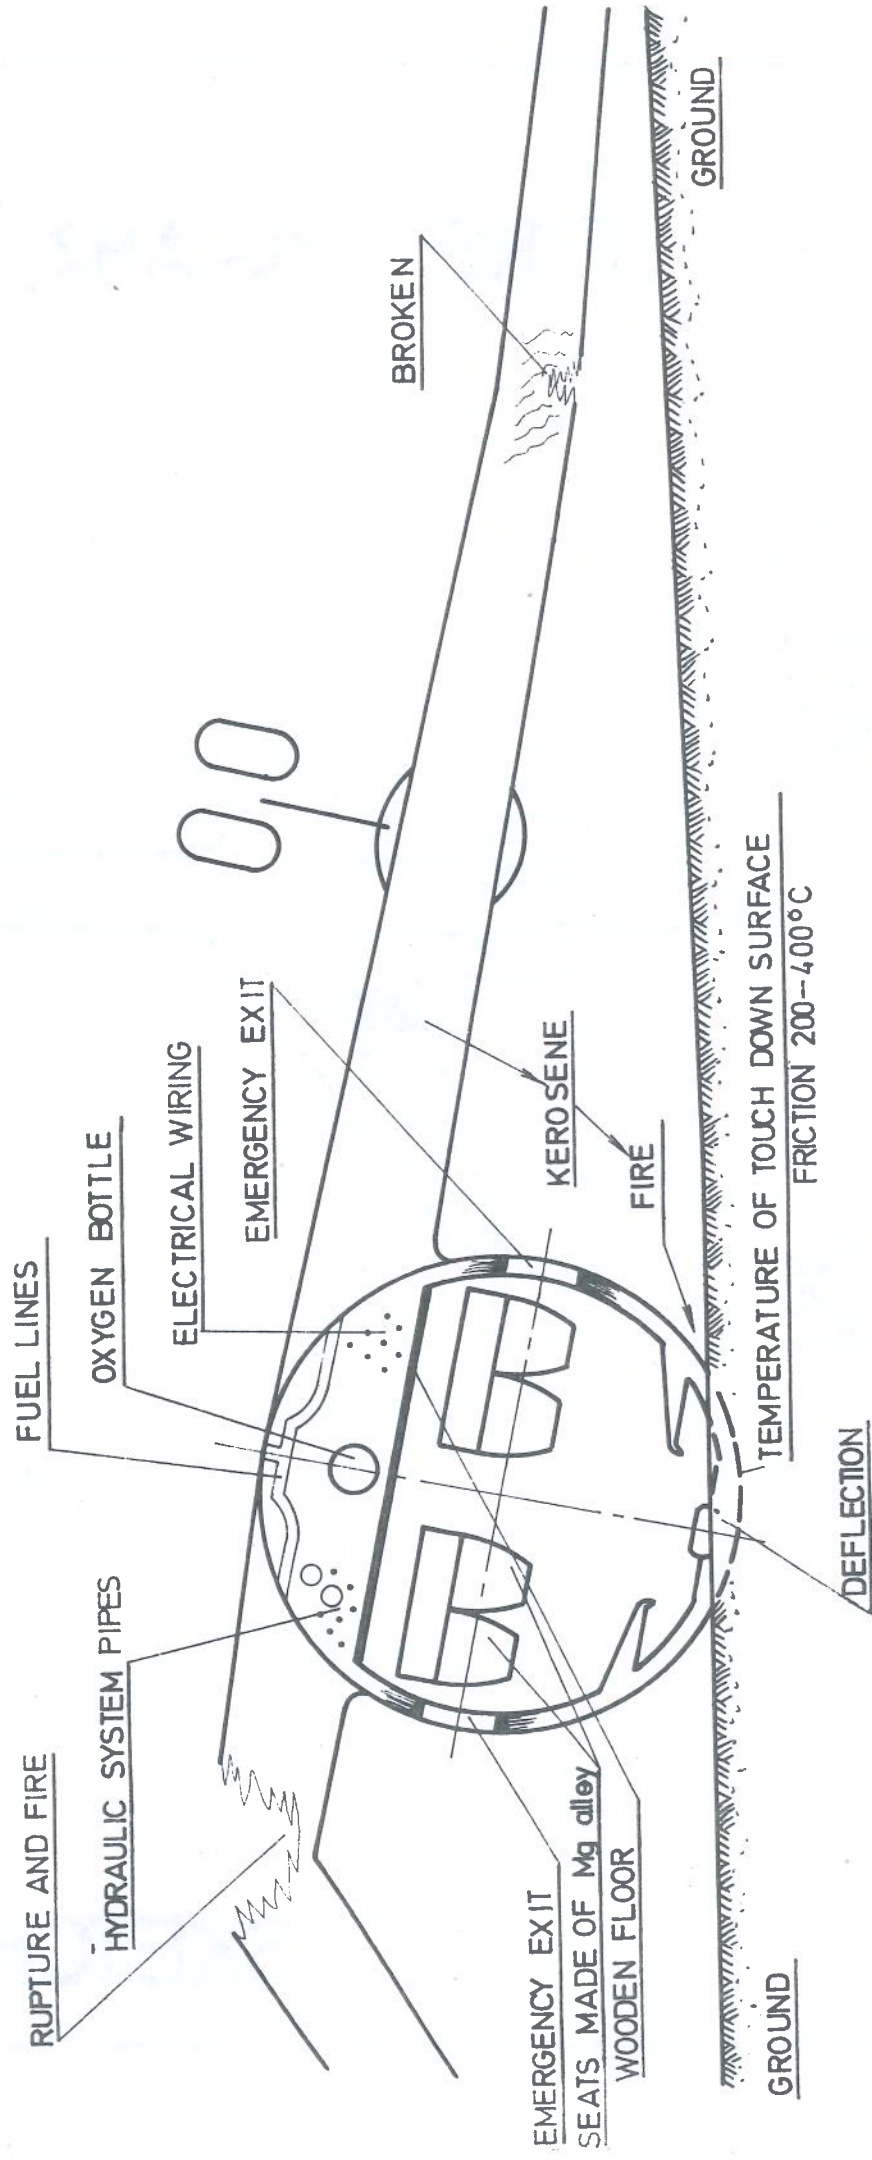
SKETCH No. 5

- intensive traces of scraping of the upper surface of fuselage, Figure No. 5,
- the fuselage nearly completely burned in the fire while the engines and the left wing remained together with the right landing gear assembly.

# PROFILE OF THE WING CENTER SECTION
