ACCIDENTS INVESTIGATION BRANCH
Department of Trade and Industry

HFB 320 Hansa D-CASY
Report on the accident off Blackpool Airport,
Lancashire, England, on 29 June 1972

**Accidents Investigation Branch
Civil Aircraft Accident Report No 15/73
(EW/C415)**

Aircraft: HFB 320 Hansa D-CASY

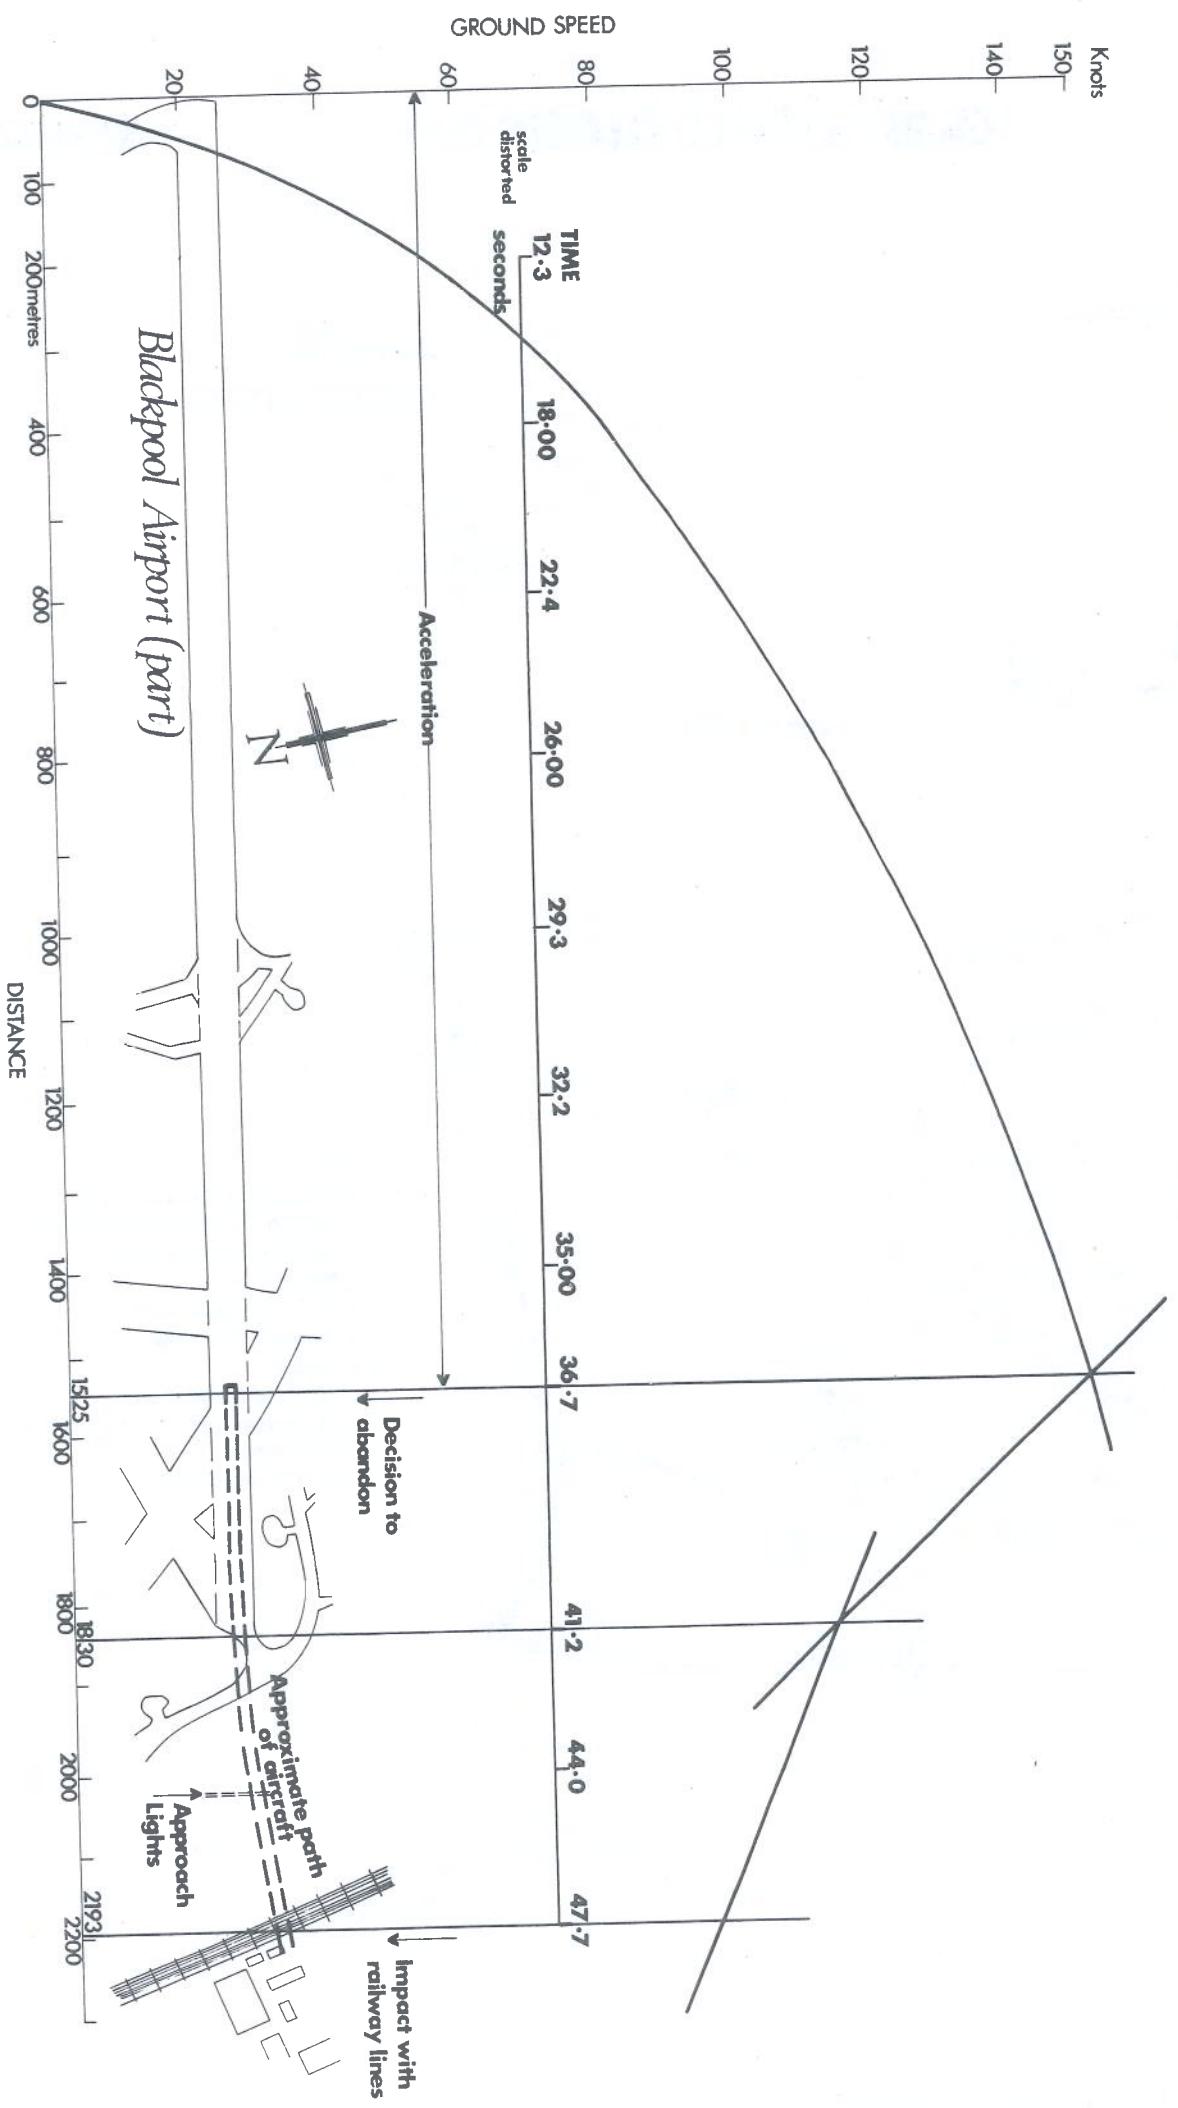
APPENDIX 1

According to the performance figures contained in the flight manual in the conditions and aircraft configuration prevailing at the time of the accident the aircraft would have reached 'rotation' speed (130 knots) within 1,170 metres (3,831 feet) and lifted off at 1,240 metres (4,061 feet) from the start of the take-off run. Energy calculations were made by a computer programmed with aircraft aerodynamic co-efficients, engine thrust information, aircraft dimensions, runway dimensions, and the weather conditions at the time. The results of these calculations agree closely with the flight manual figures and indicate that the aircraft would have reached rotation speed (V_R) after 31 seconds (1,100 metres) from the commencement of the take-off run. The calculations also showed that the aircraft continued accelerating for a further 6 seconds (425 metres) after attaining V_R , and achieved a maximum speed of 149 knots before the thrust levers were closed and the brakes applied. In all, the aircraft was travelling at or above rotation speed for 9 seconds or 600 metres of runway length. (See Appendix 1).

The computer energy calculations on the deceleration performance were based on the speeds and acceleration that, according to the evidence, occurred in the accident. The aircraft accelerated for 1,525 metres before the engines were throttled and the brakes applied. There remained 300 metres of paved area during which the speed decayed from 149 knots to 112 knots before the aircraft ran on to the wet grass where the braking effect was greatly reduced. At the point of collision with the railway lines the calculated speed was 95 knots.

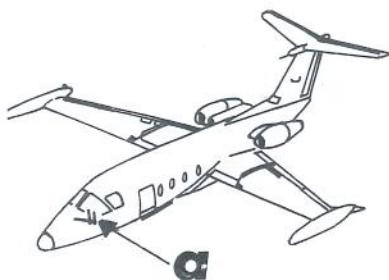
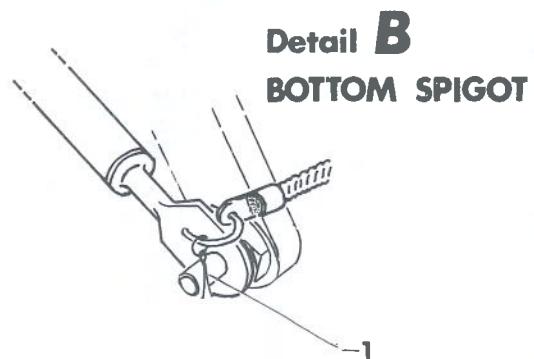
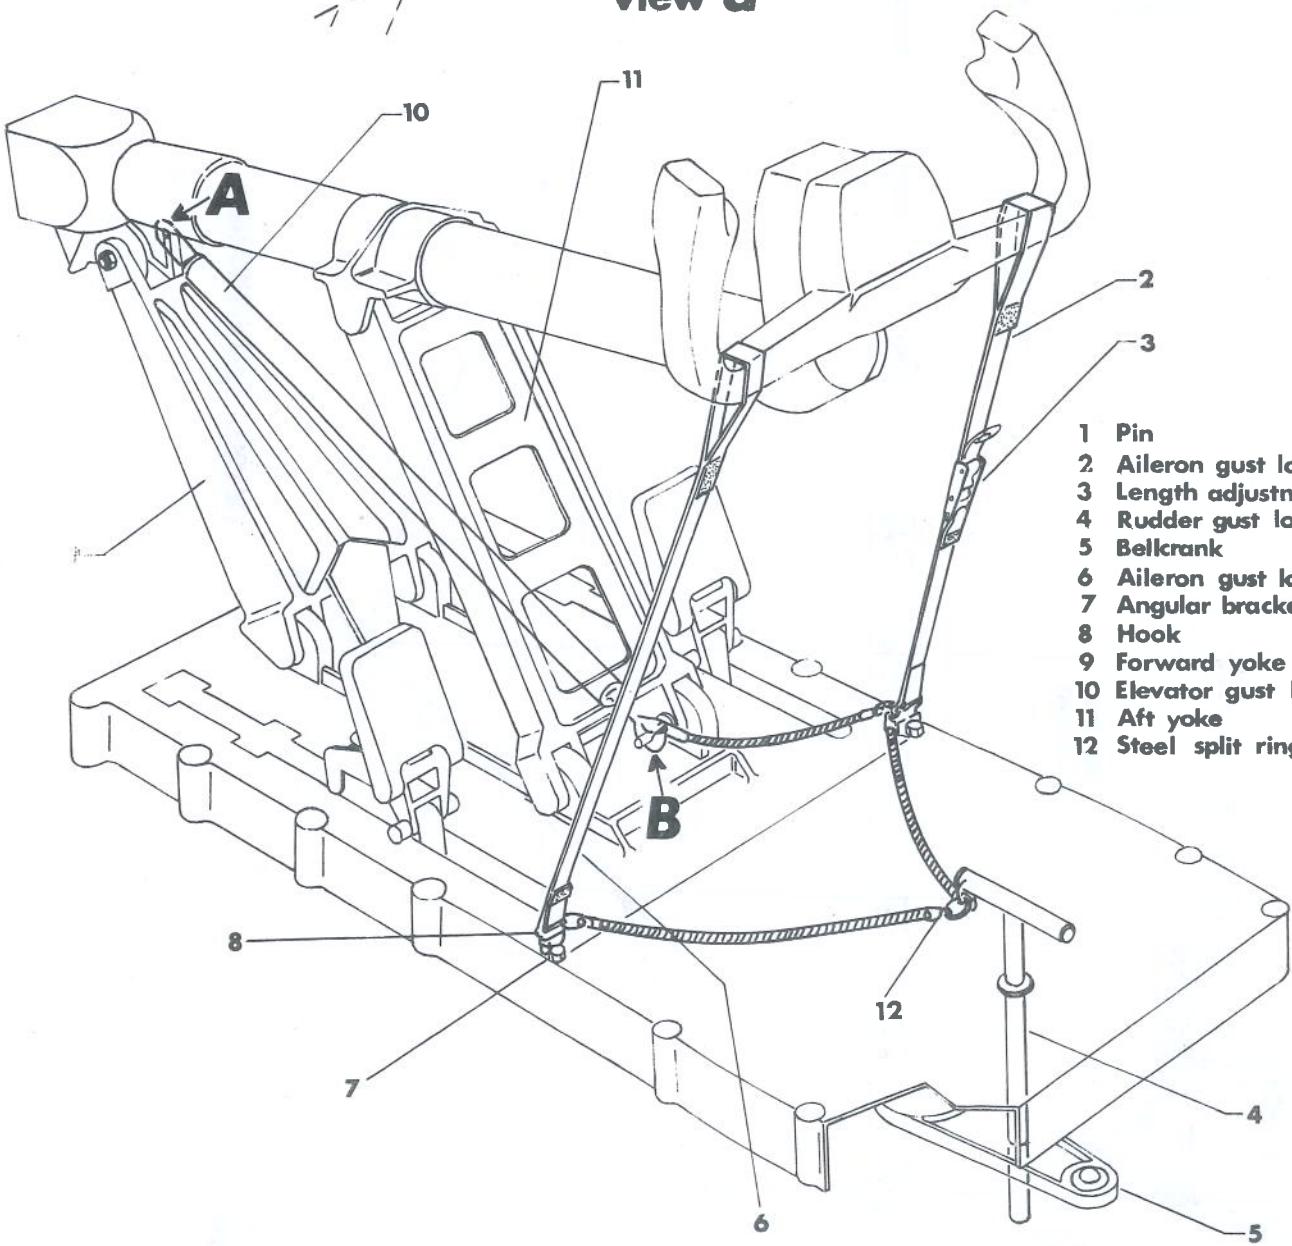
APPENDIX 2

The control surfaces of the HFB 320 could be locked by a flight deck locking system when the aircraft was parked. This gust lock system consisted of a pair of webbing straps, a 'T' shaped metal fitting and a light alloy tubular rod which were normally connected together by cord. When in use the webbing straps were fastened over the control wheel horns to provide aileron protection, the rudder was held by inserting the 'T' shaped metal fitting through a hole in the cockpit floor into a matching hole in the rudder operating mechanism and, when the light alloy rod was located on two spigots on opposite corners of the pantographic elevator control assembly, the elevator was locked in a neutral position. (See Appendix 2). The manufacturer specified that the gust locks should always be fastened together. Notwithstanding these instructions they were sometimes separated for ease of installation of the elevator lock and were reported to have been separated on D-CASY. When it was installed as the manufacturer intended, the complete gust lock system caused sufficient hindrance of access to the pilot's seat to provide a safeguard. However this hindrance was associated with the aileron straps and was lost when the elevator gust lock, disconnected from the rest of the apparatus, was installed. Since there was no interconnection between this type of gust lock and the throttles, it was possible to obtain take-off power with the locks in place. If the elevator gust lock was dislodged from its bottom spigot only, it was noted that while the control column could be moved fully forward (elevator down) fouling of the aircraft structure by the lock strut prevented any degree of rearward movement (elevator up) being achieved. A stowage compartment for the gust locks was provided behind the co-pilot's seat on the flight deck and they could also be stowed in a receptacle under the forward passenger seat on the port side of the aircraft.

The only remnant of the gust lock equipment found was the steel, tee-handled, rudder locking pin. It was noted that the steel split ring, by which the aileron straps and elevator gust lock were attached to the rudder locking pin, was missing.

The gust lock attachment spigot on the forward yoke of the captain's control column was found to be distorted in the way it would have been distorted had the gust lock been in position when the accident occurred. There was no other related impact damage or apparent reason to account for the bending of this spigot. Although the gust locks should have been attached to one another and should therefore have been stowed together after removal prior to take-off, only the rudder locking part of the gust lock assembly was found during the search of the wreckage. The aileron straps had most probably been destroyed in the fire but since there was only slight damage to the rudder fitting it was to be expected that the remainder of the assembly would also have survived. The absence of a split ring on the part that was found indicated that the components had not been fastened together despite the maker's recommendation that they should be. The cockpit area had been twisted and partially inverted before the fire developed. If the elevator gust lock rod had been in position it is very unlikely that any trace of it would have been found.

- (viii) The condition of the flying controls and the elevator gust lock attachment spigot was consistent with the elevator gust lock having been in place at impact.
- (ix) The aircraft design was such that it was not capable of unsticking with the elevator gust lock in position.

In the absence of any interconnection between the gust locks and the thrust levers in HFB 320 aircraft at the time of the accident, it was possible to obtain full power from the engines with the lock in place. Later HFB 320 aircraft have been modified so that it is no longer possible to obtain take-off power from the engines with any of the gust locks engaged.
