1. Report No. NTSB-AAR-76-14		2. Government Accession No.		3. Recipient's Catalog No.	
4. Title and Subtitle    Aircraft Accident Report - Continental Air Lines, Inc., Boeing 727-224, N88777, Stapleton International Airport, Denver, Colorado, August 7, 1975				5. Report Date May 5, 1976

AIRCRAFT ACCIDENT REPORT

CONTINENTAL AIR LINES, INC.  
BOEING 727-224, N88777  
STAPLETON INTERNATIONAL AIRPORT  
DENVER, COLORADO  
AUGUST 7, 1975

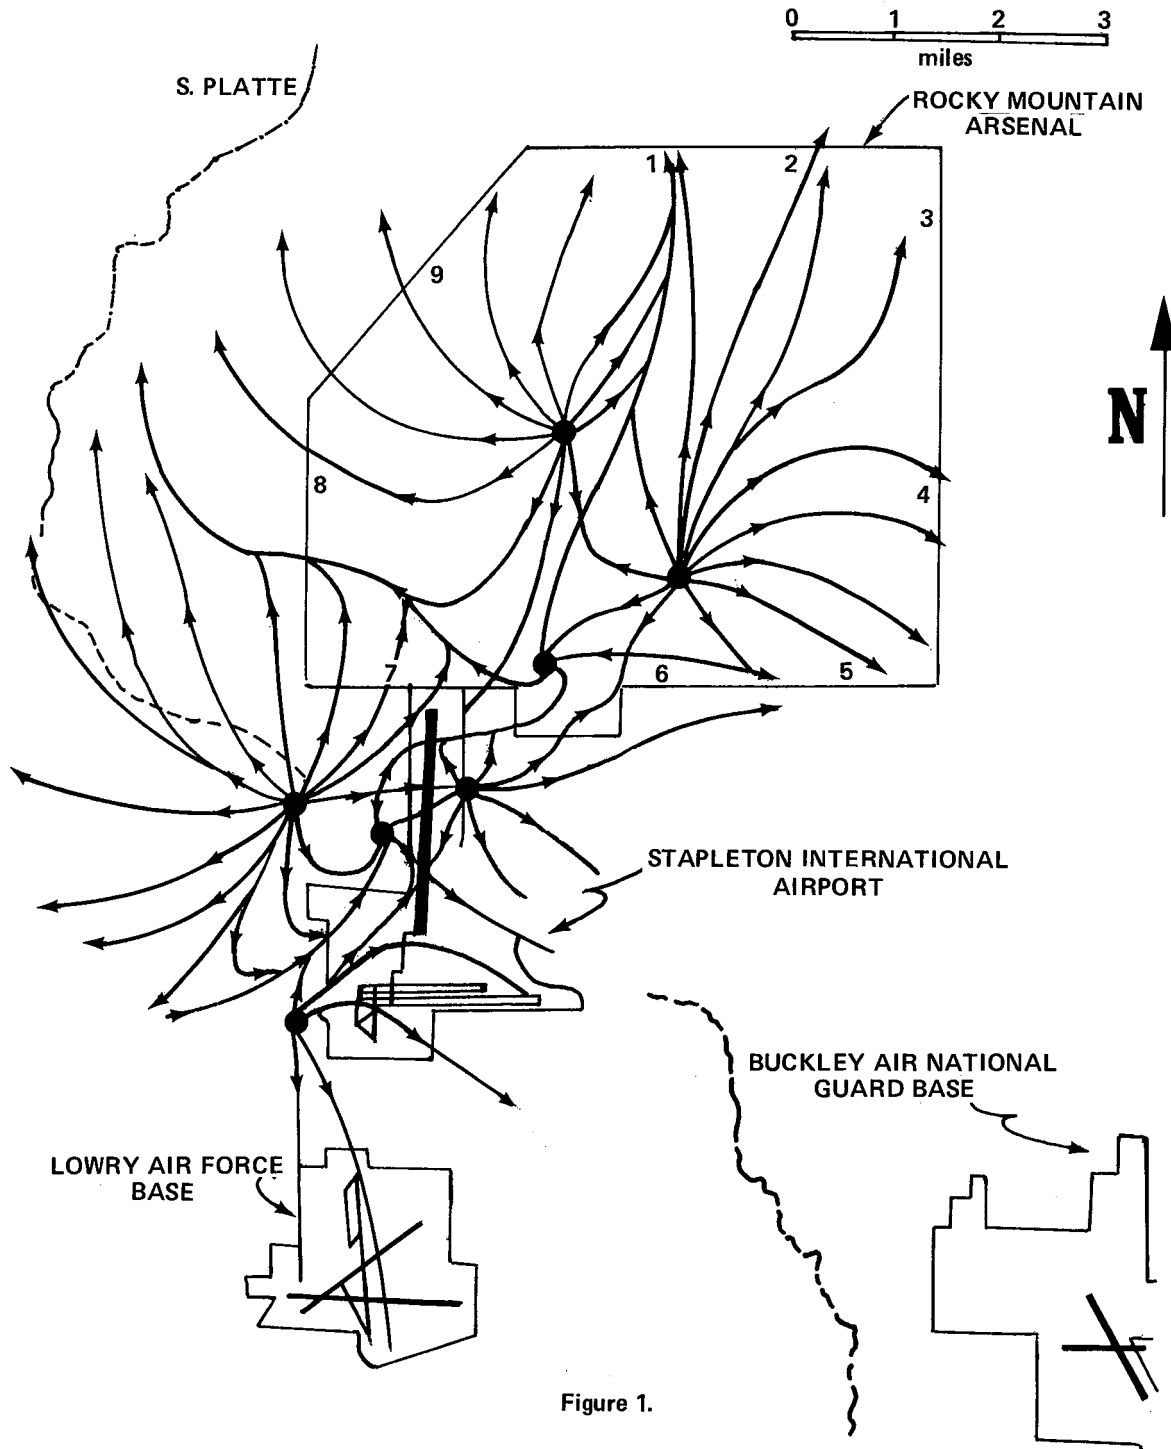
Figure 1.

Streamlines drawn from time-space conversion/isogon analysis superimposed on runway 35L at Stapleton Airport showing the probable runway and surface wind relationship at 1605:30 m.d.t.

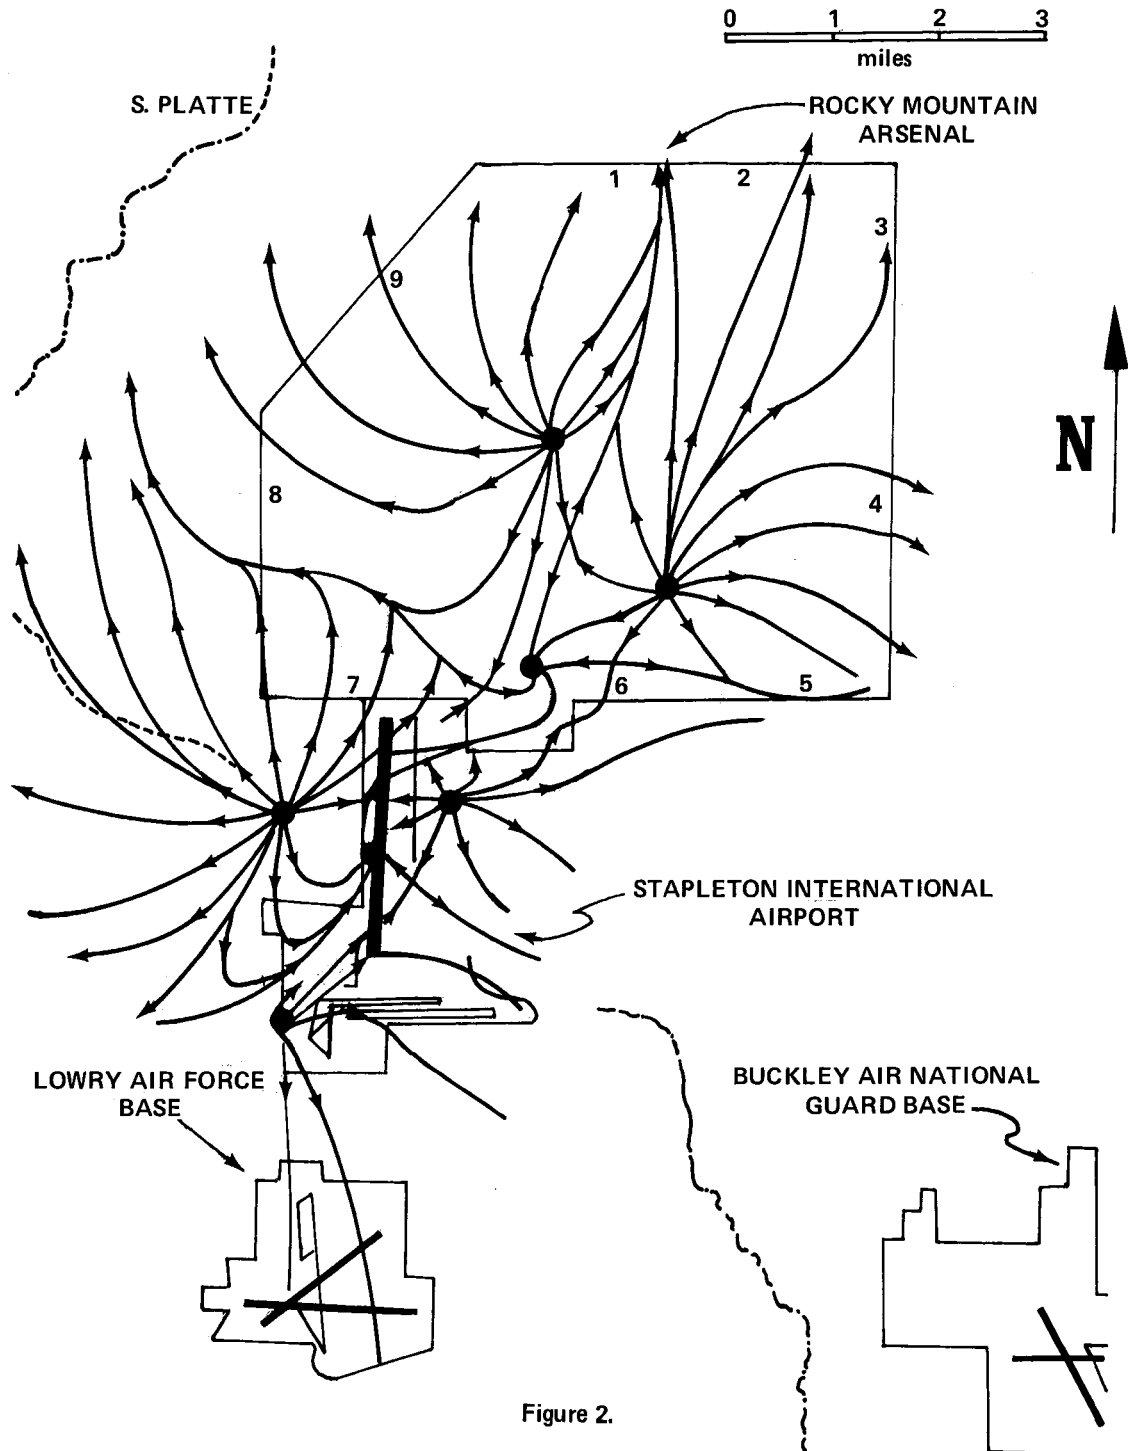
Figure 2.

Streamlines drawn from time-space conversion/isogon analysis superimposed on runway 35L at Stapleton Airport showing the probable runway and surface wind relationship at 1607 m.d.t.

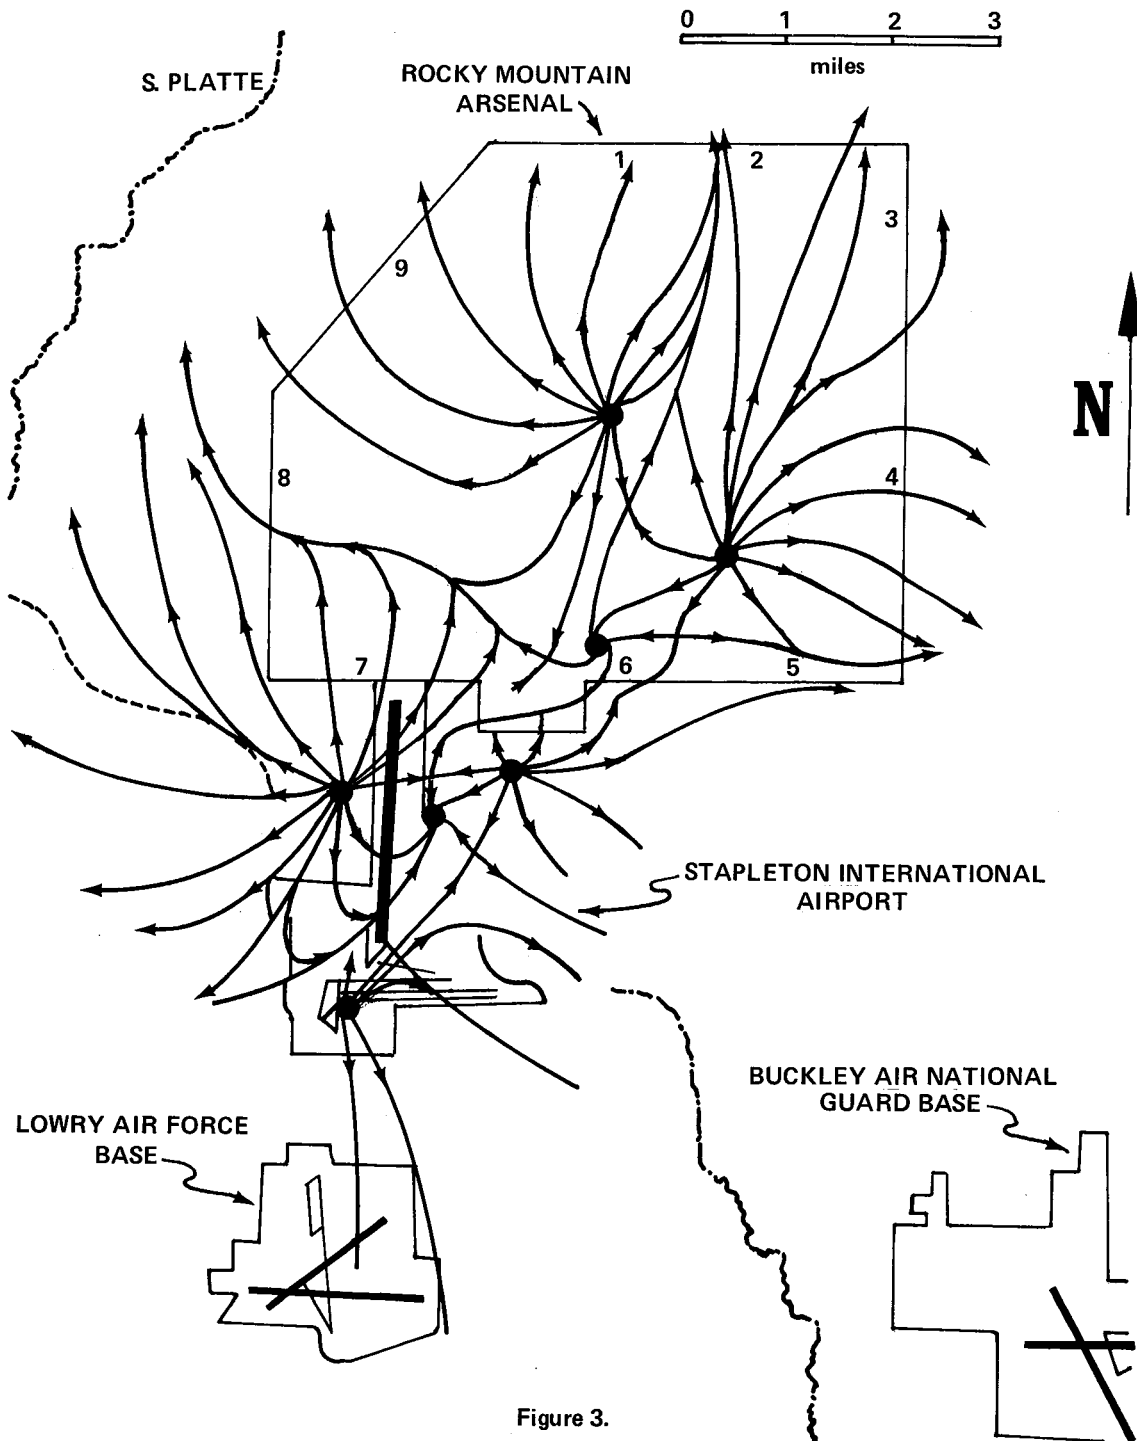
Figure 3.

Streamlines drawn from time-space conversion/isogon analysis superimposed on runway 35L at Stapleton Airport showing the probable runway and surface wind relationship at 1610 m.d.t.

About 1600, the most influential center of divergence was probably located west of the center of runway 35L; and it was moving east-northeast at about 9 kn. As the thunderstorm expanded and moved east-northeastward, this center of divergence began to strongly affect the wind conditions on Stapleton Airport because of its strong horizontal outflow.

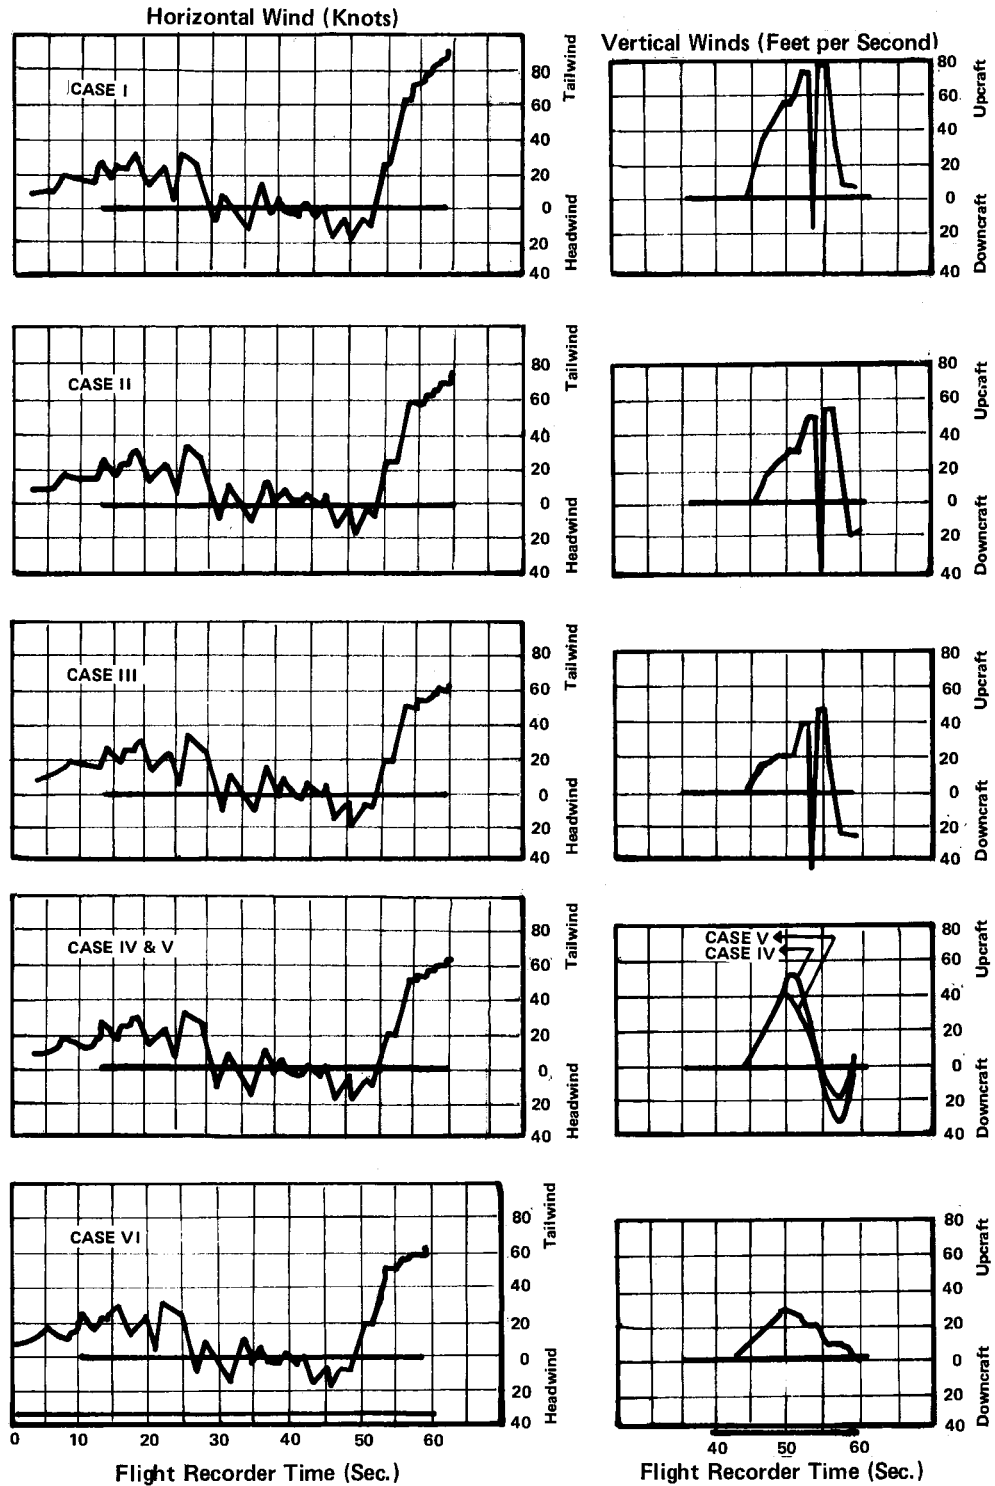
Figure 4.

# HORIZONTAL AND VERTICAL WINDS DERIVED FROM AIRCRAFT PERFORMANCE ANALYSIS

Case VI: Maximum takeoff thrust; brakes released 300 feet from beginning of runway; above 35 feet profile faired from average load factor data and assumed descent rate; rotation assumed earlier than indicated by FDR.
