1. Report No. NTSB-AAR-77-1		2. Government Accession No.		3. Recipient's Catalog No.	
4. Title and Subtitle Aircraft Accident Report -- American Airlines, Inc., Boeing 727-95, N1963, St. Thomas, Virgin Islands, April 27, 1976		5. Report Date December 16, 1976		6. Performing Organization Code

AIRCRAFT ACCIDENT REPORT

AMERICAN AIR LINES, INC.  
BOEING 727-95, N1963  
ST. THOMAS, VIRGIN ISLANDS  
APRIL 27, 1976

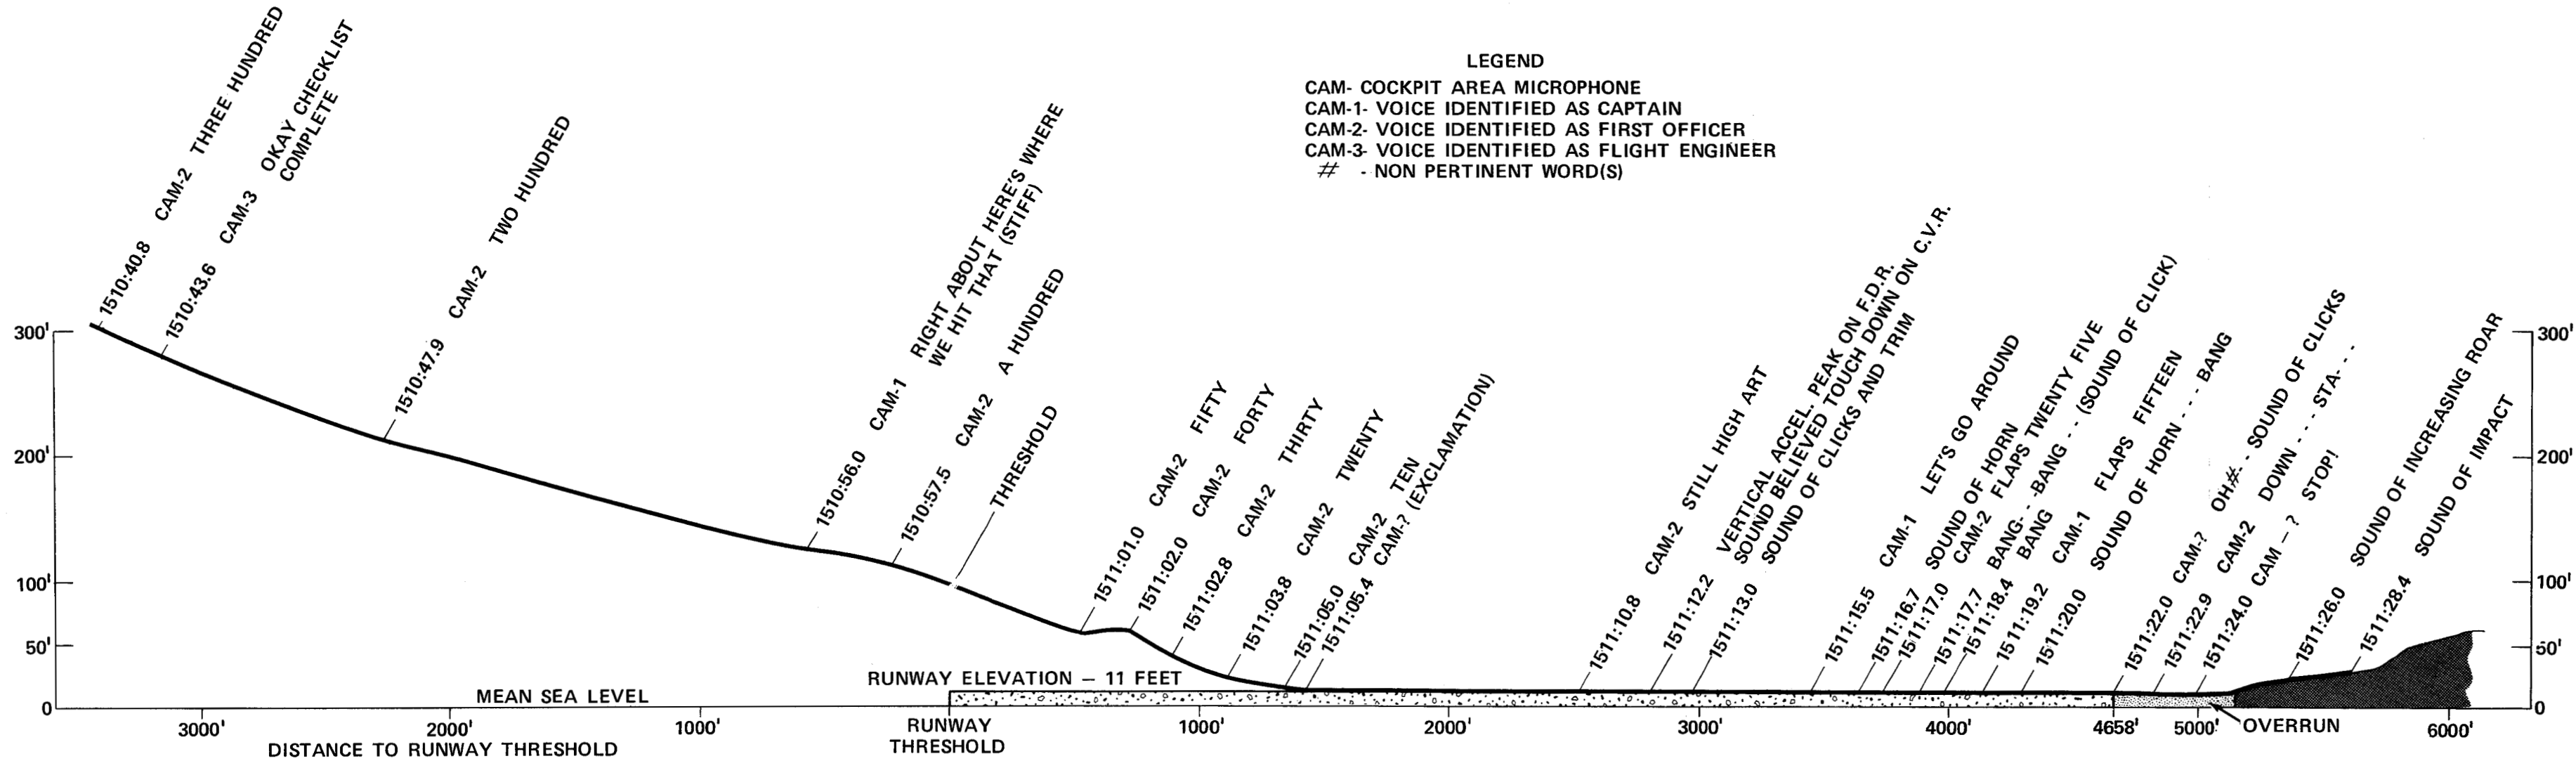
**APPROACH PROFILE**  
**AMERICAN AIRLINES, BOEING 727-95 N1963**  
**HARRY S. TRUMAN AIRPORT, ST. THOMAS, VIRGIN ISLANDS**  
**APRIL 27, 1976**

The profile shown in Appendix D was prepared using assumptions which seemed to be most logical to the investigators. These assumptions are noted thereon. This profile shows that the aircraft crossed the threshold at an airspeed of 131 knots and an altitude of about 80 feet. The touchdown was calculated to be about 2,800 feet beyond the threshold. At touchdown, about 1,850 feet of runway and 500 feet of overrun were available on which to stop the aircraft. When the captain stated "Let's go around," the aircraft was about 3,450 feet beyond the threshold, or 1,200 feet of runway and 500 feet of overrun remained.

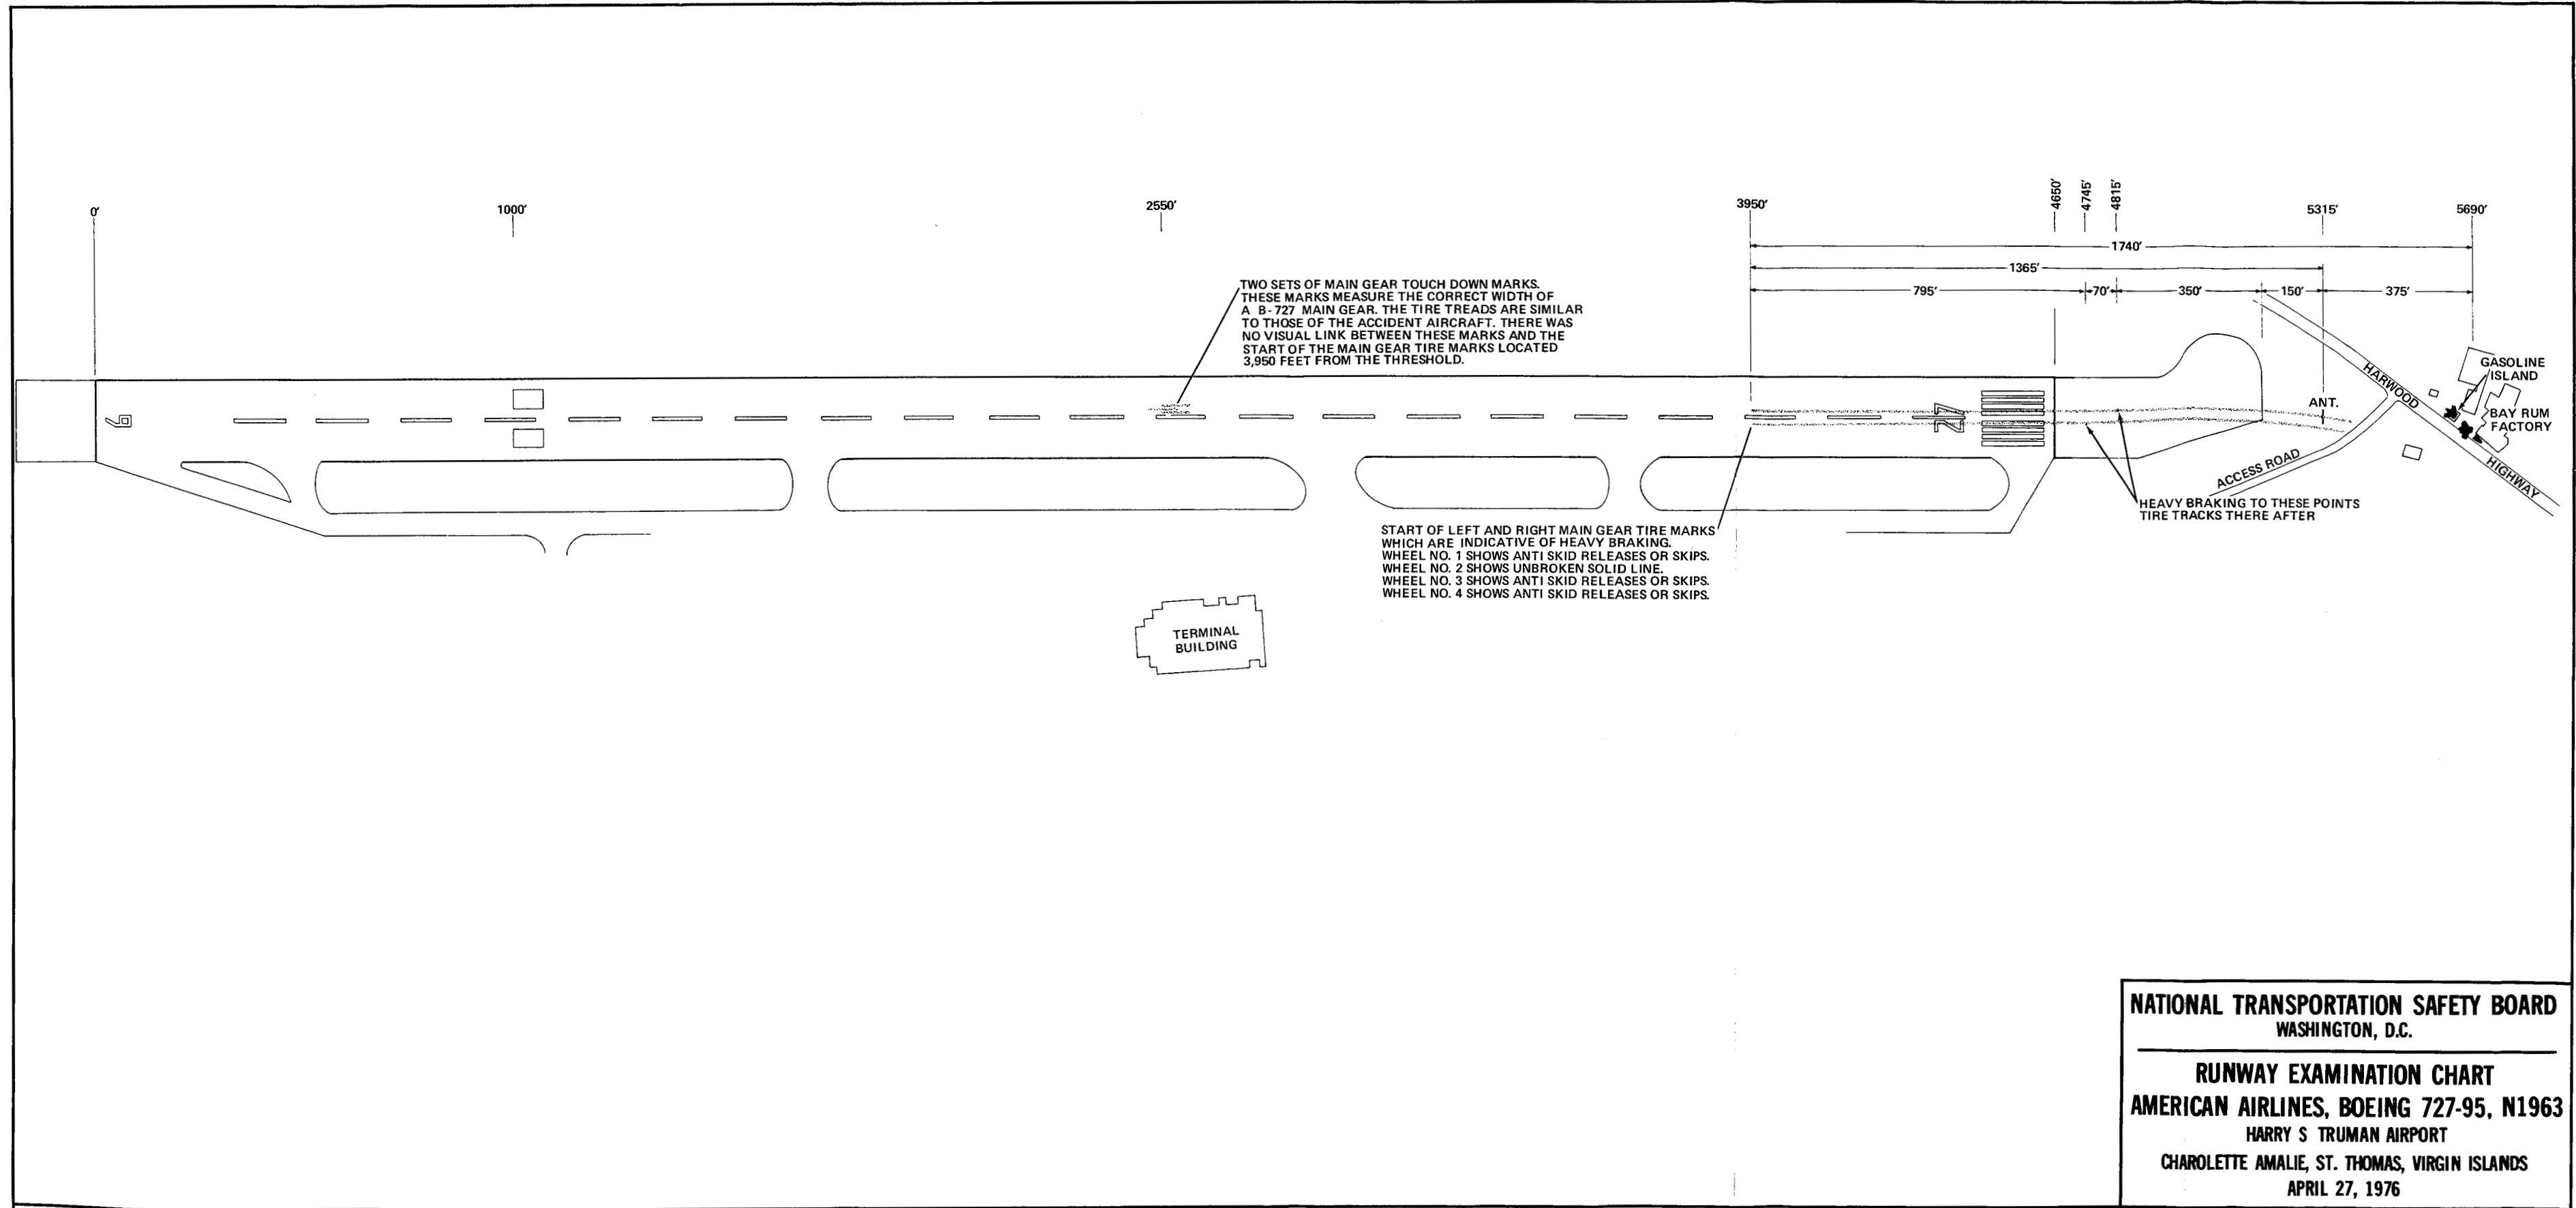
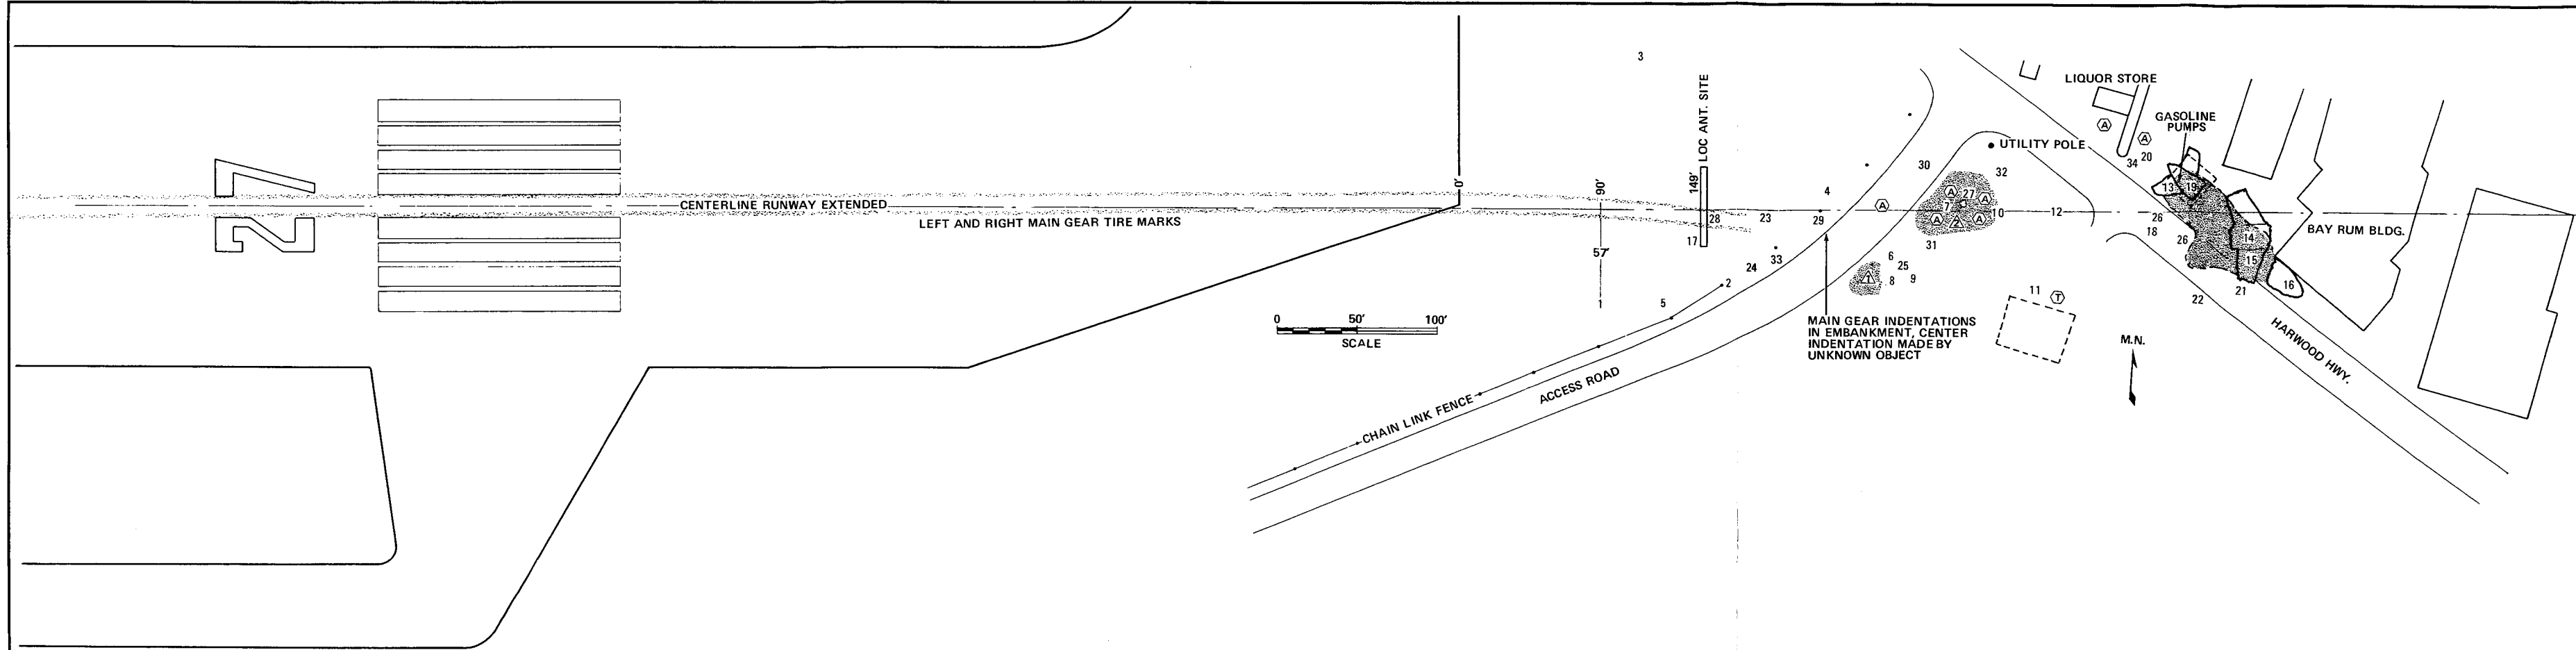
WRECKAGE DISTRIBUTION CHART  
AMERICAN AIRLINES, BOEING 727-N1963  
HARRY S TRUMAN AIRPORT  
CHARLOTTE AMALIE, ST. THOMAS, VIRGIN ISLANDS  
APRIL 27, 1976

- 1. PIECES OF RIGHT WING TIP NAV. LIGHT PLEXIGLASS, BLUE AND CLEAR - FIRST POINT OF FUSELAGE IMPACT APPROX. 8 FEET ABOVE OVERRUN ELEVATION
- 2. IMPACT WITH CHAIN LINK FENCE

- 25. FORWARD DRAIN MAST
- 26. HEAVY GOUGES AND SCRAPE MARKS ON STREET IN LINE WITH AIRCRAFT DIRECTION OF TRAVEL
- 27. TREE BROKEN APPROX. 8 FEET ABOVE GROUND

- 28. HONYCOMB FOUND IN LOCALIZER ANTENNA SUPPORT STRUCTURE
- 29. PIECES OF LEADING EDGE SLAT TRACK
- 30. LEFT MAIN LANDING GEAR AFT TRUNION BEARING SLEEVE
