ACCIDENTS INVESTIGATION BRANCH

Boeing 707 321C G-BEBP

**Report on the accident near Lusaka International
Airport, Zambia, on 14 May 1977**

Accidents Investigation Branch
Aircraft Accident Report No. 9/78
(EW/A267)

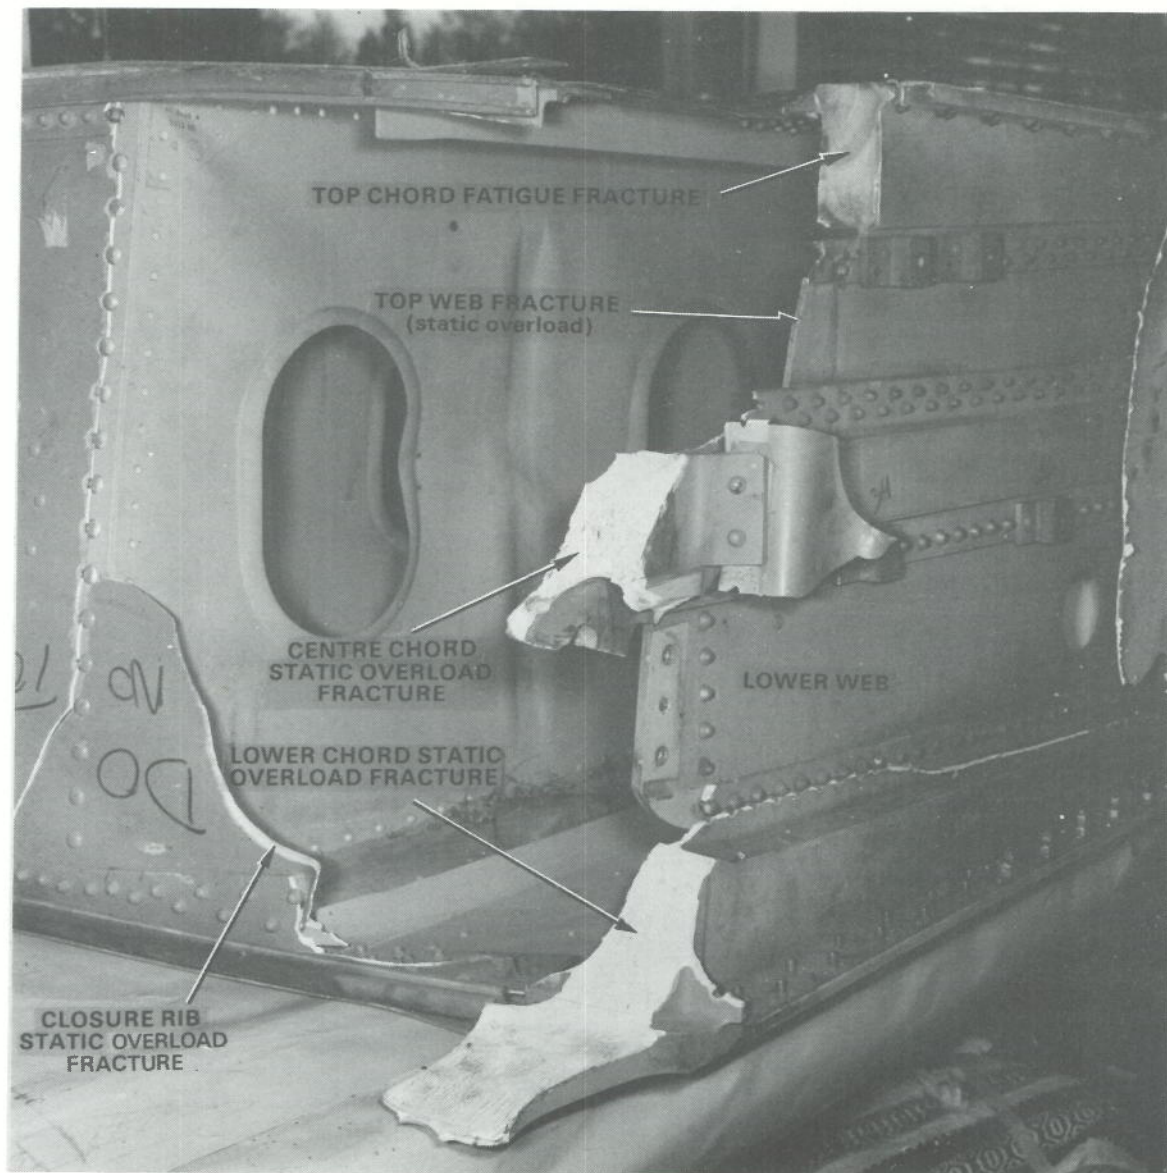
Figure 3 **BOEING 707 300 SERIES/400 SERIES HORIZONTAL
STABILIZER (G-BEBP crack location arrowed)**

Examination of the detached stabilizer revealed evidence of a fatigue failure of the top chord of the rear spar at a point approximately 36 cm outboard (see figure 3) of the root attachment pin. The rear spar centre chord, lower chord and the front spar root attachments had failed in overload (see figure 4) due to stabilizer downwards bending. There was evidence of a pre-existing fracture of the rear spar upper web between the top chord (adjacent to the fracture) and the centre chord and in certain sections of the closure rib and associated structure.

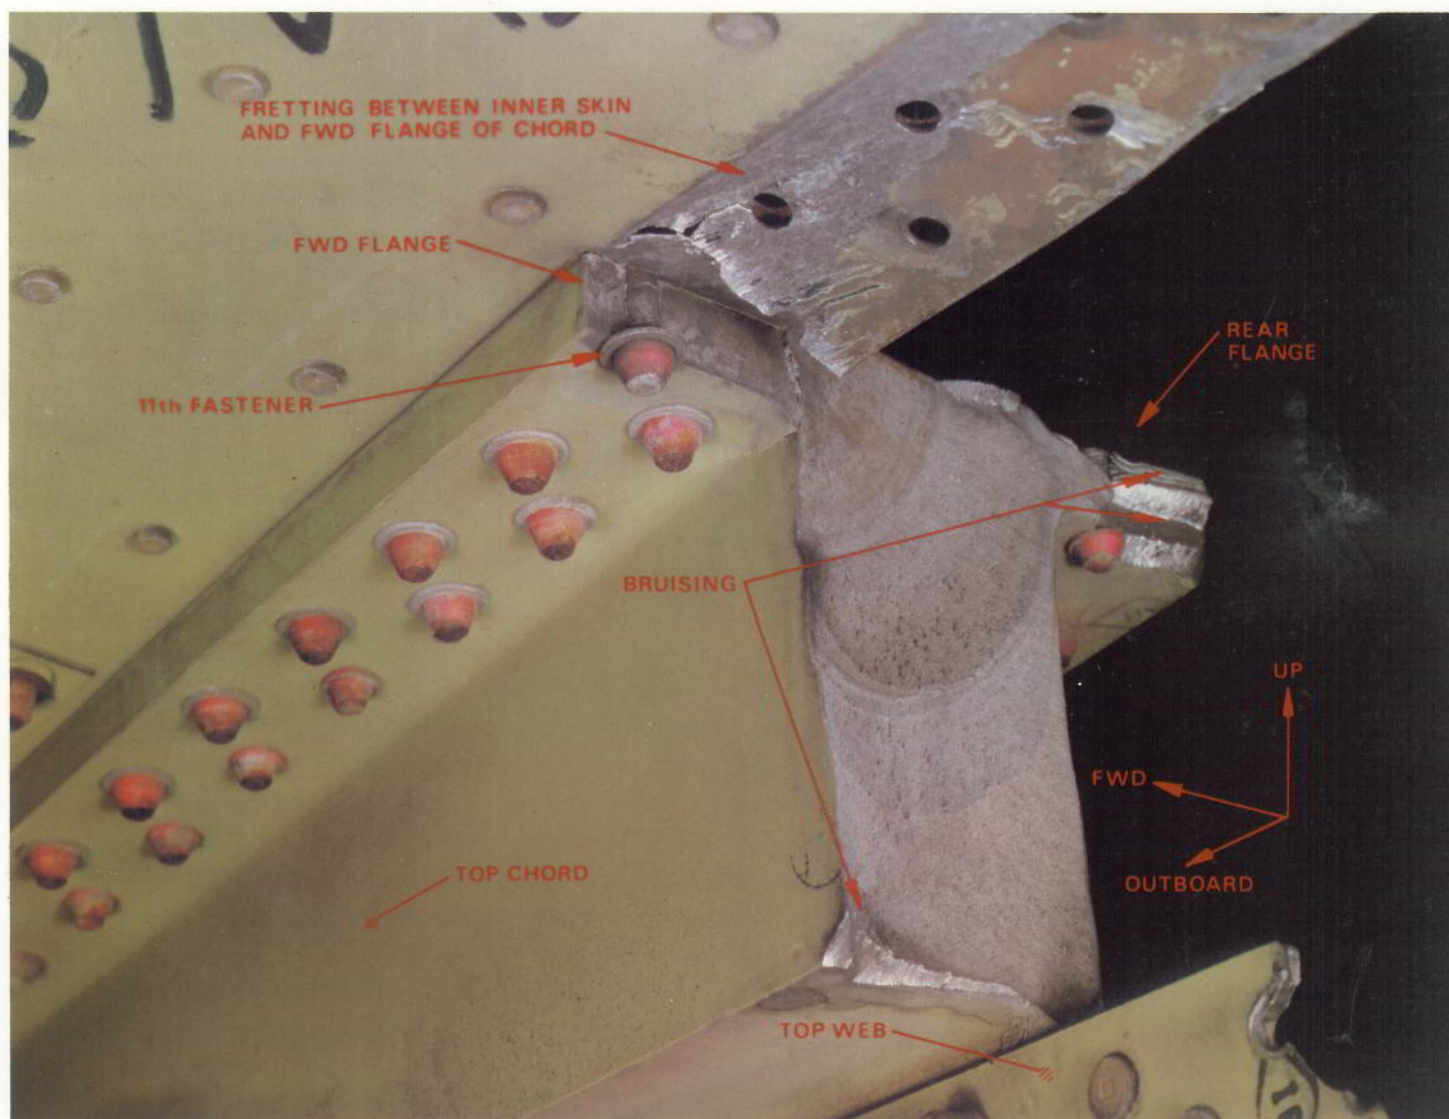
Figure 4 G-BEBP HORIZONTAL STABILIZER STRUCTURAL FAILURE DETAILS – rear spar outboard fracture surfaces and closure rib fracture.

The failure of the centre and lower chords and the lower web resulted from overload in stabilizer downwards bending following the fatigue of the top chord and subsequent static failure of the upper web. The fracture path through the rear spar structure is shown in figure 11a.

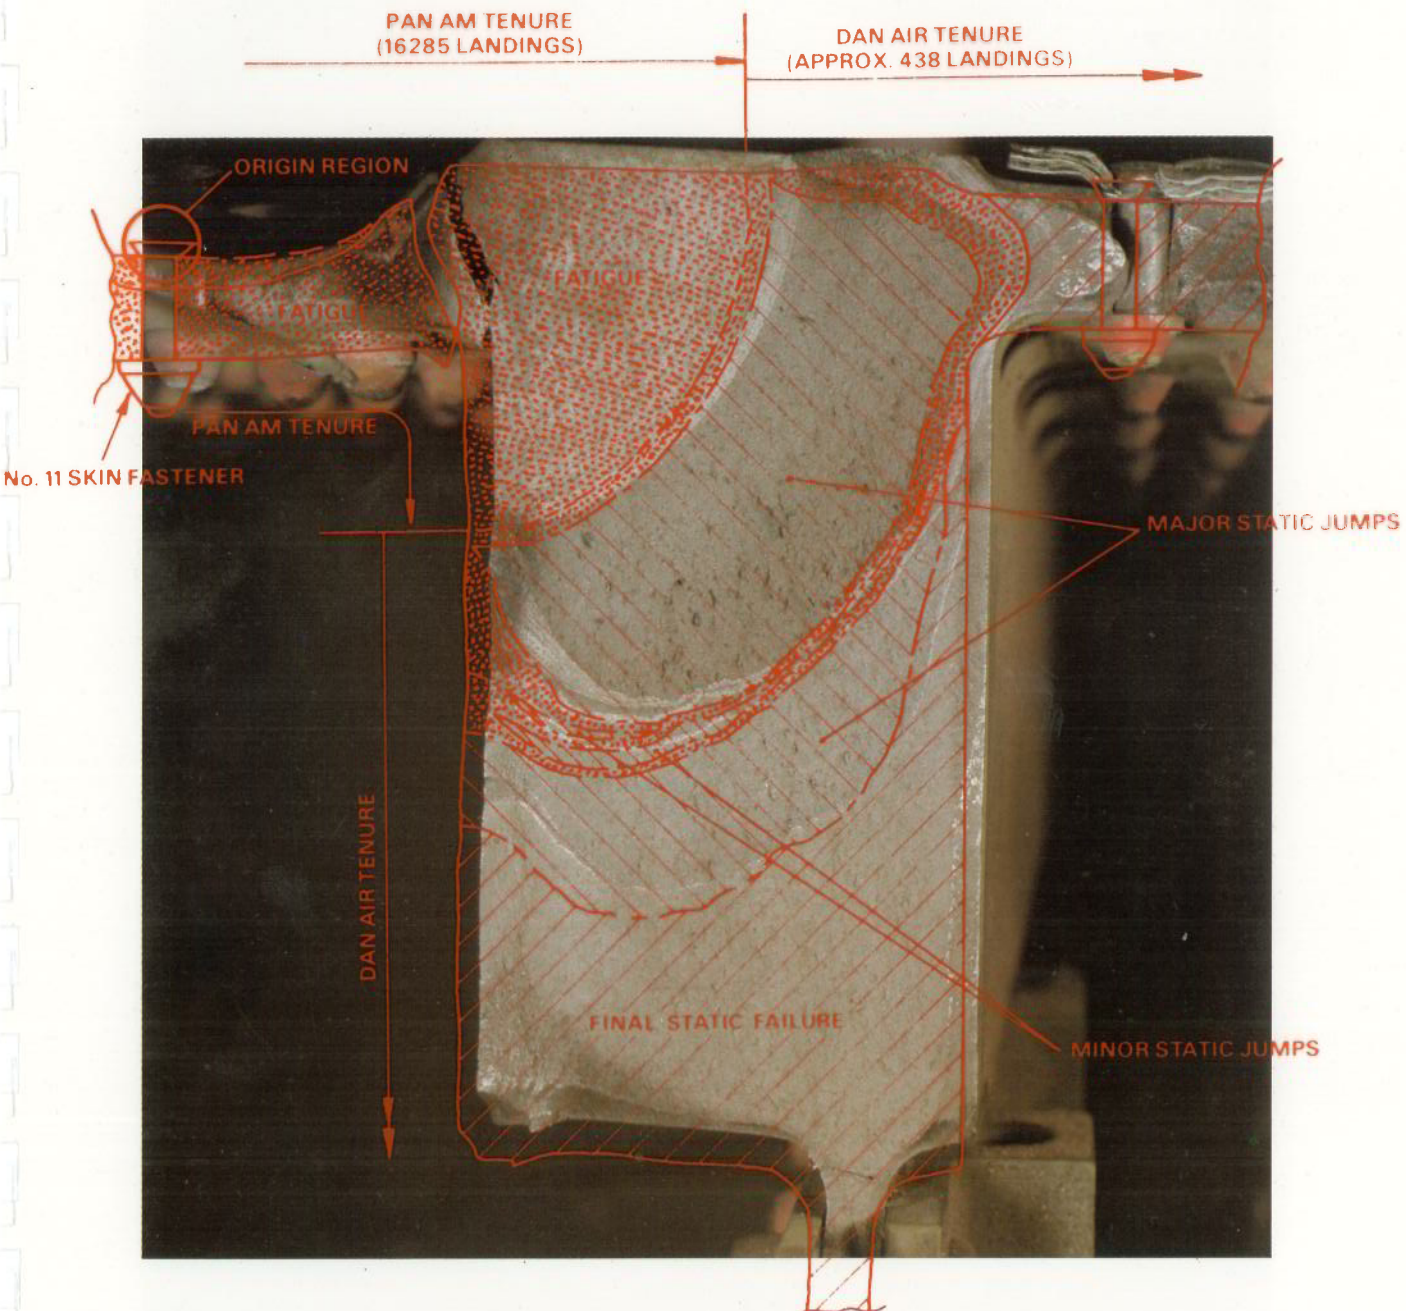
Figure 5 G-BEBP HORIZONTAL STABILIZER TOP CHORD FATIGUE FRACTURE – showing bruising on fracture surface and fretting on top skin.

The primary fracture surfaces in the top chord were examined independently by metallurgists at the Royal Aircraft Establishment, Farnborough, and at the Boeing Company. The outboard fracture face (see figure 5) was in good condition with, generally, little corrosion or bruising. There was some degree of bruising however on the lower edge of the top chord and on the aft flange which indicated that the fracture had occurred some significant time before the failure of the spar structure as a whole.

There was evidence of fretting between the skin and forward flange on both horizontal stabilizers. The fretting on the right side was extremely heavy and is considered to have occurred, mainly, after top chord fracture.

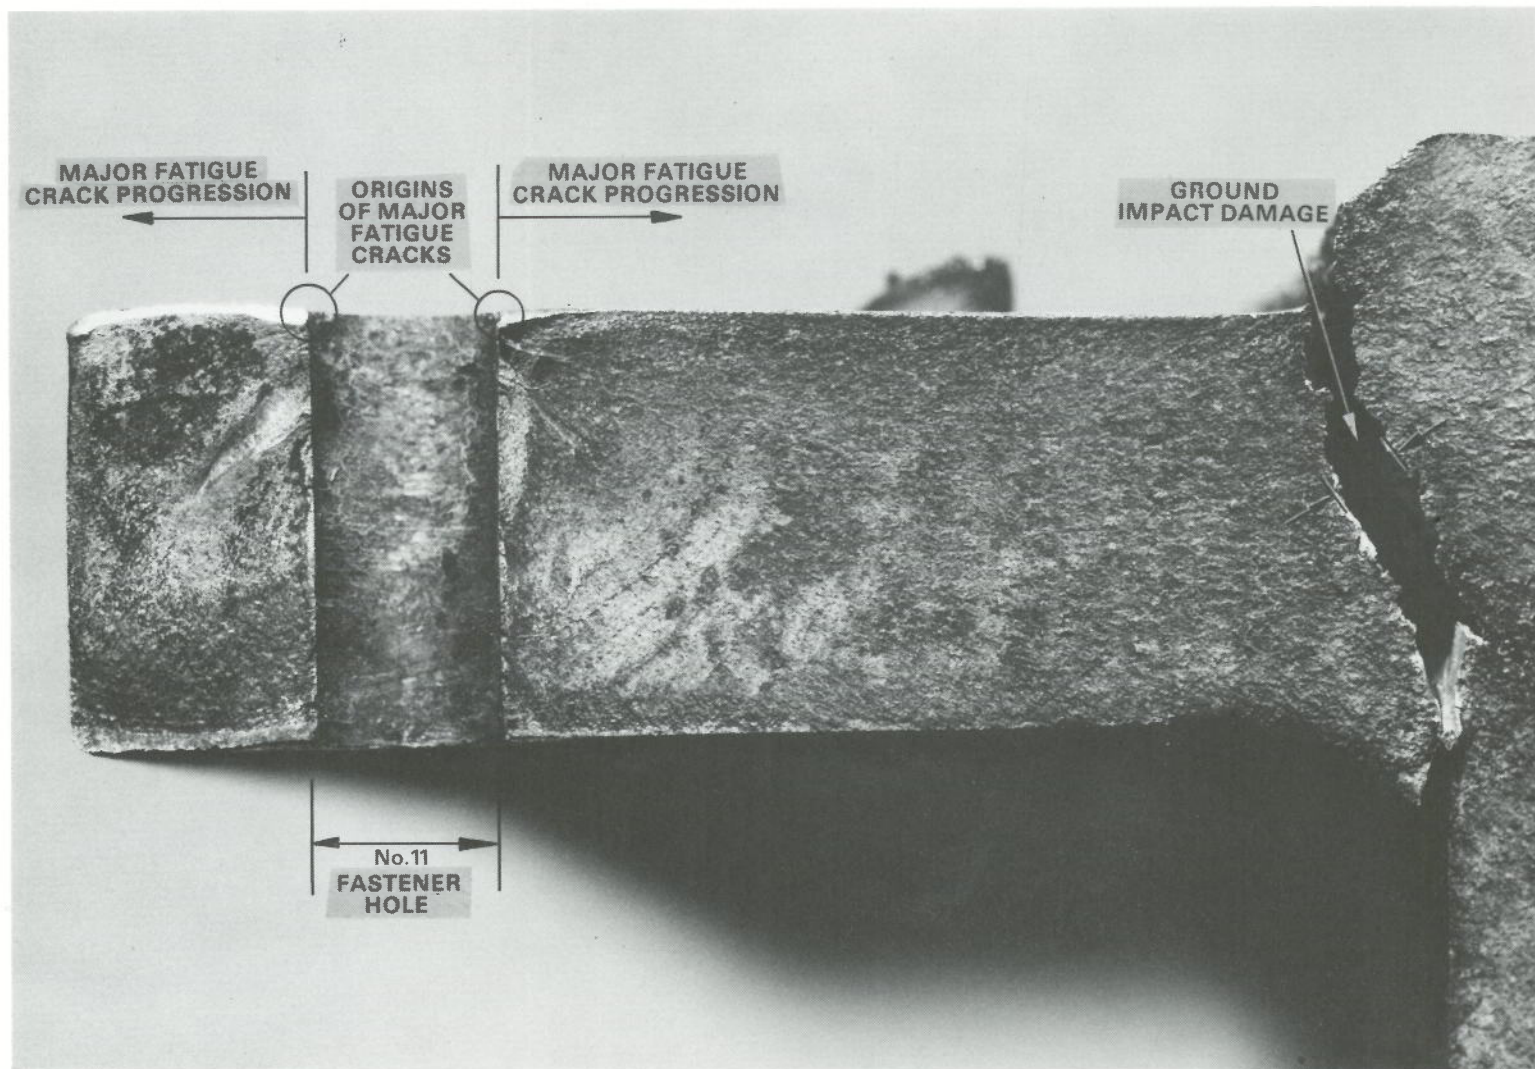
Figure 6

The primary major fatigue crack (see figures 6 and 7) was found to have propagated rearwards across the flange and into the main cross section of the chord. A secondary major fatigue crack originating in the forward side of the 11th fastener hole propagated across the flange in the same plane as the principal crack until it had reached the forward edge of the flange.

It was found that the primary major fatigue crack growth rate increased rapidly over the first 2mm of crack, after which the increase in growth rate was more gradual until, at about 7mm crack length, the growth rate settled at a reasonably constant value of approximately 125 flights per mm. This rate continued until the crack reached a point when it had progressed across approximately 60% of the exposed top surface of the chord. At this point the crack front made a static tensile jump of approximately 21mm (at its widest point) in one flight after which the growth rate settled back to its original value of

125 flights/mm. This large static jump was confined to the internal crack front only; the external crack length did not increase significantly at this time, (see figure 6). During the next 200 or so flights the growth rate remained basically stable but there were a number of smaller tensile jumps ahead. When the crack had progressed right across the top of the exposed chord surface and had reached approximately 60% of the depth of the main cross section there was another large jump and after a short period during which the crack progressed in the fatigue mode, there was a final tensile jump and the chord failed completely. The total number of flights between the initiation of the fatigue crack and the final failure of the upper chord is estimated as being in the order of 7,200 flights with some 3,500 flights of propagation occurring across the exposed top surface of the rear chord.

FATIGUE FRACTURE DETAILS – G-BECP HORIZONTAL STABILIZER REAR SPAR TOP CHORD

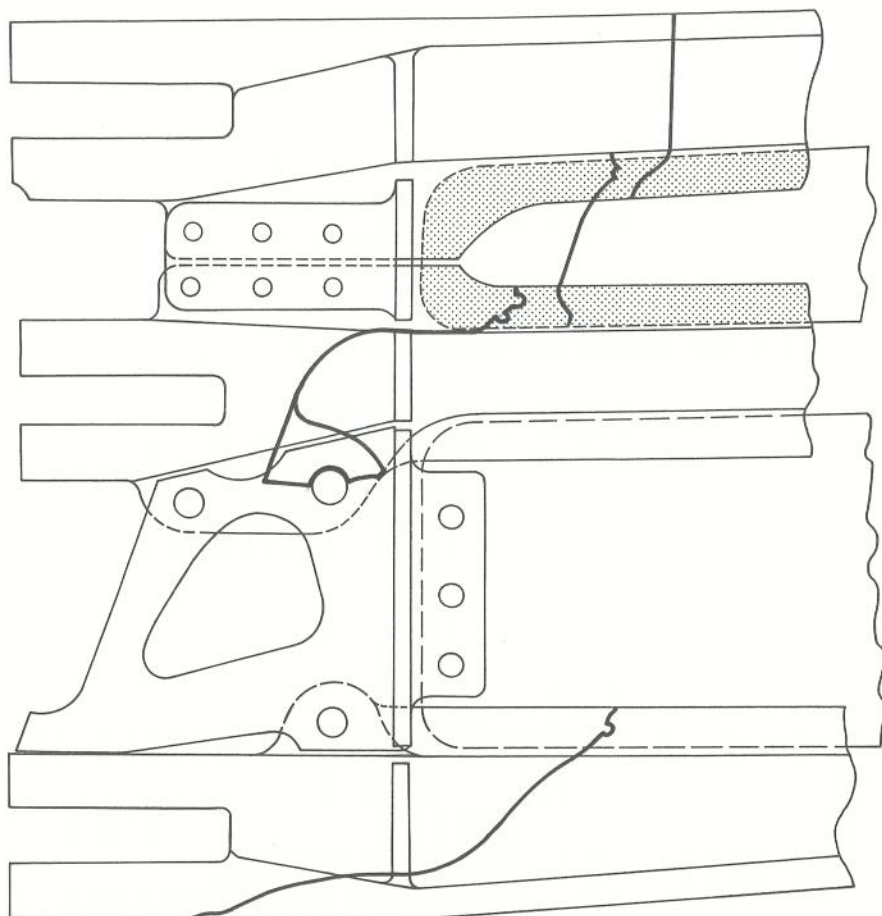
Figure 11a G-BEPP REAR SPAR
FRACTURE

The character of the spar failure produced on test was strikingly similar to that evident in the wreckage of G-BEBP. (See figures 11a and 11b).

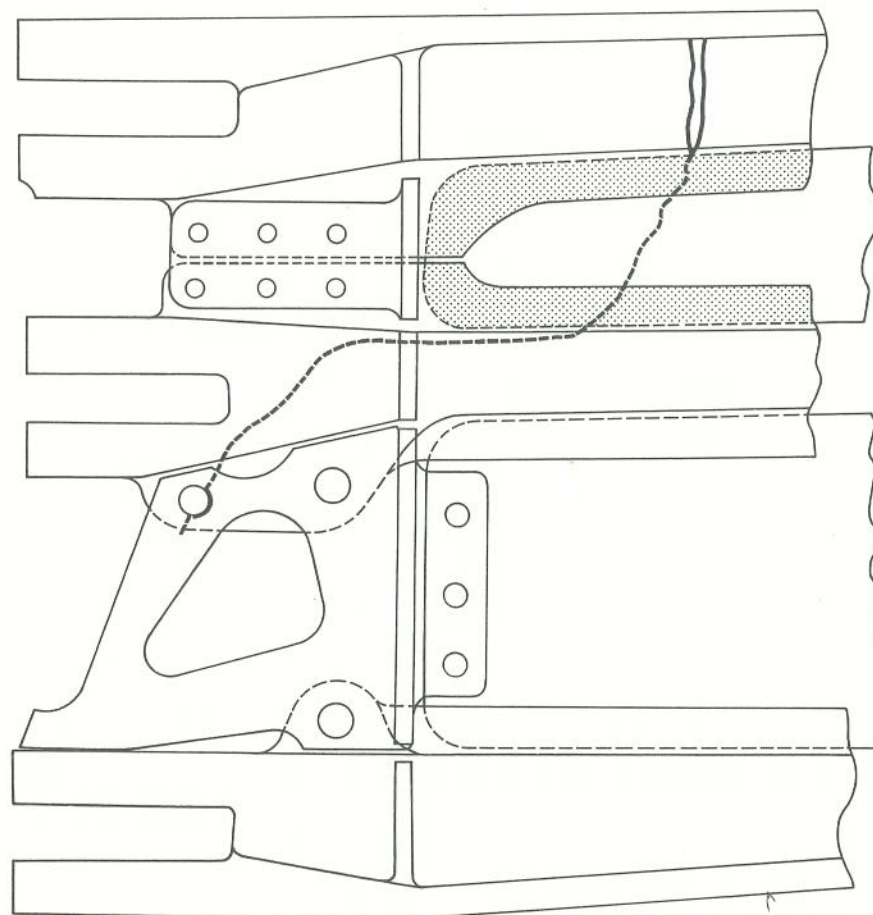
Figure 11b TEST SPECIMEN REAR
SPAR FRACTURE

The final test, number 9, was conducted without making any repairs to the stabilizer. A load was applied incrementally to 80% of load case 4. Whilst holding this load the right stabilizer rear spar, front spar and closure rib fractured.

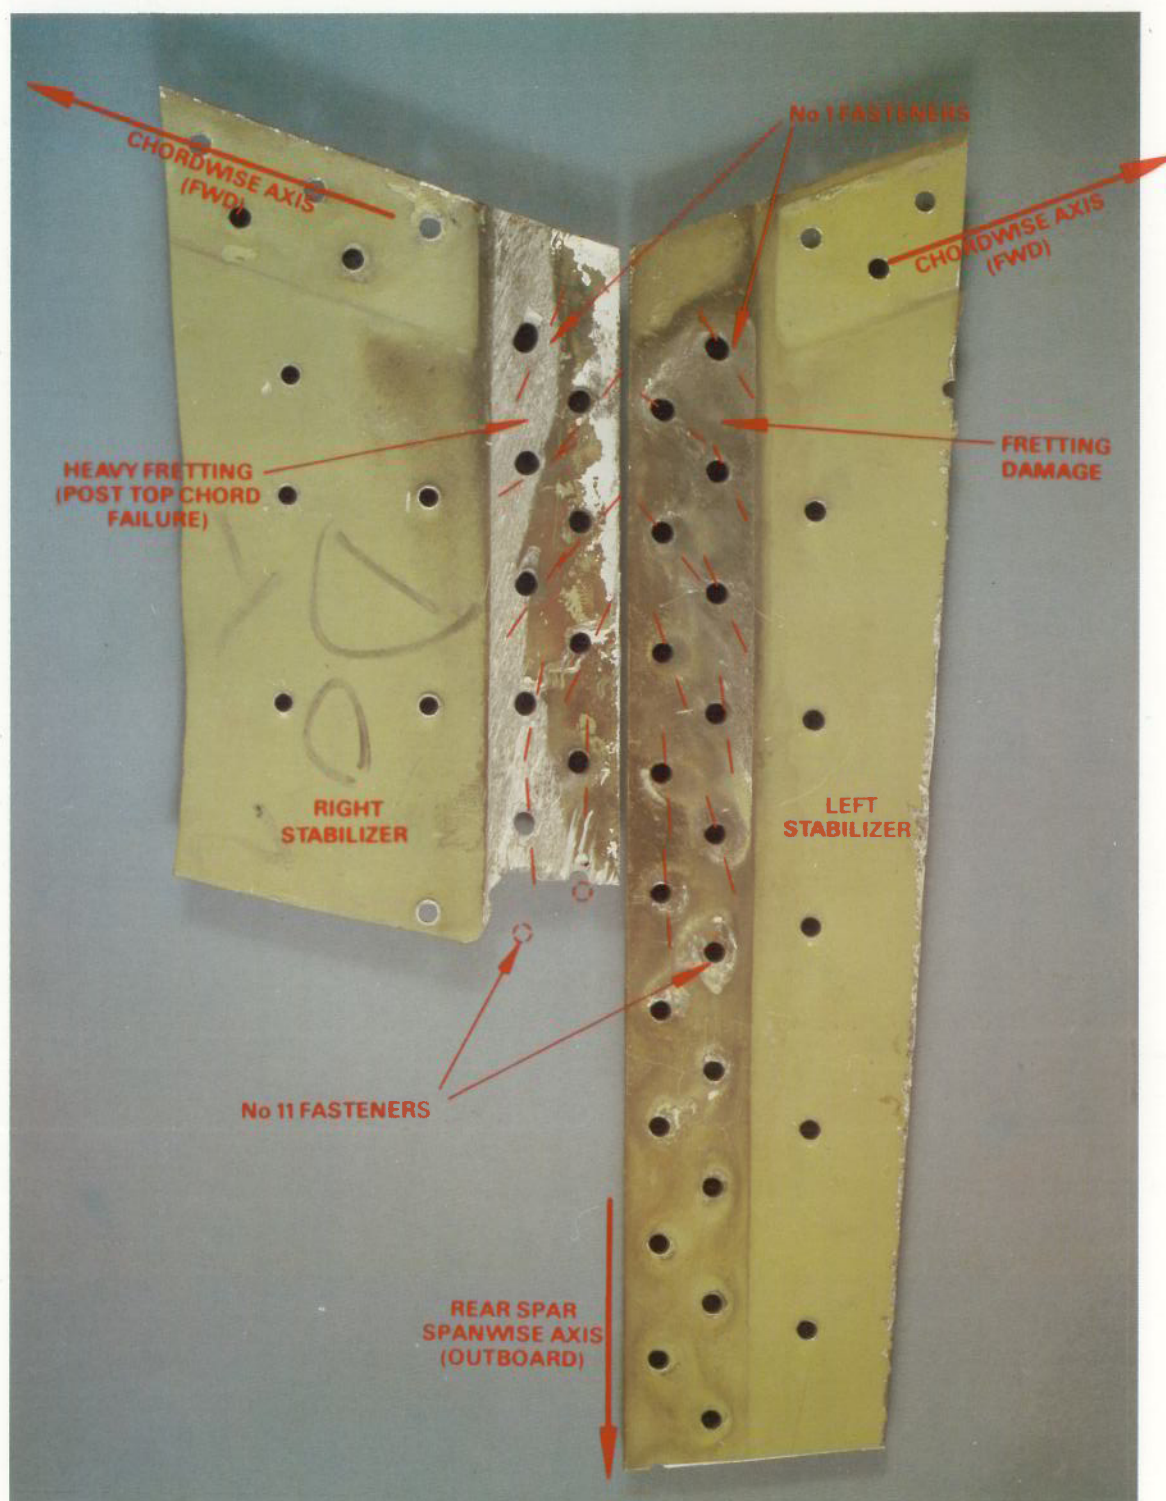
Figure 18

Examination of the fastener holes in the top skin of the left stabilizer revealed a pattern of distortion that reflected the previously observed fastener distortion and fretting between the skin and flange. The axis of hole elongation was found to be variable. Generally the axes were spanwise, but the inboard group were at an angle to the chord spanwise axis. The holes in the corresponding skin from the right stabilizer were also found to have been distorted but with the elongation in two distinct directions; one set of axes being a mirror image of those on the left stabilizer skin and the other set being spanwise. The precisely spanwise elongation is considered to have occurred when the fasteners sheared following top chord failure and the other elongation pattern to have occurred as a result of a similar loading mechanism to that which produced the corresponding damage on the left stabilizer.

G-BEBP HORIZONTAL STABILIZER TORSION BOX TOP SKIN DOUBLERS FROM REGION ADJACENT TO INNER END OF REAR SPAR – Comparison fastener hole distortion patterns and fretting damage to inner face of skins from left (undamaged) and right (separated) stabilizers
