DEPARTMENT OF TRADE

**Report on the accident to
BAe HS 748 G-BEKF at
Sumburgh Airport, Shetland Islands,
on 31 July 1979**

Civil Aircraft Accident Report No 1/81 (EW/C671)

<i>Owner and Operator:</i>	Dan-Air Services Limited
<i>Aircraft: Type:</i>	British Aerospace HS 748 Series 1
<i>Model:</i>	105
<i>Nationality:</i>	British
<i>Registration:</i>	G-BEKF
<i>Place of Accident:</i>	Sumburgh Airport, Shetland Islands Latitude 59°53'N Longitude 01°18'W
<i>Date and Time:</i>	31 July 1979, at 1601 hrs
	All times in this report are GMT

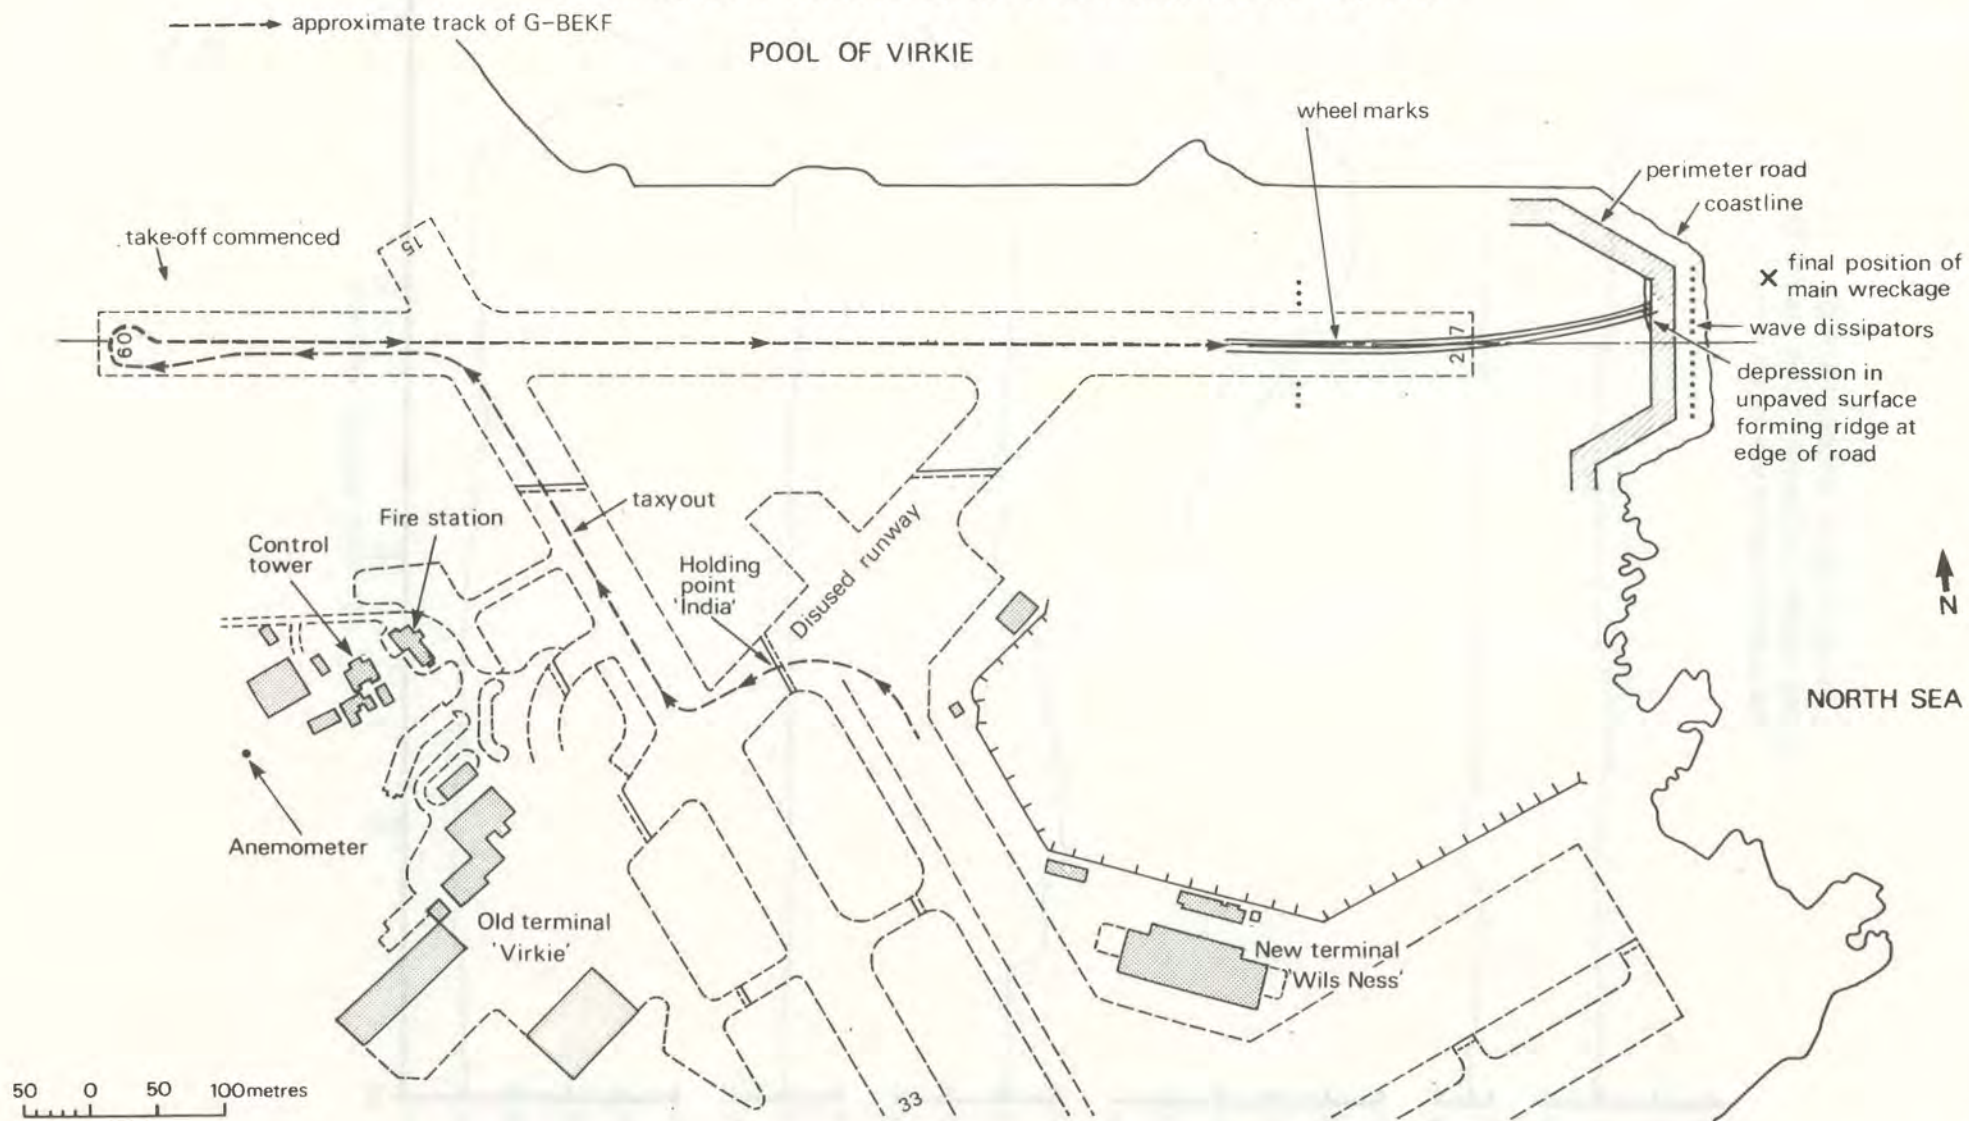
SUMBURGH AIRPORT

Showing path followed by HS 748 G-BEKF on 31 July 1979

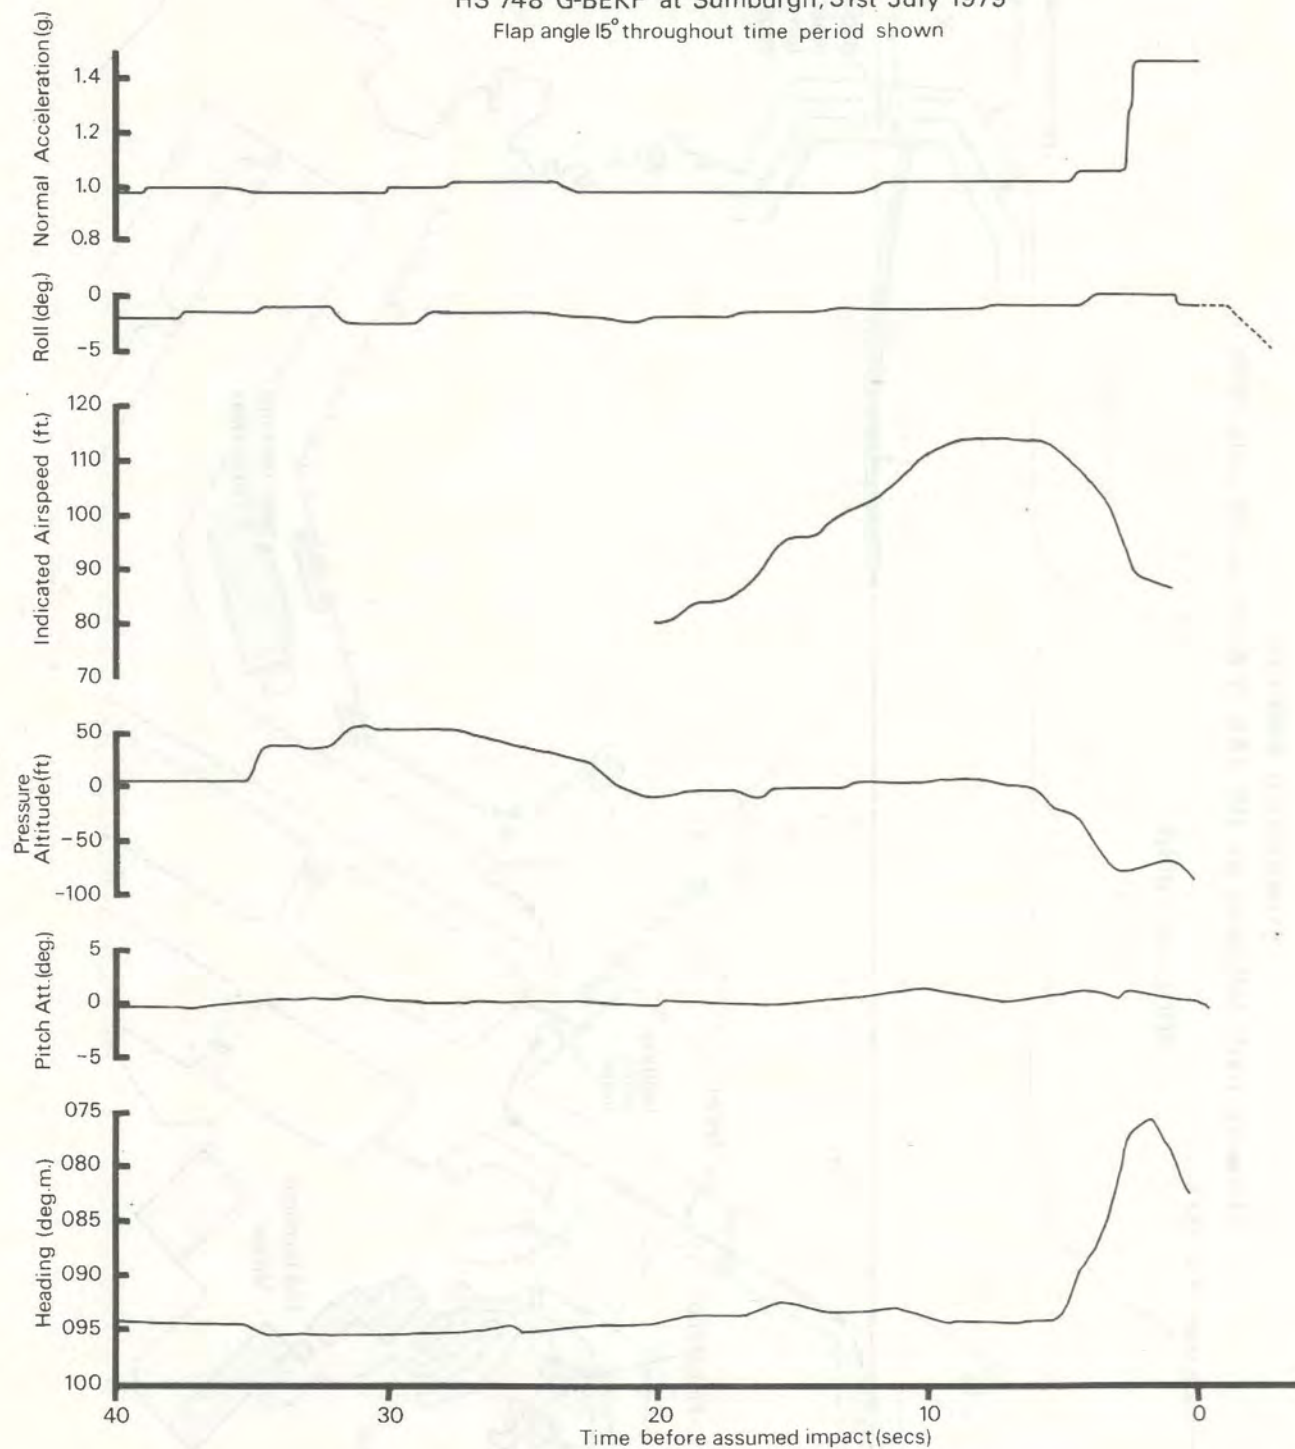
During the replay of some previous take-offs and landings it was noticed that a fault in the airspeed trace was present until the landing immediately prior to the accident flight, when it apparently disappeared. The cause of the fault could not be identified, and the accuracy of the airspeed readings therefore remains suspect. For the same reason, no tolerance can be quoted.

FLIGHT DATA RECORDER PLOT
HS 748 G-BEKF at Sumburgh, 31st July 1979
Flap angle 15° throughout time period shown

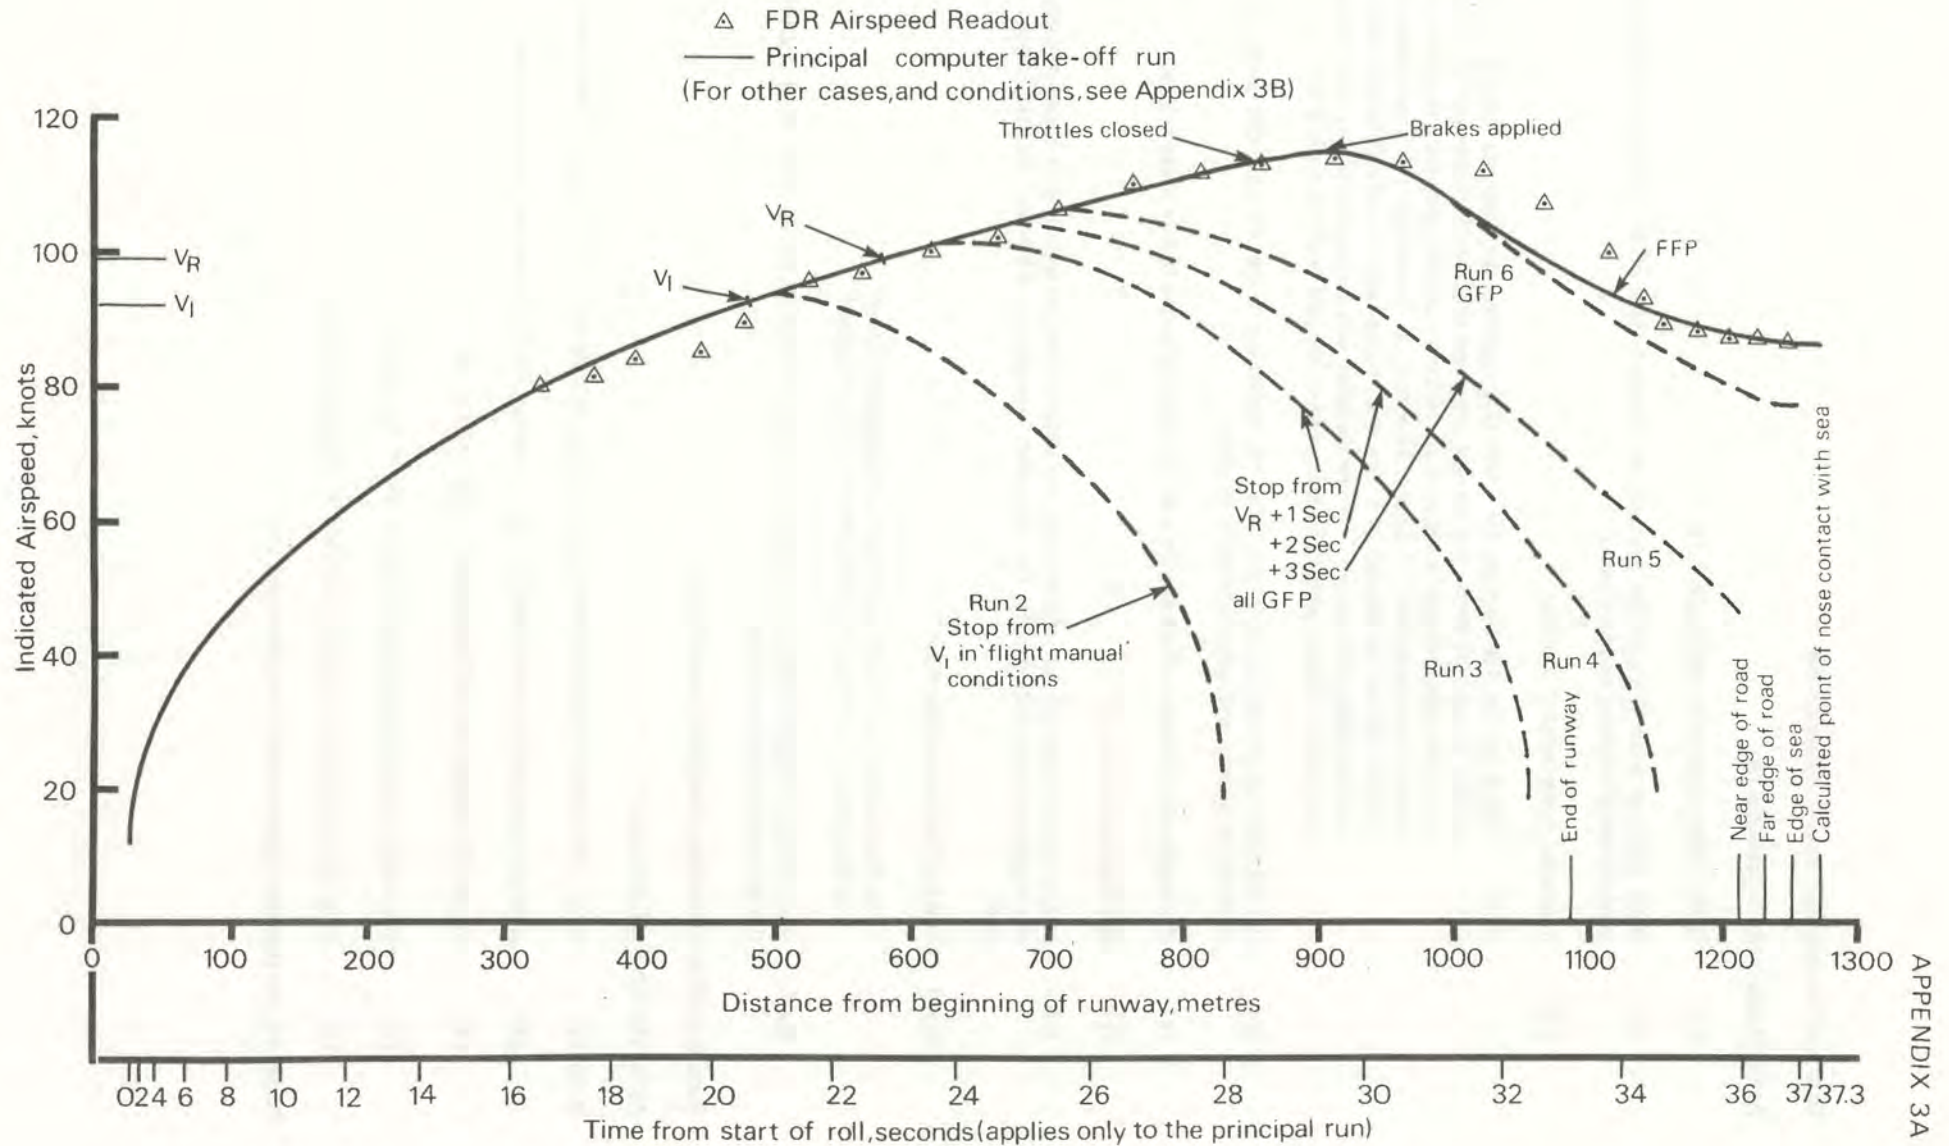
CALCULATED ACCIDENT RUN & STOPPING DISTANCES COMPARED WITH FDR AIRSPEED READ-OUT

HS 748 G-BEKF at Sumburgh, 31st July 1979

15° Flap, water-methanol on
12 Knot headwind at aircraft level

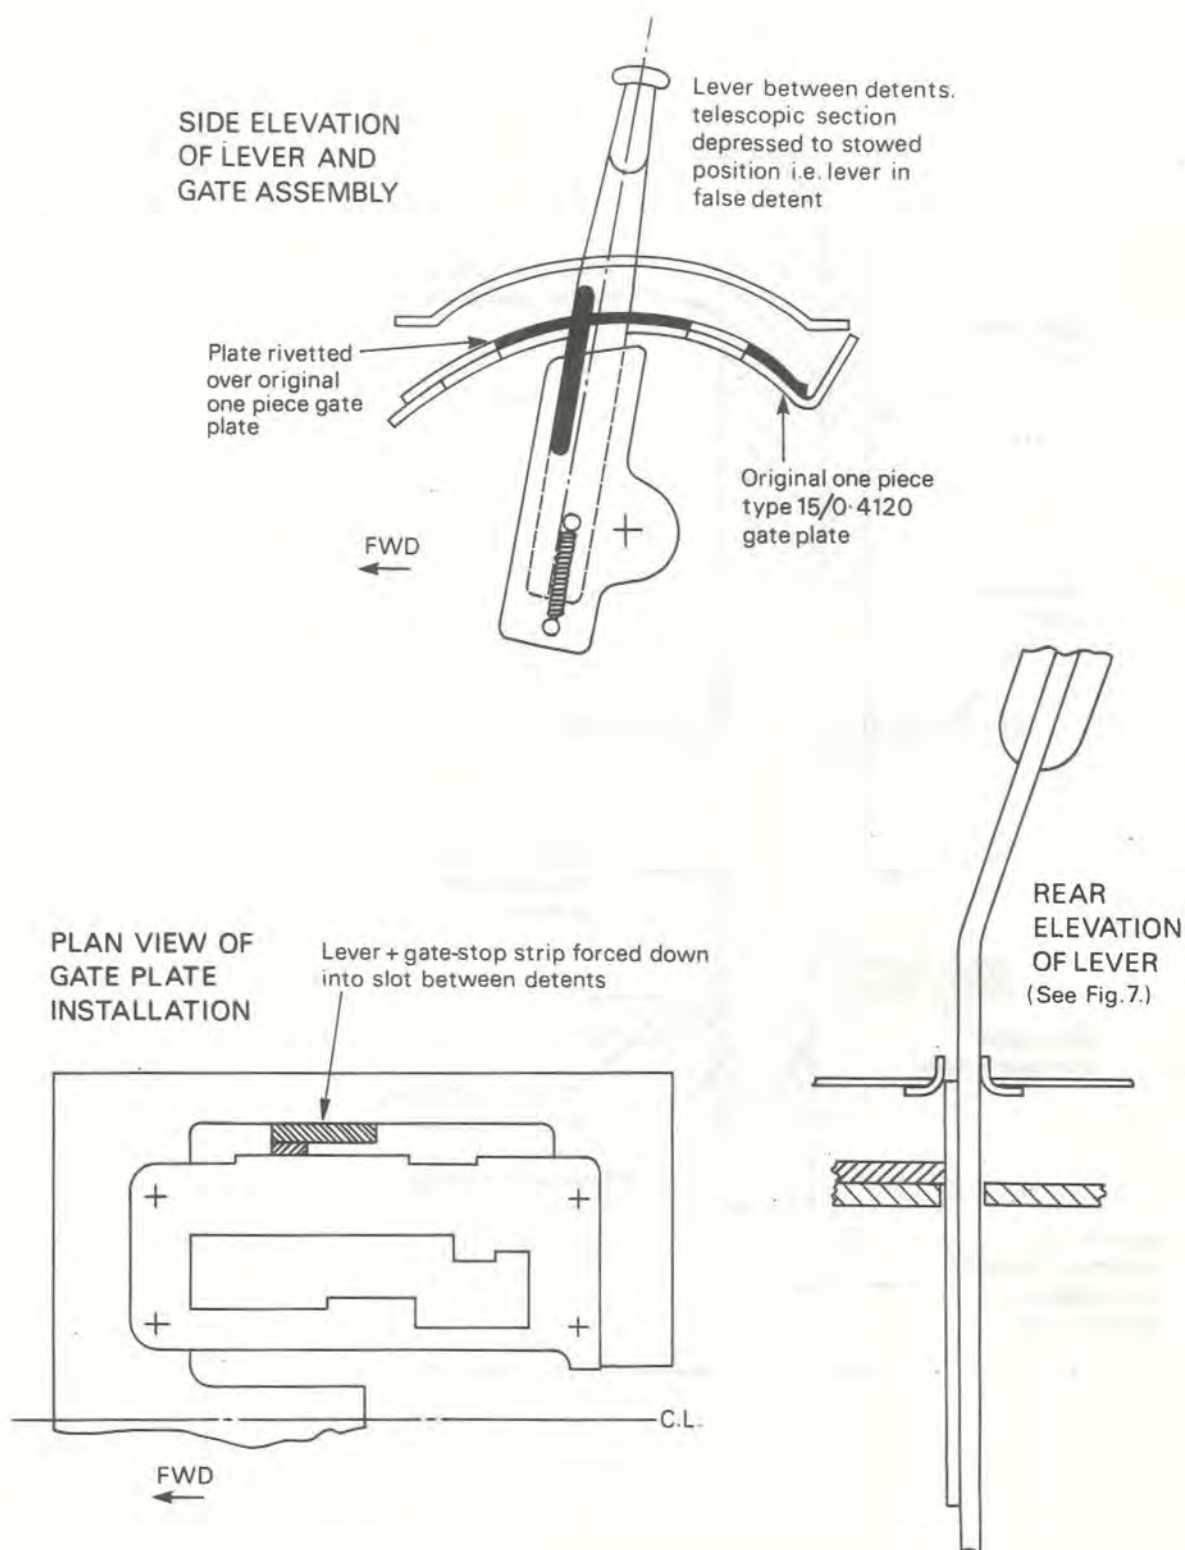
FIGURE 5

Examination of the gate plate in the control console indicated that it was basically a type 15/0.4120 plate, ie a one piece component with a paxoline facing layer which was installed on early 748 aircraft at the time of manufacture. It was noted, however, that the paxoline facing layer was no longer present, but that a steel plate had been rivetted over the basic metal component to form the profile of the HP cock slot and the left-hand side of the gust-lock lever slot. In addition, a steel strip was rivetted along the right-hand side of the slot, although of the three holes in this strip, only two were occupied by rivets. The strip was thus free to deflect sideways (being curved in vertical profile), and therefore did not contribute to the lateral location of the gust-lock lever. It has not been possible to determine when this freedom of movement first came into being.

Examination of these steel rivetted components indicated that they did not conform to the drawings for any of the standards of gate plate produced by the aircraft manufacturer and either incorporated as original parts or made available as replacement components to operators.

The distance between the 'locked' and 'unlocked' detents of the gate plate was found to be approximately 11% shorter than the minimum specified by the manufacturer.*

SITUATION OF GUST-LOCK LEVER AND GATE
PLATE IN CONTROL CONSOLE AS DEMONSTRATED ON G-BEKF

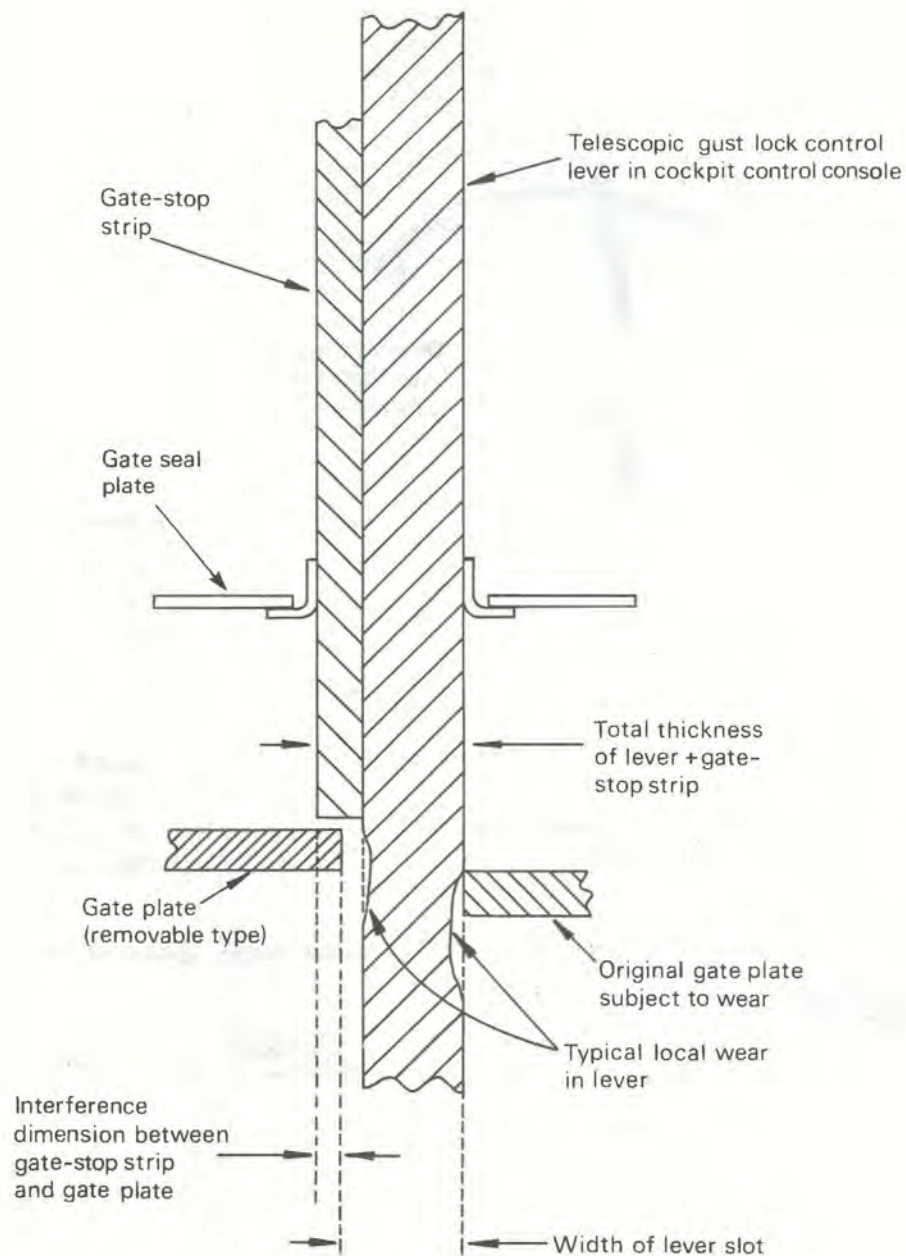
FIGURE 6

The gate-stop strip on the gust-lock lever was found to have a protrusion at its upper end which indicated that it was originally manufactured from a thicker strip than that used as standard by the aircraft manufacturer. The strip did not conform to the manufacturer's drawings.

Measurements were made of the gust-lock lever slot width, and the total thickness of the lever and gate-stop strip. These were then compared with the nominal dimensions and tolerances specified at manufacture by the aircraft's constructors. It should be noted, however, that the thickness of the gate-stop strip decreased slightly over the lowest 0.3 inches of its length and that the protrusion already mentioned occupied the top 0.4 inches of the strip. The bottom contact face was chamfered instead of flat.

SECTION THROUGH TYPICAL GUST-LOCK LEVER
AND GATE-STOP STRIP, SHOWING INTERFERENCE
WITH GATE PLATE (LOOKING FORWARD)

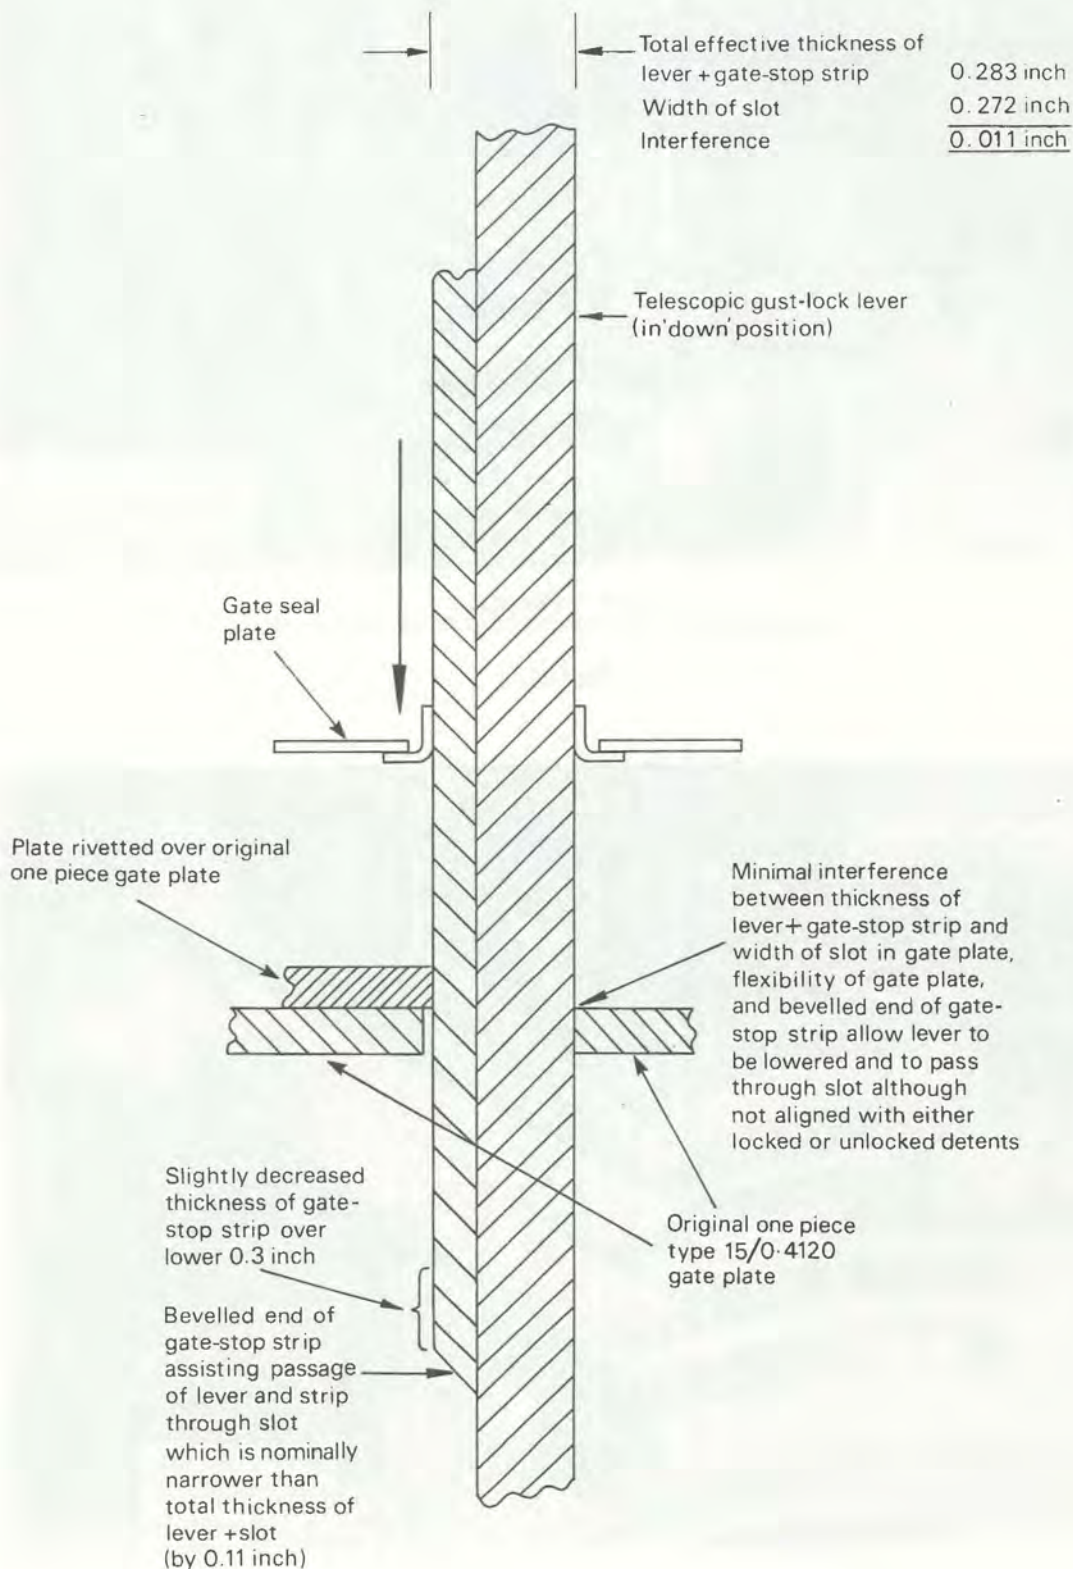
FIGURE 7

- 2.2.1 On initial examination of the gust-lock system, it was postulated that the 11% shortfall in distance between the 'on' and 'off' detents could have been the cause of the elevator lock not withdrawing. However, on further investigation, it was established that a considerably greater shortfall would be needed in an otherwise correctly rigged aircraft before the elevator lock could remain engaged with the lever in the 'off' detent or, alternatively, that the 11% shortfall would have to be accompanied by severe mis-rigging of the control cables.

DIAGRAM OF SECTION THROUGH GUST-LOCK LEVER, GATE PLATE AND GATE-STOP STRIP, SHOWING SITUATION DEMONSTRATED ON G-BEKF, WITH LEVER LOWERED BETWEEN DETENTS TO A POSITION RESEMBLING 'LOCKS DISENGAGED' POSITION

(Note: loose steel strip on right hand side of slot and protrusion at top of gate-stop strip omitted for clarity)

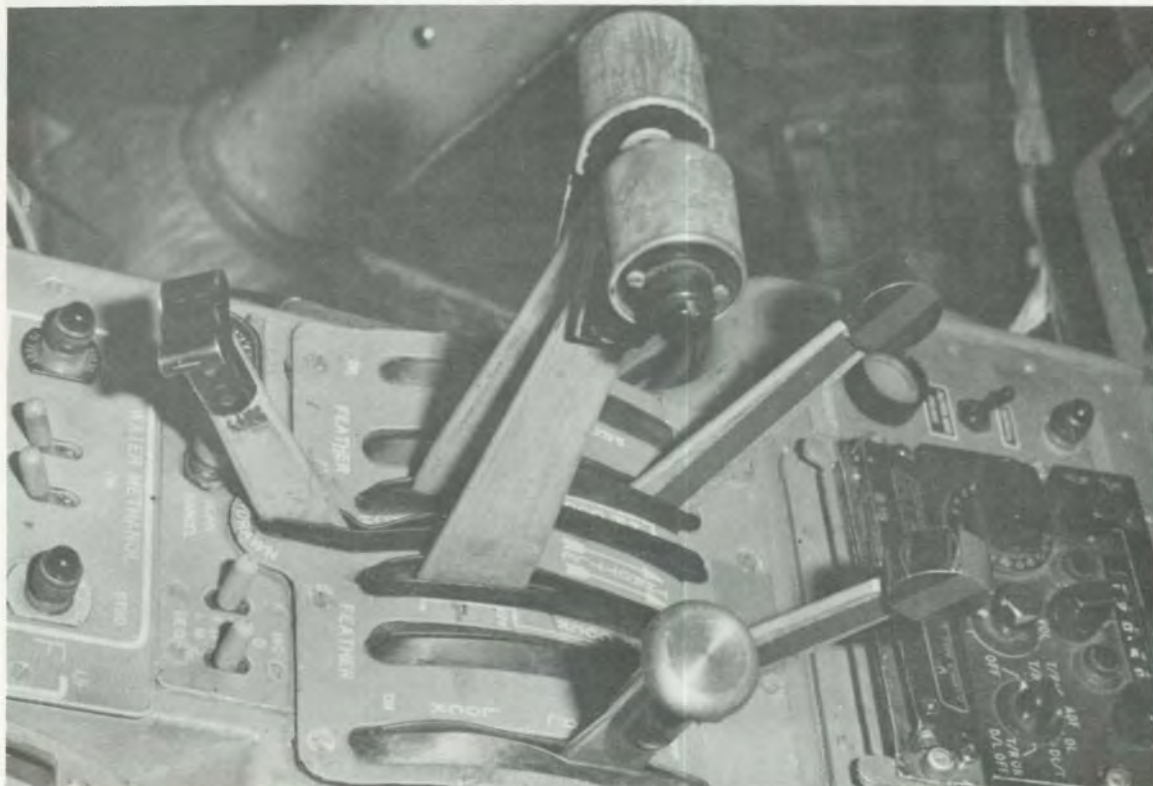
Plate 4 : throttle position when baulked by the interlock

It was found that the elevator lock had become re-engaged.

Cockpit controls-centre pedestal
Gust-lock lever approximately 30% back from 'off' detent, in false detent position.
Throttles closed

Plate 5 : approximately as viewed from the co-pilot's position

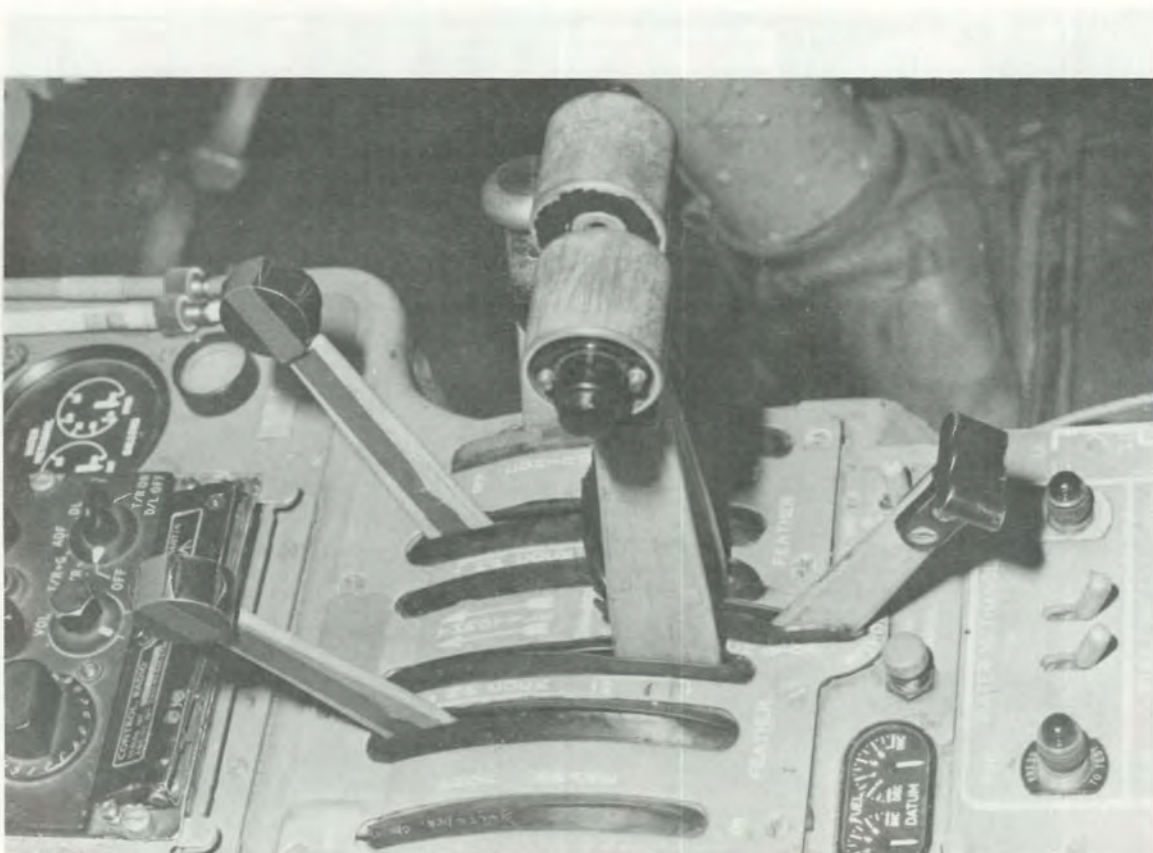
Plate 6 : approximately as viewed from the commander's position

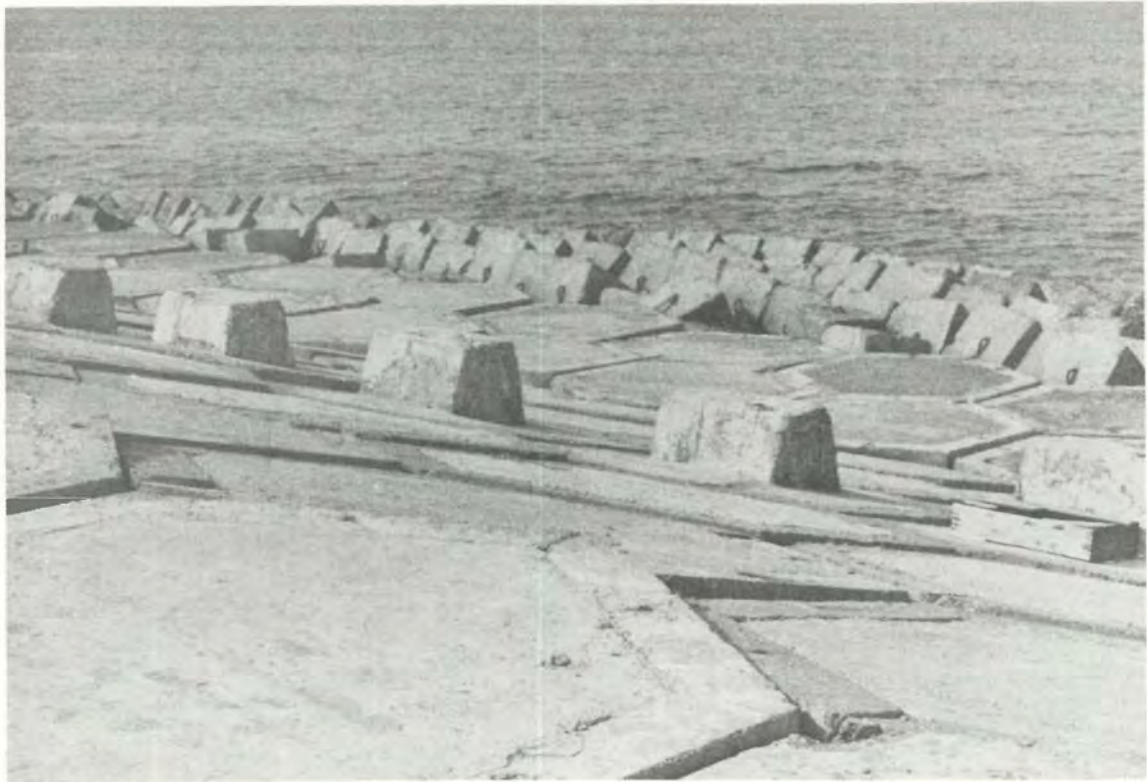
Topography at eastern end of overrun area

- (ii) they consulted their Consultant Engineers regarding the possible re-design or elimination of the protruding concrete blocks forming part of the sea wall, without serious detriment to the sea defences. However, the Engineers recommended that no change should be made on these lines, but rather that a further 40 blocks should be constructed at the south east corner to enhance the sea defences;

Plate 7 : the sea defences, viewed from the perimeter road

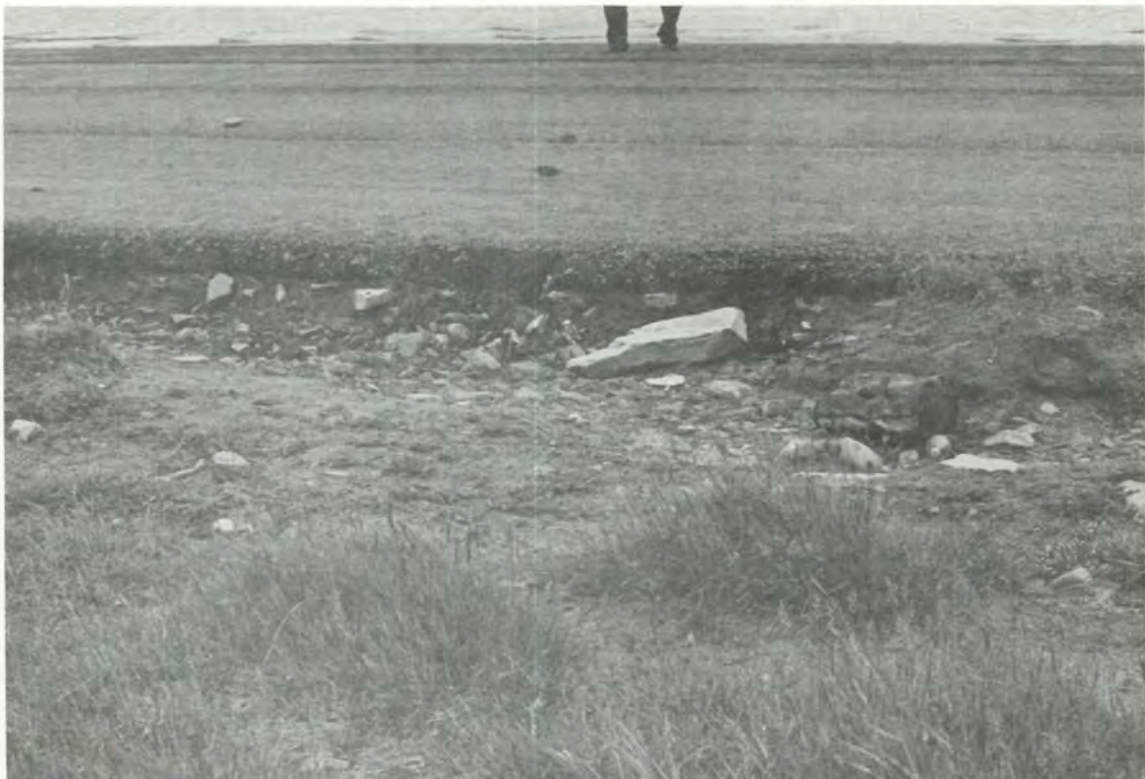
Damage to the port propeller, nose underside and the surface of the perimeter road indicated that the aircraft had crossed the perimeter road with the underside of the nose and the port propeller in contact with the surface.

Plate 8 : the step up to the perimeter road, viewed along aircraft track
