**Air New Zealand
McDonnell-Douglas DC10-30 ZK-NZP
Ross Island, Antarctica
28 November 1979**

REPORT 79-139

**OFFICE OF AIR ACCIDENTS INVESTIGATION
MINISTRY OF TRANSPORT
WELLINGTON**

**AIRCRAFT ACCIDENT
REPORT No. 79-139**

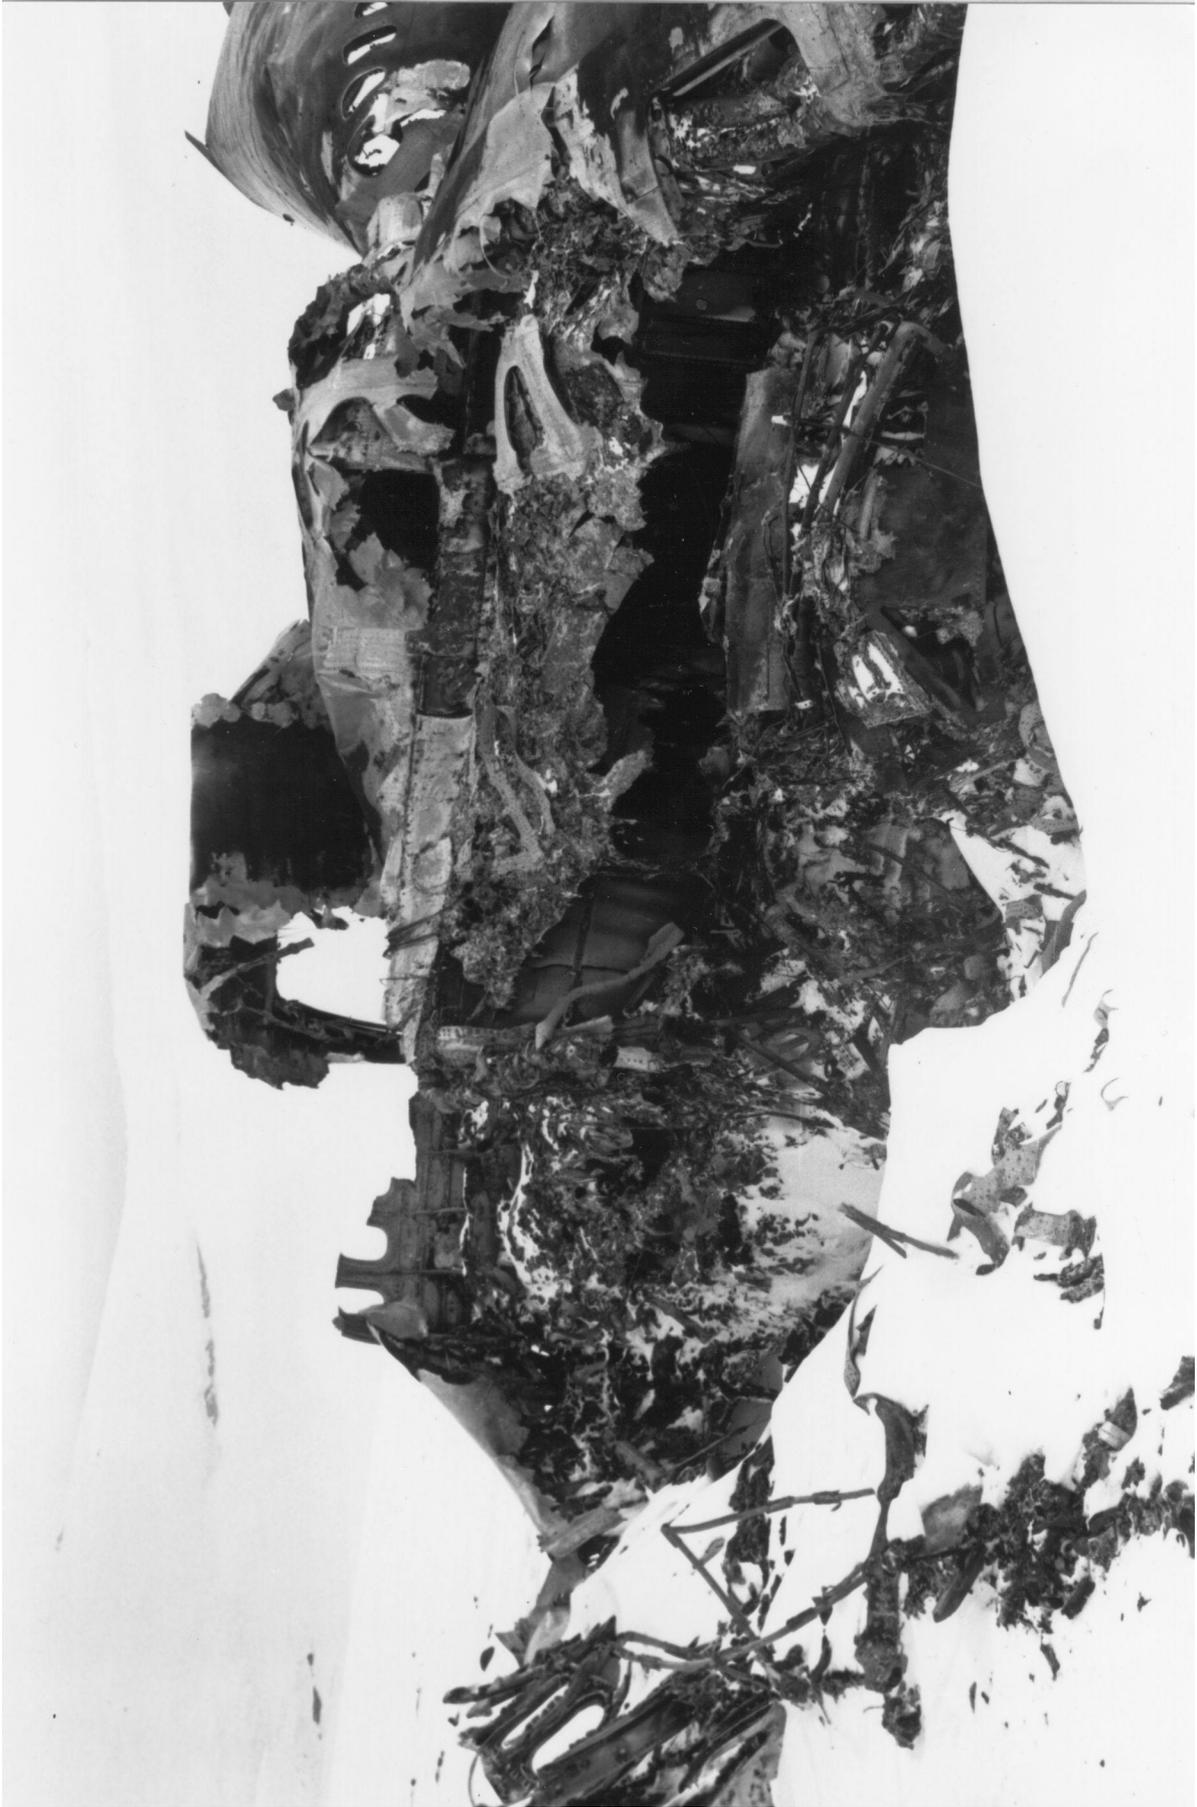
- 1.14.1 The evidence in the wreckage trail indicated that a fire was ignited immediately after the impact and that a persistent fire raged in the centre section of the fuselage but aft of the front galley. The residual fuel in the left wing tanks which were the only fuel tanks to retain their essential integrity probably sustained this conflagration. The source of ignition was not determined.
- 1.14.2 The fire did not involve the fuselage interior immediately after impact and many of the victims showed no evidence of being burnt.
- 1.14.3 The fire burnt itself out before the wreckage was located therefore no fire fighting equipment was involved.

FIG 4 AFTERMATH OF INTENSE FIRE IN CABIN AREA
