Final Report of the Board of Inquiry

Investigating
the circumstances of an accident involving the
Air Canada Boeing 767 aircraft
C-GAUN that effected an emergency landing
at Gimli, Manitoba on the
23rd day of July, 1983

Commissioner
The Honourable Mr. Justice George H. Lockwood
April 1985

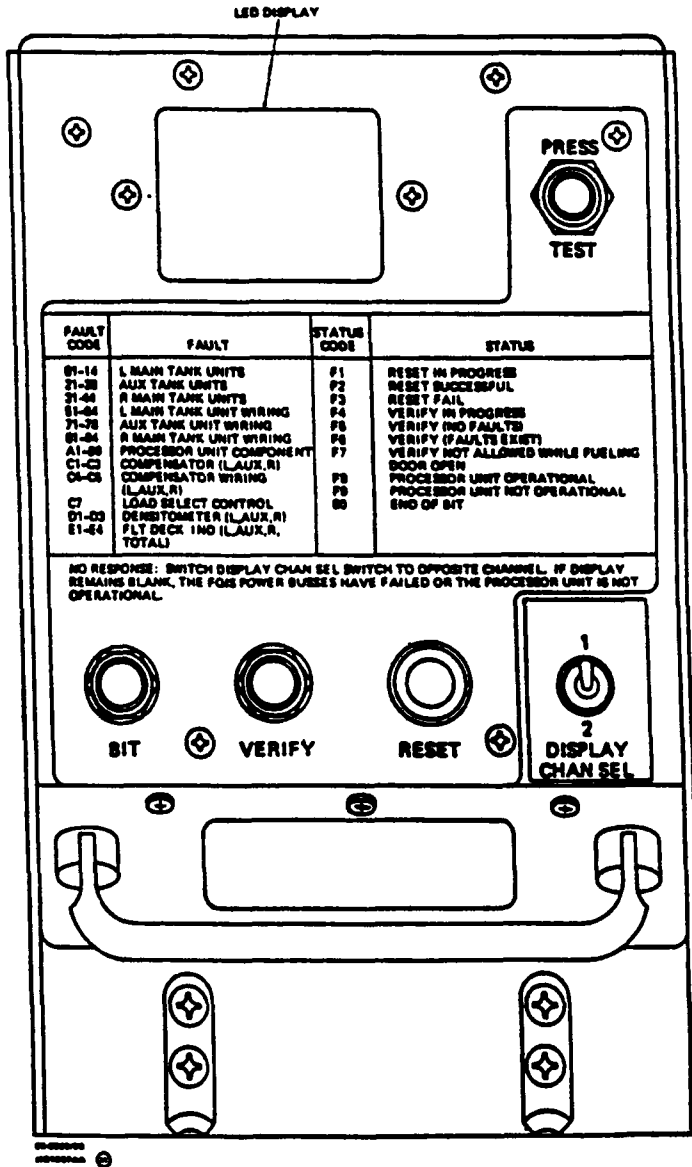
HG1057AA Digital Fuel Gauge Processor, Front Panel
Figure 3

BITE stands for Built-in Test Equipment. It refers to the fact that the processor had been designed and built so as to be able to identify faults within its own system. Before doing the test, he reset the number 2 channel circuit breaker. This caused the fuel gauges in the cockpit to go blank.

Mr. Ouellet was not satisfied with the test and decided that the processor had to be replaced. When he tried to order a new one, he was told that none were available in Montreal, but that one had been ordered to be available that night in Edmonton.
