# **NATIONAL TRANSPORTATION SAFETY BOARD**

## **AIRCRAFT ACCIDENT REPORT**

**SCANDINAVIAN AIRLINES SYSTEM  
FLIGHT 901**

**FEBRUARY 28, 1984**

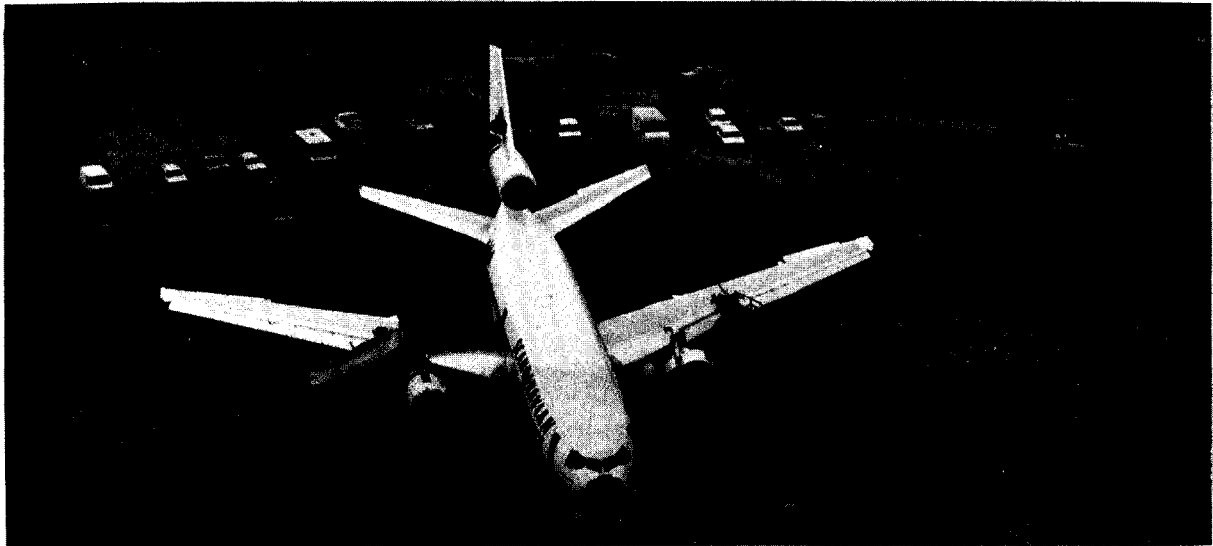
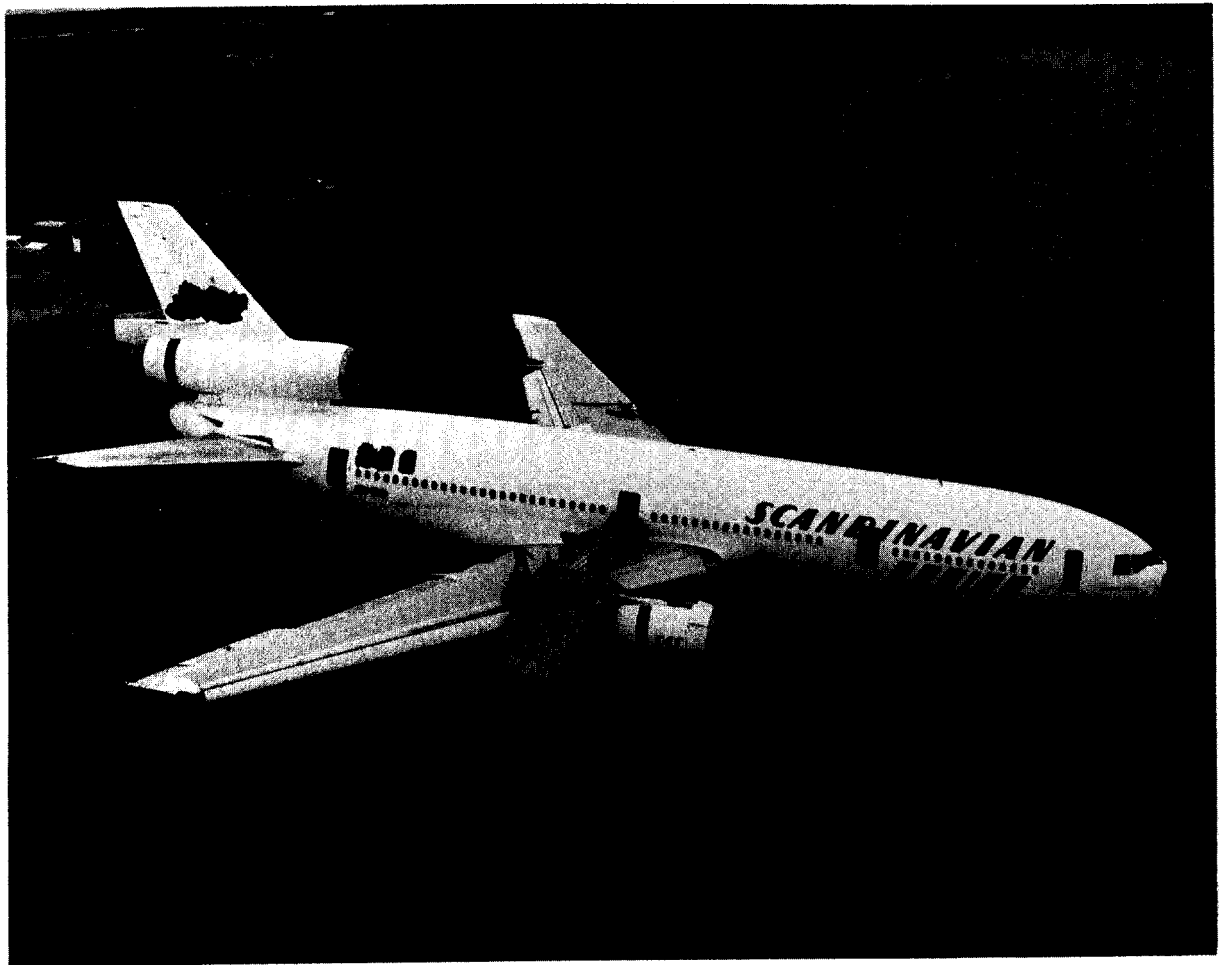
Figure 2.—Flight 901 at rest in Thurston Basin.

The forward section of the airplane fuselage came to rest in Thurston Basin, a tidal waterway about 600 ft (182.88 meters) from the runway 4R departure end. The airplane was damaged substantially. (See figure 2.) The captain immediately began to execute the memory items of the "On-Ground Emergency Check List." However, neither he nor the systems operator could move the engine fire selectors or fuel cutoff levers to their full off positions.

The aft portion of the fuselage remained generally intact. There was major damage at the lower nose area, to the radome, and to the forward pressure bulkhead at fuselage station (FS) 275. The nose landing gear structure had collapsed under the fuselage. The drag braces were fractured and had separated from their attachment fittings. The interior of the forward fuselage area was deformed and exhibited fractures at the flight deck and galley floor locations. Several floor beams below the galley floor were fractured and twisted.

The wings, leading edge slats, and flaps sustained moderate damage from impact with the wooden pier structure. The leading edge slats were extended fully and the trailing edge flaps were extended to the 40° position.

The No. 1 engine pylon structure was buckled and twisted; the No. 2 and 3 engine pylons exhibited no major structural damage. The No. 1 and No. 3 engines sustained major impact and salt water damage. The No. 2 engine sustained no impact damage. All three fan and turbine thrust reversers were in the fully deployed (reverse thrust) positions.

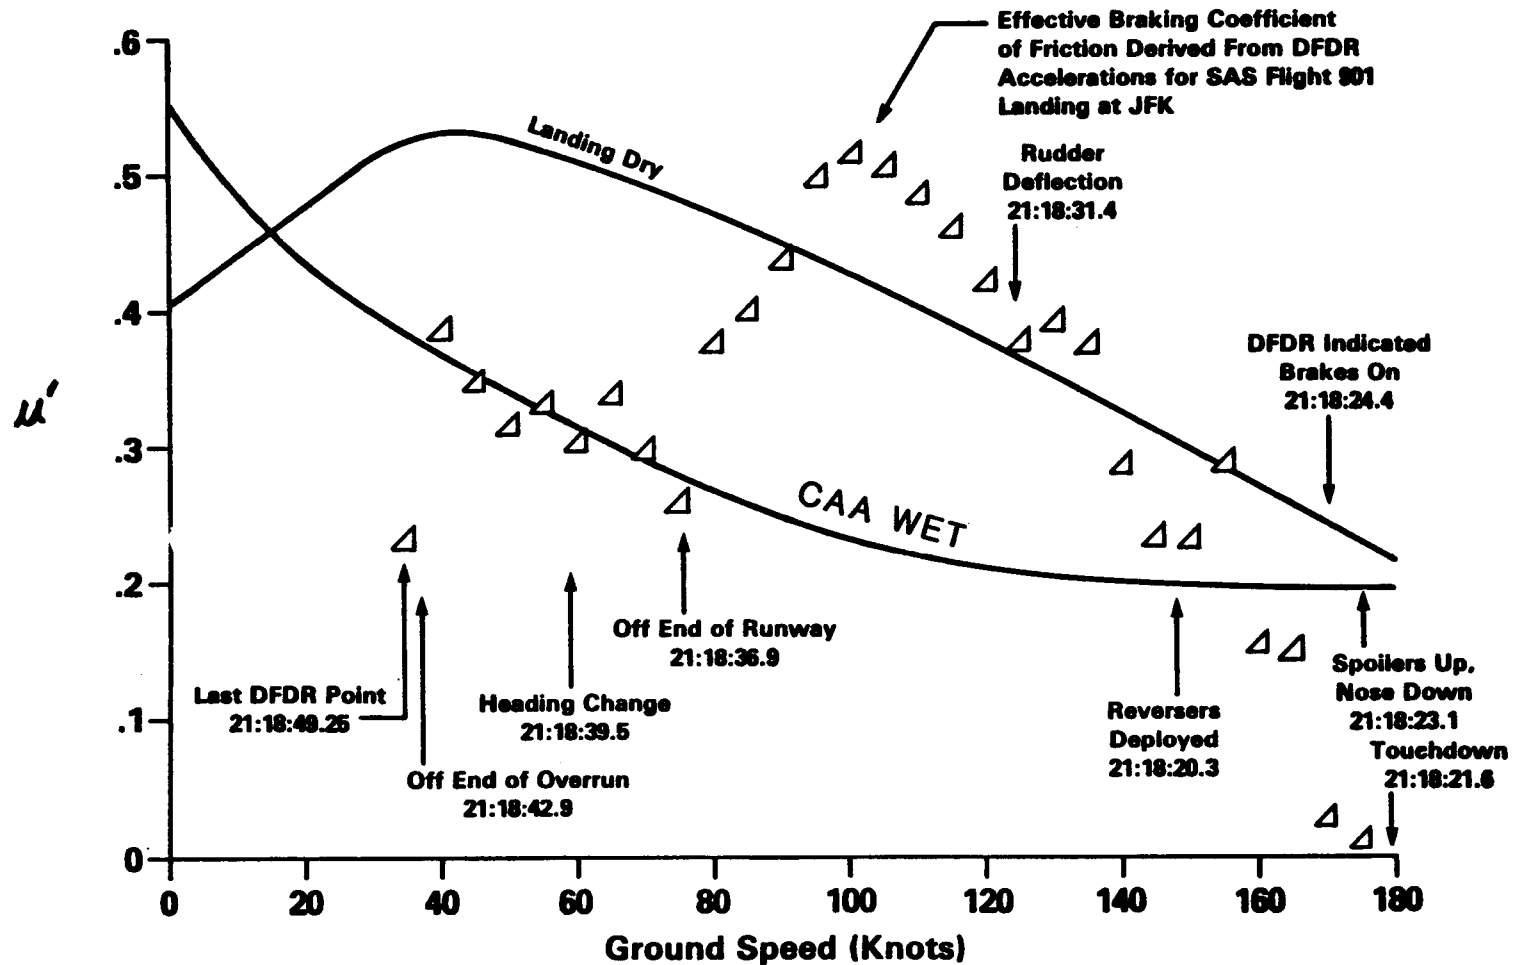
Figure 5.—Effective Braking Coefficient Derived from DFDR.

**Effective Braking Coefficient Derived From  
DFDR Decelerations – CF6-50 Engine  
Turbine Reversers Inoperative**
