ACCIDENTS INVESTIGATION DIVISION

Civil Aviation Department
Hong Kong

Report on the accident to
Hawker Siddeley Trident 2E B-2218
at Hong Kong International Airport
on 31 August 1988

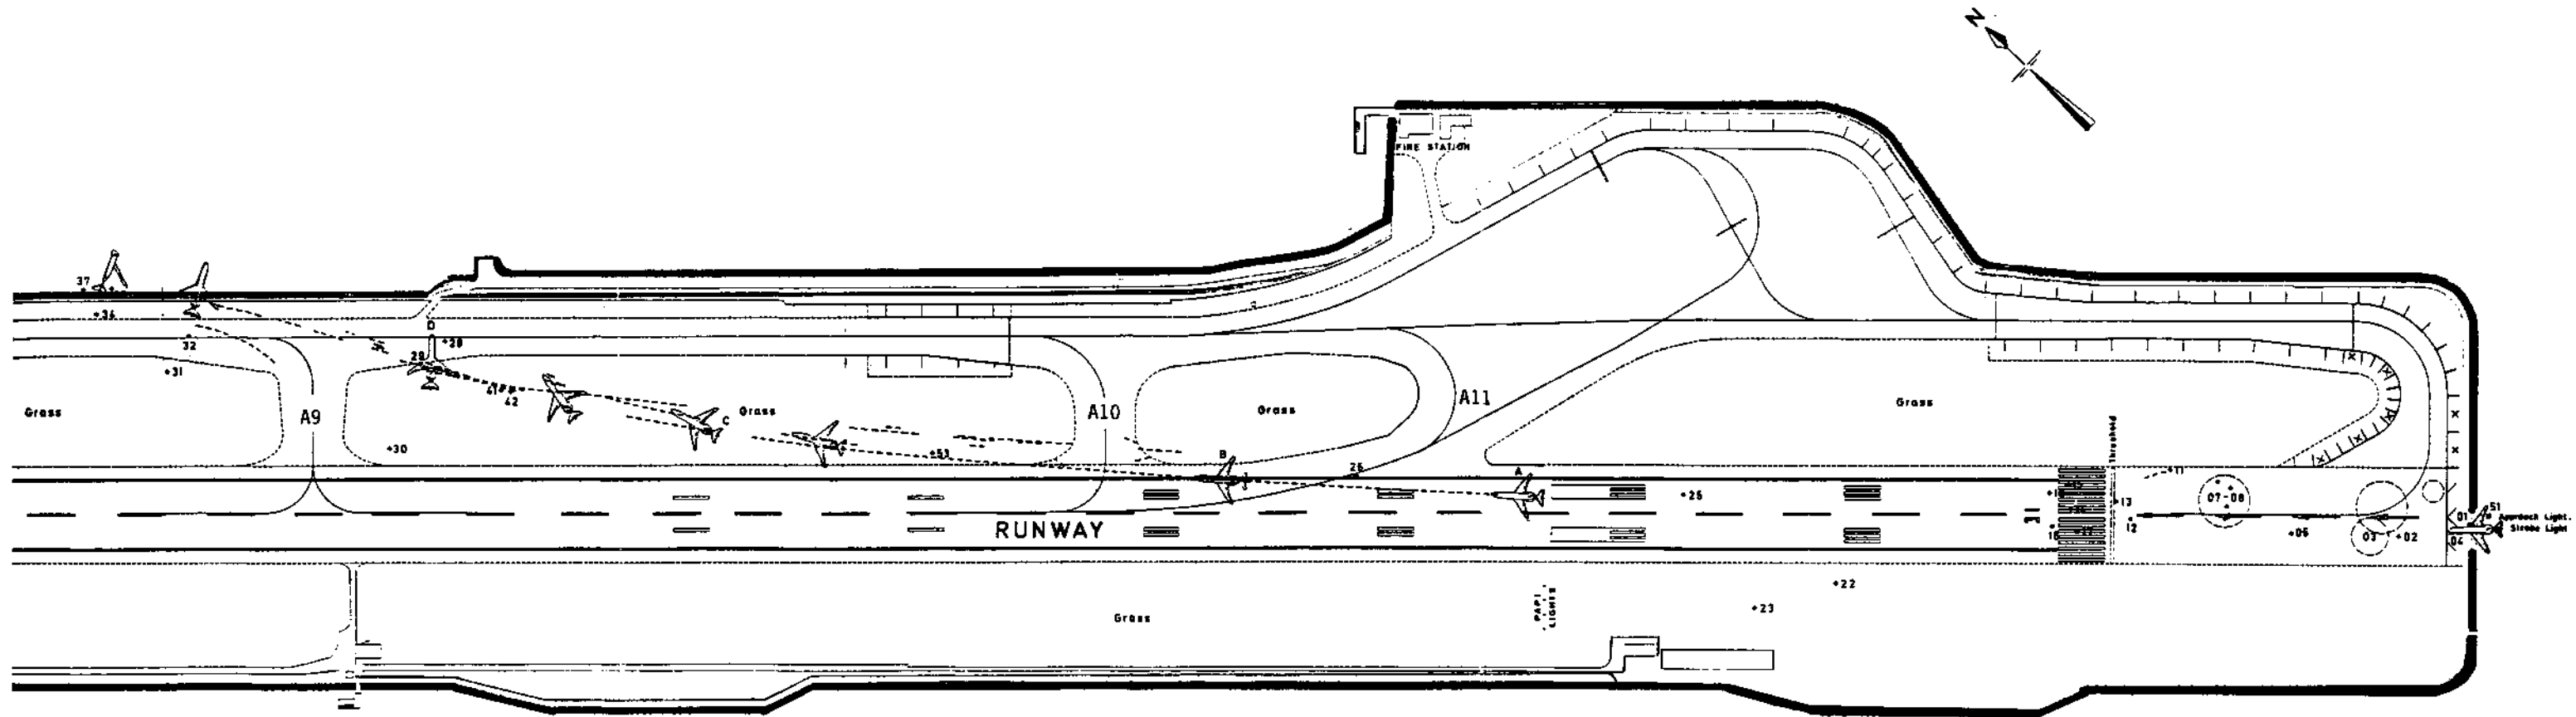
Wreckage Distribution and Impact Sequence

From the disposition of the contact marks of the right main gear tyres on the facing edge of the sea wall, and the left main gear tyres on the paved undershot surface, a roll attitude at impact of five degrees right wing low was determined. The precise pitch attitude of the aircraft at this time could not be determined from either the ground witness marks or the UFDR. However by manipulation of scale drawings it seems probable that at all likely pitch attitudes the aircraft was descending. This view is supported by the fact that the aircraft failed to strike the single crossbar light structure immediately before the approach light that was hit. Appendix 8 depicts the impact sequence and shows the wreckage distribution.

The first object to be struck by the aircraft was the last of the red approach light structures located 12 m before the sloping sea wall at the start of the undershoot area to runway 31 (elevation 15 ft) and projecting 21 feet above the water. The aircraft's right outboard flap hit the light and damaged it for a distance of 1.58 ft down from its top, with corresponding damage occurring to the wing flap at a point 7.57 m from the aircraft's centreline. Almost simultaneously the right main landing gear tyres struck the inclined edge of the sea wall approximately 1.5 ft below the top,

The left main gear wheels contacted the paved horizontal undershoot surface about 2 m from the sea wall, without damaging the tyres, and left four white tracks (characteristic of aquaplaning) for a distance of approximately 9 m before they faded out. The aircraft's track at this time was 312.5 degrees magnetic. No evidence of nose wheel contact was found in the initial impact area and no further identifiable ground contact marks attributable to the crashed aircraft were found for a distance of 609 m down the runway. Then, at a point some 10 m beyond the runway touchdown markings, the left main gear tyres started to leave marks 9 m to the right of the runway centreline. From this position the aircraft departed the runway to the right and progressively yawed to the right as it slid across the grass between the runway and taxiway, supported now by the left main and nose gears and the right outer trailing edge flap. As its heading and track began to significantly differ, the nose gear failed, allowing the forward fuselage to strike the ground. It is likely that it was at this point that structural damage first occurred to the front fuselage in the area behind the flight compartment. The aircraft continued travelling almost completely sideways until, after losing two leading edge slat sections from the right wing, it struck the edge of the taxiway at the A9 turn off. Here the left gear collapsed inwards, disrupting the local wing and inner flap support structure. The aircraft continued on an essentially straight path until it came to the edge of the sea wall adjacent to the taxiway, some 1463 m from its first point of impact. As it went diagonally sideways over the sea wall on to a ledge of stone blocks 12 ft below it still had enough forward speed to continue along the same track and further damage was caused to the underside of the fuselage, centre engine, left flaps and left wing. It seems probable that it was at this point that the forward part of the fuselage ruptured and became structurally detached. The aircraft eventually came to rest in Kowloon Bay in a slightly nose up attitude, heading ENE, with the rear extremity of the fuselage supported at water level on the ledge of stones that jutted out from the promontory. The centre engine was detached from the airframe, the left wing structure was damaged and a fire started internally in the centre engine intake duct. Fuel spread over the surface of the surrounding water. Most of the fuselage remained above water but the aircraft's attitude meant that the rear of the passenger cabin was partially submerged. The flight compartment and front portion of the front passenger cabin was attached to the remainder of the aircraft only by control cables and secondary structure and hung down into the water at a steep angle, with the nose resting on the sea bed. The aircraft had travelled 1485 m from the point of first impact with the runway promontory.

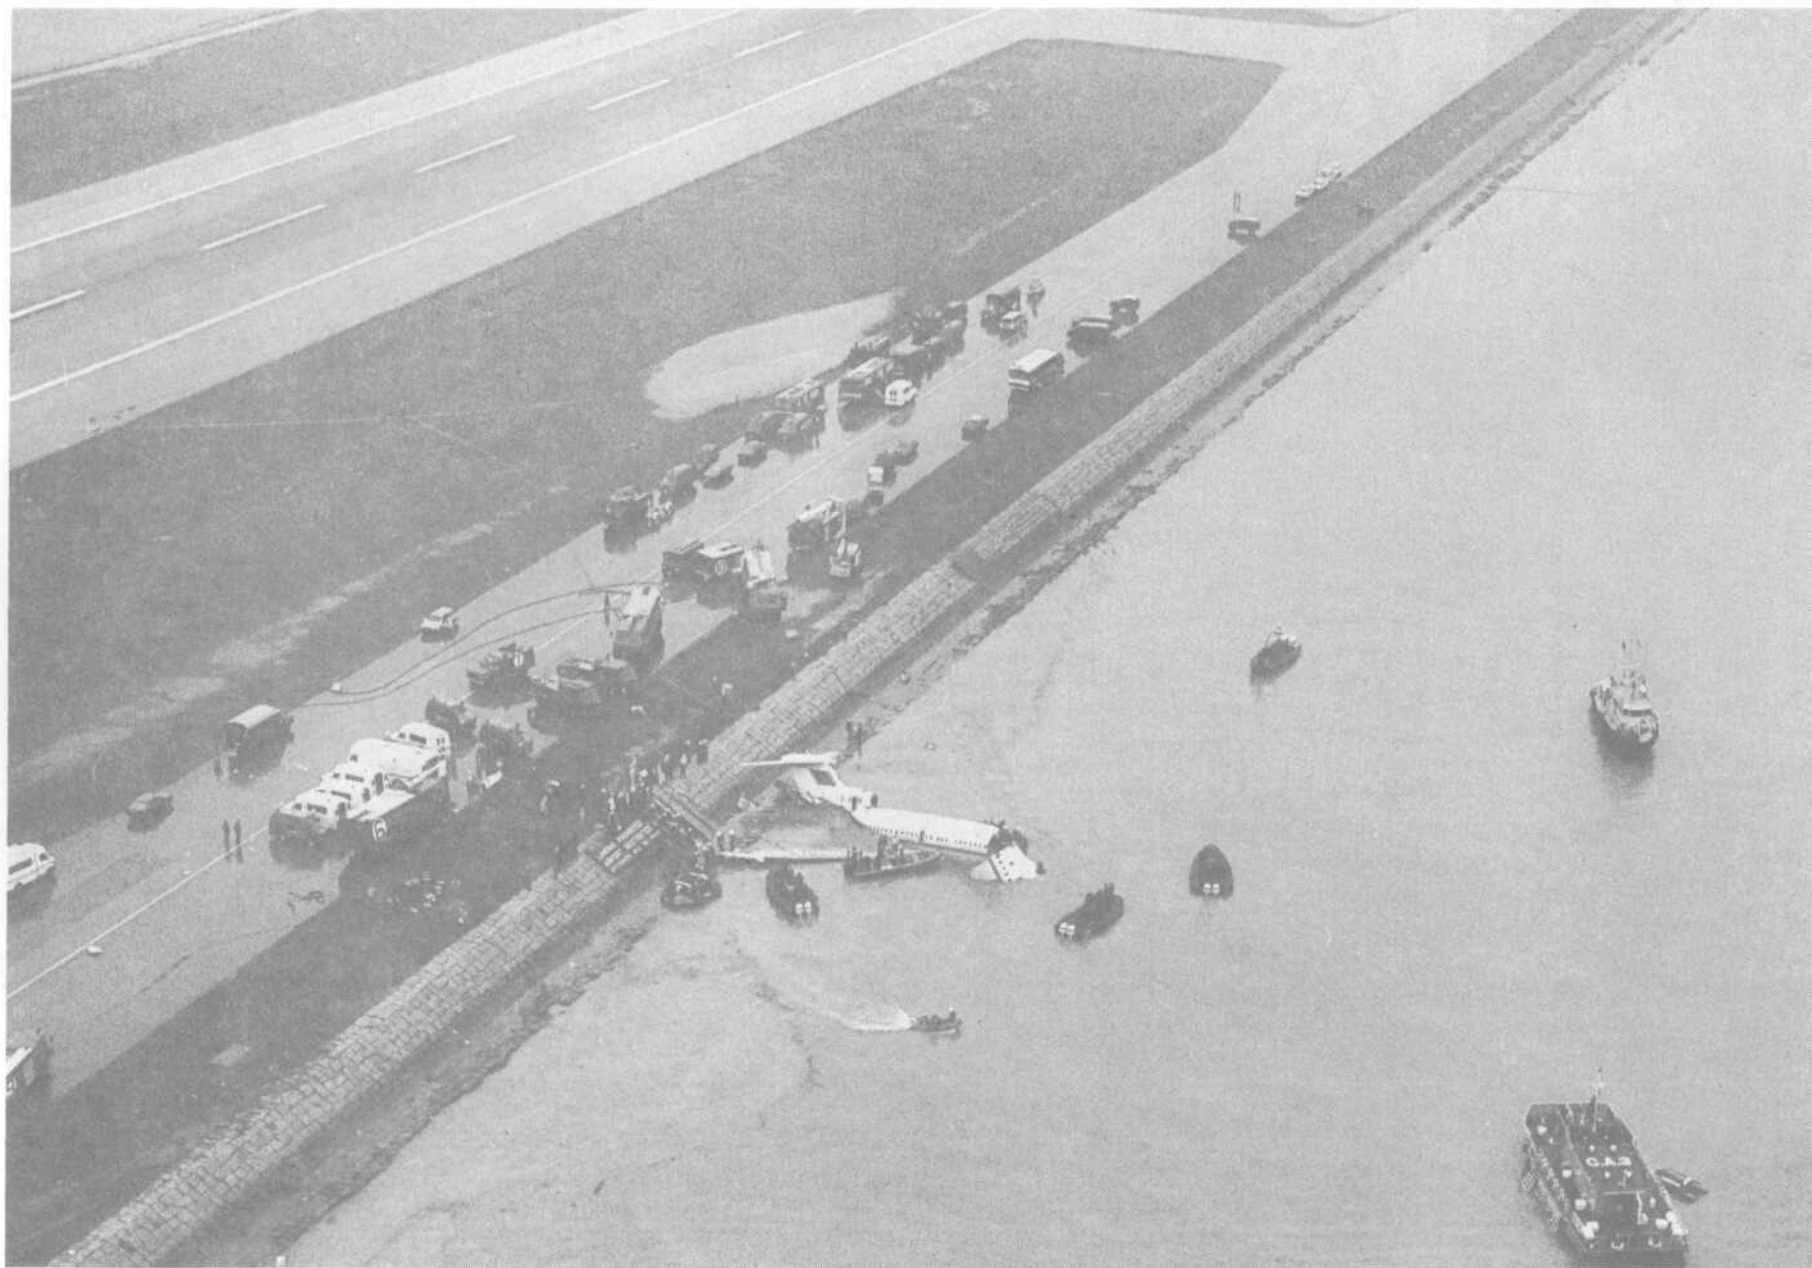
At the end of the accident sequence the aircraft came to rest in the water in a nose high attitude and slightly left wing low. The left sidewall of the fuselage near passenger seat rows 3 and 4 was severely buckled inward, whilst the roof and the opposite fuselage sidewall had failed in tension. Forward of this area the front of the aircraft remained attached only by secondary structure at, and below, cabin floor level and drooped down in to the water at a steep angle. A diver reported that the extremity of the nose rested in contact with the sea bed approximately 12 ft below the surface. The water was foul with almost zero visibility underwater.

Crash scene - left side of aircraft

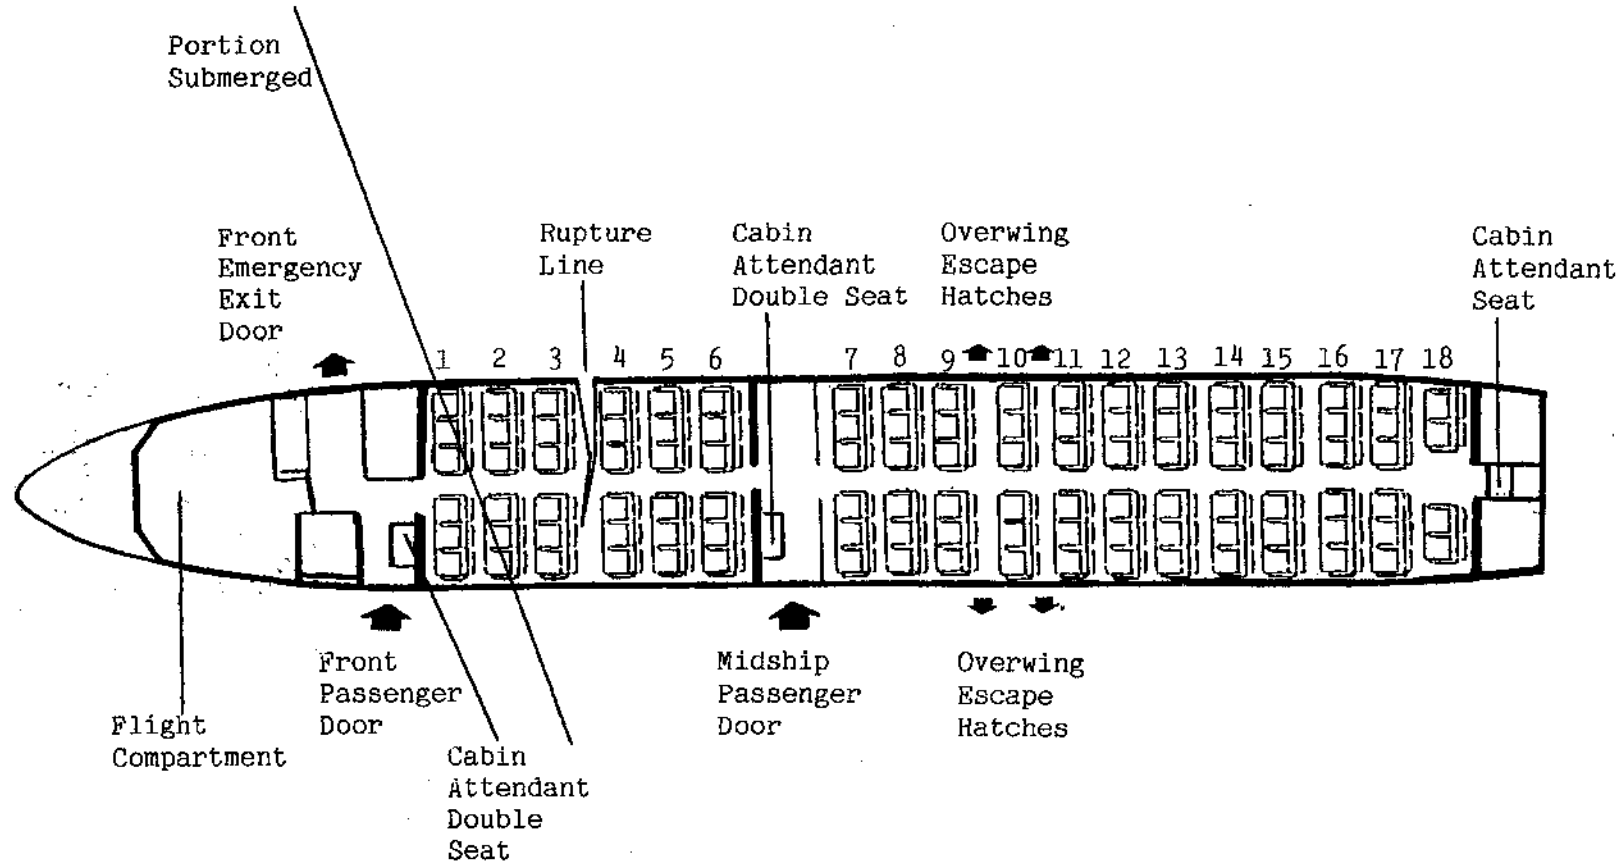
There was a strong current flowing in Kowloon Bay and this caused the wreck to rotate slowly clockwise, as it turned the right wing remained above water and provided a convenient platform for the passengers who exited the aircraft via the right hand overwing escape hatch. Eventually the right wing tip contacted, and lodged upon, a ledge of stones at the base of the promontory. Passengers reported that the rear of the passenger cabin was under water to a depth of approximately three feet.

Crash scene - right side of aircraft
