PB92-910402  
NTSB/AAR-92/02  
(SUPERSEDES NTSB/AAR-90/01)

## AIRCRAFT ACCIDENT REPORT

EXPLOSIVE DECOMPRESSION--  
LOSS OF CARGO DOOR IN FLIGHT  
UNITED AIRLINES FLIGHT 811  
BOEING 747-122, N4713U  
HONOLULU, HAWAII  
FEBRUARY 24, 1989

**Abstract:** This report explains the explosive decompression resulting from the loss of a cargo door in flight on United Airlines flight 811, a Boeing 747-122, near Honolulu, Hawaii, on February 24, 1989. The safety issues discussed in the report are the design and certification of the B-747 cargo doors, the operation and maintenance to assure the continuing airworthiness of the doors, and emergency response. Recommendations concerning these issues were made to the Federal Aviation Administration, the State of Hawaii, and the U.S. Department of Defense.

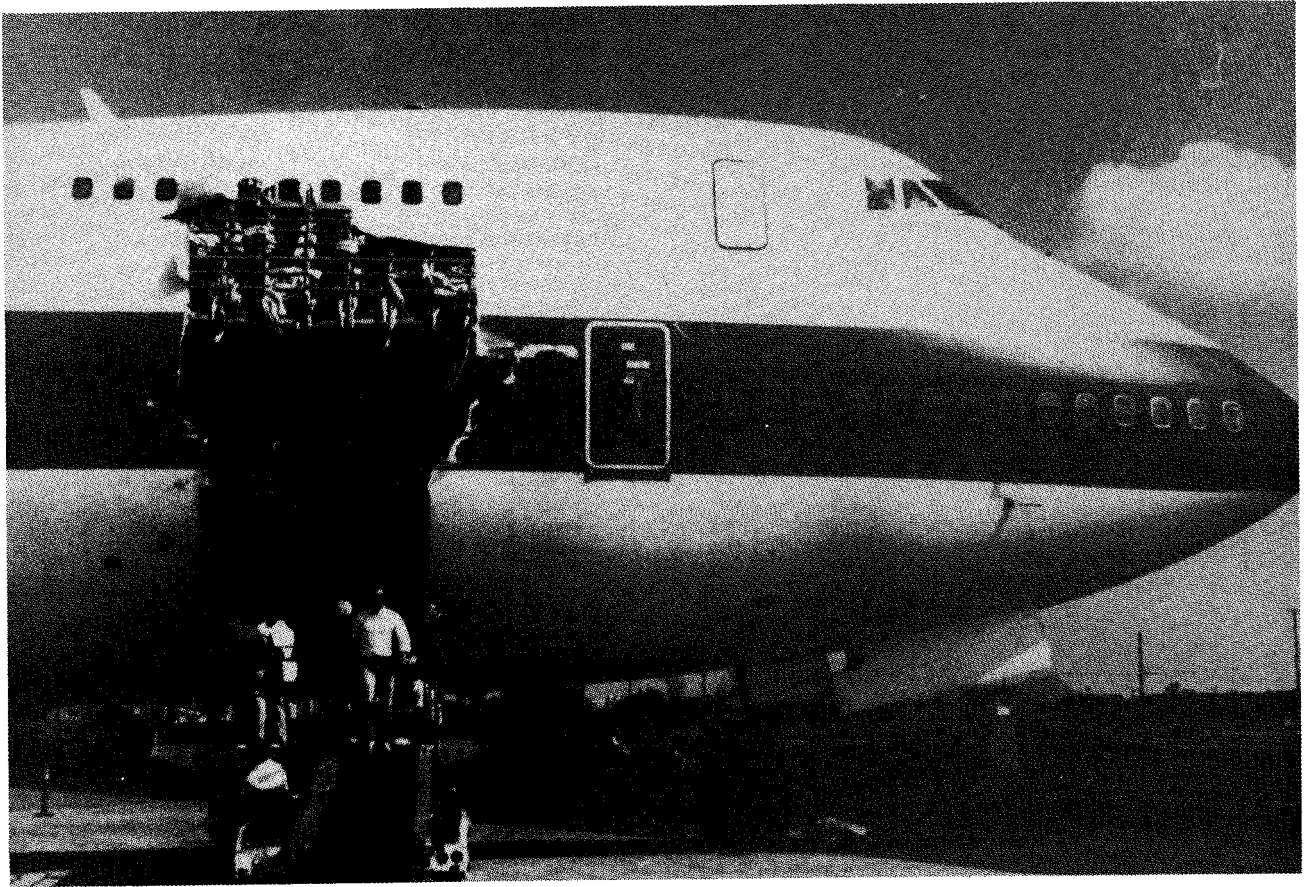
Figure 1.--Overall view of forward cargo door area  
on the right side of the aircraft.

The primary damage to the airplane consisted of a hole on the right side in the area of the forward lower lobe cargo door, approximately 10 by 15 feet large. The cargo door fuselage cutout lower sill and side frames were intact but the door was missing (see figures 1 and 2). An area of fuselage skin measuring about 13 feet lengthwise by 15 feet vertically, and extending from the upper sill of the forward cargo door to the upper deck window belt, had separated from the airplane at a location above the cargo door extending to the upper deck windows. The floor beams adjacent to and inboard of the cargo door area had been fractured and buckled downward.

Examination of all structure around the area of primary damage disclosed no evidence of preexisting cracks or corrosion. All fractures were typical of fresh overstress breaks.

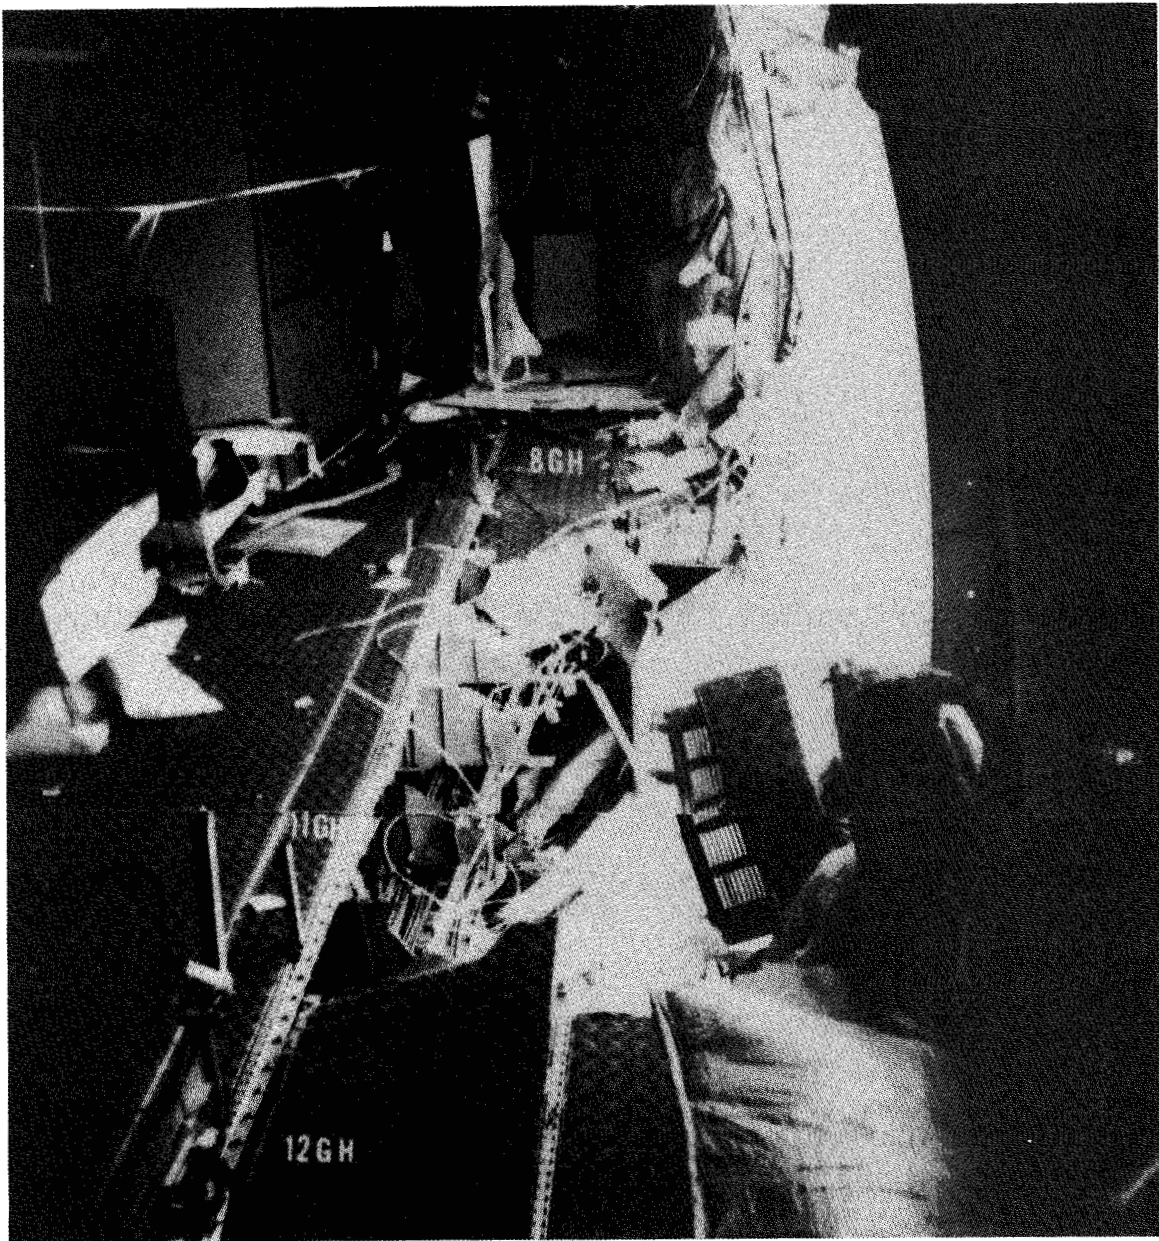
Figure 3.--Forward view of Cabin Zone B.  
Note missing seats 8GH through 12GH.

The cargo door separation resulted in the loss of fuselage shell structure above the cargo door, along with main cabin floor structure below seats 8GH through 12GH (see figure 3). The missing floor area extended inboard from the interior of the right side fuselage wall to the inboard seat track of seats 8GH through 12GH.

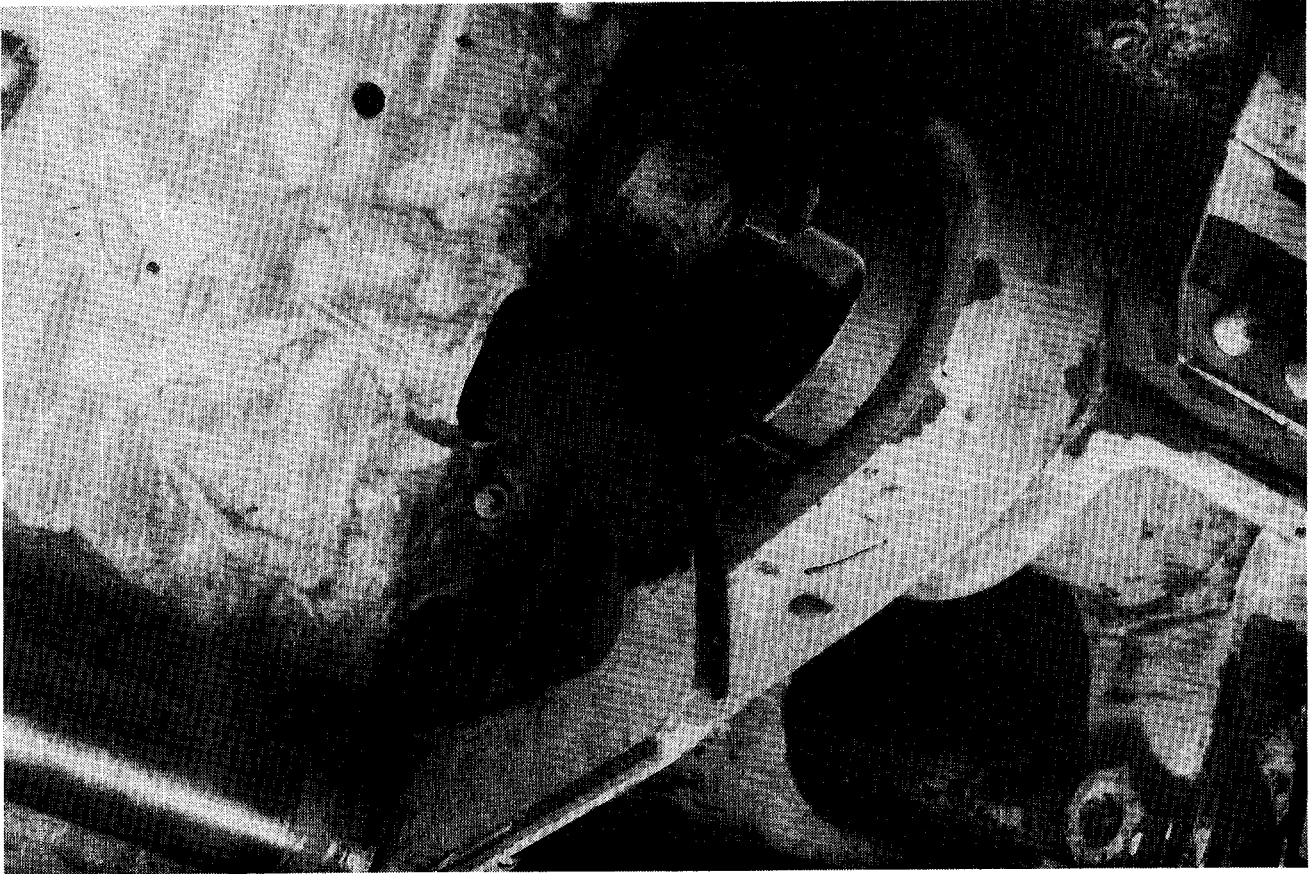
Figure 6.--Recovered lock sectors and cams.

Examination of the lock sectors disclosed that the bottom of the lower arm of each lock sector was gouged. For seven of the eight lock sectors, the distance from the main gouge area to the location of the interference between the latch cam and the lock sector was approximately 0.75 inch. (The No. 2 lock sector was corroded and had fractured at the location of the large gouge common to the other seven lock sectors. Consequently, it was not in contact with the No. 2 latch cam when the door was retrieved).

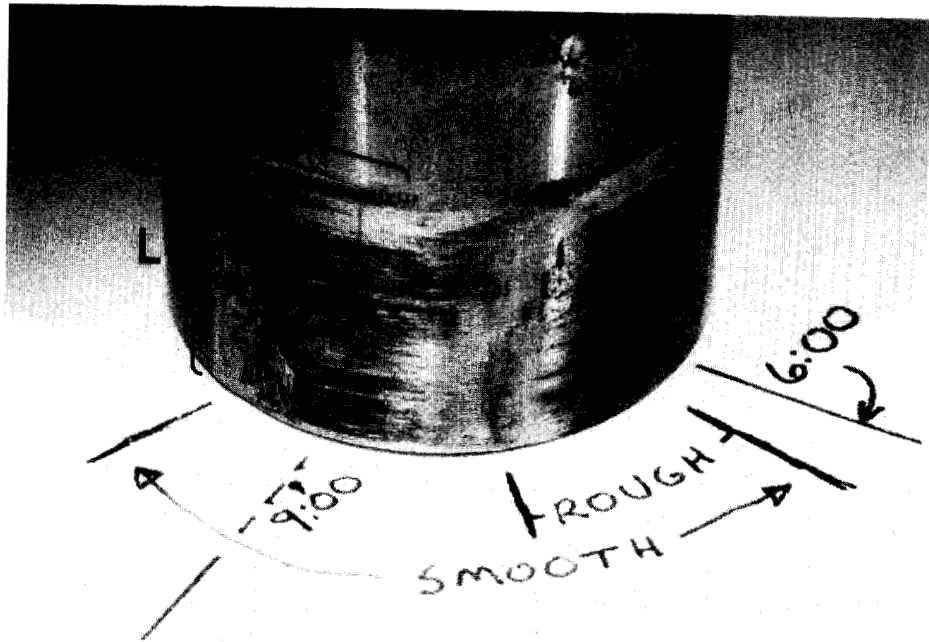
Based on the orientation of the latching mechanisms, the fully unlatched latching cams would first contact the latch pins from about the 1:15 o'clock position to the 7:15 position as the door was closed. As the cams are being latched around the pins, they would rotate approximately 80°, making contact with the pins from about the 4:15 position to the 10:15 position (See figure 7).

Figure 7.--Latch pin number 6. Note the rough and smooth areas and the steps indicating the contact area with the latch cam.

Detailed examination of the exposed surface of the pins (the portion of the pins extending from the housings) revealed various types of wear and damage. In general, all of the forward door cargo latch pins had smooth wear over the entire portion of the pin area contacted by the cams during normal closing and opening of the door. The pins also had distinct roughened (smeared) areas between the 6:15 and the 7:30 positions (See figure 8). The roughened areas had evidence of "heat tinting" and transfer of cam material to the surface of the pins. On pins 1 and 8 the roughened areas extended past the pin bottom to the 5:00 position. The 7:30 position approximately corresponds to the area on the pin where the lower surface of the cam would be relative to the pin when the latch cams are in the unlatched or nearly unlatched position.

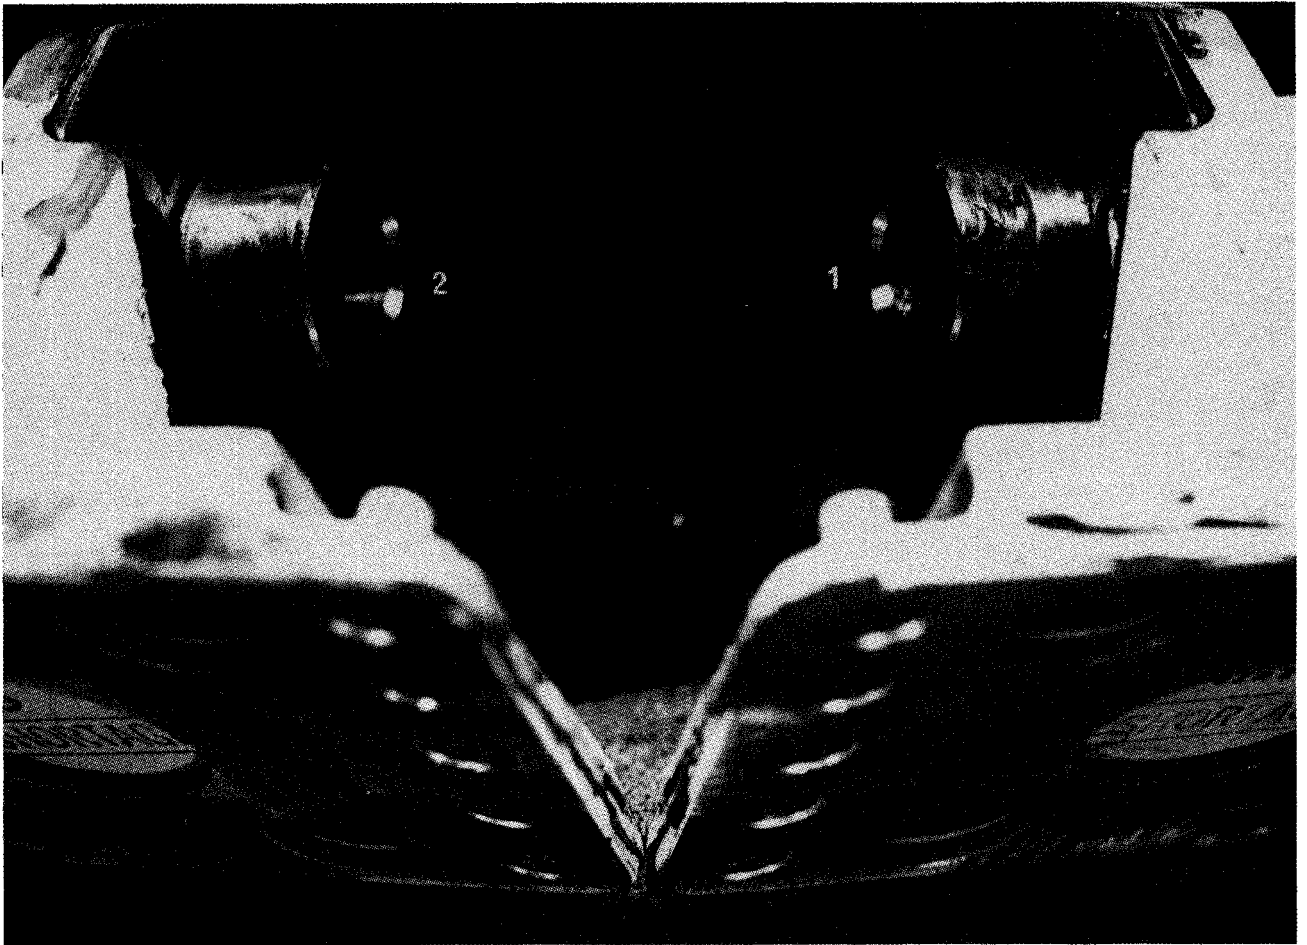
Figure 8.--Lower latch pin and housing assemblies  
Nos. 1 and 2 looking up and slightly outboard.

The forward mid-span latch pin was relatively undamaged. The aft mid-span latch pin had definite areas of damage. Both pins had wear areas where the cams would contact the pins during latching.

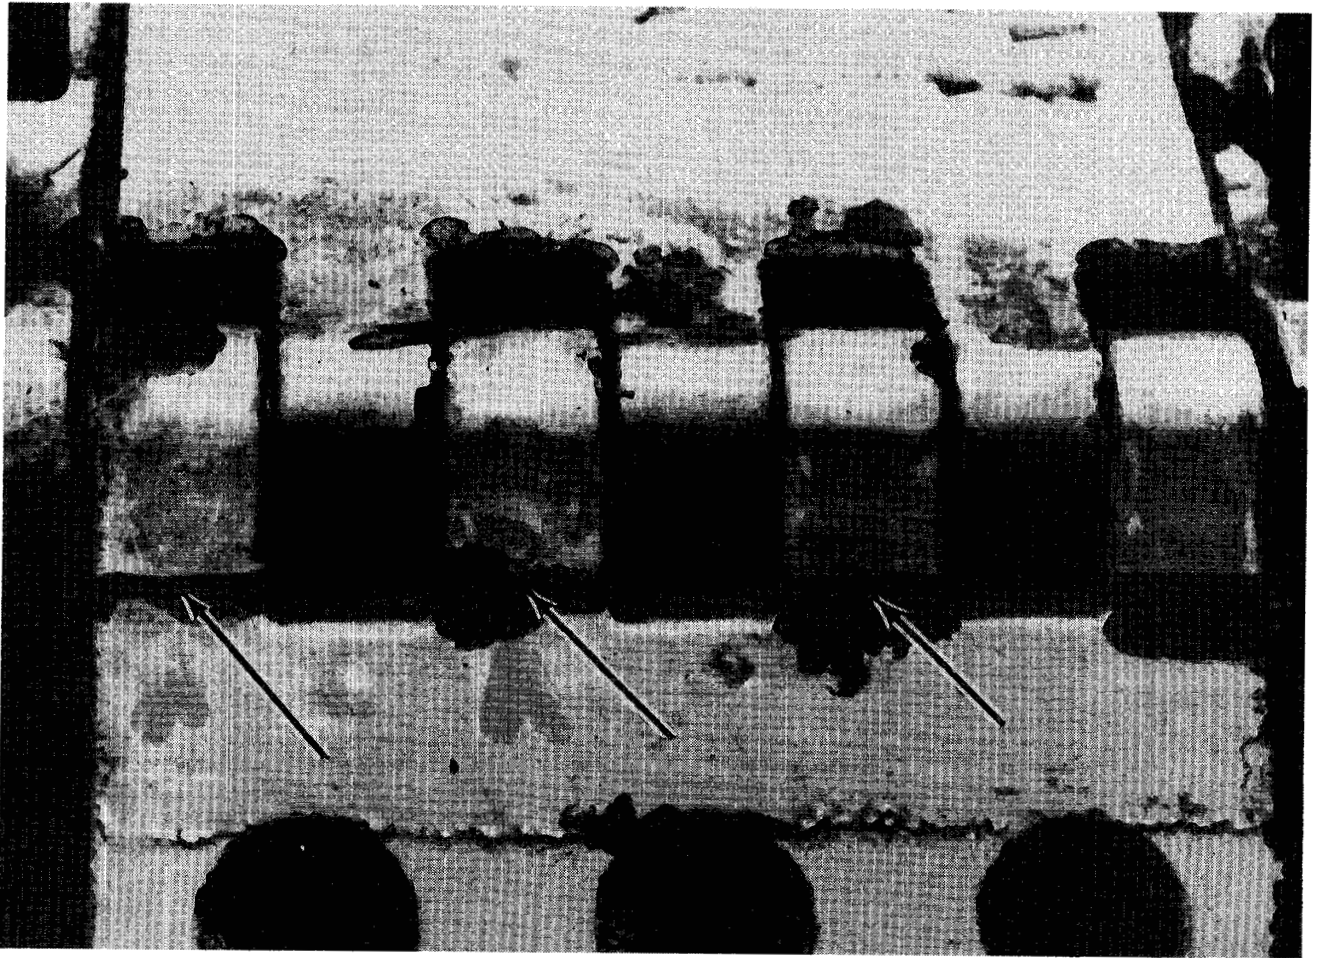
Figure 14.--Close-up view of cargo door hinge section.  
Arrows show impressions caused by contact with opposite hinge section.

were slightly bent. The upper flange of the door, to which the door hinges are attached, was not deformed. The forward cargo door can rotate open 143 degrees before the hinge would deform, permitting the door to contact the fuselage above.

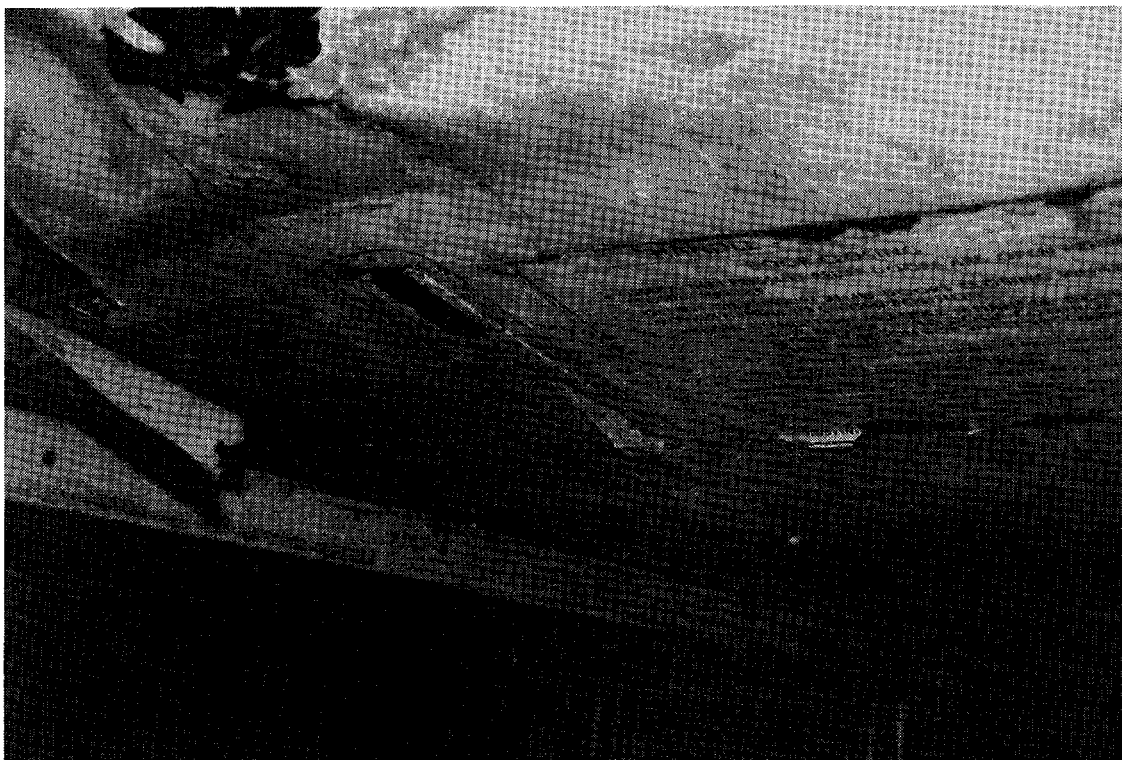
Figure 16.--Position of master latch lock handle.

The master latch lock handle housing and trigger were found relatively flush with the door outer skin. The top of the handle was recessed approximately 0.50 inch inward from flush, and the bottom of the handle was protruding approximately 0.40 inch outward from flush (See figure 16). This

position of the handle indicates that the lock sectors were in a position past fully locked. The fuse pin was found in three pieces but was heavily corroded. The handle housing was undamaged.

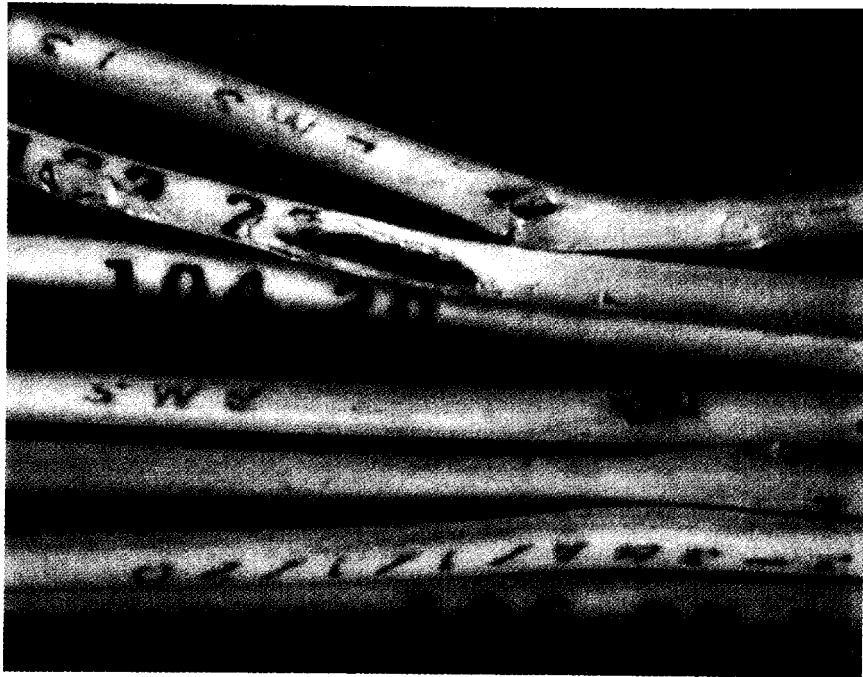
Figure 18.--Wires (from top to bottom) 101, 122, 104, 107, 110, 108, 105 at 3.8 inches from pin end (4X Magnification).

Seven wires numbered 101-20, 102-20, 105-20, 107-20, 108-20, 122-20, and 135-20 had visible damage located near a 3.8 inch position as measured from the P3 plug pin tips. This common position on the wire corresponds to a 360-degree loop in the wire bundle, which is located immediately below the junction box. Figures 18 and 19 show typical wire damage. Wire 122-20 had an open insulation area approximately 0.25 inch long. The other four wires had flattened insulation damage areas.
