REPORT ON THE ACCIDENT TO BAe 146-200A
OY-CRG AT POSITION 620351N 071626W, THE FAROE ISLANDS.

Operator: P/F Atlantic Airways, the Faroe Islands

Aircraft: *Type and model:* British Aerospace BAe 146-200A
 Nationality: Danish
 Registration: OY-CRG

Date and Time: 2 August 1989 at 1827 hours

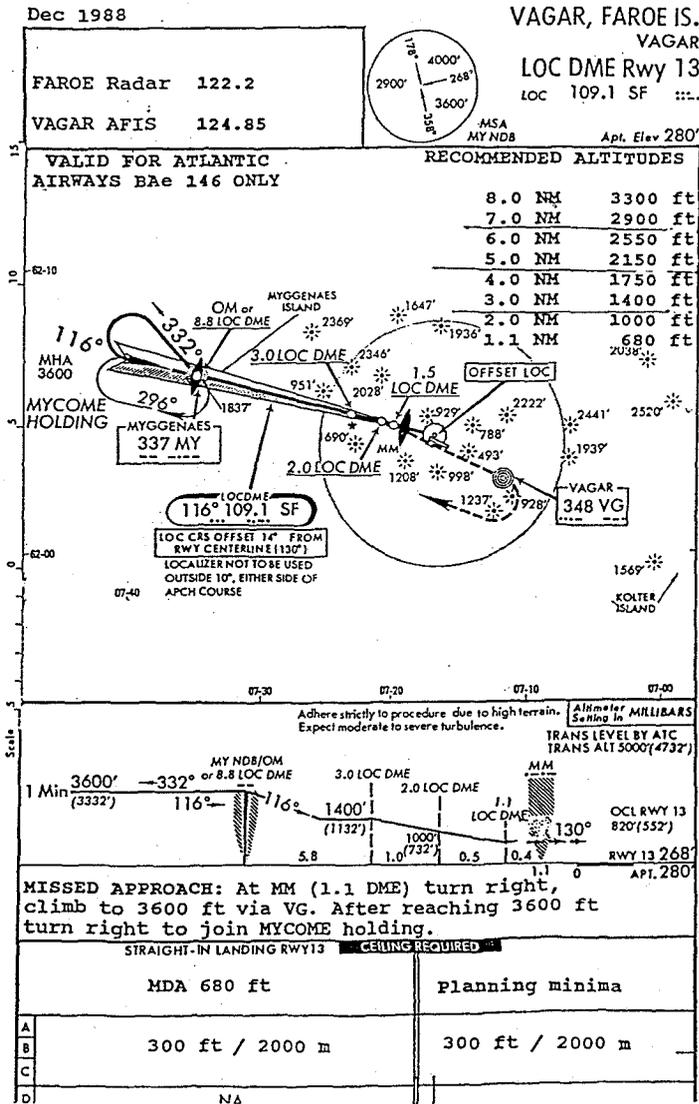
APPENDIX B

- 1.1.4 At 1823 hours the co-pilot reported "MY" (NDB) inbound (runway 13). As to the captain's statement a LLZ/DME approach (refer Appendix B) was carried out in accordance with company procedures and with the combined speed indicator (CSI) bug set at the recommended speed (V_{REF}) of 119 knots (+ 5 knots) corresponding to the aircraft mass. At 1.2 NM DME, or just before the minimum descent altitude (MDA) of 680 ft, the crew obtained visual contact with the runway lights and the approach was continued with reference to the lights and to the PAPI. During the final approach phase, the captain had his doubt about a possible overshoot of the marked touchdown zone (refer Appendix C); however, there was no doubt in his mind that the landing would be successful.

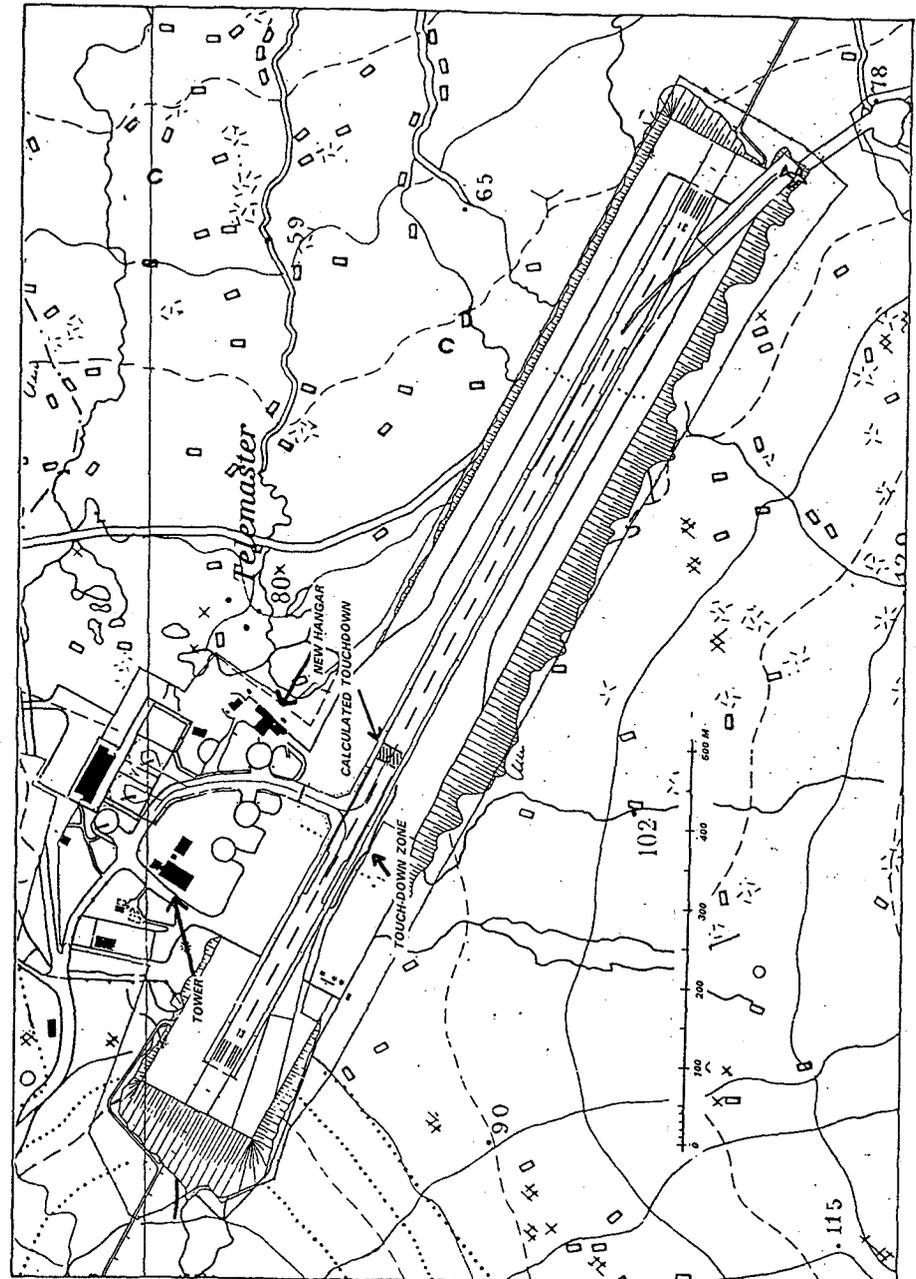
APPENDIX C

paragraph 1.10.2) and 45 metres beyond that area. One witness onboard the aircraft noted the touchdown point to be opposite the new hangar building (refer Appendix C).

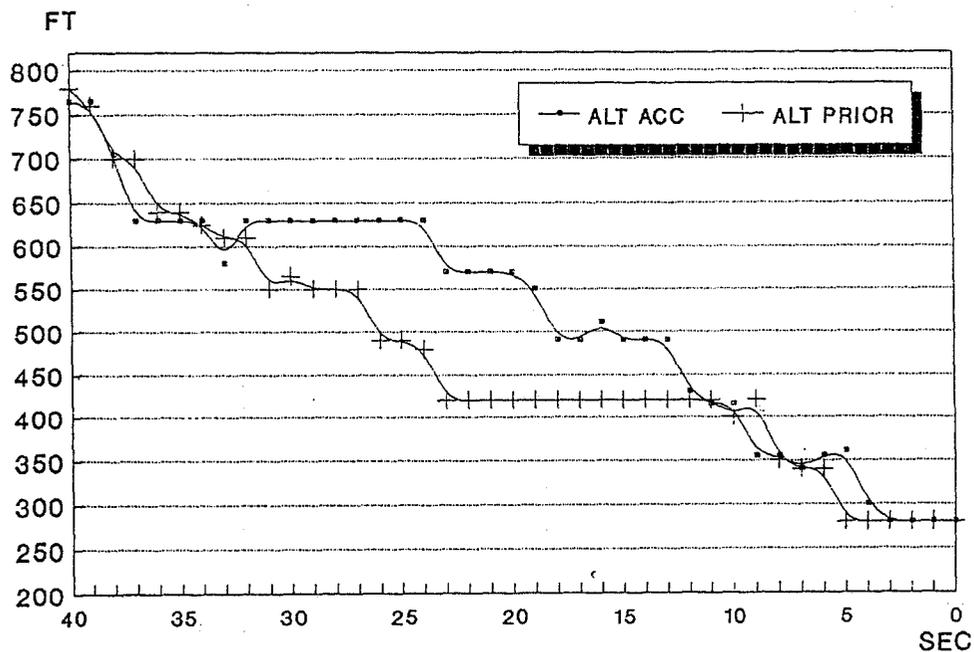
ALT BEFORE T/D ACC.FL.&PR.LND

- 1.11.2 Read outs of the last 40 seconds before touchdown and a read out from touchdown until the aircraft came to a full stop (both flights) are shown at Appendix D1-D3.
Before the events shown at Appendix A, the aircraft was established on the localizer to runway 13. The heading trace shows that the aircraft maintained a fairly constant heading during the approach and during the ground roll.
Calculations of the FDR data show that the aircraft touched down with a speed of 121.68 knots and that the lift spoilers were fully deployed at a maximum of 3 seconds after touchdown. 13-14 seconds after touchdown or after a landing roll of 587-624 metres, with a recorded speed of 74-70.9 knots, the aircraft commenced the right turn on to the high speed turn-off area.
