**THE AIRCRAFT ACCIDENT INVESTIGATION BOARD / NORWAY**

**HAV 02/93**

**REPORT ON THE CONVAIR 340/580 LN-PAA AIRCRAFT  
ACCIDENT NORTH OF HIRTSHALS, DENMARK, ON  
SEPTEMBER 8, 1989**

**SUBMITTED FEBRUARY 1993**

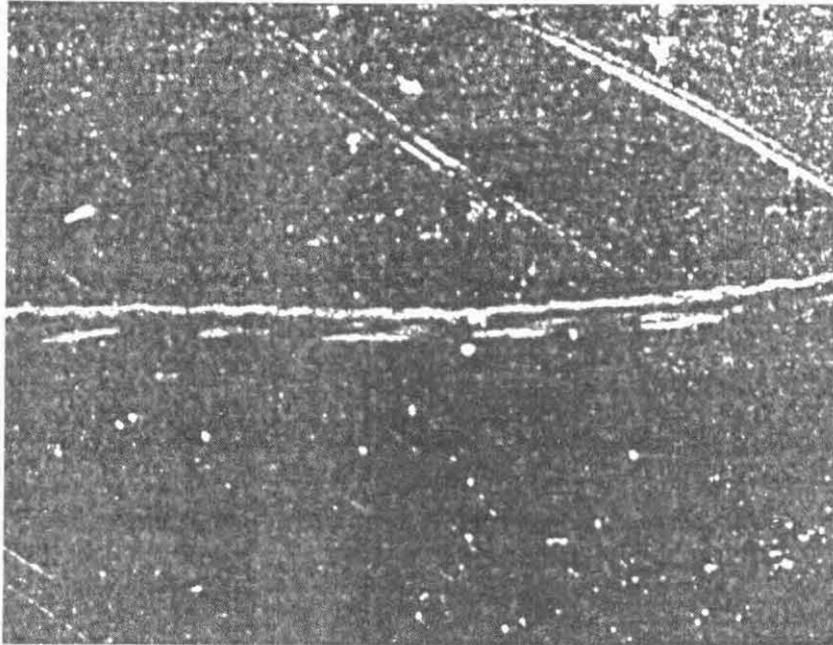
PHOTO 1 (FOTO) Typical double trace due to stylus resonance causing multiple alternative knife edge indentations on altitude parameter of Flight #2. Photo magnified 32 X.

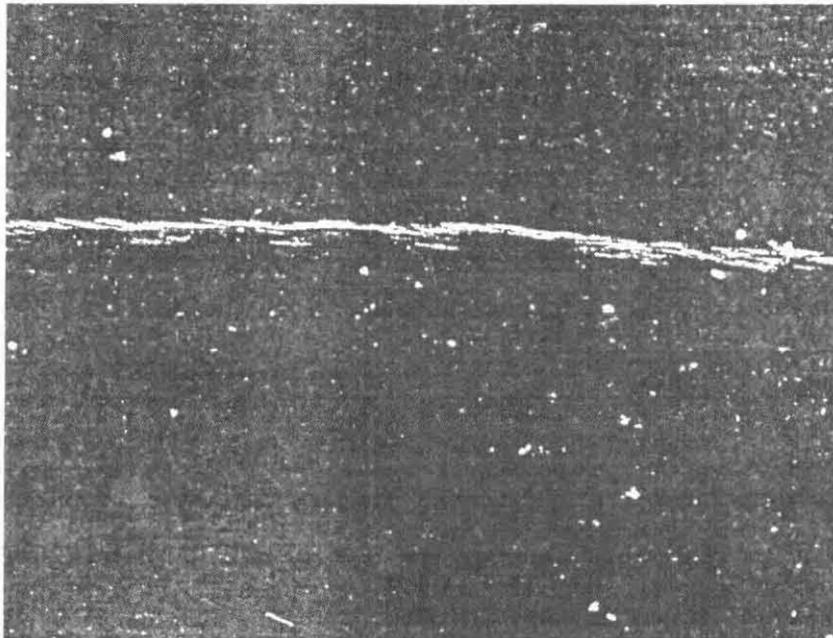
PHOTO 2 (FOTO) Typical double trace due to resonance on altitude parameter of Flight #16. Photo magnified 32 X.

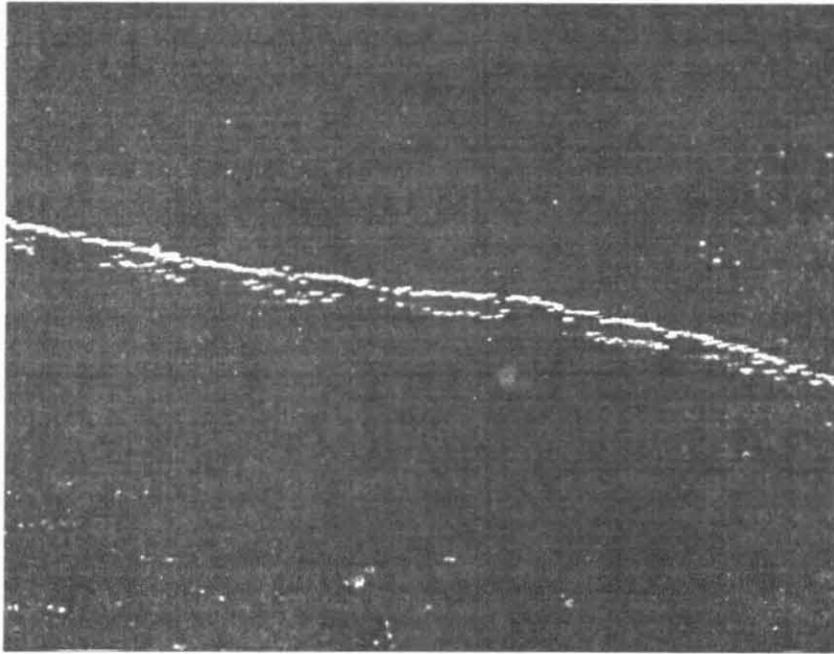
PHOTO 3 Typical double trace due to resonance on altitude parameter of (FOTO) Flight #28. Photo magnified 32 X.

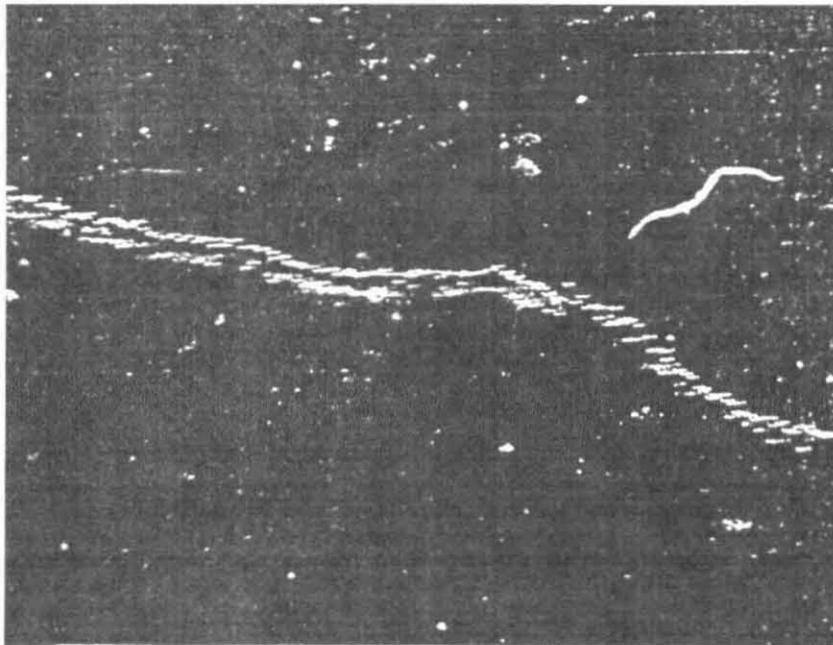
PHOTO 4 Typical double trace due to resonance on altitude parameter of the (FOTO) accident Flight #33. Photo magnified 32 X.

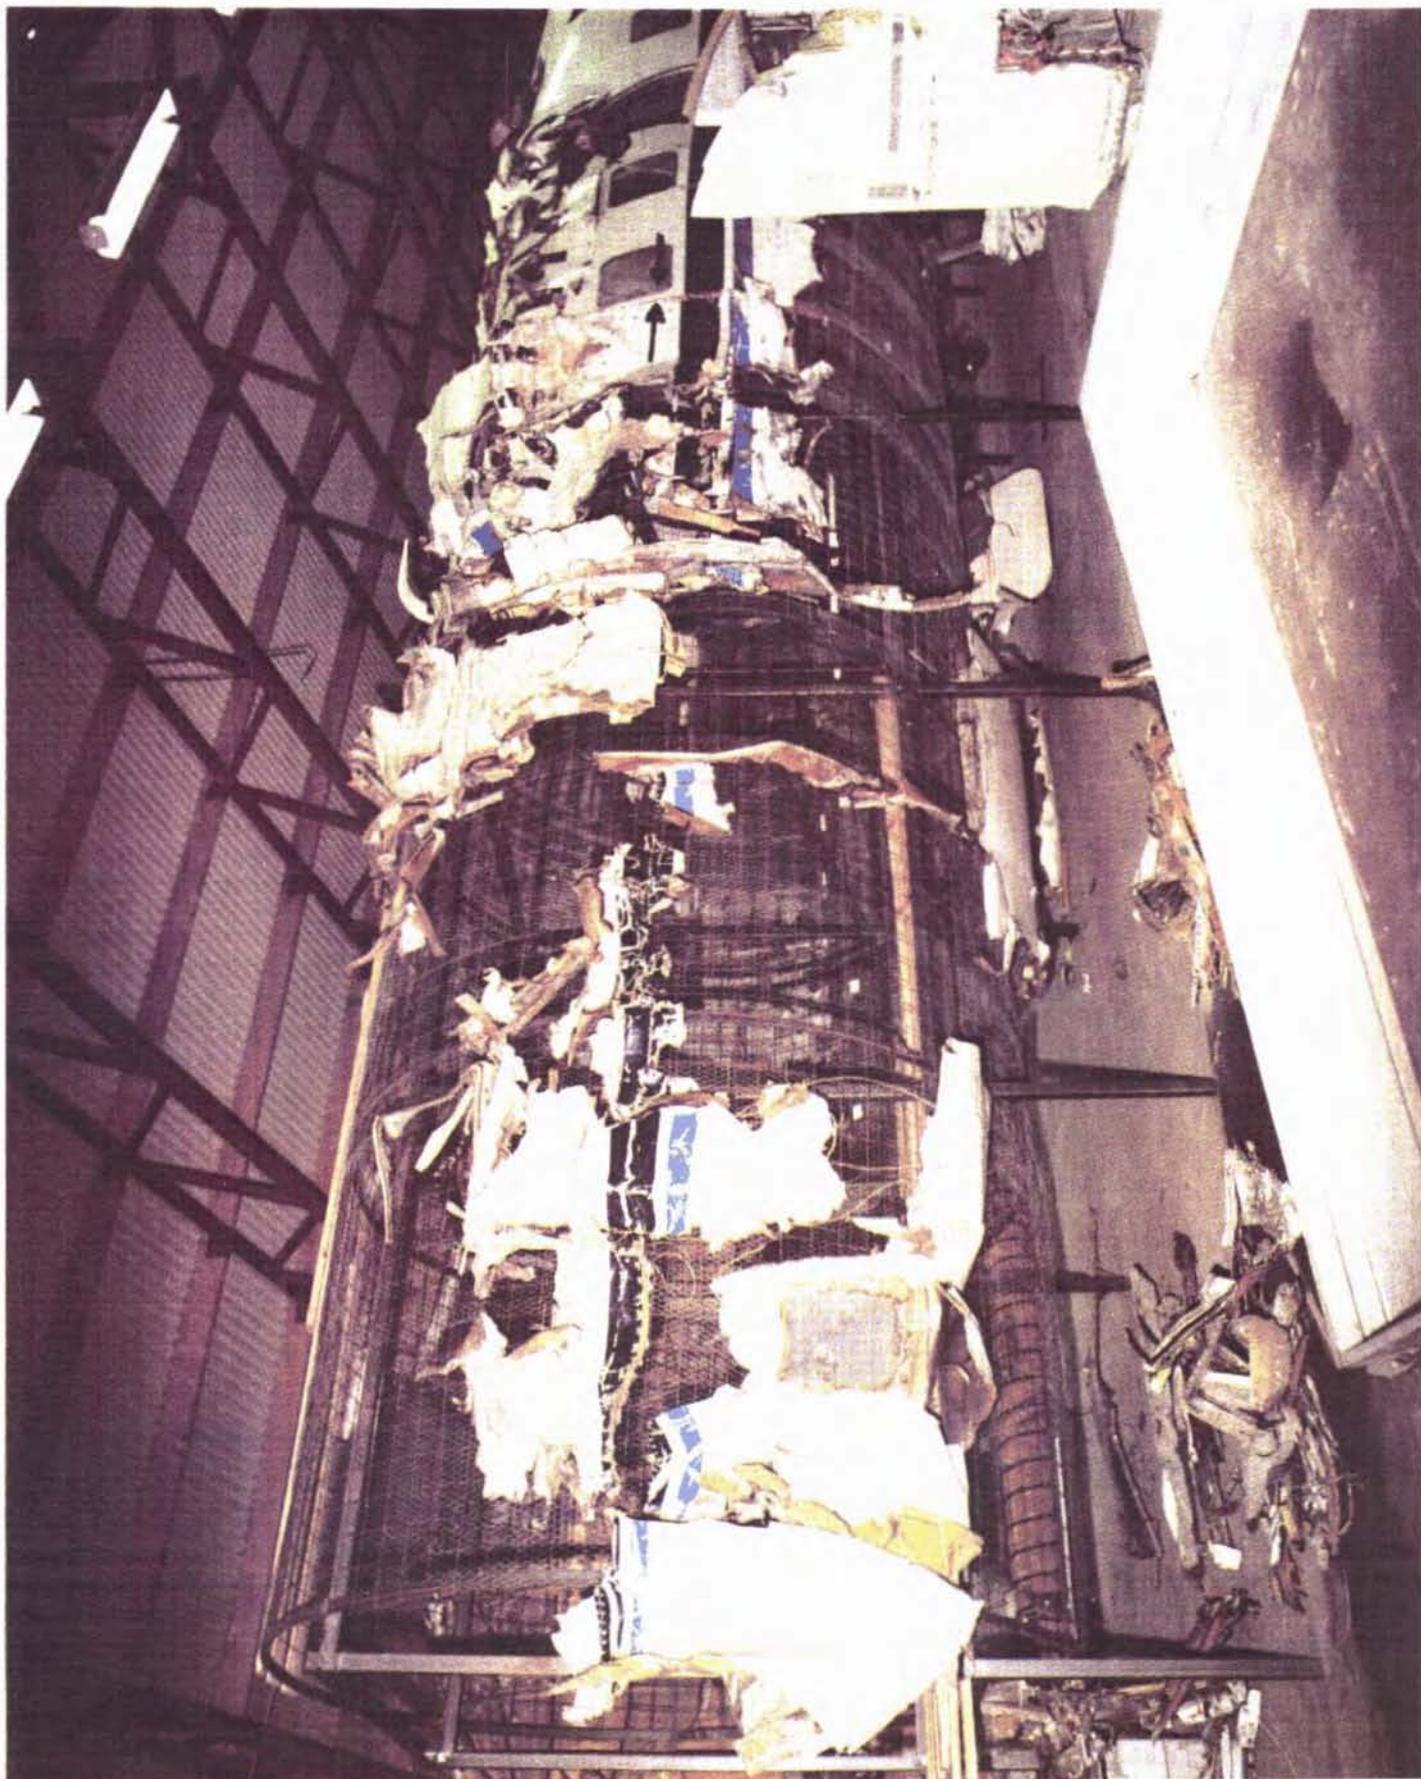
PHOTO (FOTO) 5A

The most extensive damage to the fuselage was to the forward left side. Practically the entire construction of this part of the fuselage broke up into small pieces in a

FORWARD, LEFT SIDE OF THE FUSELAGE  
ARROWS POINT AT STA 261  
(VENSTRE SIDE AV SKROGET, FREMRE DEL  
PILENE VISER STA 261)

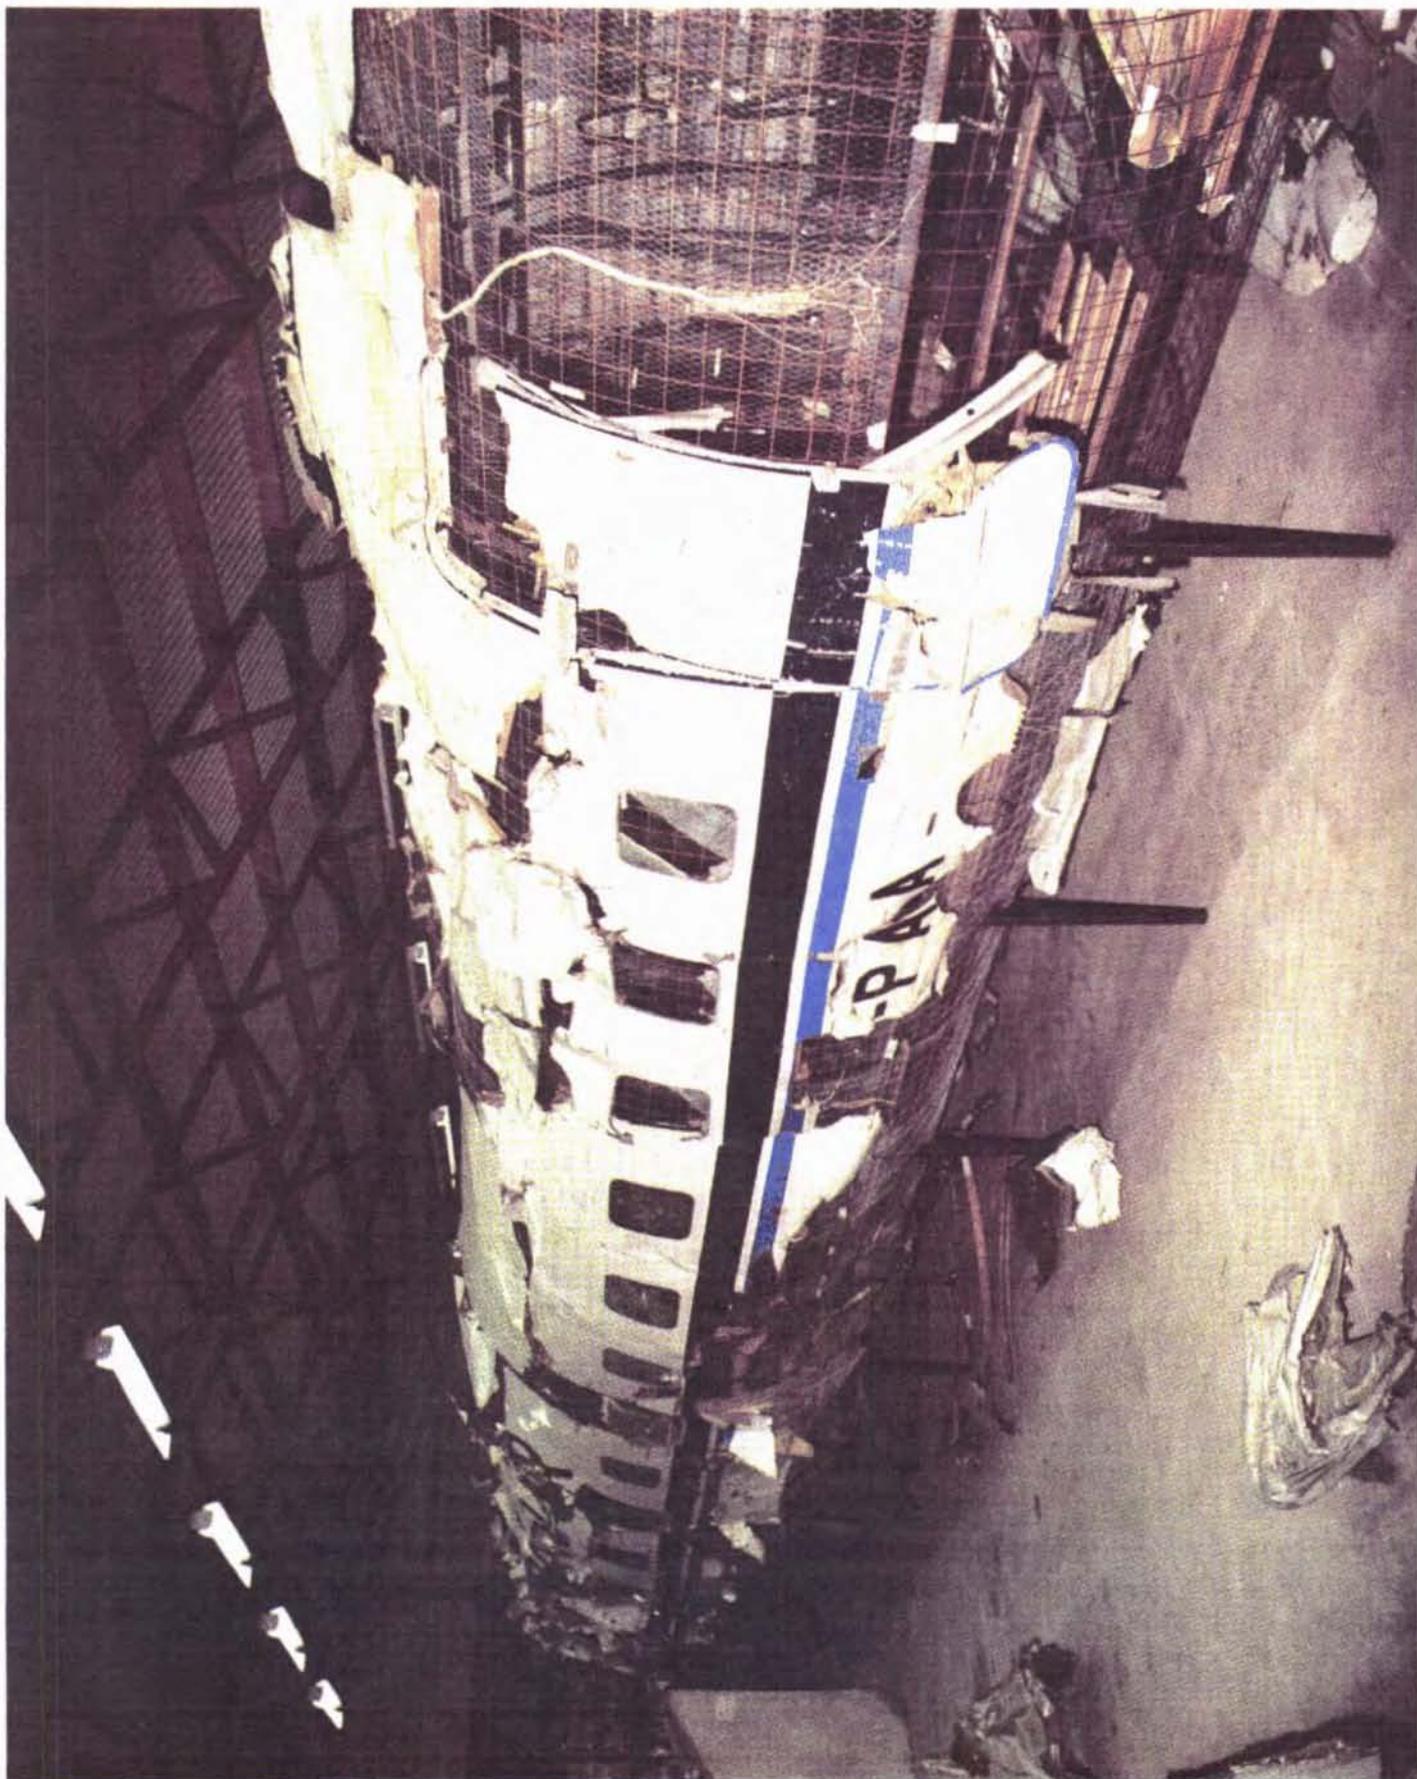
PHOTO (FOTO) 5B

AFT, LEFT SIDE OF THE FUSELAGE  
(VENSTRE SIDE AV SKROGET, BAKRE DEL)

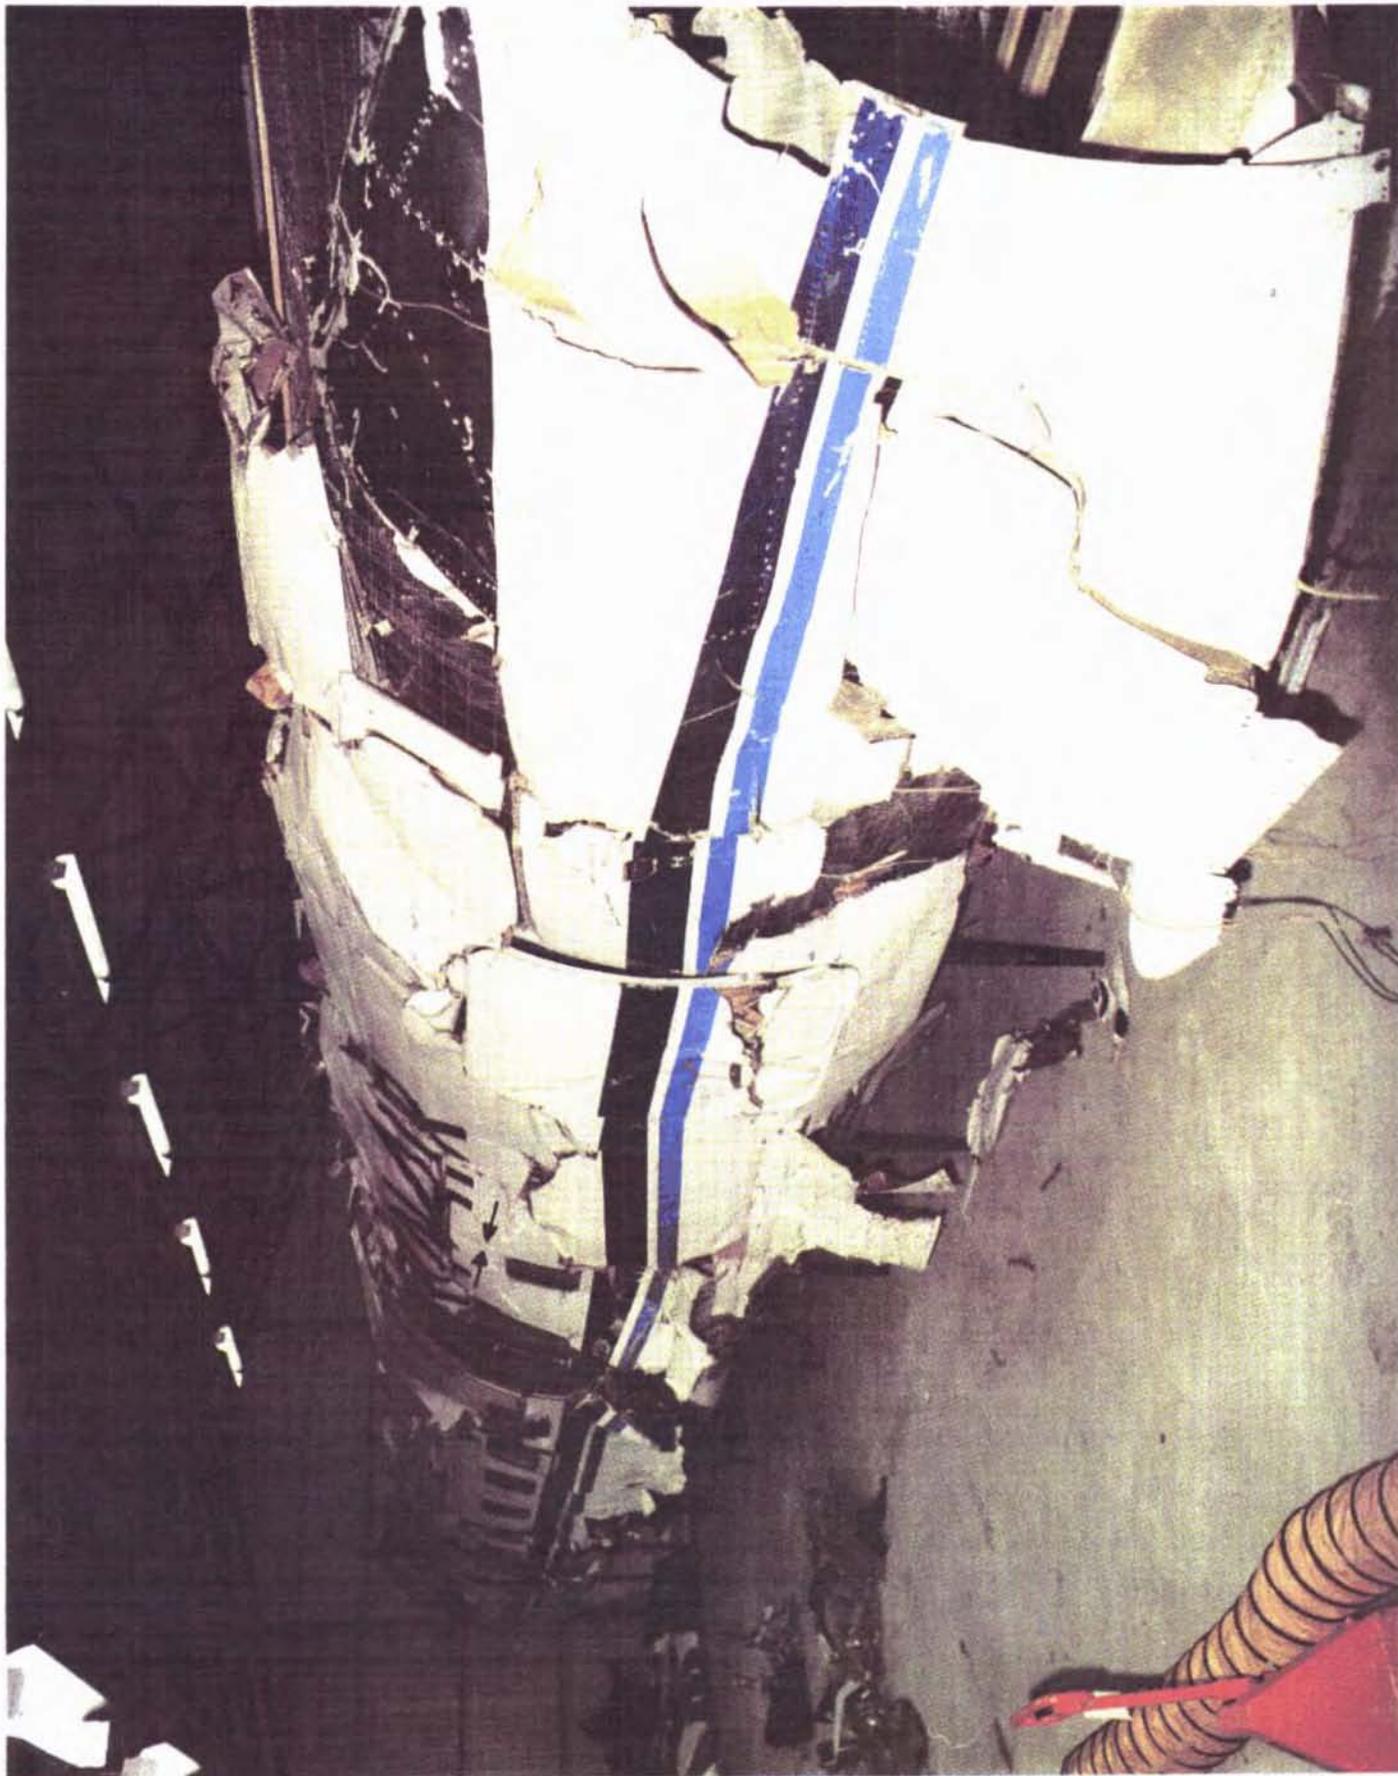
PHOTO (FOTO) 6

FORWARD, RIGHT SIDE OF THE FUSELAGE  
ARROWS POINT AT STA 261  
(HØYRE SIDE AV SKROGET  
PILENE VISER STA 261)

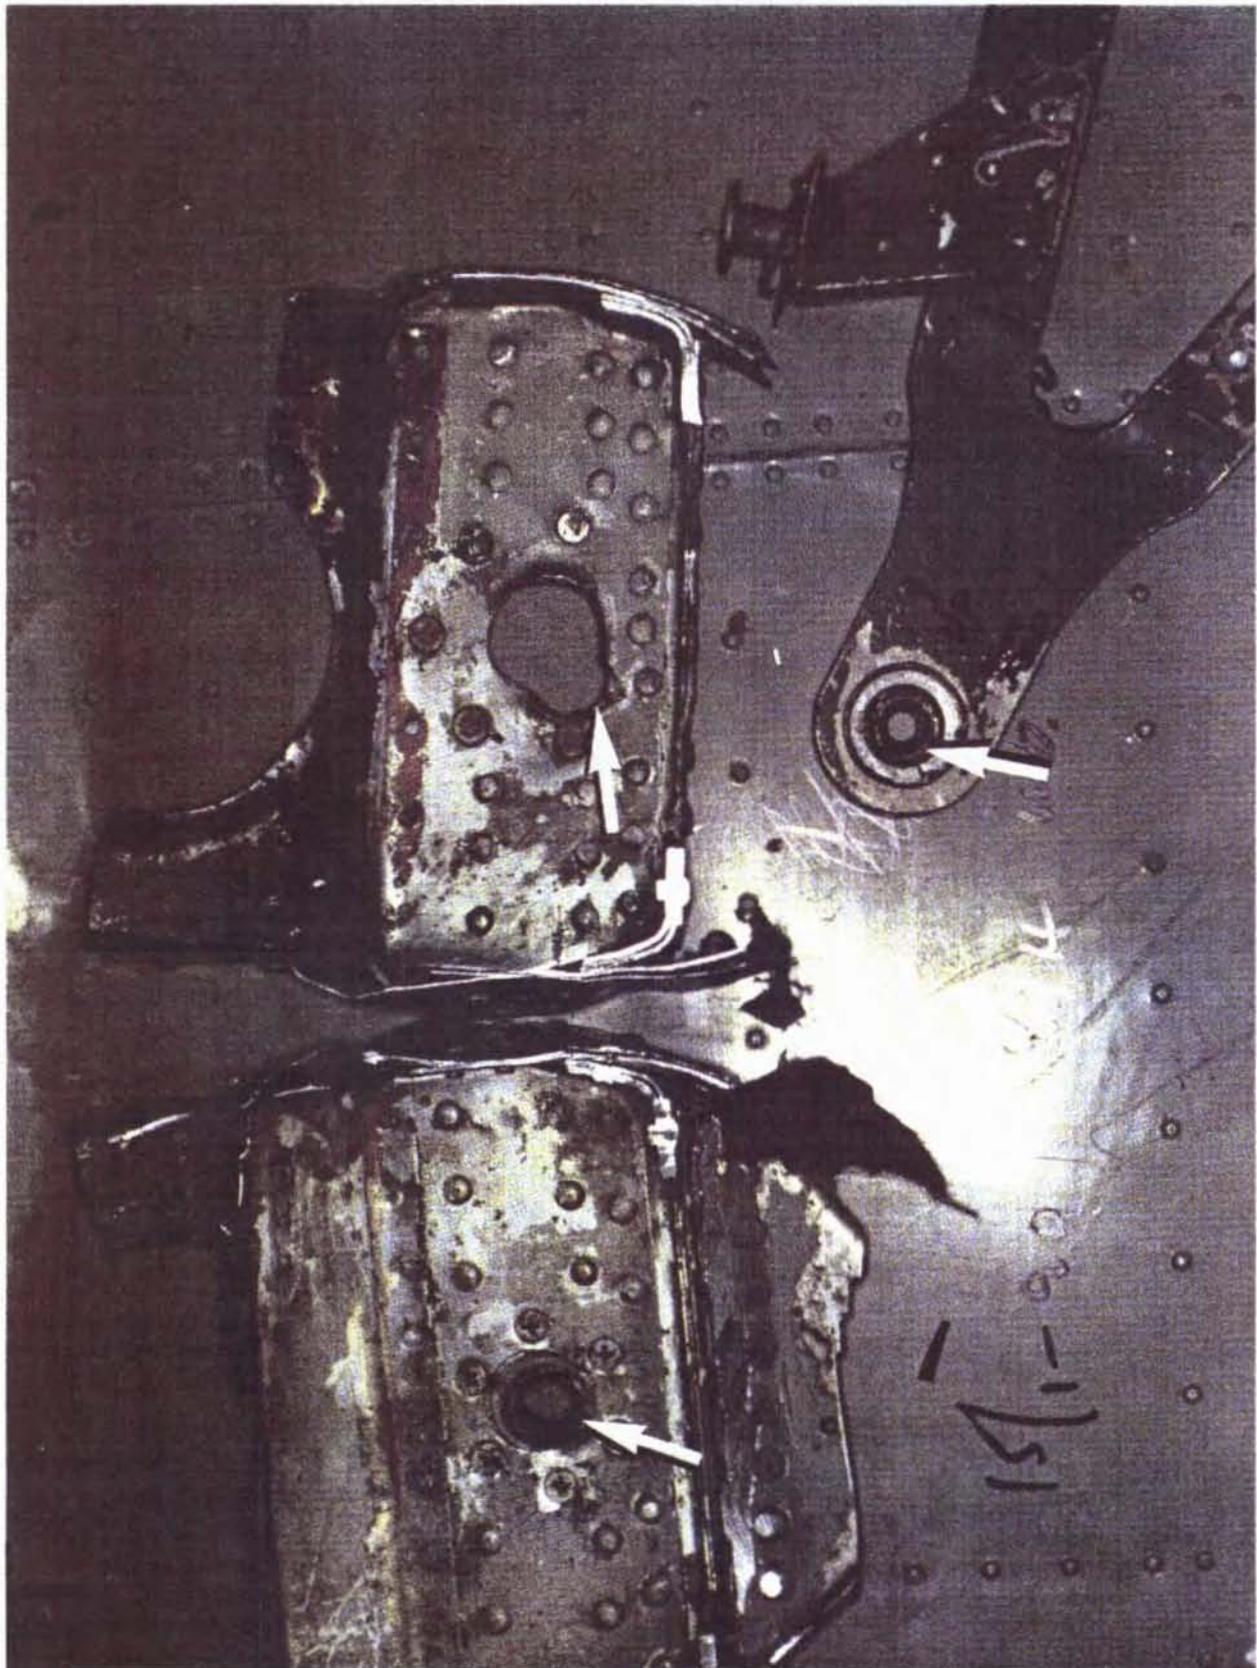
Technical investigations revealed that the inner right-hand elevator hinge was severely damaged. The hinge pin was not found. The anchor nut the pin had been screwed into was torn off in such a way that the threaded portion had disappeared with the pin. The hinge bracket was examined in detail at the Veritec laboratory. There were signs that the bracket had been exposed to strong vibrations in both holes since the hinge pin bushing holes were severely deformed. The material had been substantially compressed in such a way that the holes had changed to an oval shape towards the end of the deformation process (See photo 11).

PHOTO 11 Right elevator inner hinge assembly. Note severe wear and (FOTO) pounding effects on bearing plates and hinge arm (arrows).

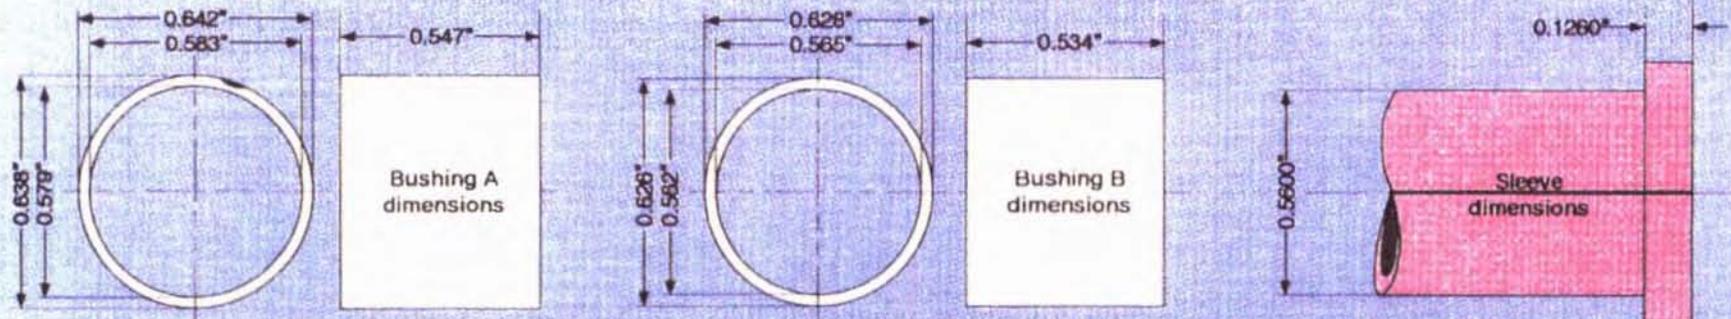
A check carried out on the bushings installed in the aluminum lugs on the rear right-hand attachment bracket showed a considerable discrepancy between the dimensions in the front and rear bushings. The difference between the outer diameters was approximately 0.013 inches while the difference between the inner diameters was approximately 0.018 inches (figure 4). In the production of these bushings the maximum allowable deviation is 0.001 inches.

MEASURED DIMENSIONS OF THE AFT RIGHT VERTICAL STABILIZER ATTACHMENT BUSHINGS AND SLEEVE FROM LN-PAA

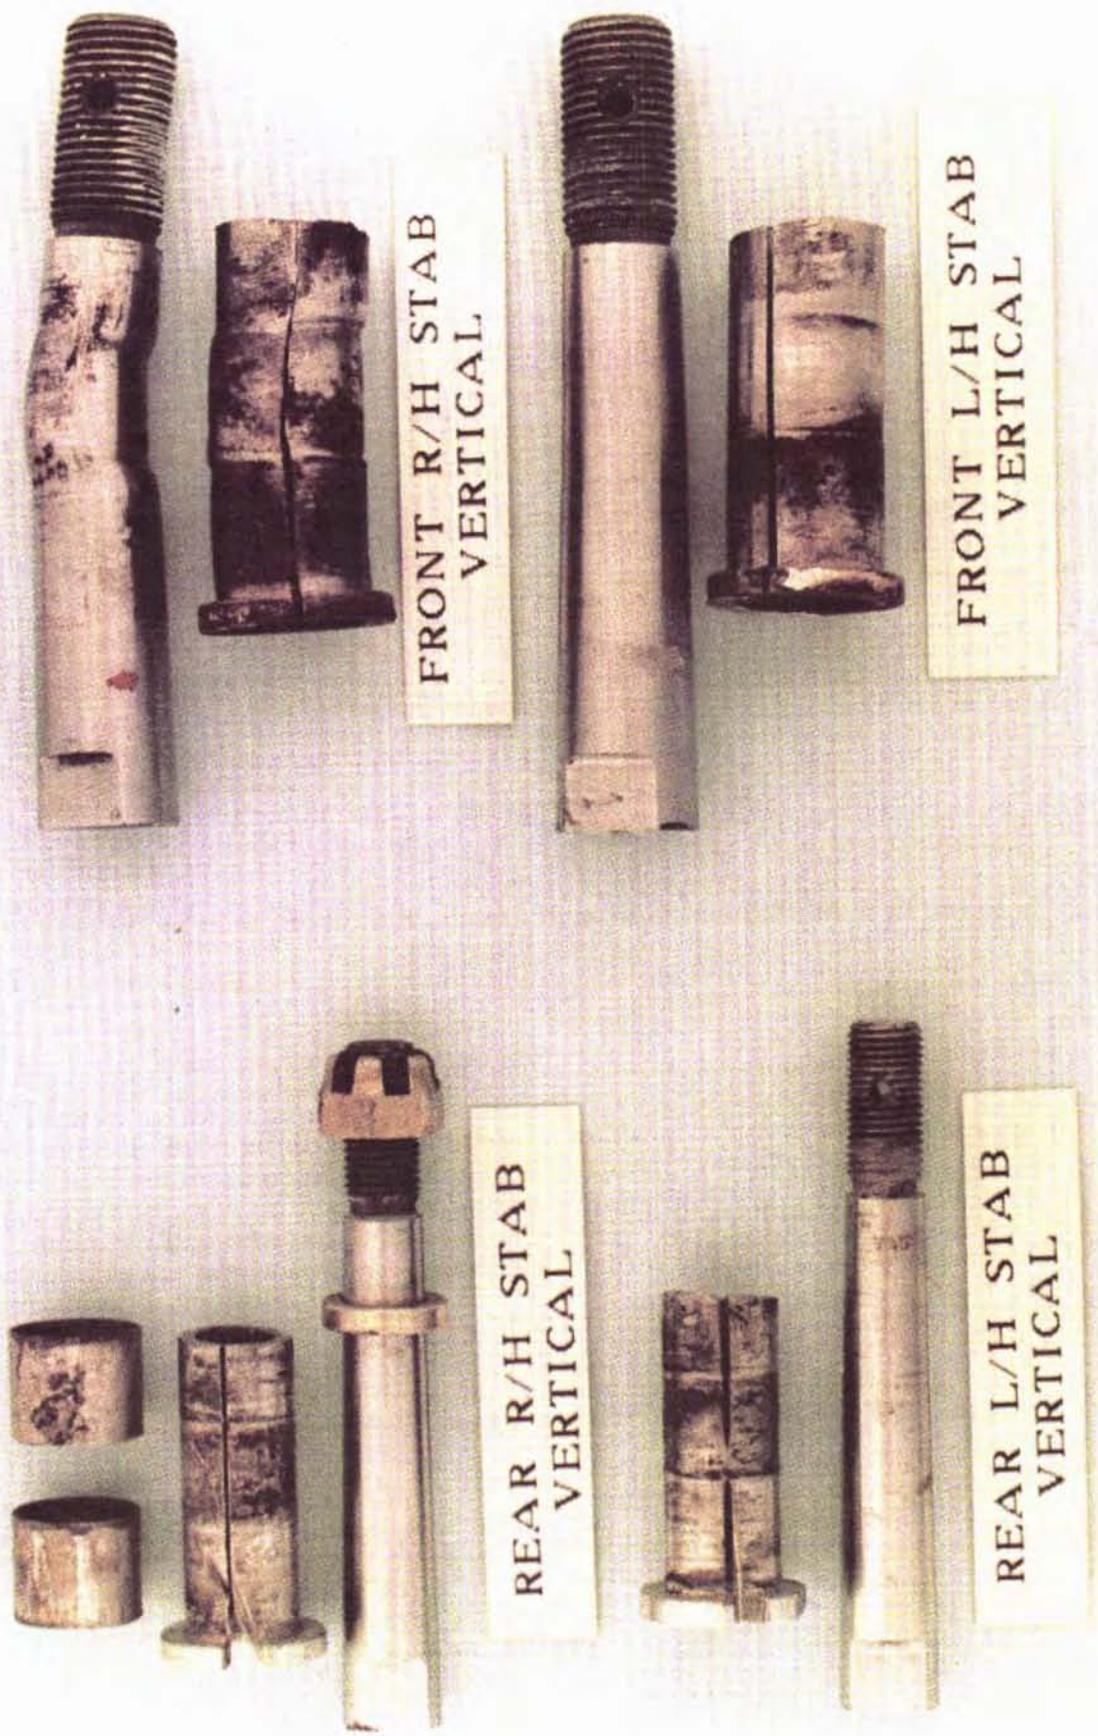
PHOTO (FOTO) 12

Later examinations by AIR also revealed that the two front attachment pins, as well as their respective sleeves, did not satisfy the specifications. The hardness was between 200 and 230 (HV5). A hardness of 200 - 230 corresponds to a tensile strength of approximately 100,000 psi. Convair's specification for hardness corresponds to a tensile strength of 160,000 to 180,000 psi.

SHEAR PINS, SLEEVES AND BUSHINGS FROM LN-PAA FOR VERTICAL STABILIZER ATTACHMENT (BOLTER, HYLSE OG FORINGER FRA LN-PAA FOR FESTE AV VERTILKALFINNEN TIL SKROGET)

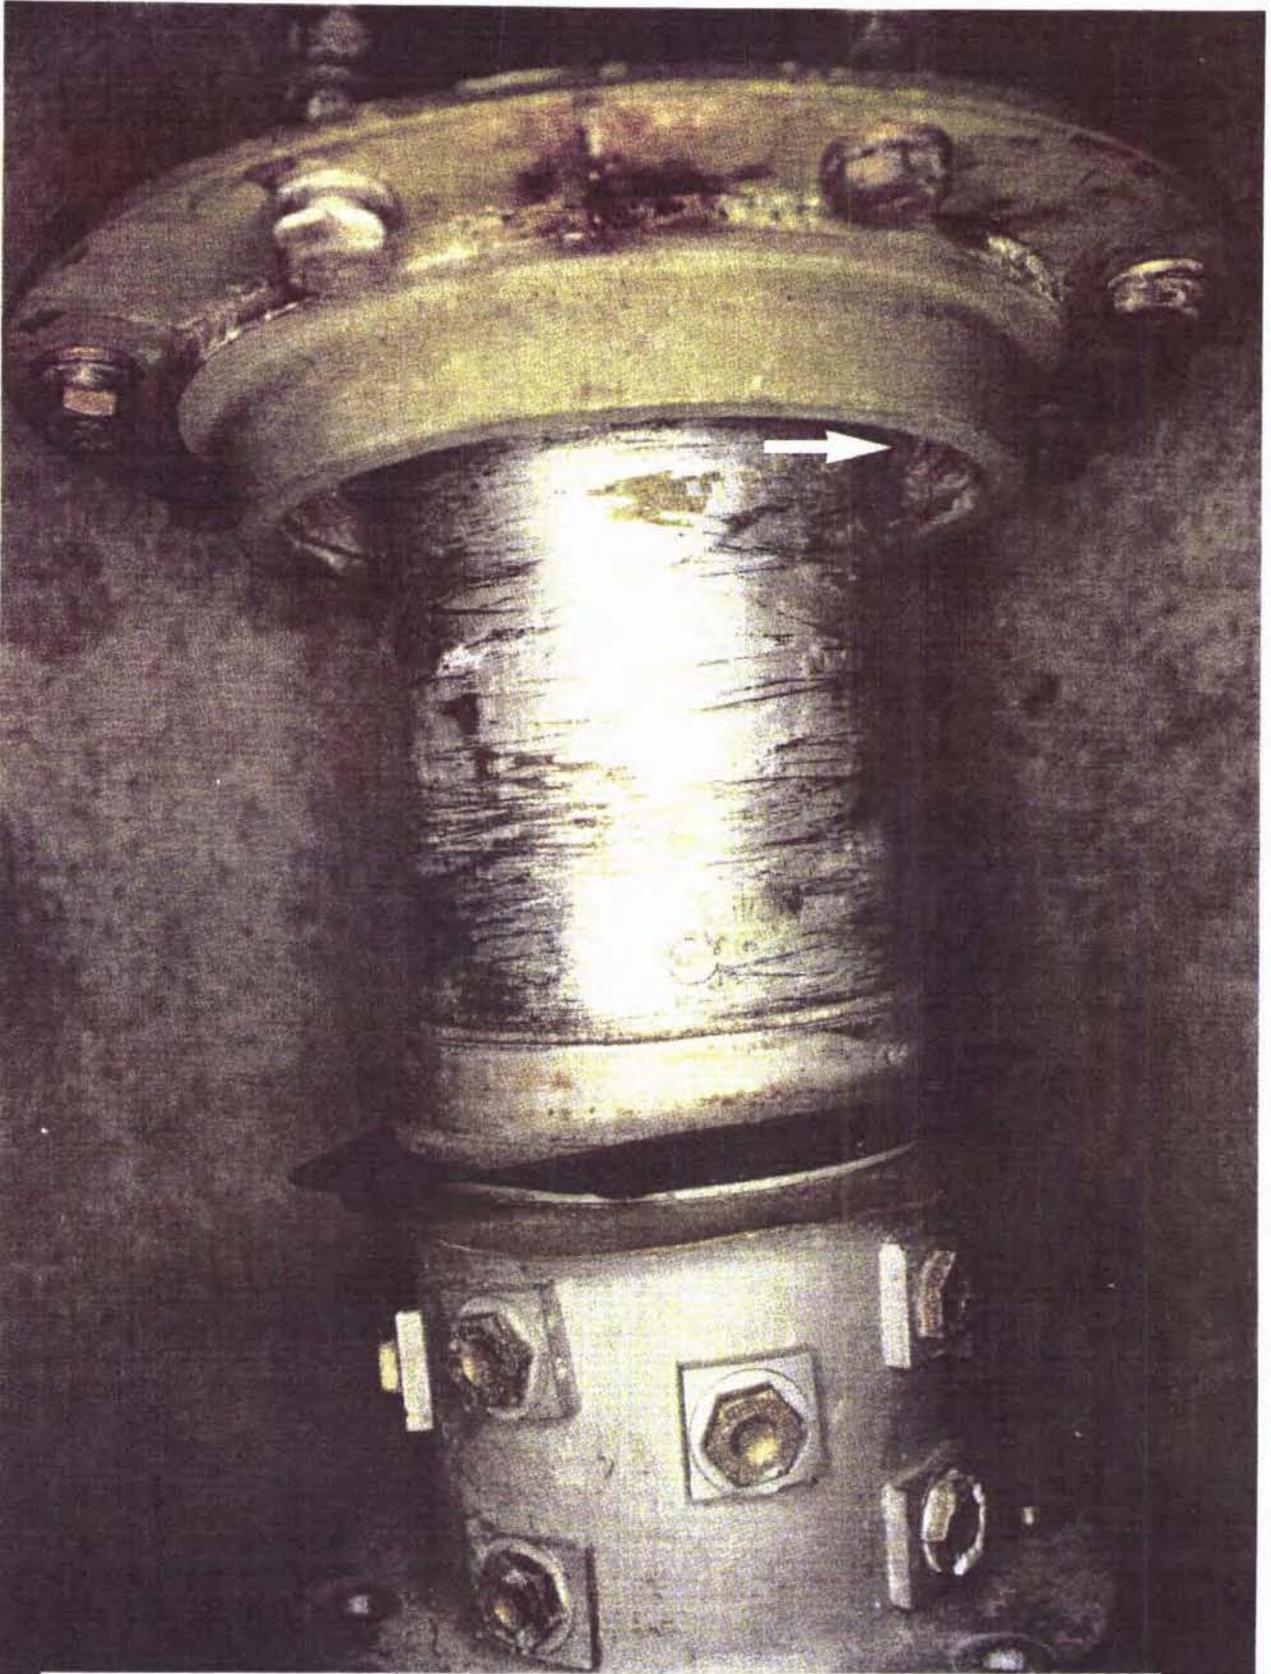
PHOTO 13 Fully displaced (outboard) retainer collar reveals 3" zone of severe scoring on torque tube. The scoring was caused by abnormal rotation of the retainer collar inner land (arrow) against the tube.

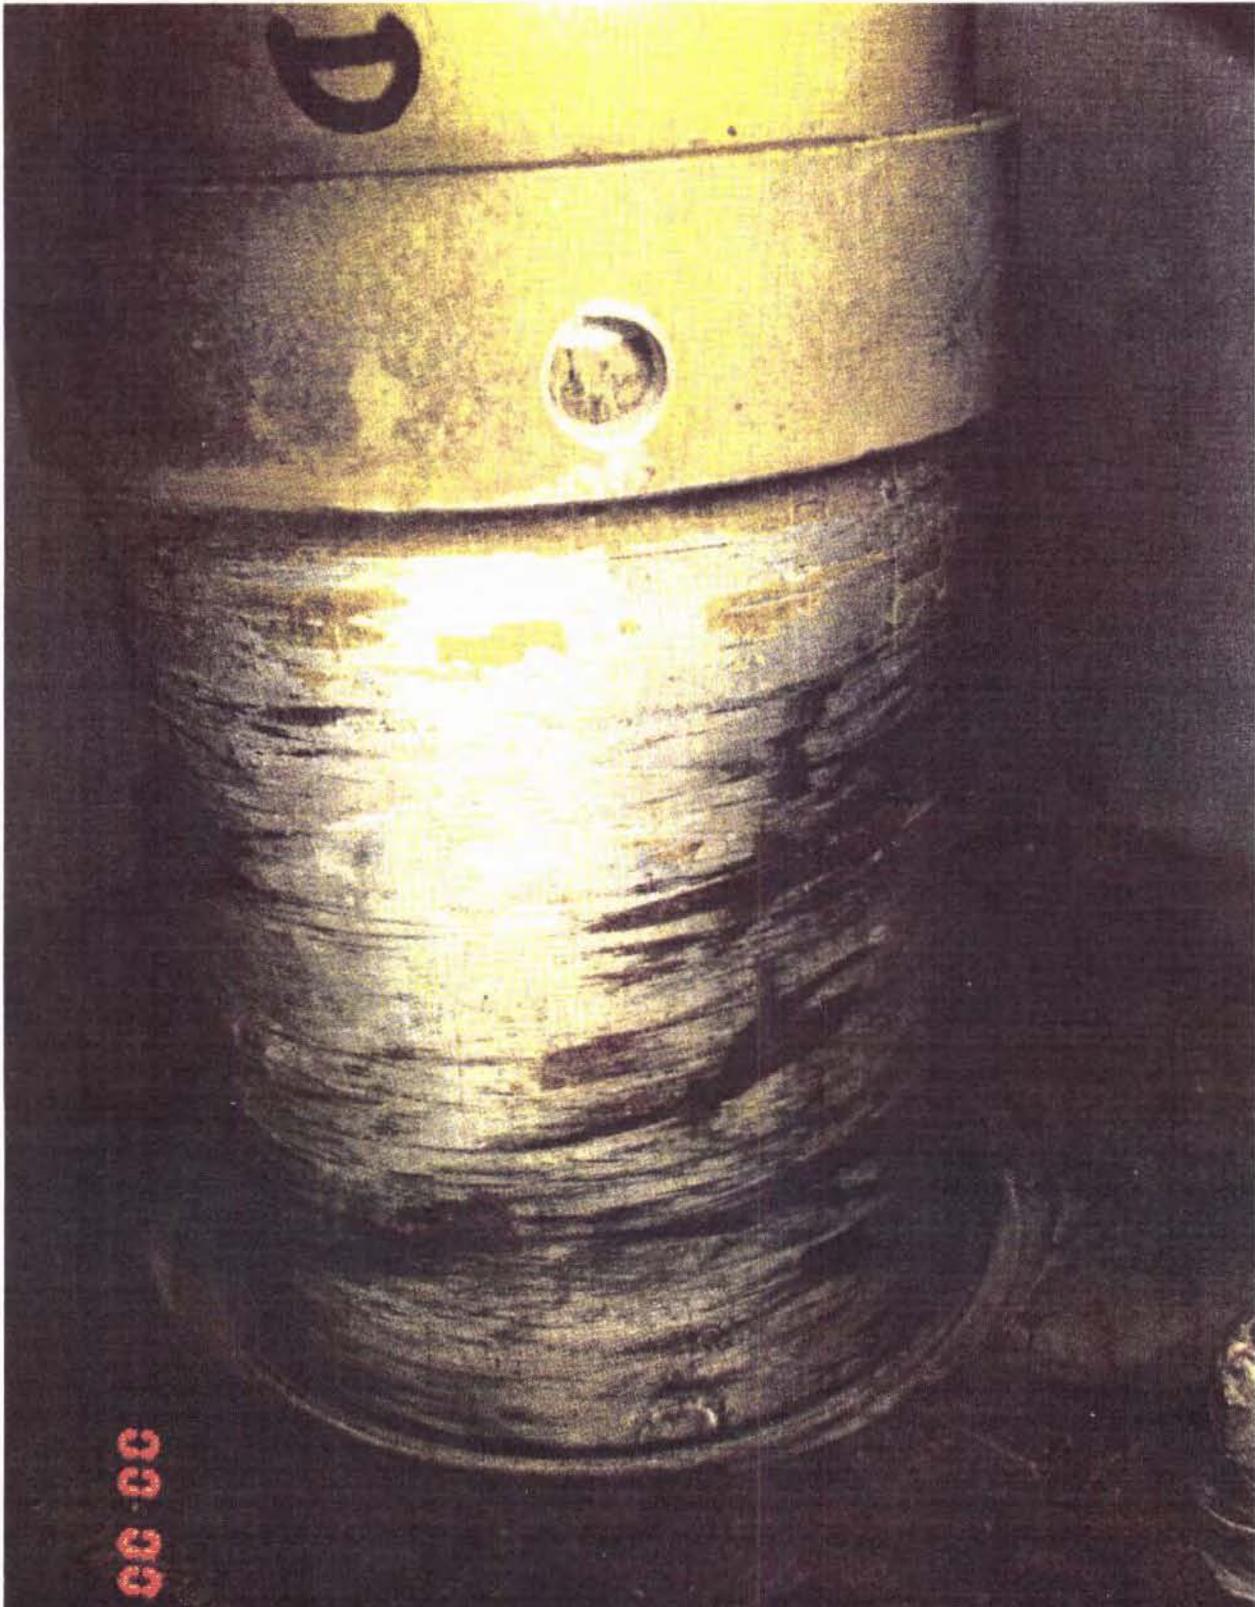
PHOTO 14 (FOTO) Clearly exhibits the extensive scoring. Note the circumferential length and angles of the score marks well in excess of the normal 35° of elevator travel. Some marks are up to 90° of the circumference.

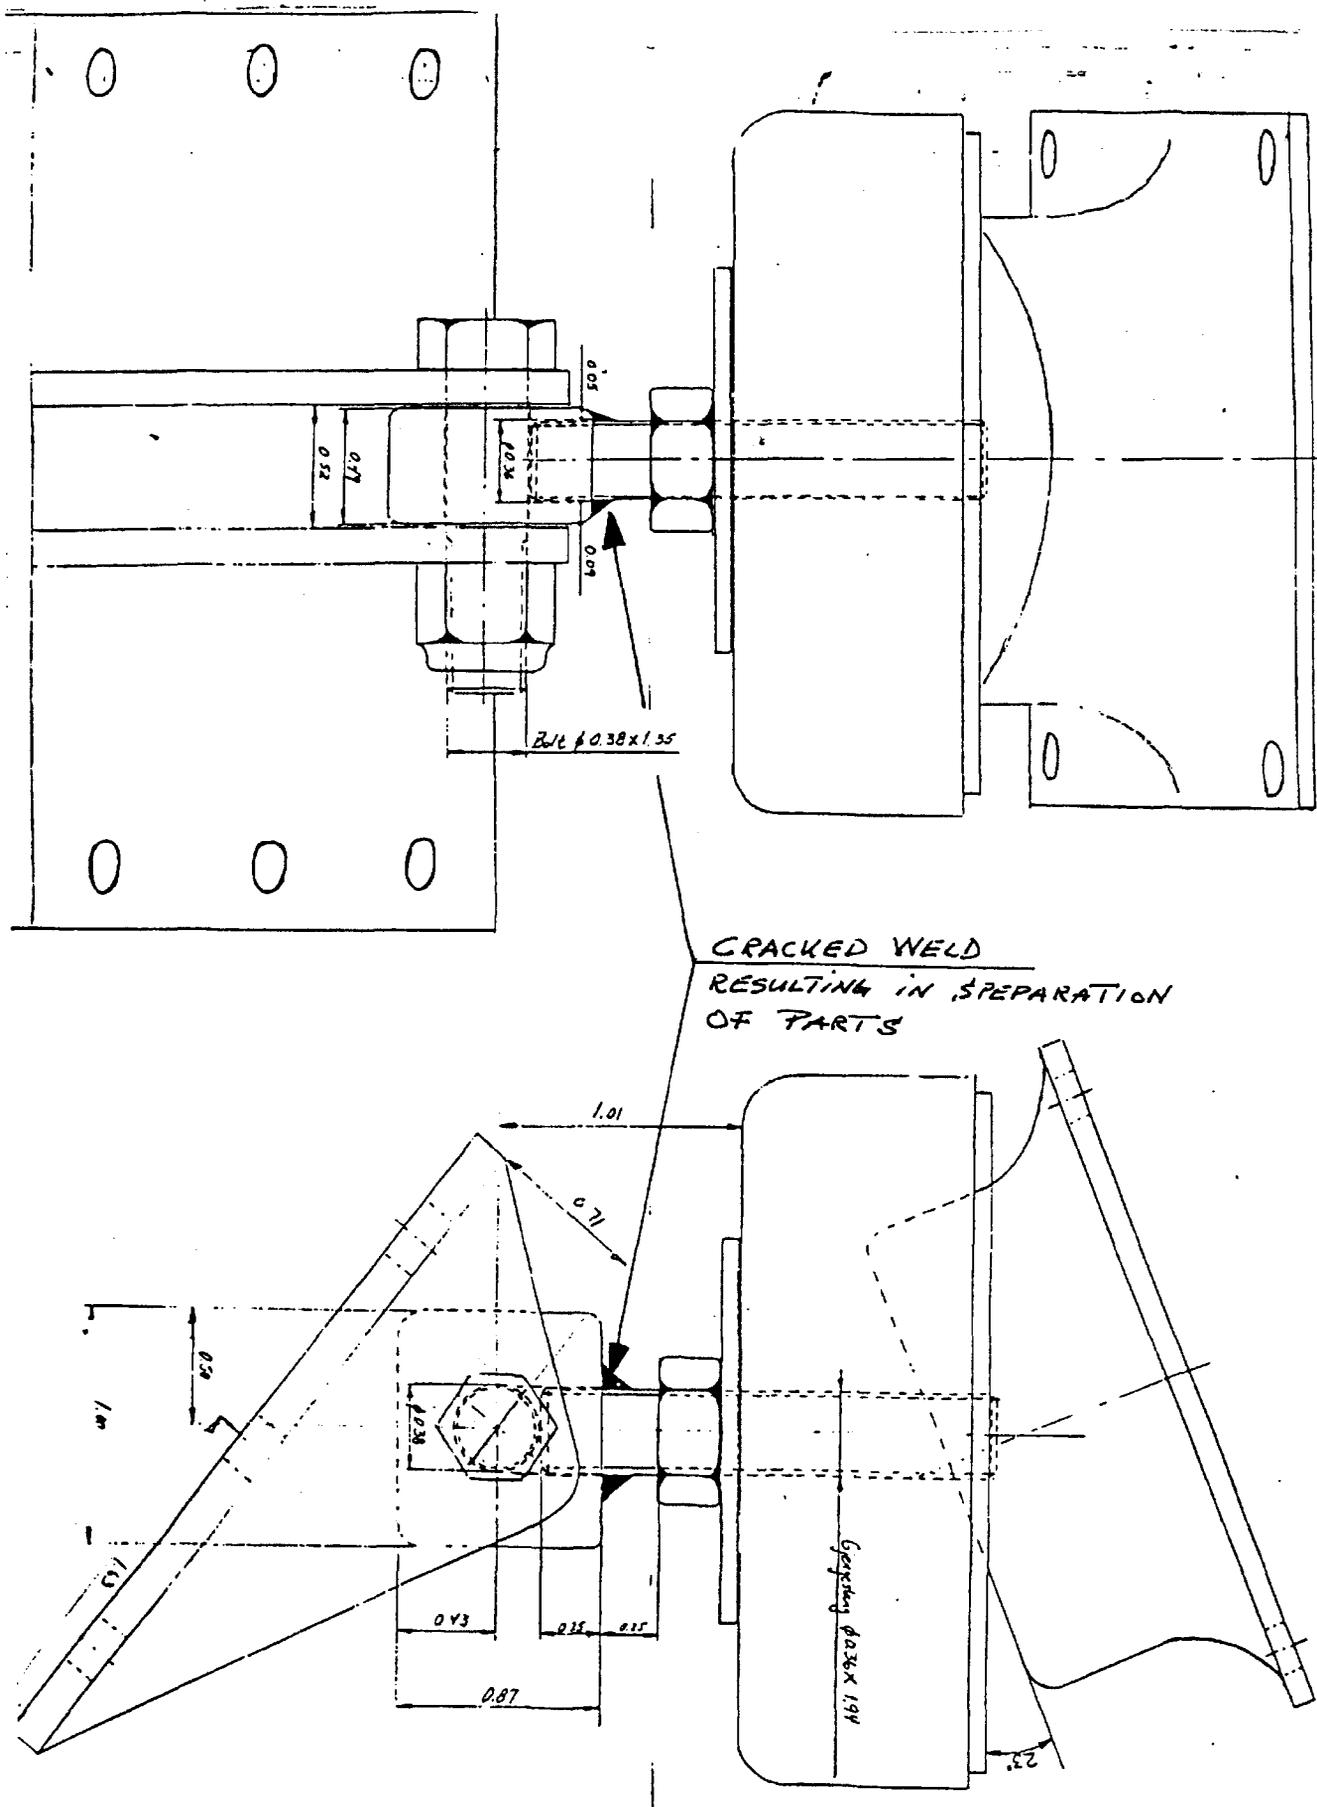
**FIG. 5**

1.16.6.2 The APU had a total of four attachments to the aircraft structure. The two main supports were intact. The other two were fractured. Metallurgical examinations revealed that the rear support had failed in overload while the front support showed signs of fatigue failure. The front support was of a design and manufacture which did not conform to the manufacturer's specifications. The support end fitting, which is normally a rod end with an internal spherical bearing, had been replaced by a locally-manufactured design. This consisted of a square piece of iron and a threaded rod which had been welded together (figure 5). The quality of the welding was poor and the wrong type of material had been used. The fatigue fracture was caused by a fault in the welding. The method used to make the support and the choice of material did not conform to the standards used in aircraft parts. The support had signs of repeated loads having been applied to it after the fracture took place (photos 15 and 16).

**FORWARD MOUNT FOR THE APU (AS FOUND)  
 FREMRE MONTERINGSFESTE FOR APU (SOM FUNNET)**
