**THE AIRCRAFT ACCIDENT INVESTIGATION BOARD / NORWAY**

**HAV 02/93**

**REPORT ON THE CONVAIR 340/580 LN-PAA AIRCRAFT  
ACCIDENT NORTH OF HIRTSHALS, DENMARK, ON  
SEPTEMBER 8, 1989**

**SUBMITTED FEBRUARY 1993**

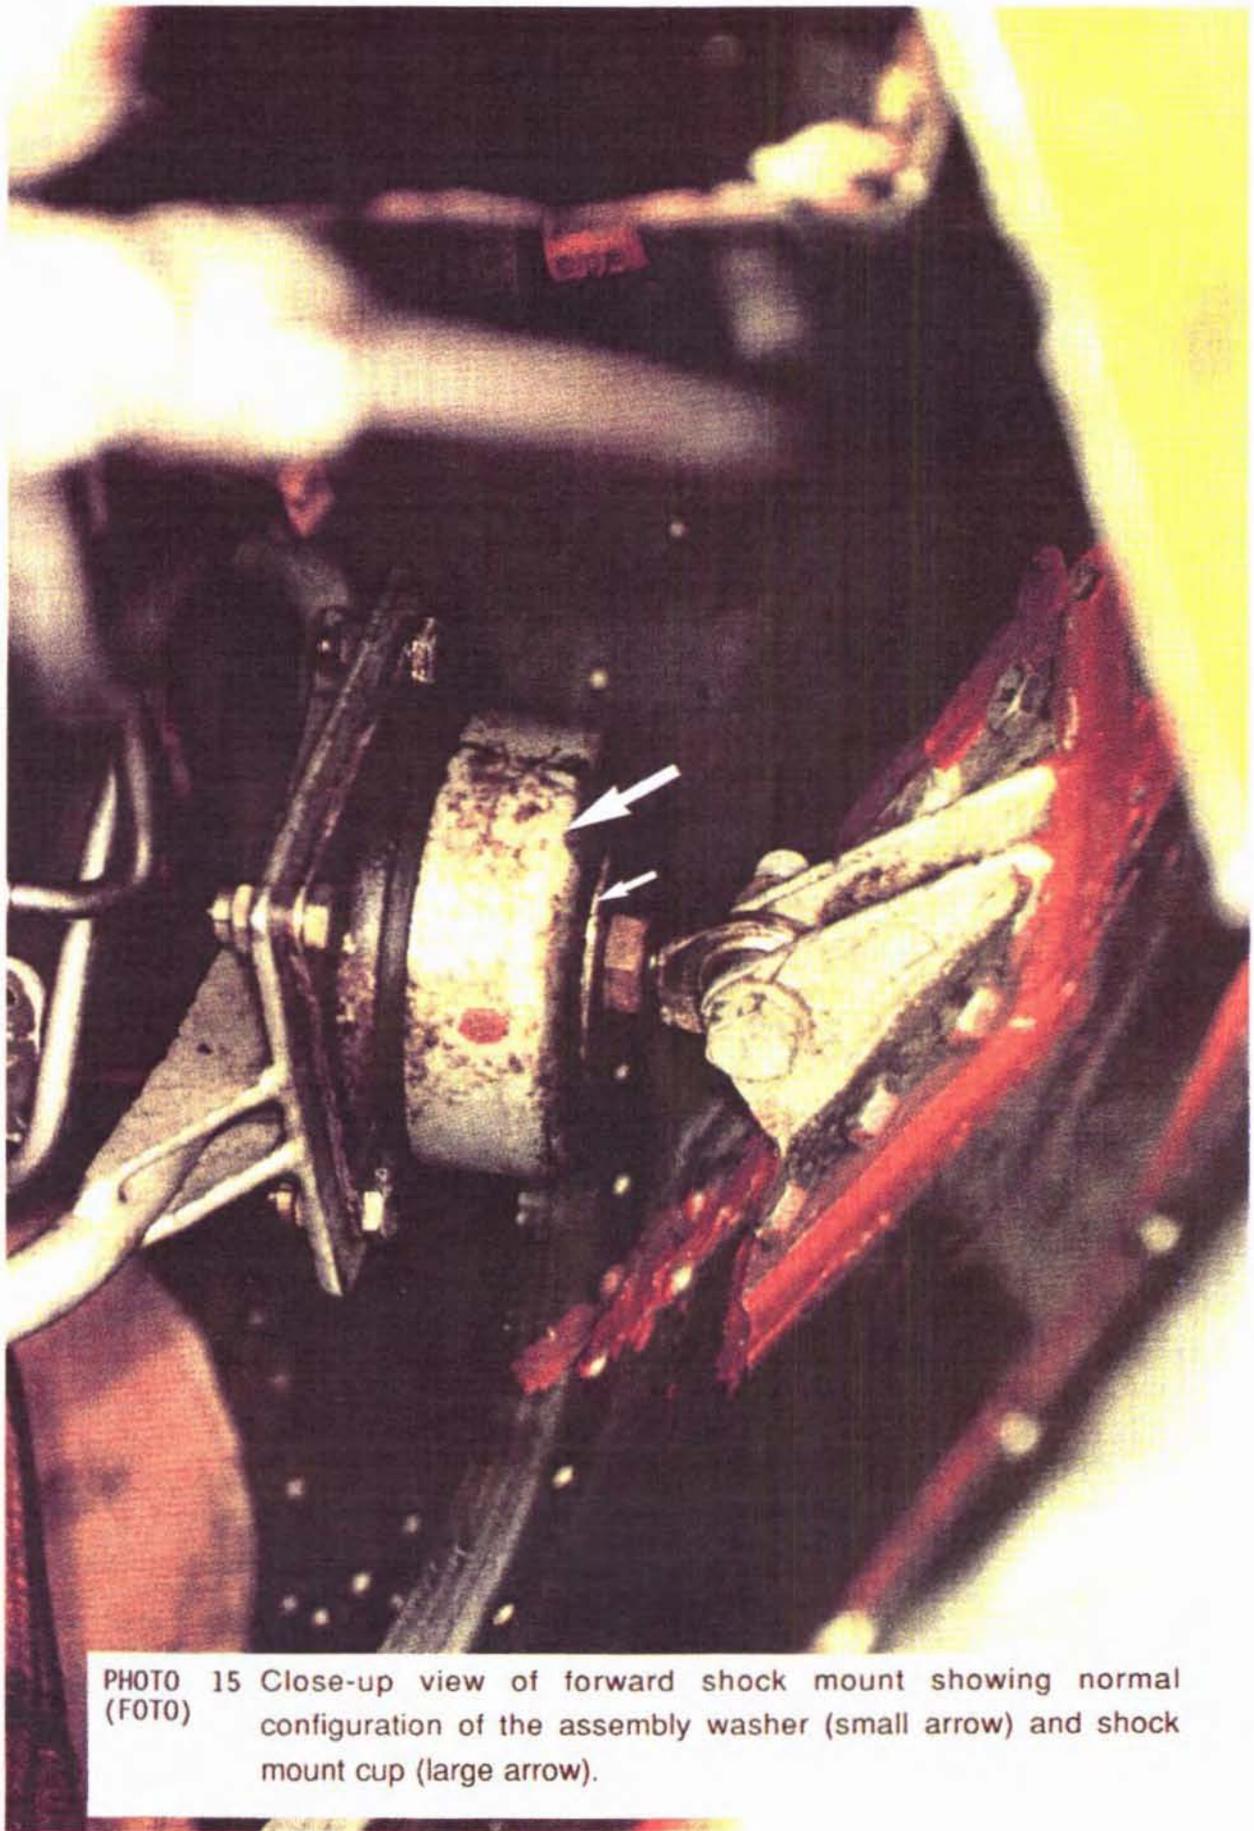
1.16.6.2 The APU had a total of four attachments to the aircraft structure. The two main supports were intact. The other two were fractured. Metallurgical examinations revealed that the rear support had failed in overload while the front support showed signs of fatigue failure. The front support was of a design and manufacture which did not conform to the manufacturer's specifications. The support end fitting, which is normally a rod end with an internal spherical bearing, had been replaced by a locally-manufactured design. This consisted of a square piece of iron and a threaded rod which had been welded together (figure 5). The quality of the welding was poor and the wrong type of material had been used. The fatigue fracture was caused by a fault in the welding. The method used to make the support and the choice of material did not conform to the standards used in aircraft parts. The support had signs of repeated loads having been applied to it after the fracture took place (photos 15 and 16).

PHOTO 15 Close-up view of forward shock mount showing normal (FOTO) configuration of the assembly washer (small arrow) and shock mount cup (large arrow).

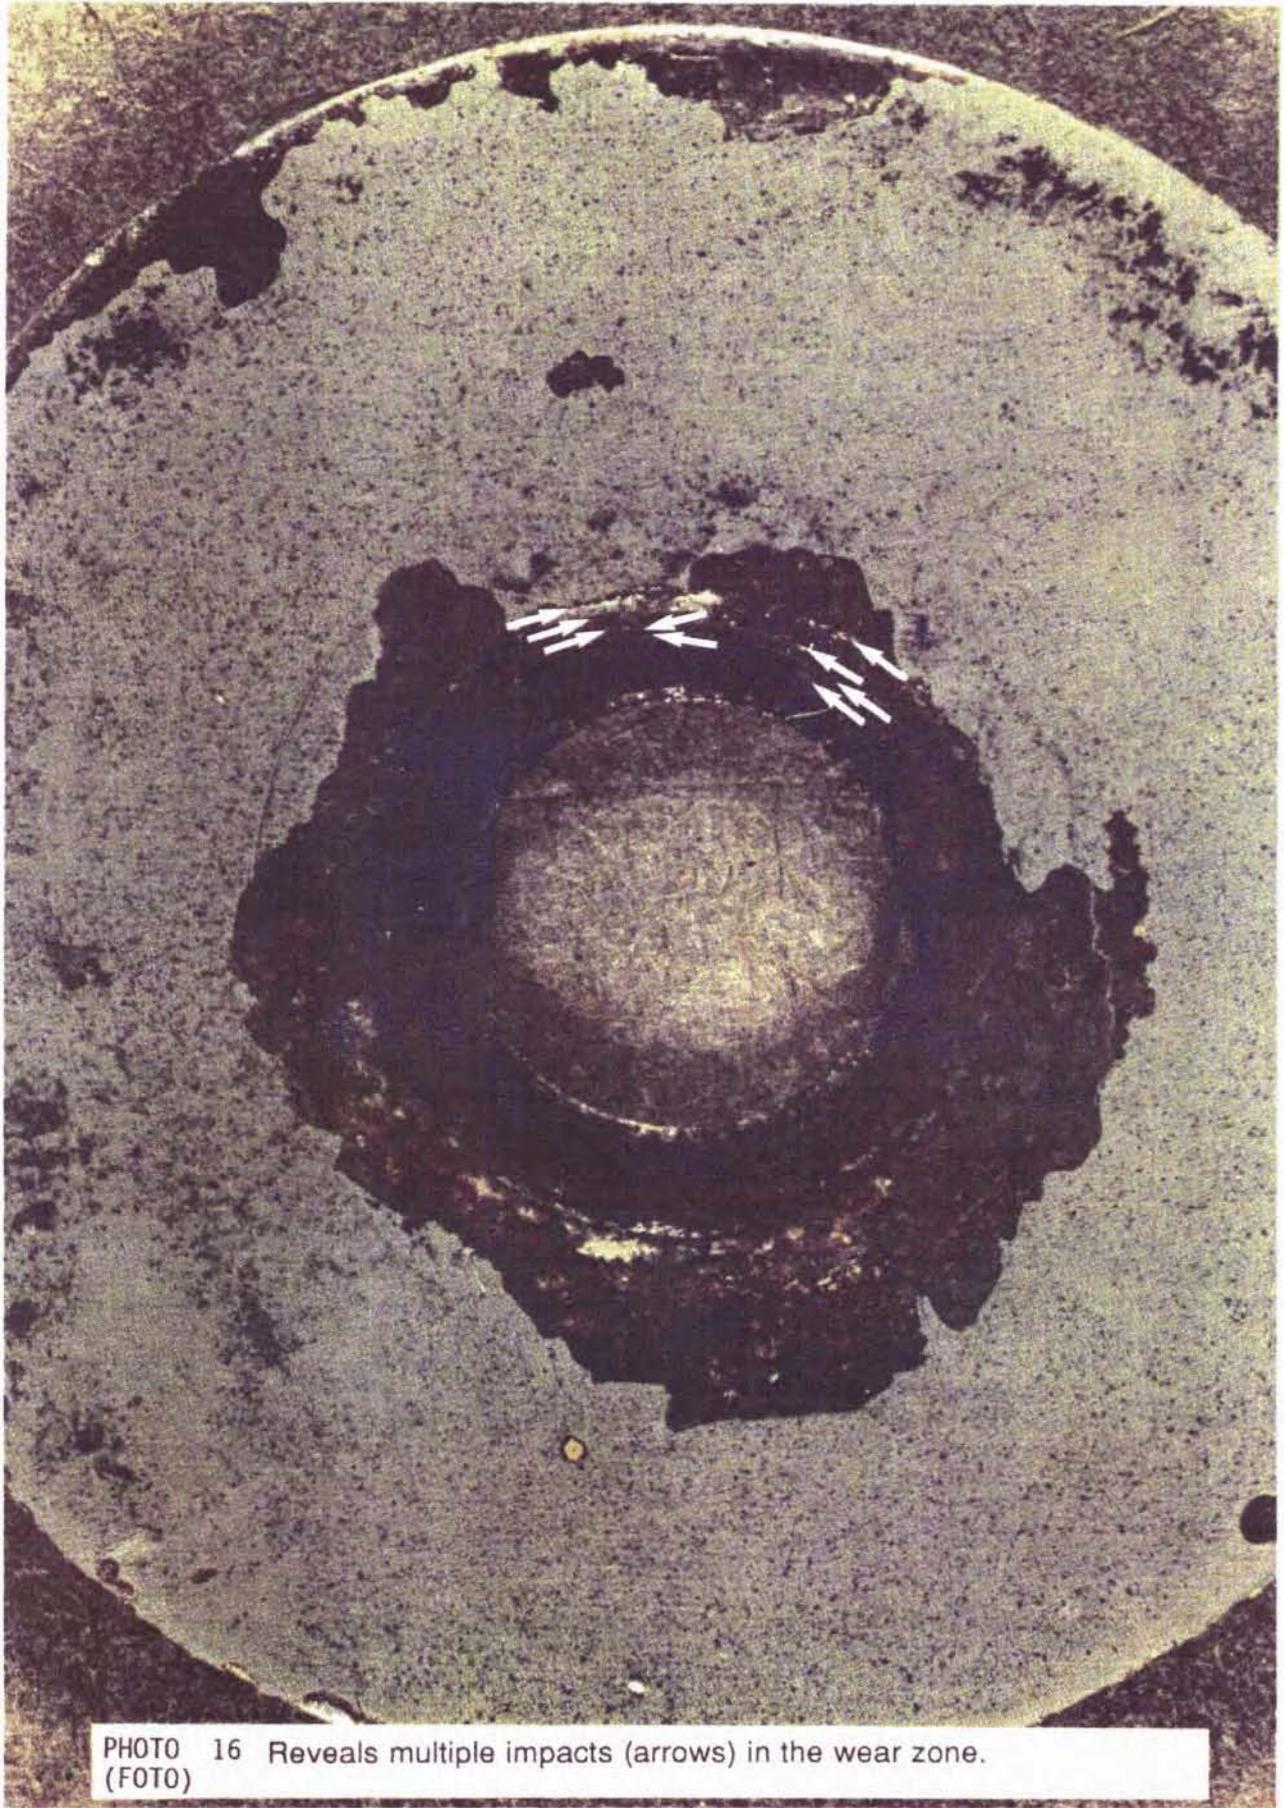
PHOTO 16 Reveals multiple impacts (arrows) in the wear zone.  
(FOTO)
