**Report on the accident to
British Aircraft Corporation/SNIAS
Concorde 102, G-BOAB,
over the North Atlantic,
on 21 March 1992**

AIRCRAFT ACCIDENT REPORT 5/93

Air Accidents Investigation Branch

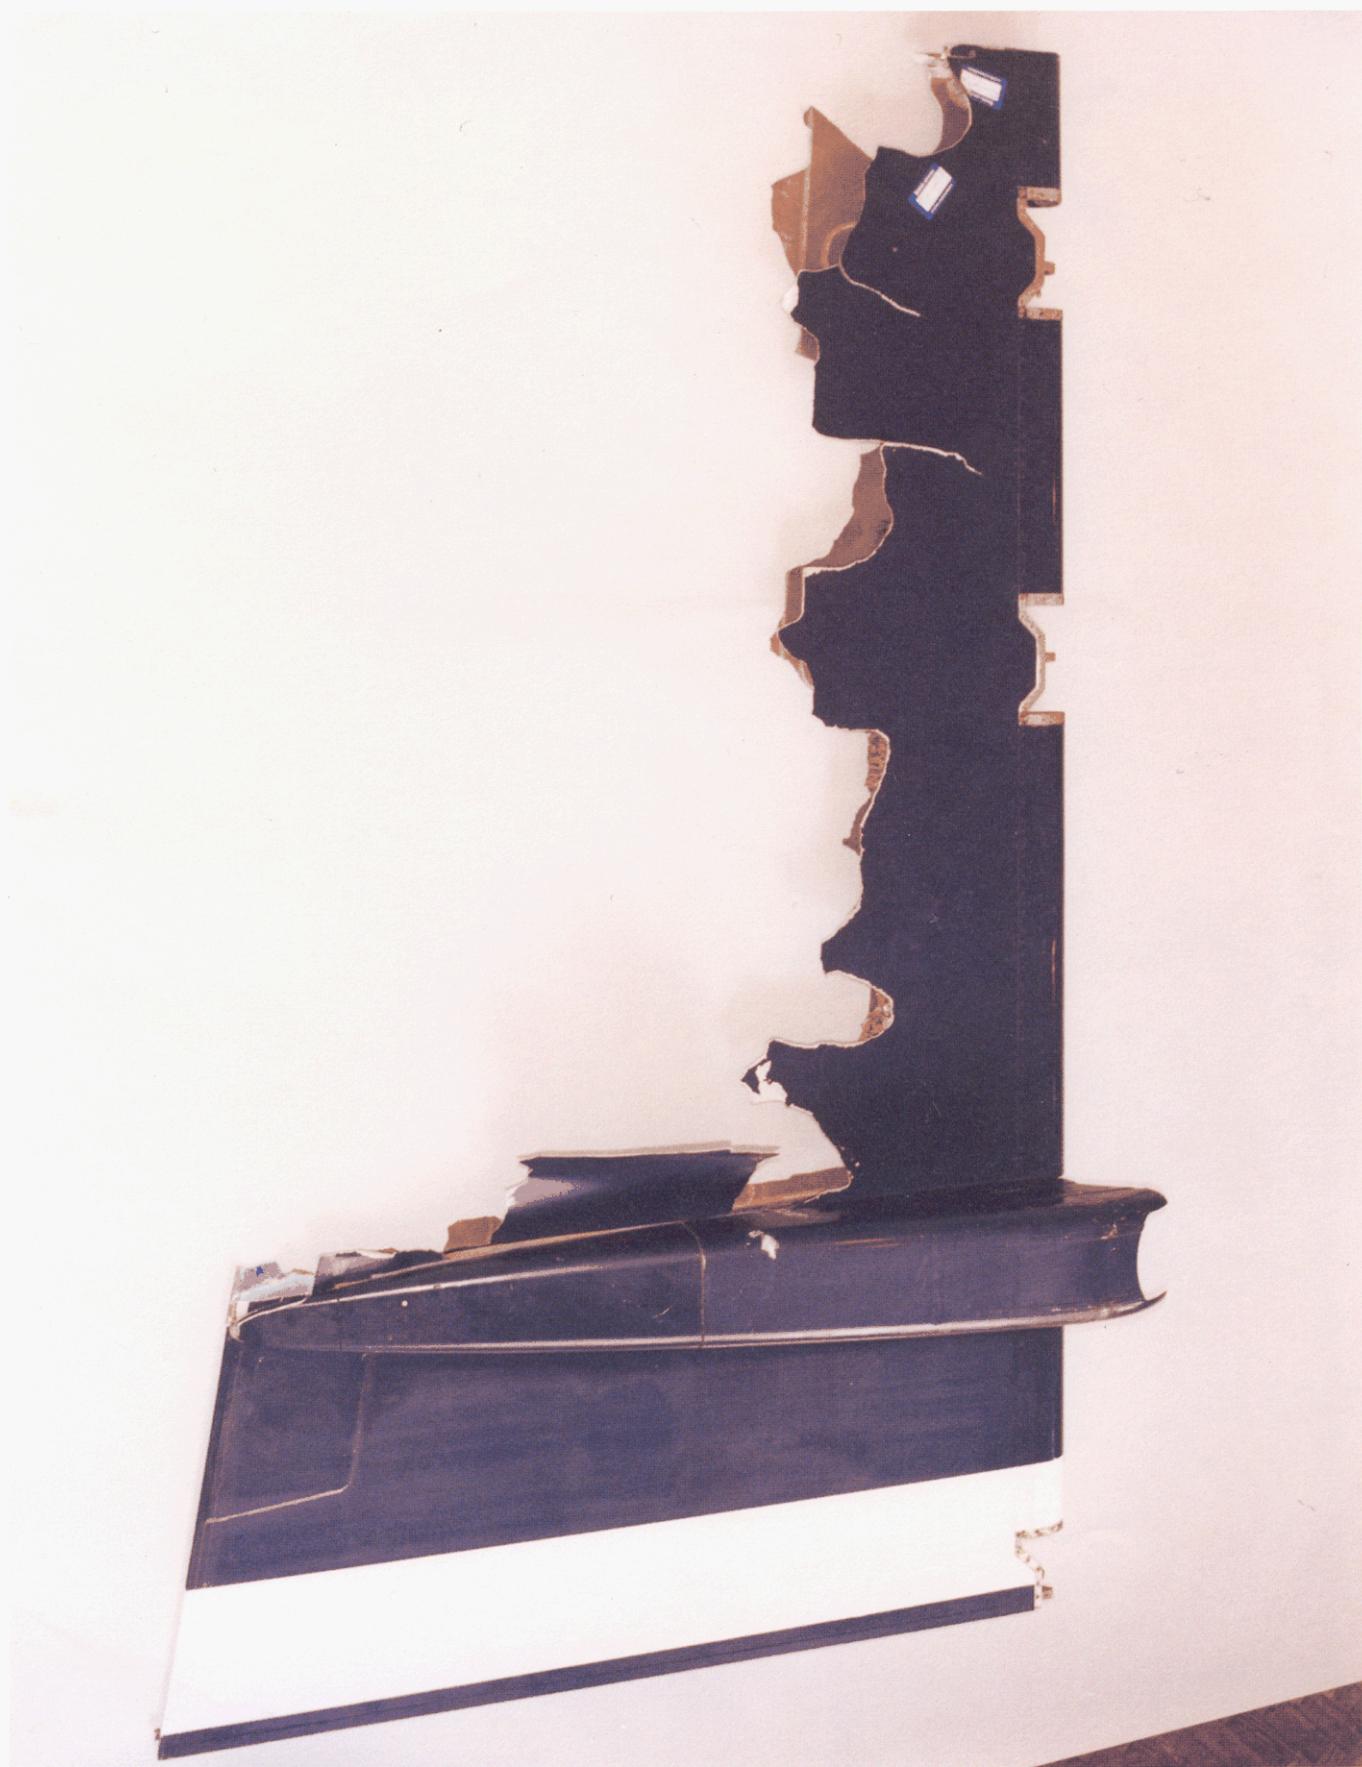
APPENDIX B

The aircraft was examined at J F Kennedy International Airport, New York. It was obvious that almost all of the top wedge of the upper rudder was missing (see Appendix B). In fact, the fracture paths were virtually identical to those seen on the upper rudder failure suffered by G-BOAF in April 1989. Irregular-shaped flaps of the skin remained attached to the leading edge spar member and the PFCU attachment arm which connects the upper to the lower wedge. Some pieces of the honeycomb core remained attached to these skin fragments but had disbonded from one side or the other.

A small section at the bottom of the upper wedge trailing edge had remained and along with the apparently undamaged lower wedge clearly exhibited the presence of the repair carried out the previous year.

Right Hand Side of Failed Rudder

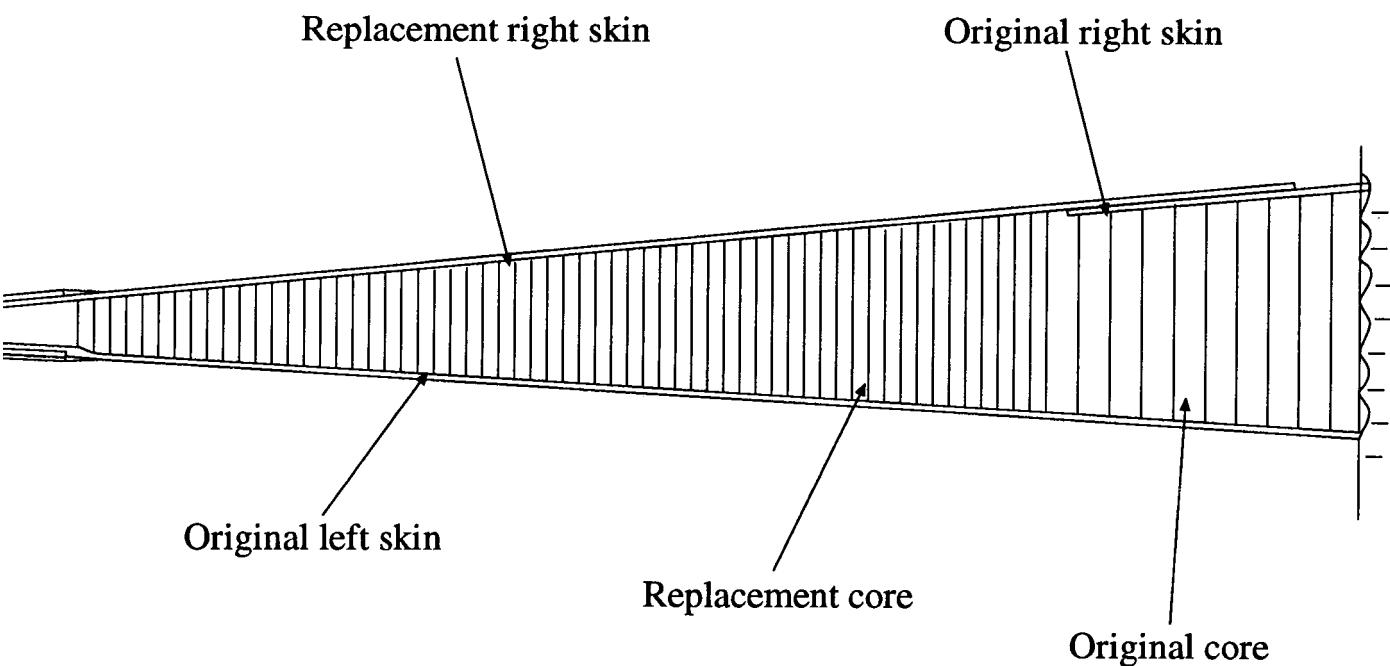
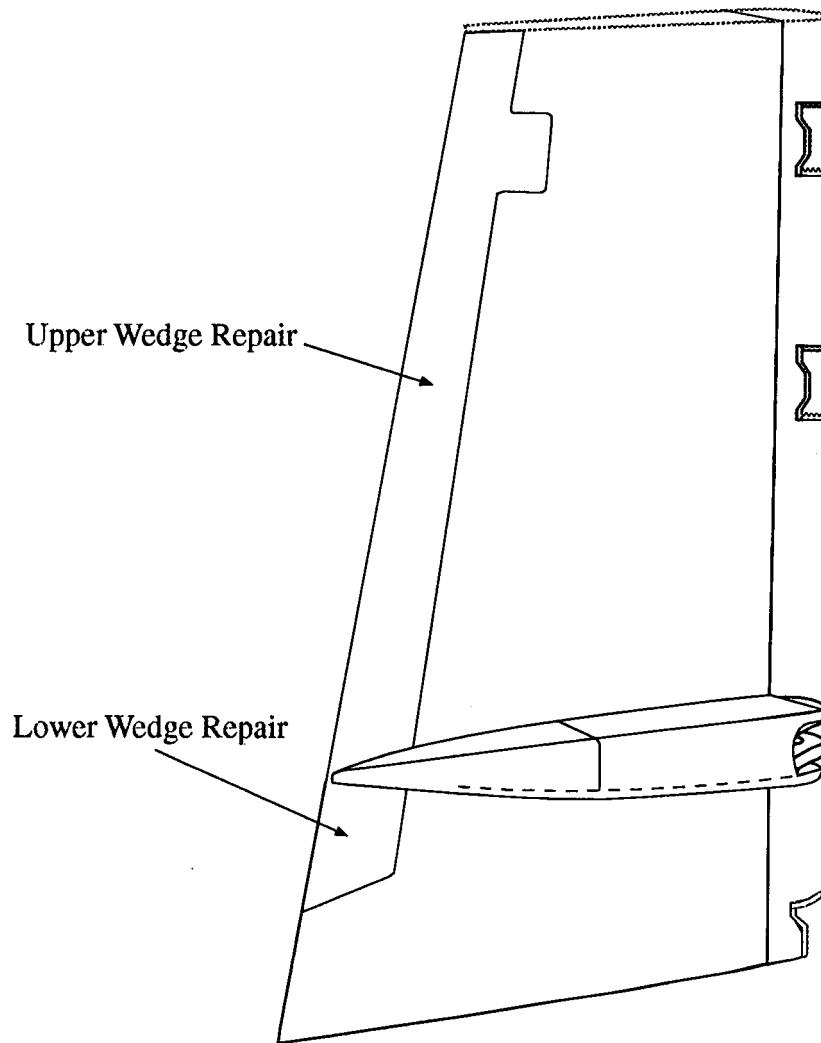
Details of Upper Rudder Repair Scheme

The repair carried out on VW23 therefore followed the above procedure and an appropriate letter was obtained from British Aerospace agreeing to the principle of the repair but recommending a different method of re-attaching the trailing edge extension. In fact, British Airways eventually elected not to refit the extension at all. The subject repair was the most extensive carried out on a Concorde flying control surface to that date and involved replacement of the honeycomb core along the entire length of the upper wedge trailing edge (see Appendix C).

Essentially the repair was accomplished by cutting back and removing the right side skin over a width of approximately 25 cm. The exposed honeycomb was then mechanically removed and the remains of the adhesive on the left skin abraded away. The edges of the remaining core were solid potted and sealed in an attempt to prevent ingress of the surface preparation materials used in the next stage of the process.
