AIRCRAFT ACCIDENT REPORT 1/95

# **ACCIDENTS INVESTIGATION DIVISION**

**Report on the accident to  
Boeing 747-409B B-165  
at Hong Kong International Airport  
on 4 November 1993**

**Hong Kong  
August 1995**

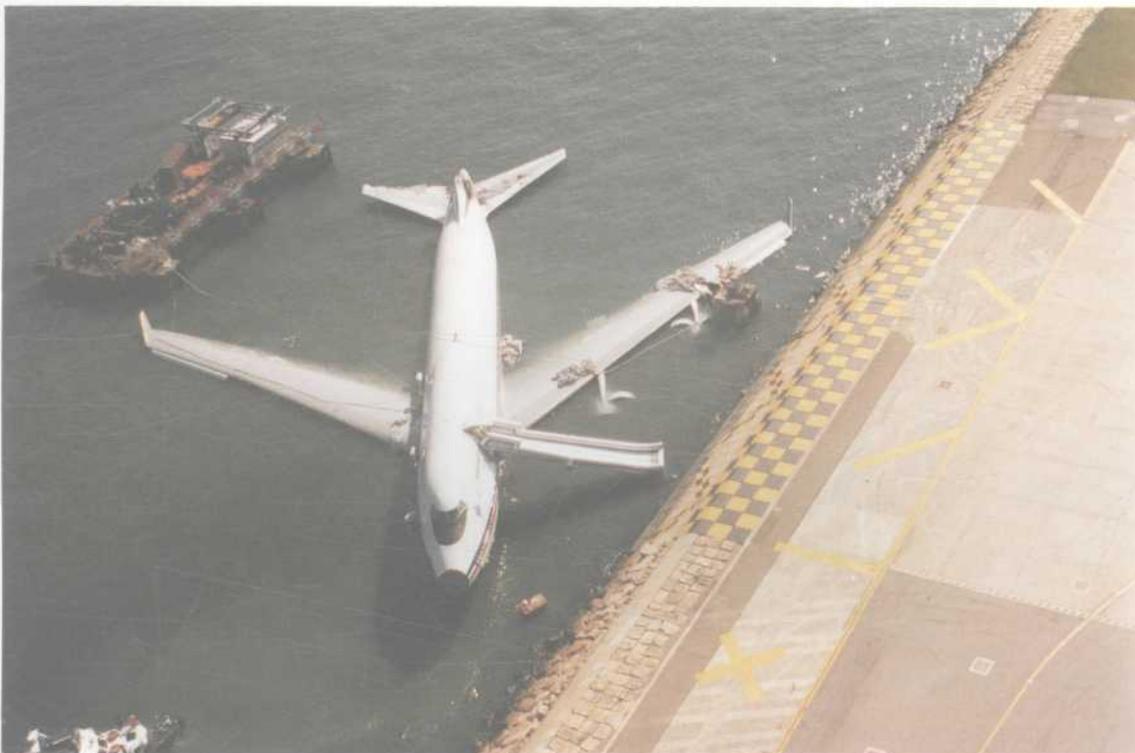
**Figure A**

General view of aircraft in relation to runway 13 end, sea wall, tyre tracks and approach lighting structures

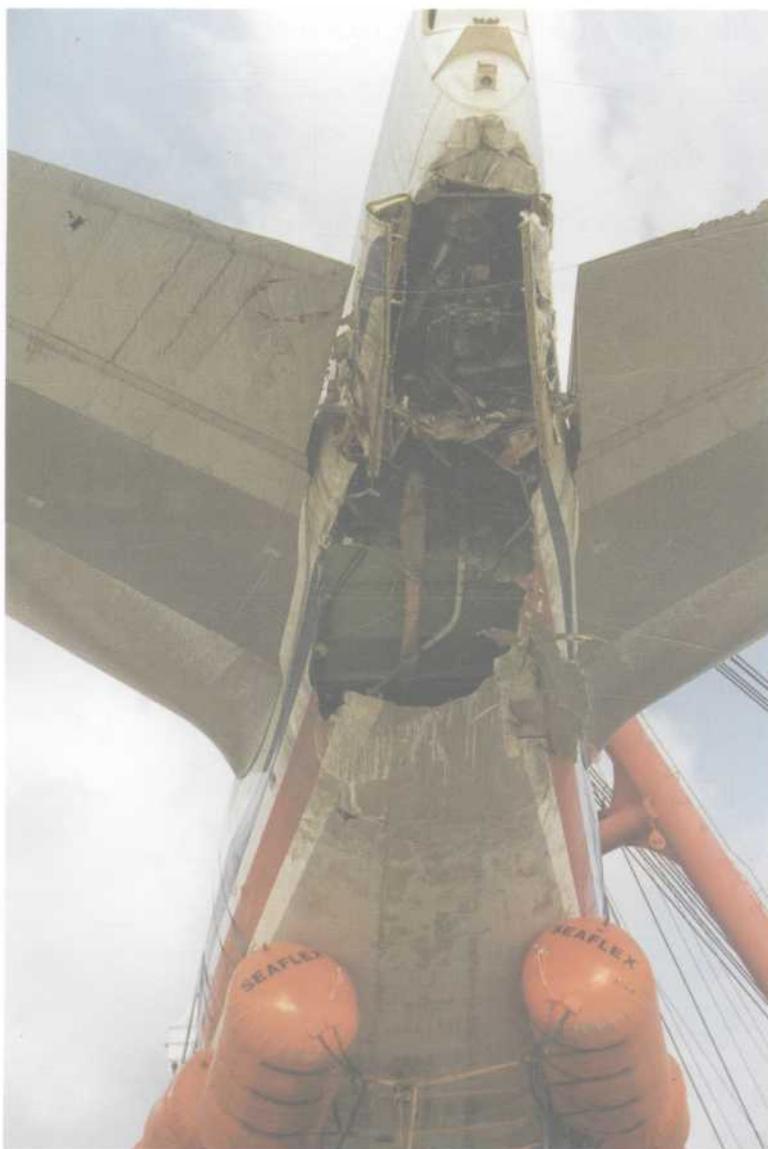
**Figure B**

Damage occasioned to rear fuselage structure by contact with the sea wall; APU cone was pushed up into lower rudder

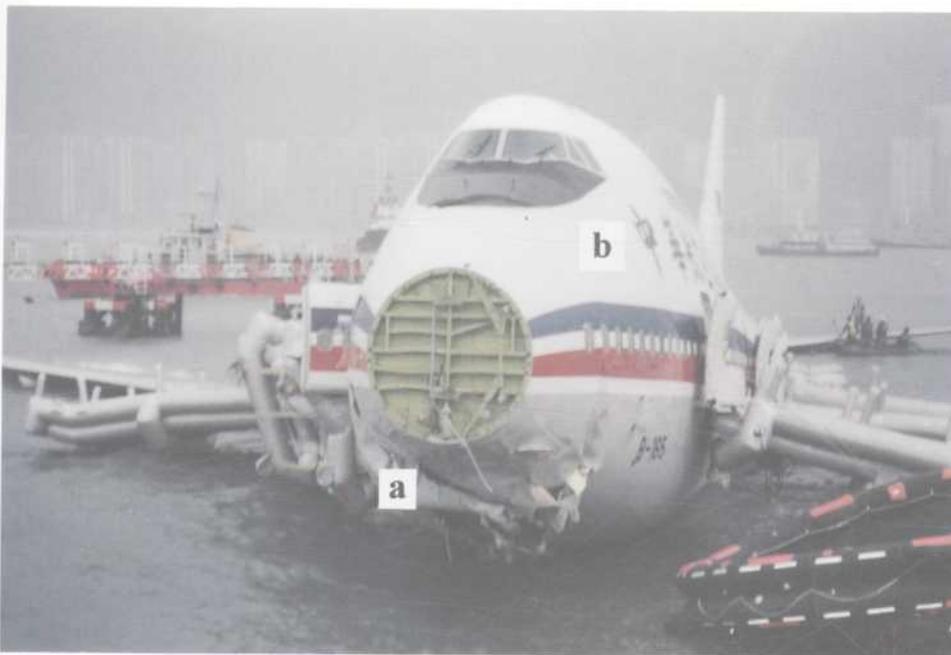
Damage to aircraft nose structure caused by water impact pressure centred on area 'a'. Complete section forward of station 220 moved aftwards, pivoting about area 'b' with resulting compression creasing around the fuselage circumference  
**Figure C**

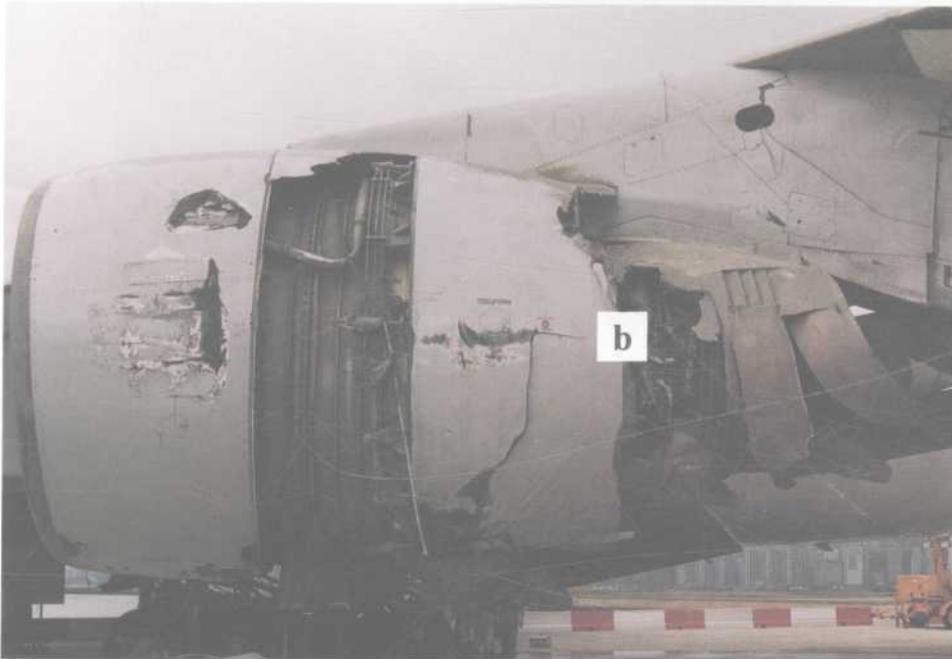
Damage to engine No 1 from sea wall strike along line 'a'. Secondary damage from prolonged contact with approach light structure marked 'b'  
**Figure D**

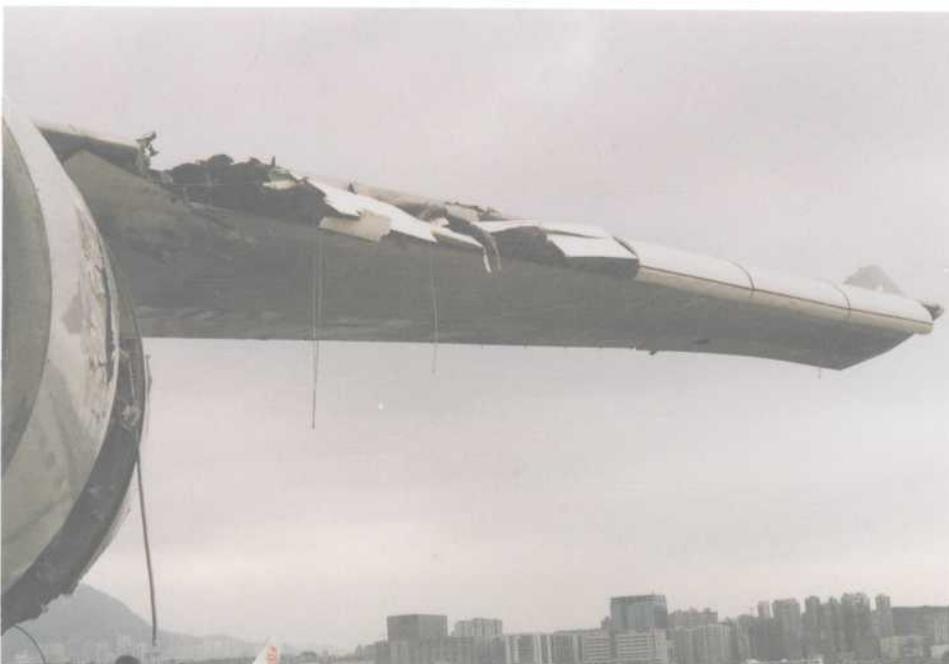
Left outboard leading edge flap damage caused by contact with approach lighting structure  
**Figure E**

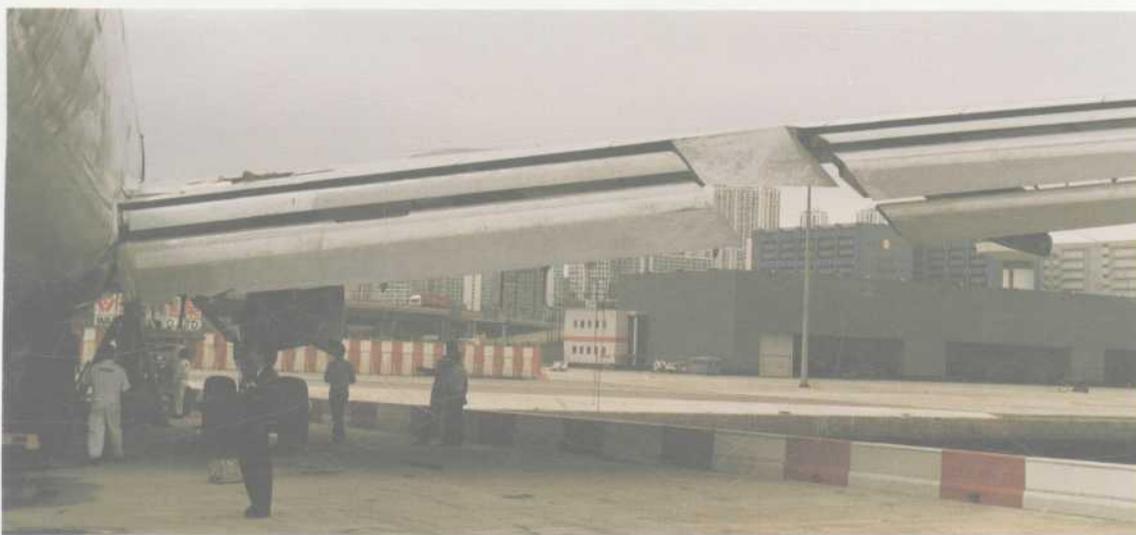
**Figure F**

Right inboard trailing edge flap, aft segment detached on water entry

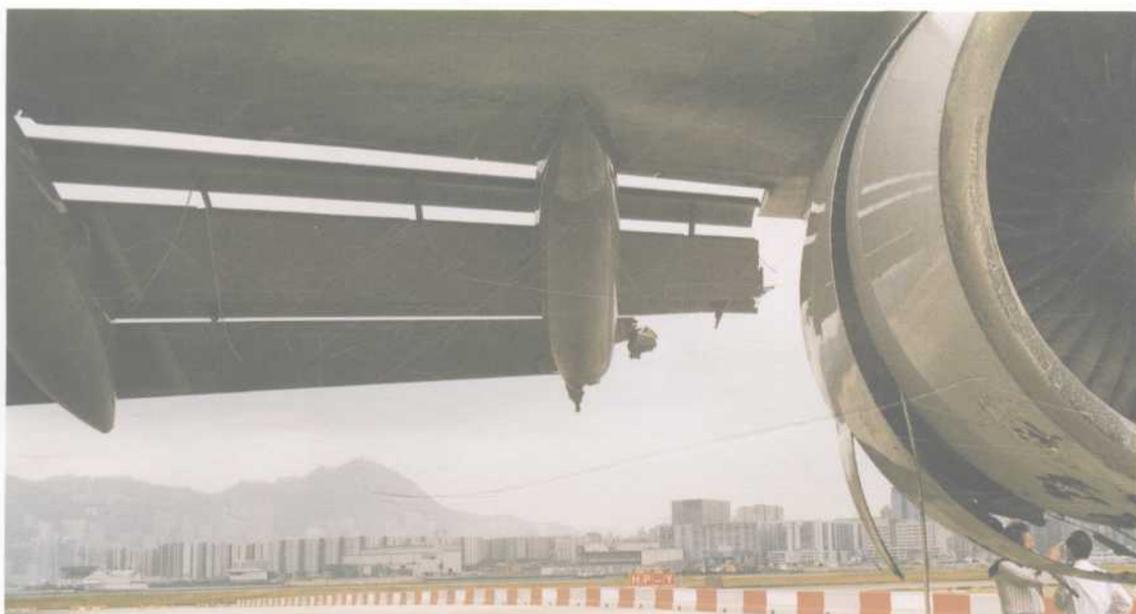
**Figure G**

Left outboard trailing edge flap, aft outboard corner damaged by seawall contact

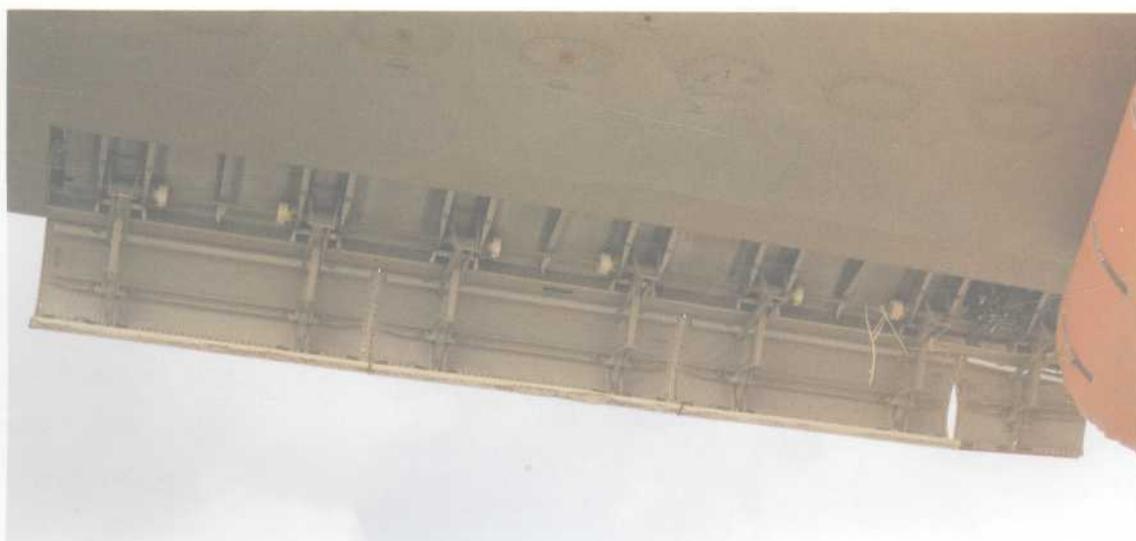
**Figure H**

Left outer leading edge flap, lower edge scraped by contact with the seawall

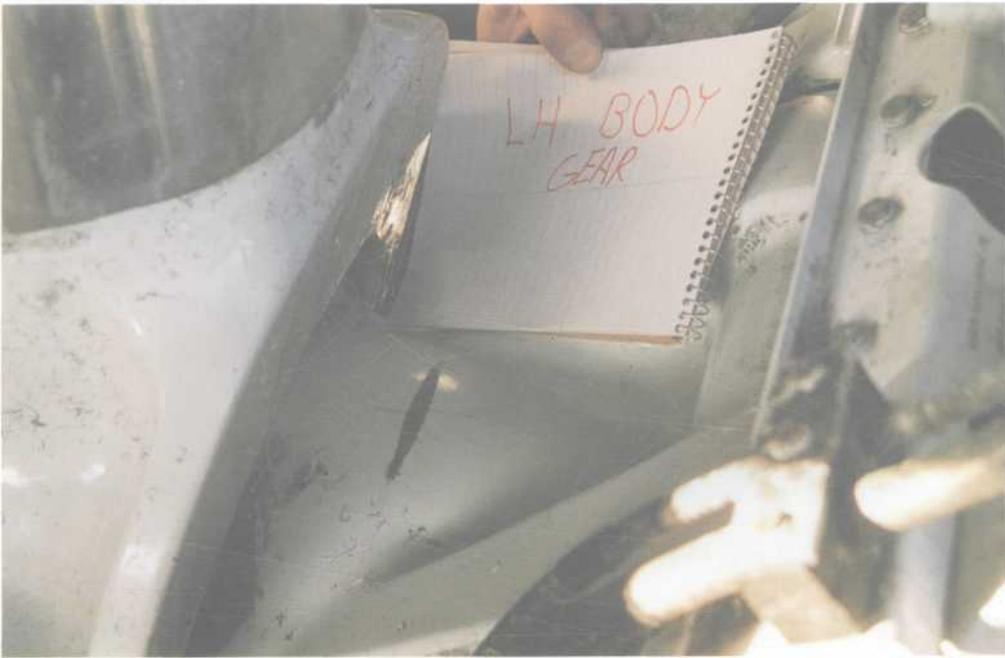
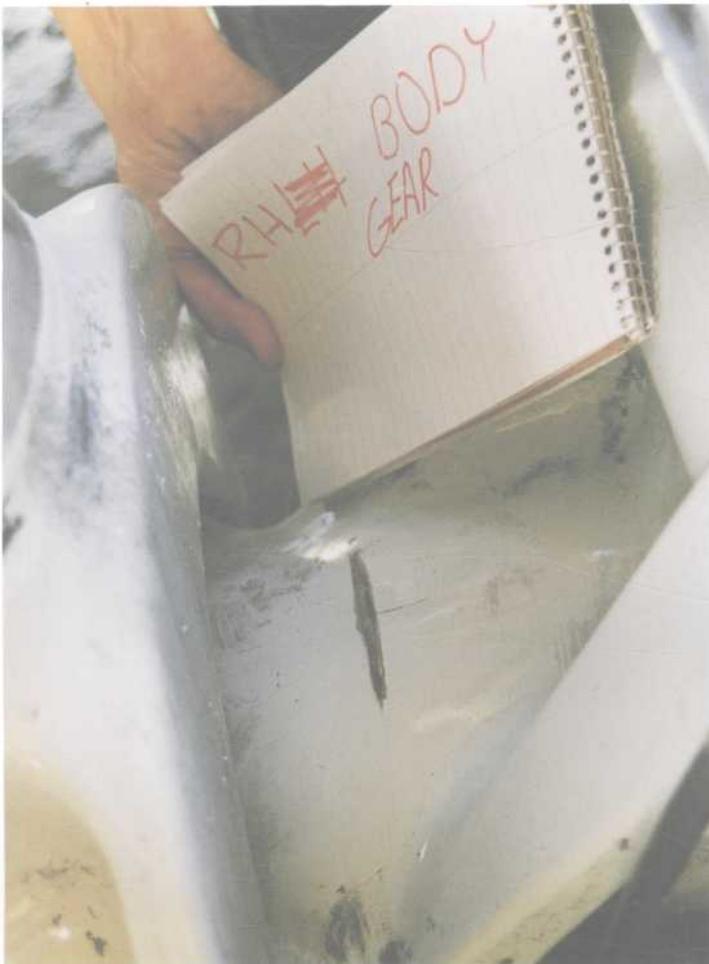
**Figure J**

**Damage areas on both body gear trucks as a result of overtravelling in a leading-wheel down sense as the aircraft rolled over the sea wall lip**

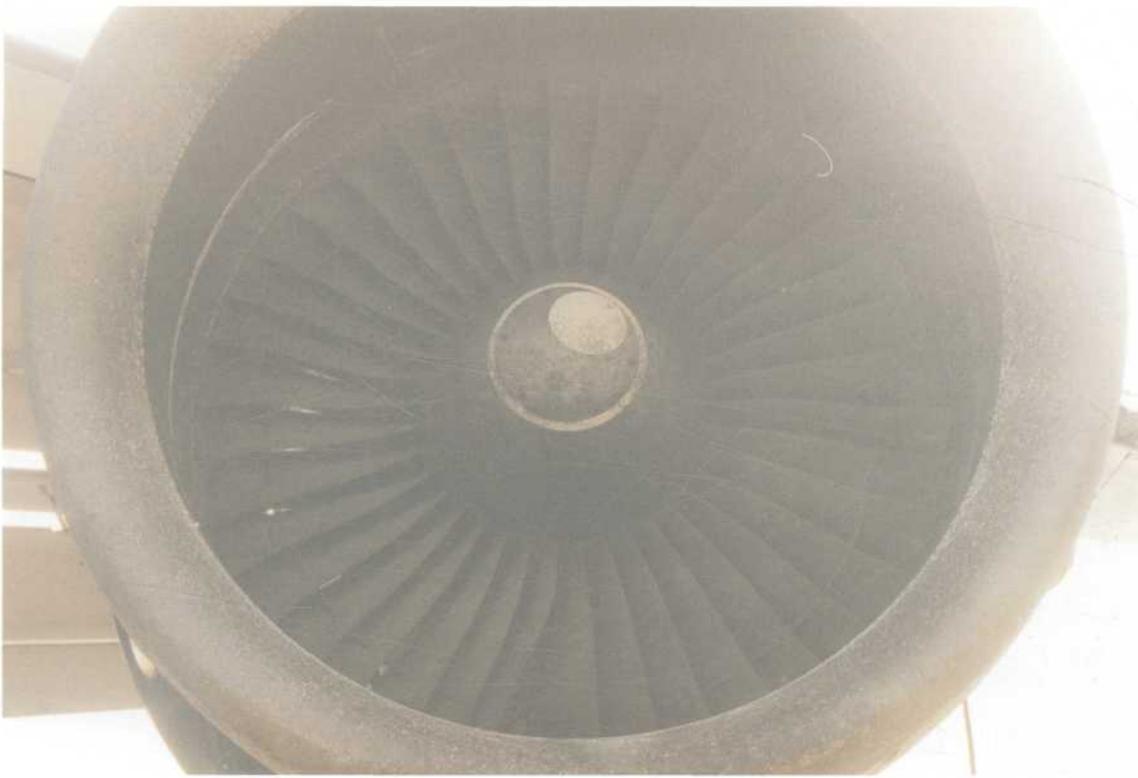
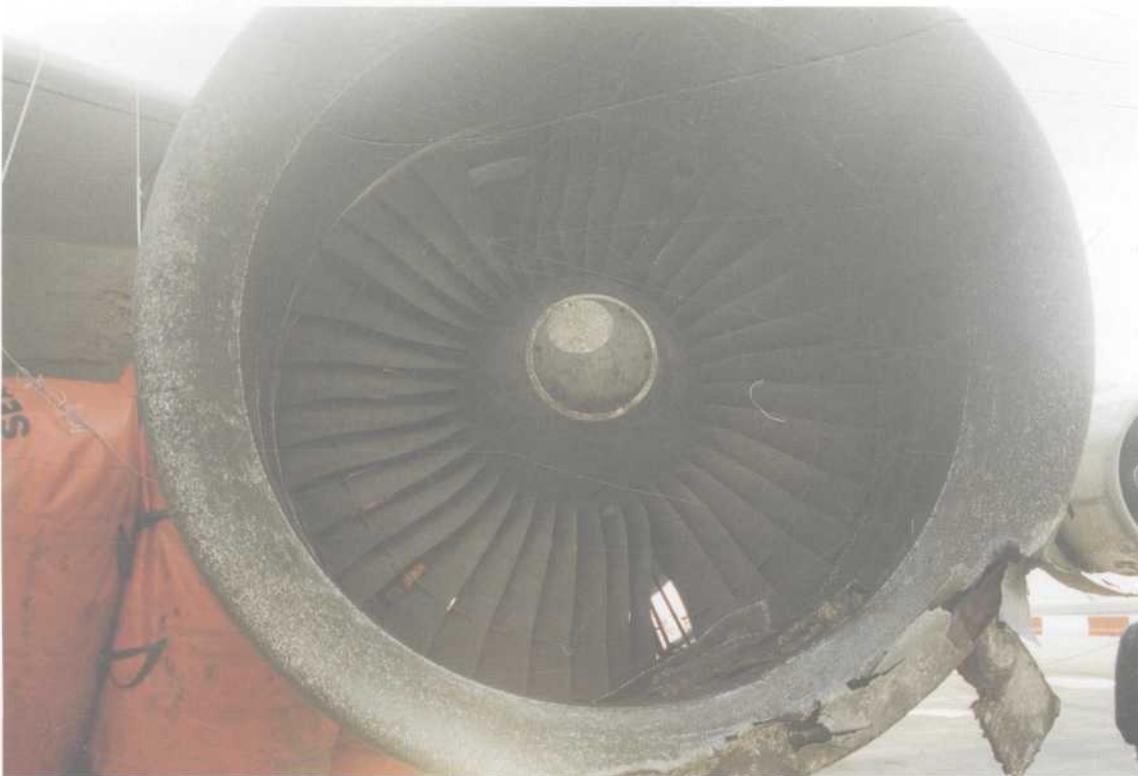
**Engines 1 and 2 fans showing evidence of low power condition at water entry, consistent with DFDR data**

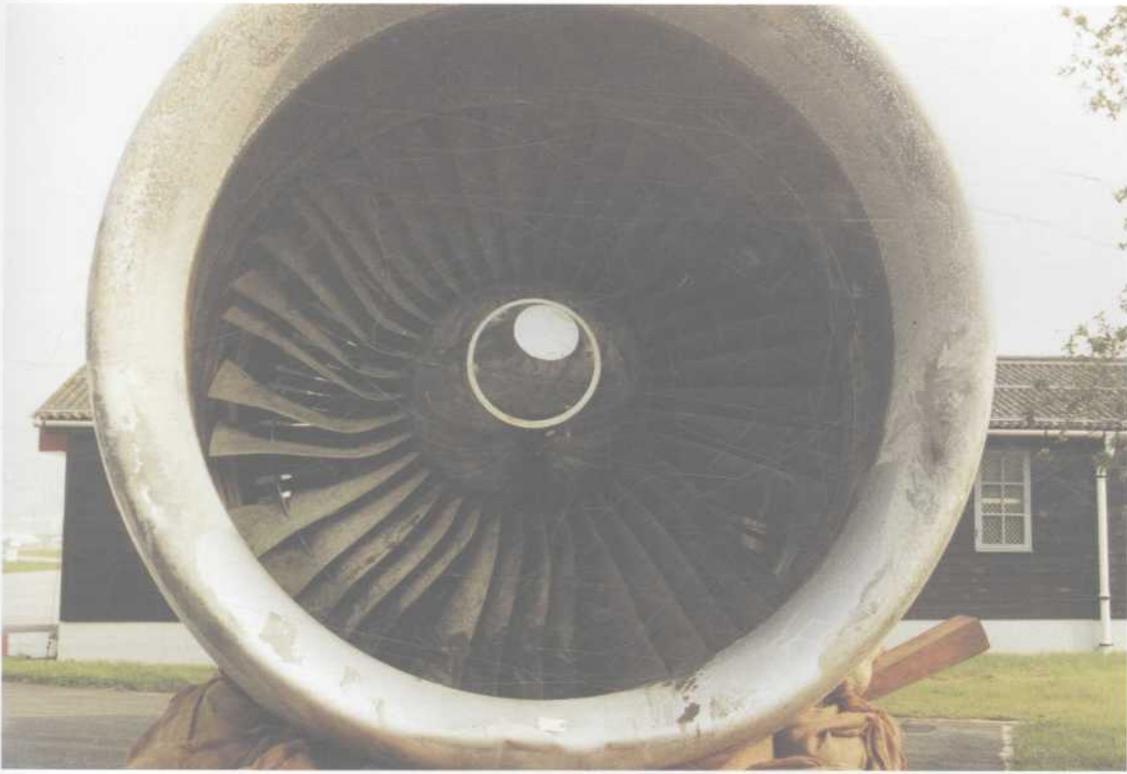
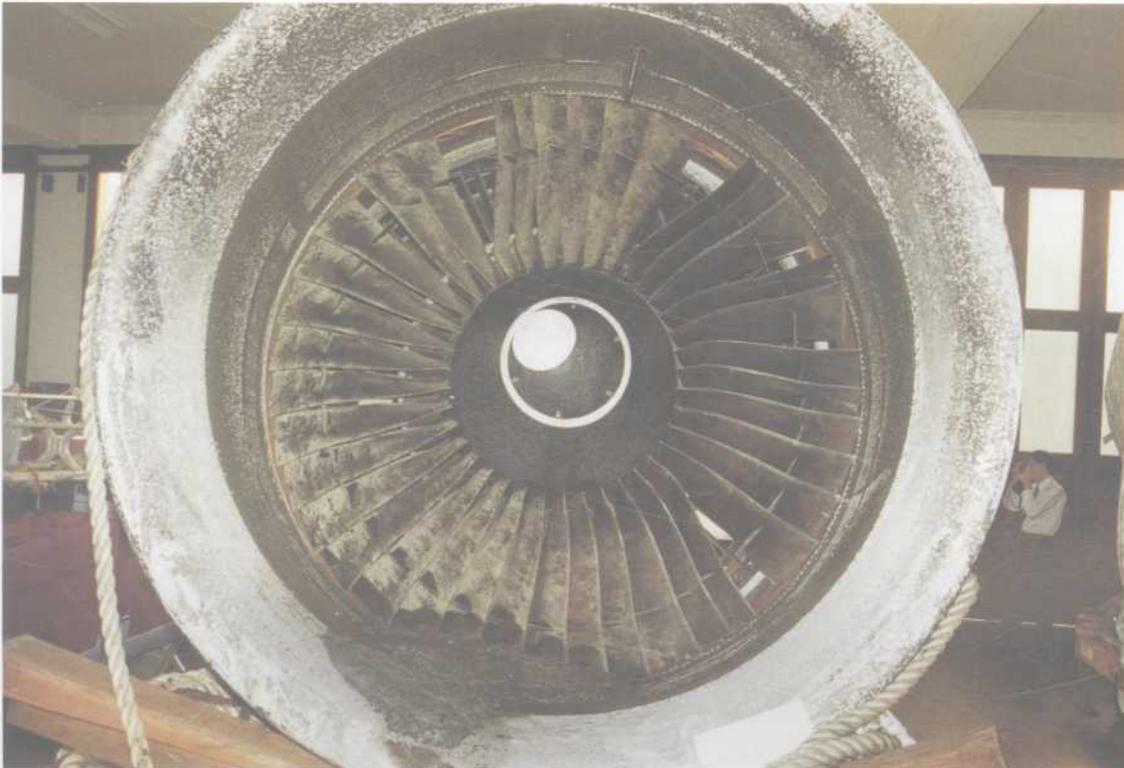
**Engines 3 and 4 showing evidence of low power condition at water entry, consistent with DFDR data.**

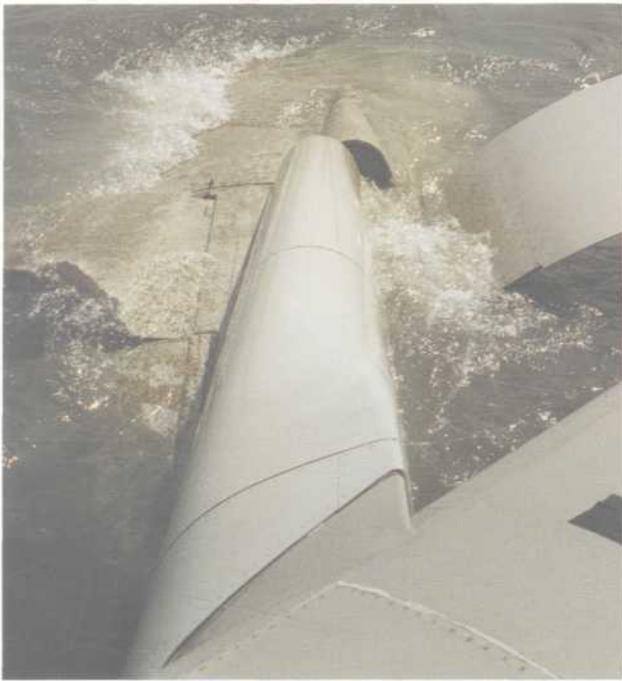
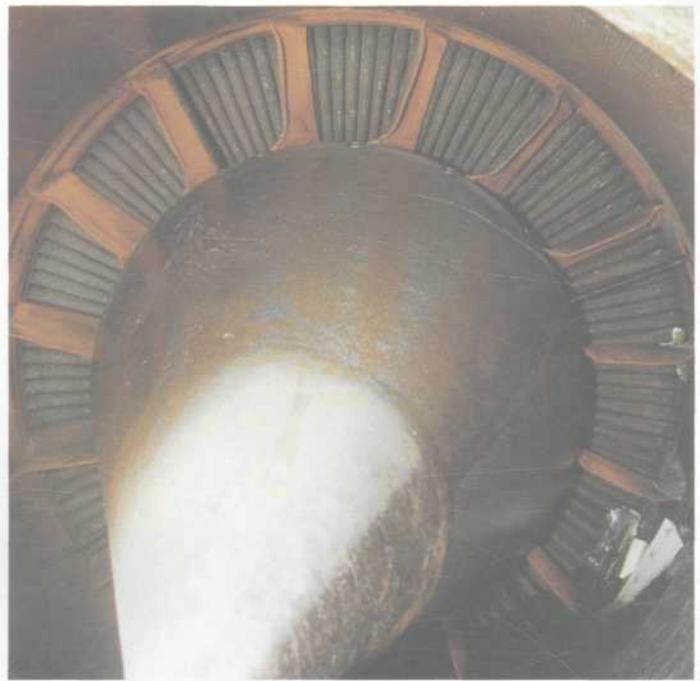
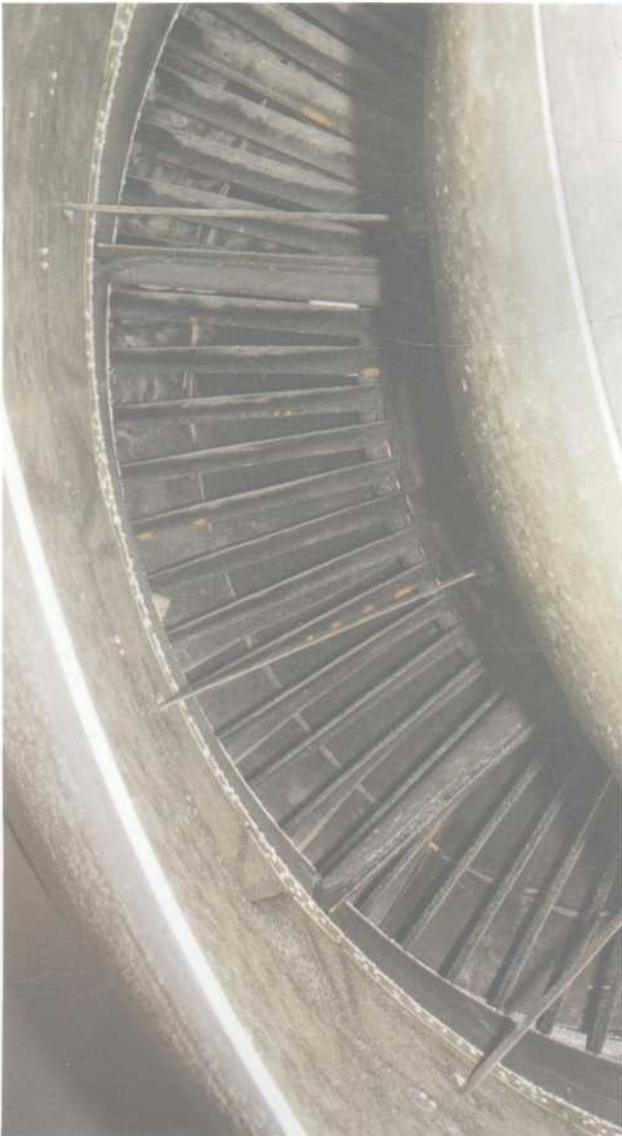
No 4 engine details showing effect of engine rear mount deformation due to strike on sea wall. Fan and turbine exit areas for engine No 3 are also shown, which identify no evidence of pre-impact damage and stowed thrust reverse blocker doors. All engines were similar in this respect.

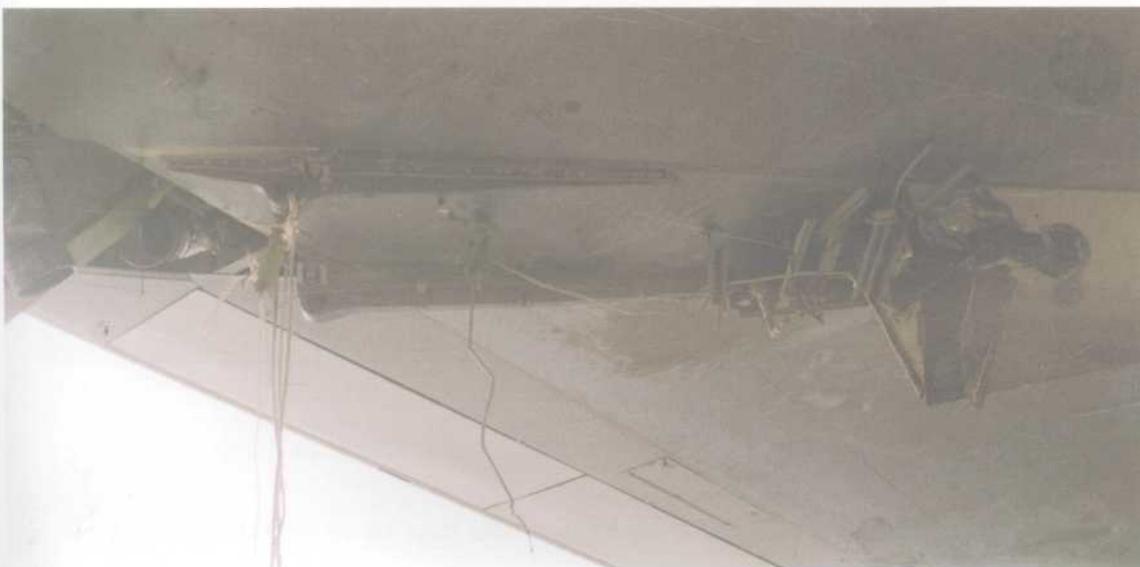
**Figure R**

Details of Engine No 3 strut separation from the wing by fuse pin failure. The wing structural box remained intact.

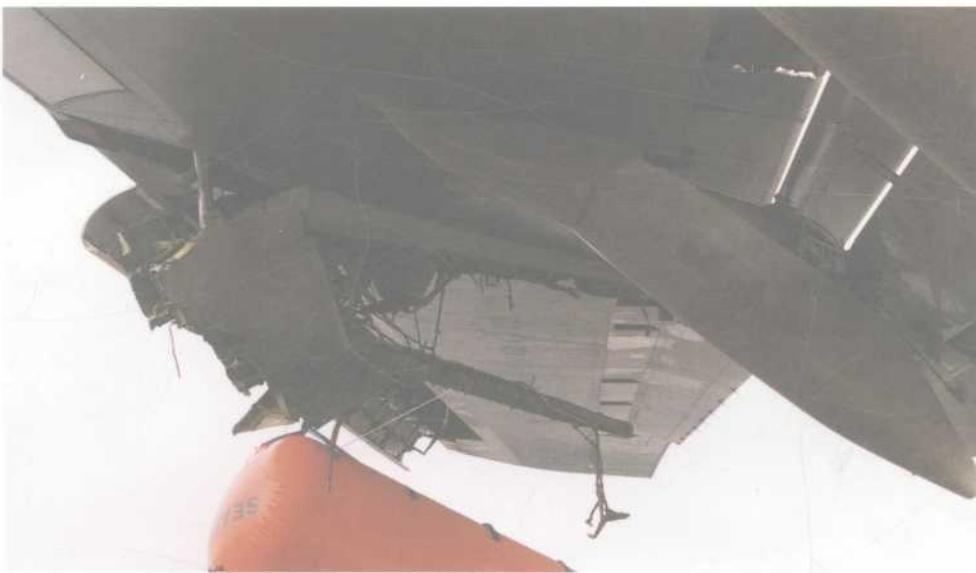
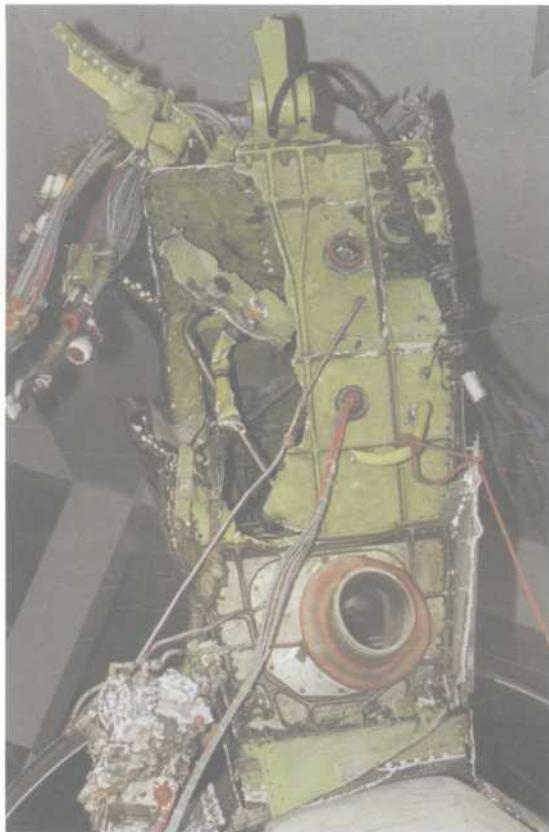
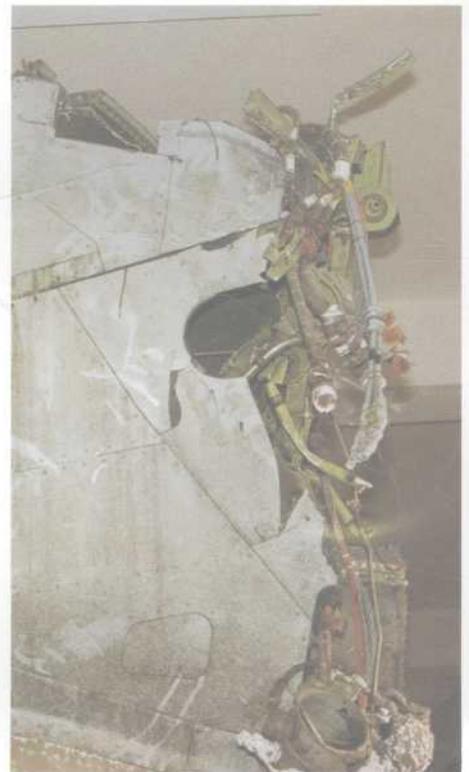
**Figure S**

**Details of No 4 engine strut failure. The engine was first to enter the water, at approximately 30 kts, with the aircraft yawed left by some 15 degrees. The wing structural box remained intact.**

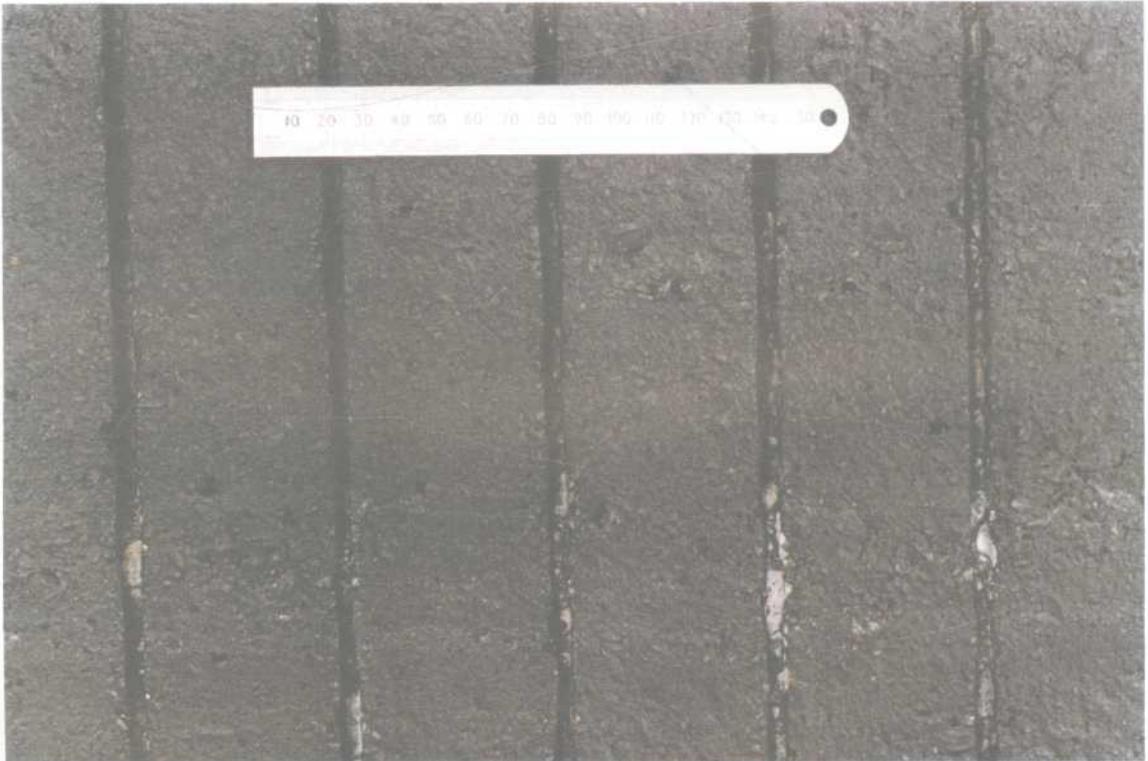
**Fig 2 Close-up of rubber contaminated grooved asphalt surface**

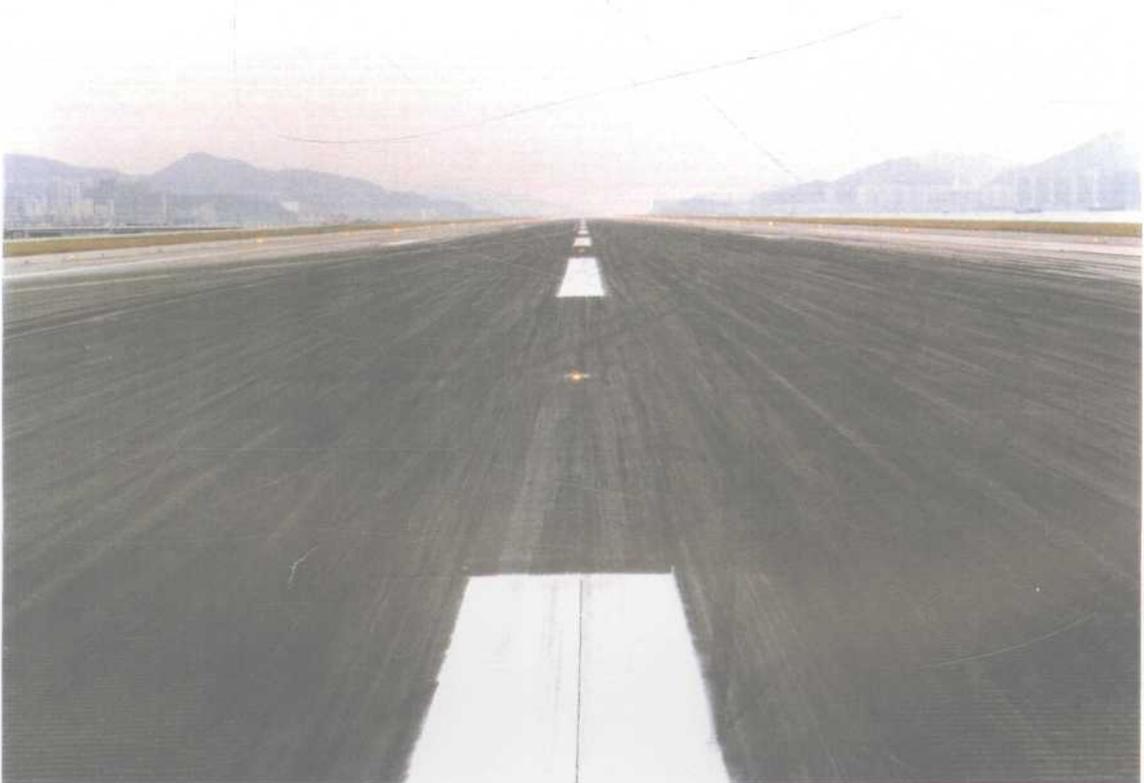
**Fig 4 Rubber deposits at 13 threshold**

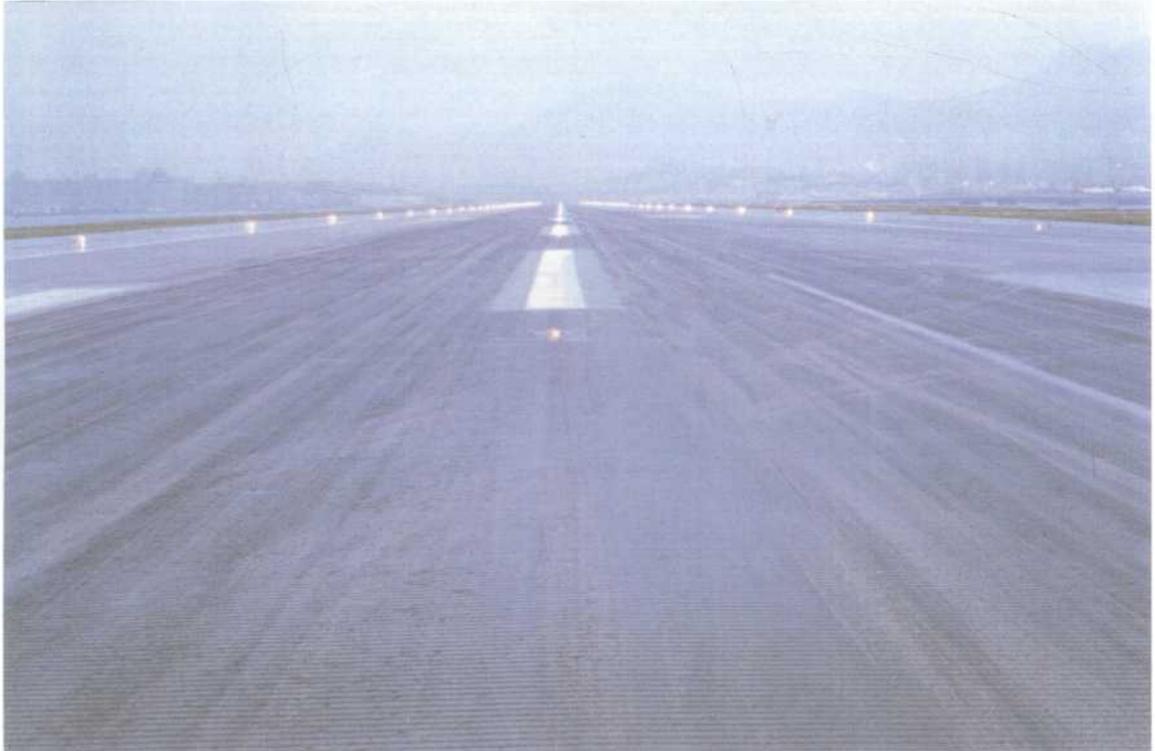
**Fig 5 Rubber deposits at 31 threshold**

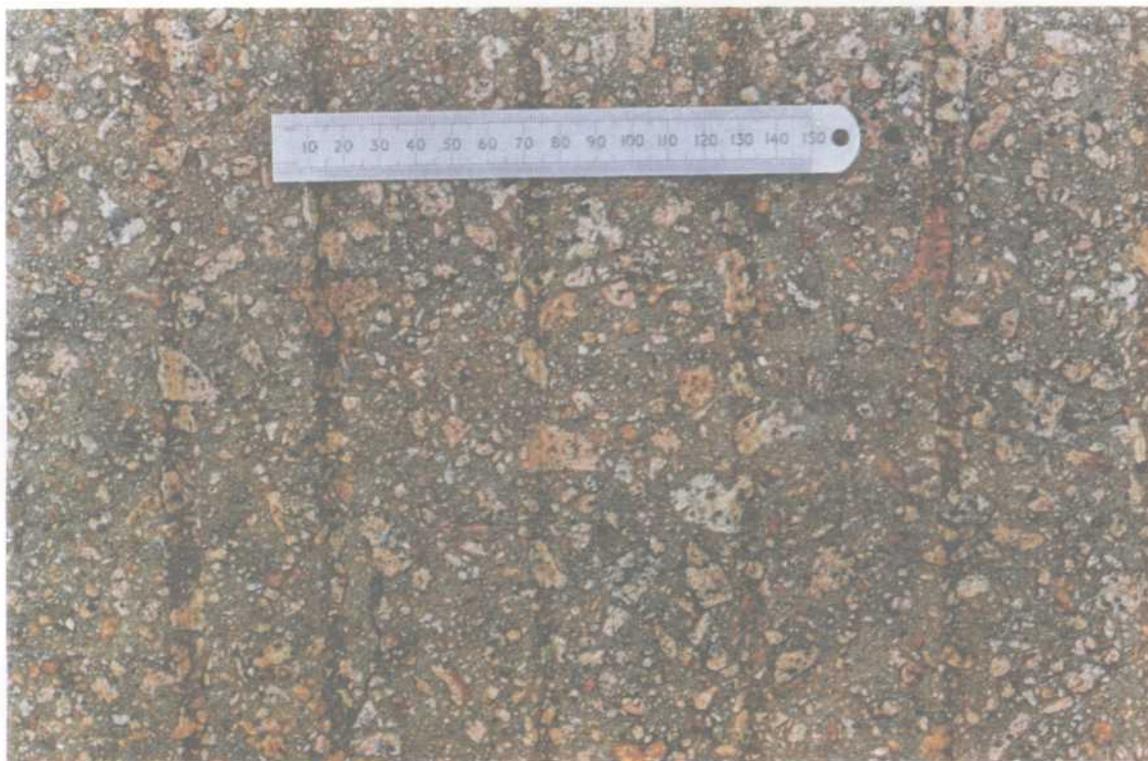
**Fig 7 Close-up of worn grooves**

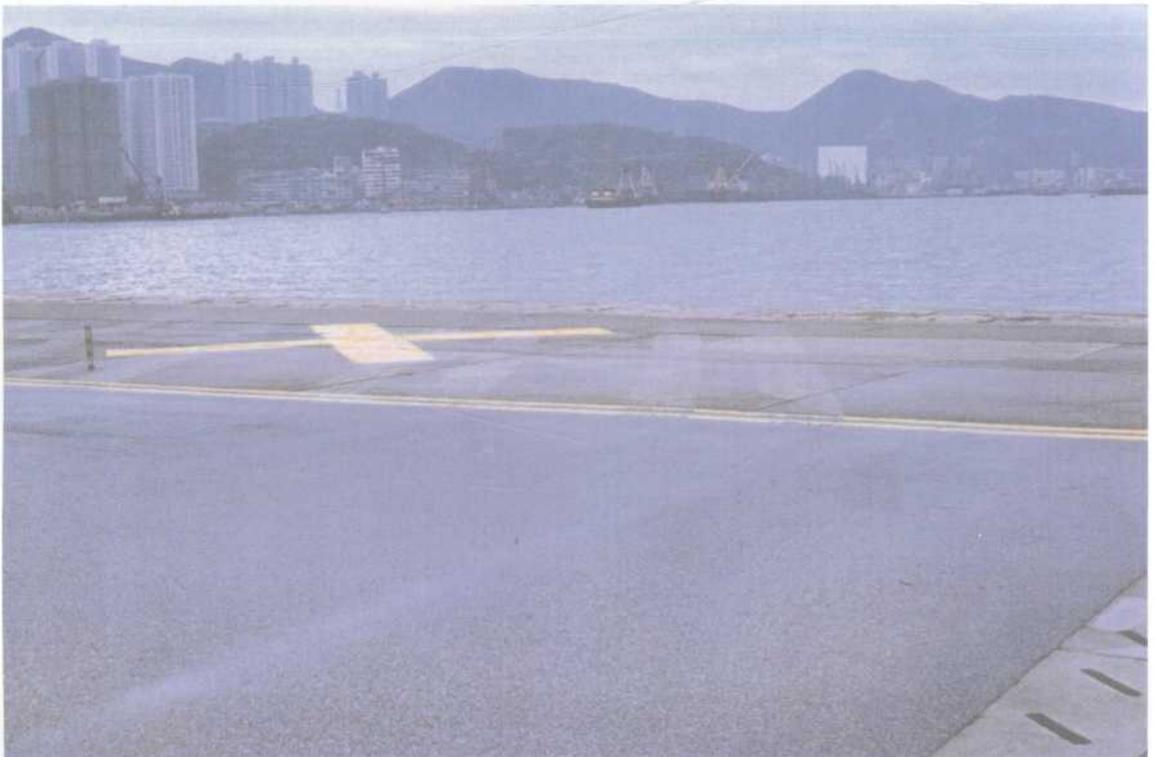
**Fig 10** Tracks of aircraft entering water
