## AIRCRAFT ACCIDENT REPORT

OVERSPEED AND LOSS OF POWER  
ON BOTH ENGINES DURING DESCENT AND  
POWER-OFF EMERGENCY LANDING  
SIMMONS AIRLINES, INC., d/b/a  
AMERICAN EAGLE FLIGHT 3641, N349SB  
FALSE RIVER AIR PARK, NEW ROADS, LOUISIANA  
FEBRUARY 1, 1994

**Adopted: September 27, 1994  
Notation 6293A**

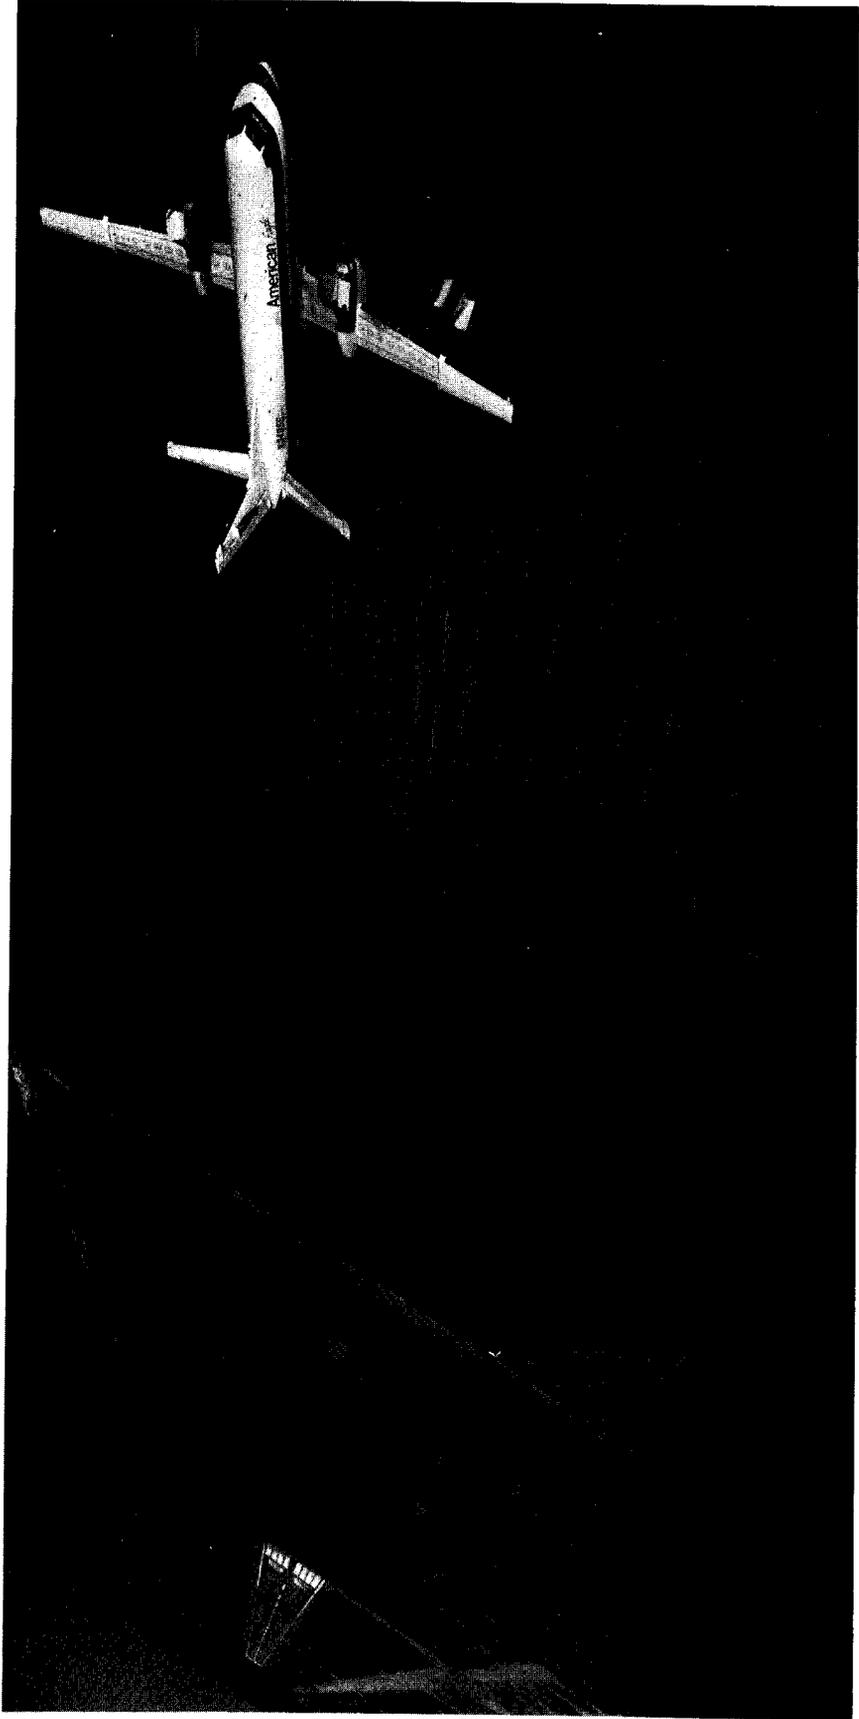
Figure 1.--Resting position of airplane.

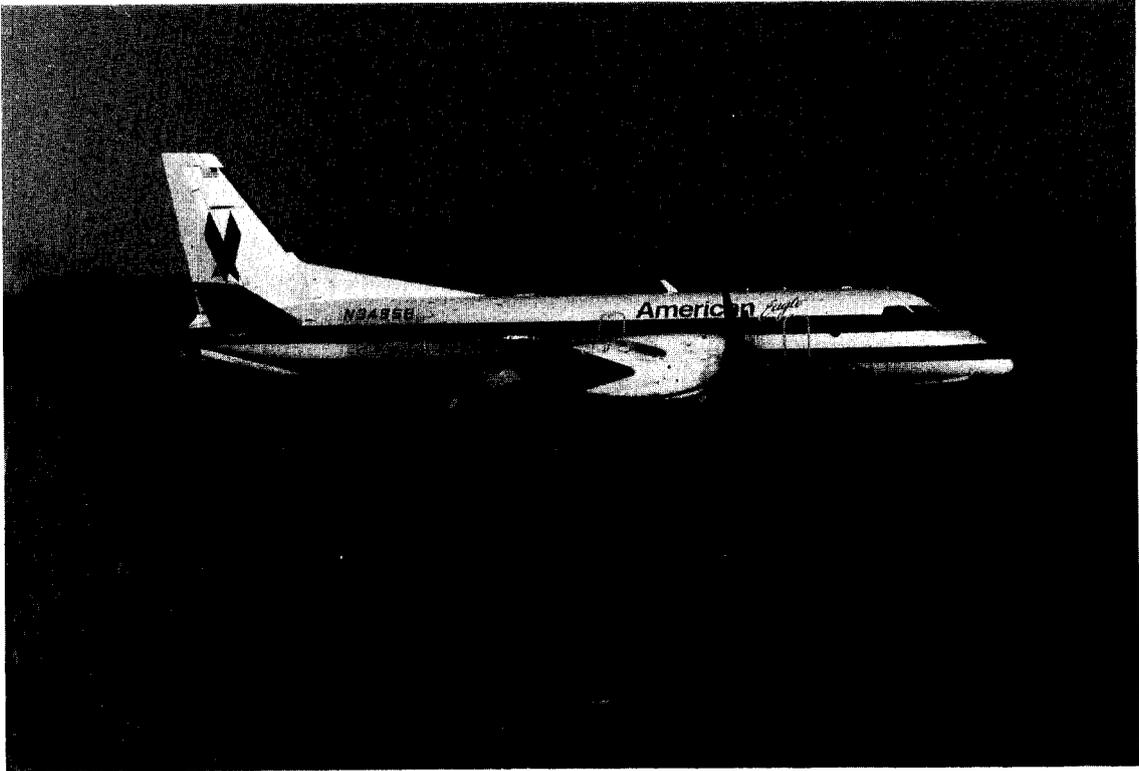
Figure 2a.--Airplane in sugar cane field with fence visible on landing gear.

After the airplane came to a stop, the first officer exited the cockpit. After he observed fencing materials wrapped around the landing gear, he lowered the airstair door to assist passengers exiting the cabin so that they would not jump

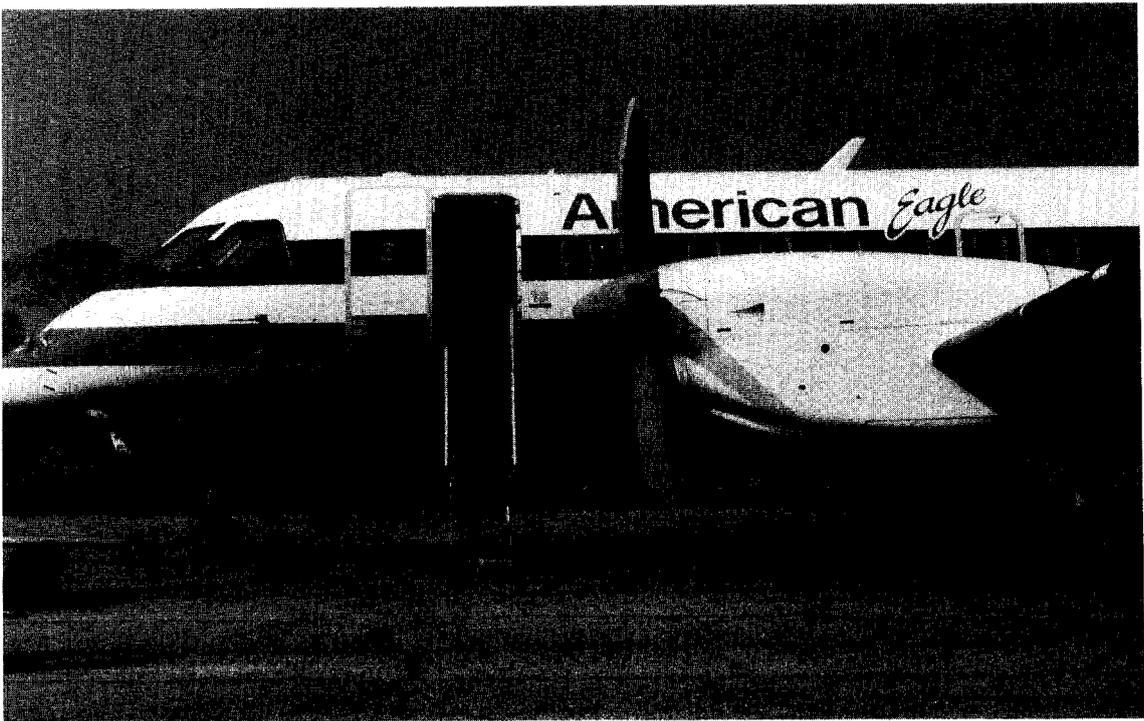
Figure 2b.--Airplane after recovery showing radome, puncture (in front of logo), and dented leading edge of wing.

Structural damage to the airplane included dents and punctures in wing leading edge panels and flap panels, a horizontal crease in the left nose structure at the radome, and crushing of the composite radome. There was a 2- by 3-inch hole surrounded by a 6- by 12-inch dent in the fuselage aft of the main cabin door upper edge. Also, there was a 3-inch tear near the forward hinge point for the right nose landing gear door, a buckled skin and former section on the left side of the left nacelle, and a bend in the lower forward spar cap at the root of the left wing. Figures 4a and 4b illustrate the wreckage site and damage to the airplane.

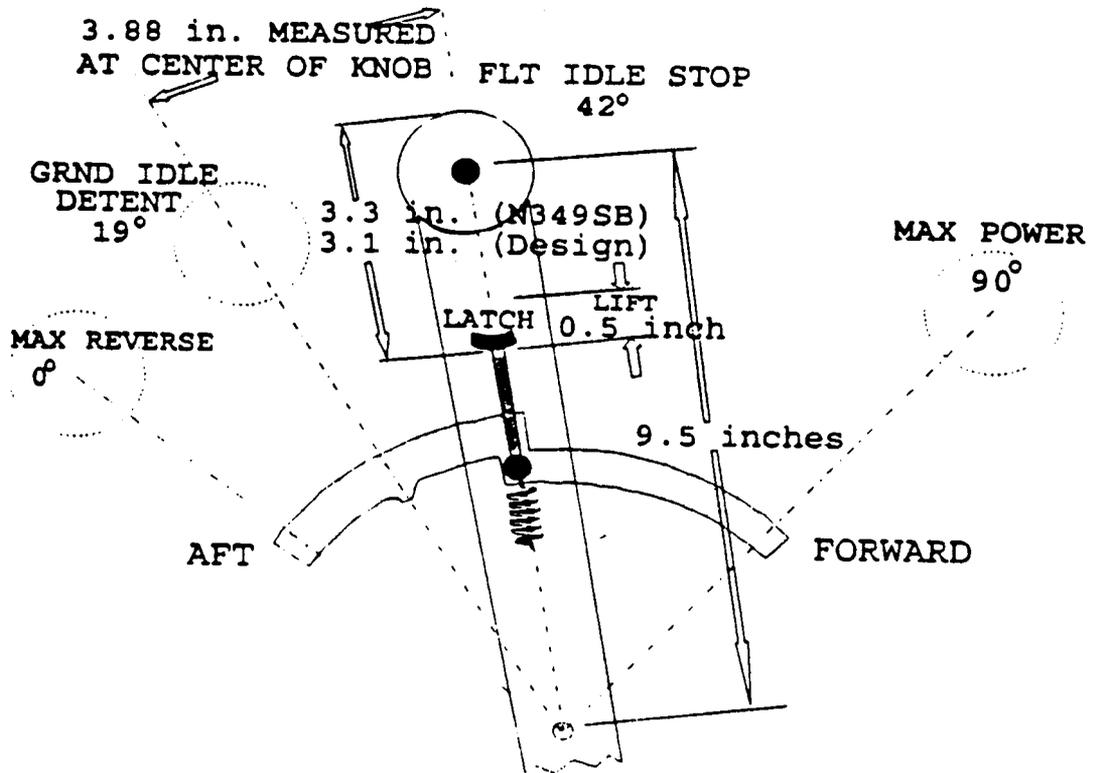
1. Left latch movement began with 3.0 pounds of lift and topped at 7.0 pounds. Right latch movement began with 3.0 pounds of lift and topped at 5.5 pounds. Saab design calls for beginning of 2.5 pounds and 7.0 pounds at .5 inch lift.
2. Dimensions measured on N349SB and confirmed with Saab documents.

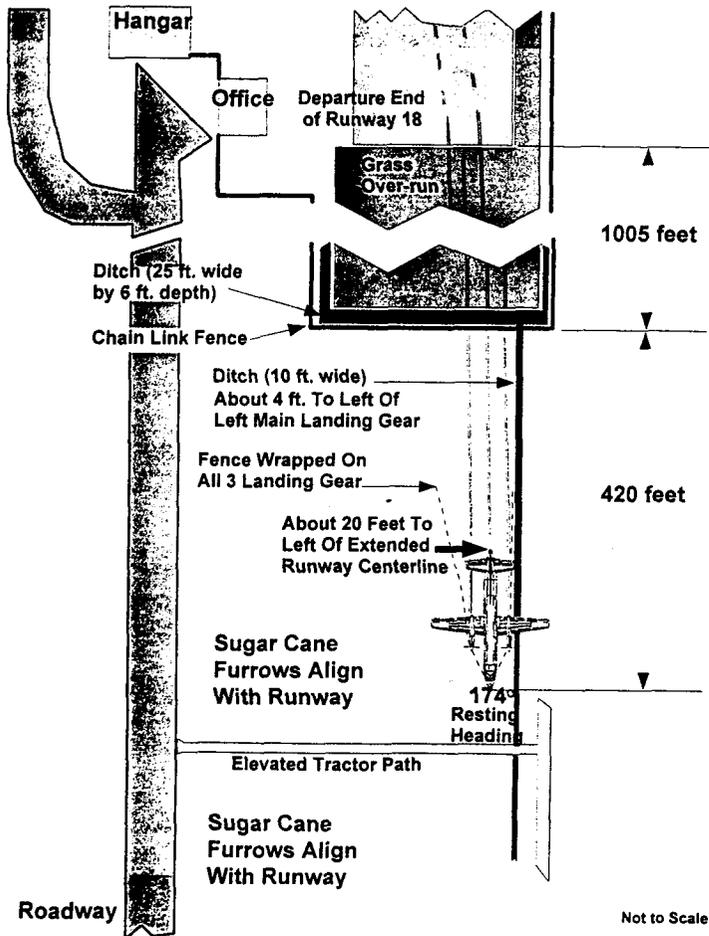
Figure 4a.--Wreckage site and airplane damage.

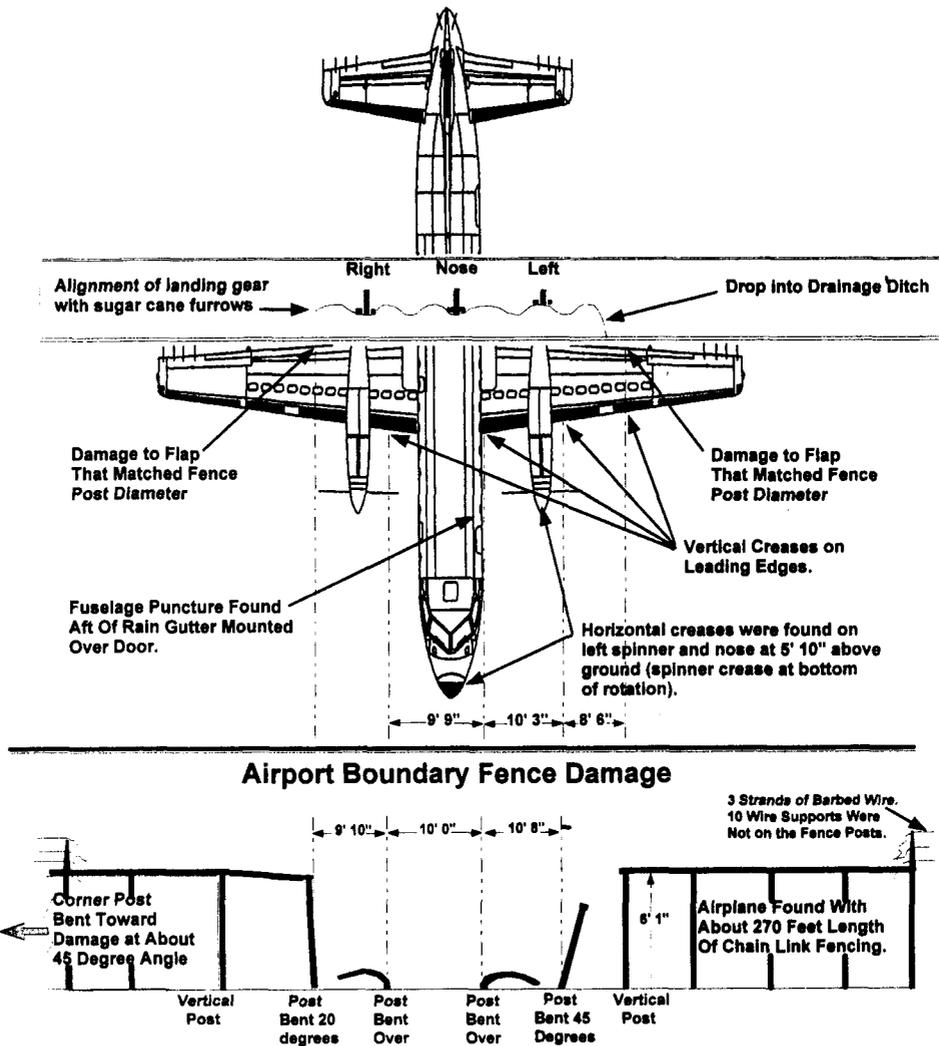
Figure 4b.--Wreckage site and airplane damage.
