AVIATION OCCURRENCE REPORT

FUEL EXHAUSTION

**BUFFALO AIRWAYS (1986) LTD.
DOUGLAS DC-3C C-FROD
FORT SIMPSON AIRPORT, NORTHWEST TERRITORIES .5 nm SW
26 JUNE 1994**

REPORT NUMBER A94W0106

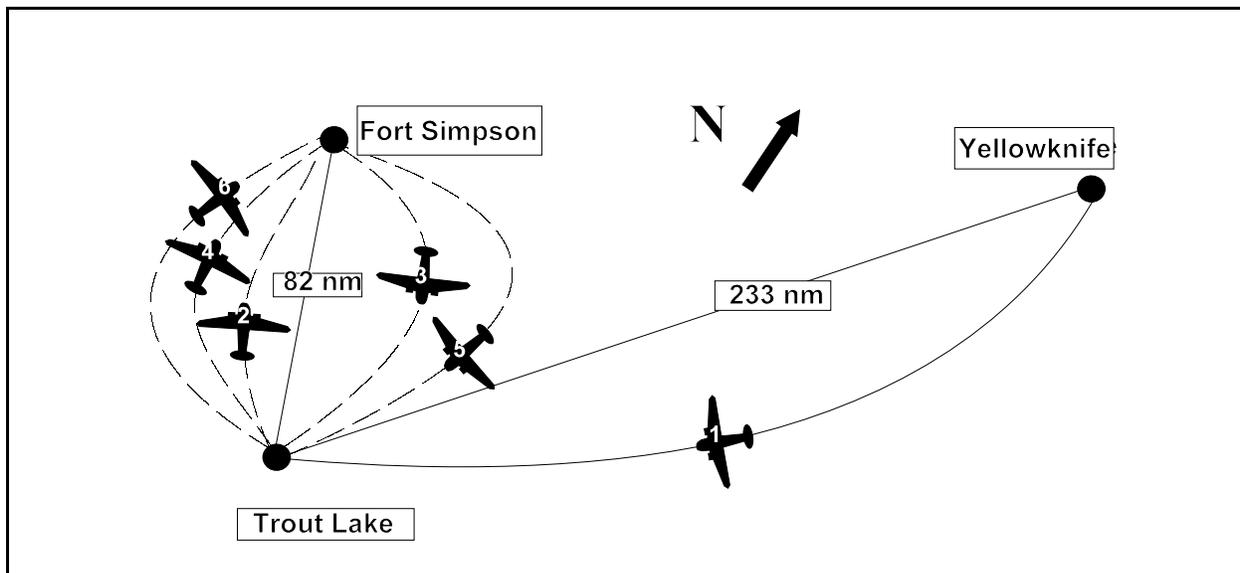
Figure 1 - Flight Segments

At 0925 the aircraft landed at Trout Lake, and the 17 drums of jet fuel were off-loaded; the aircraft then departed for Fort Simpson at 0945. The 82-nautical-mile (nm) flight to Fort Simpson was flown at an altitude of about 2,500 feet above sea level (asl); the flight crew reported encountering light headwinds.

noticed that the fuel pressure was fluctuating, indicating that the auxiliary tanks were empty. The captain repositioned the fuel tank selectors to their respective main tanks and enquired about the dip-stick measurements. The first officer responded that he had not checked the fuel quantity because the fuel dip-stick was missing. The crew discussed the fuel quantity remaining and the captain calculated that the aircraft had approximately 45 minutes of fuel remaining.

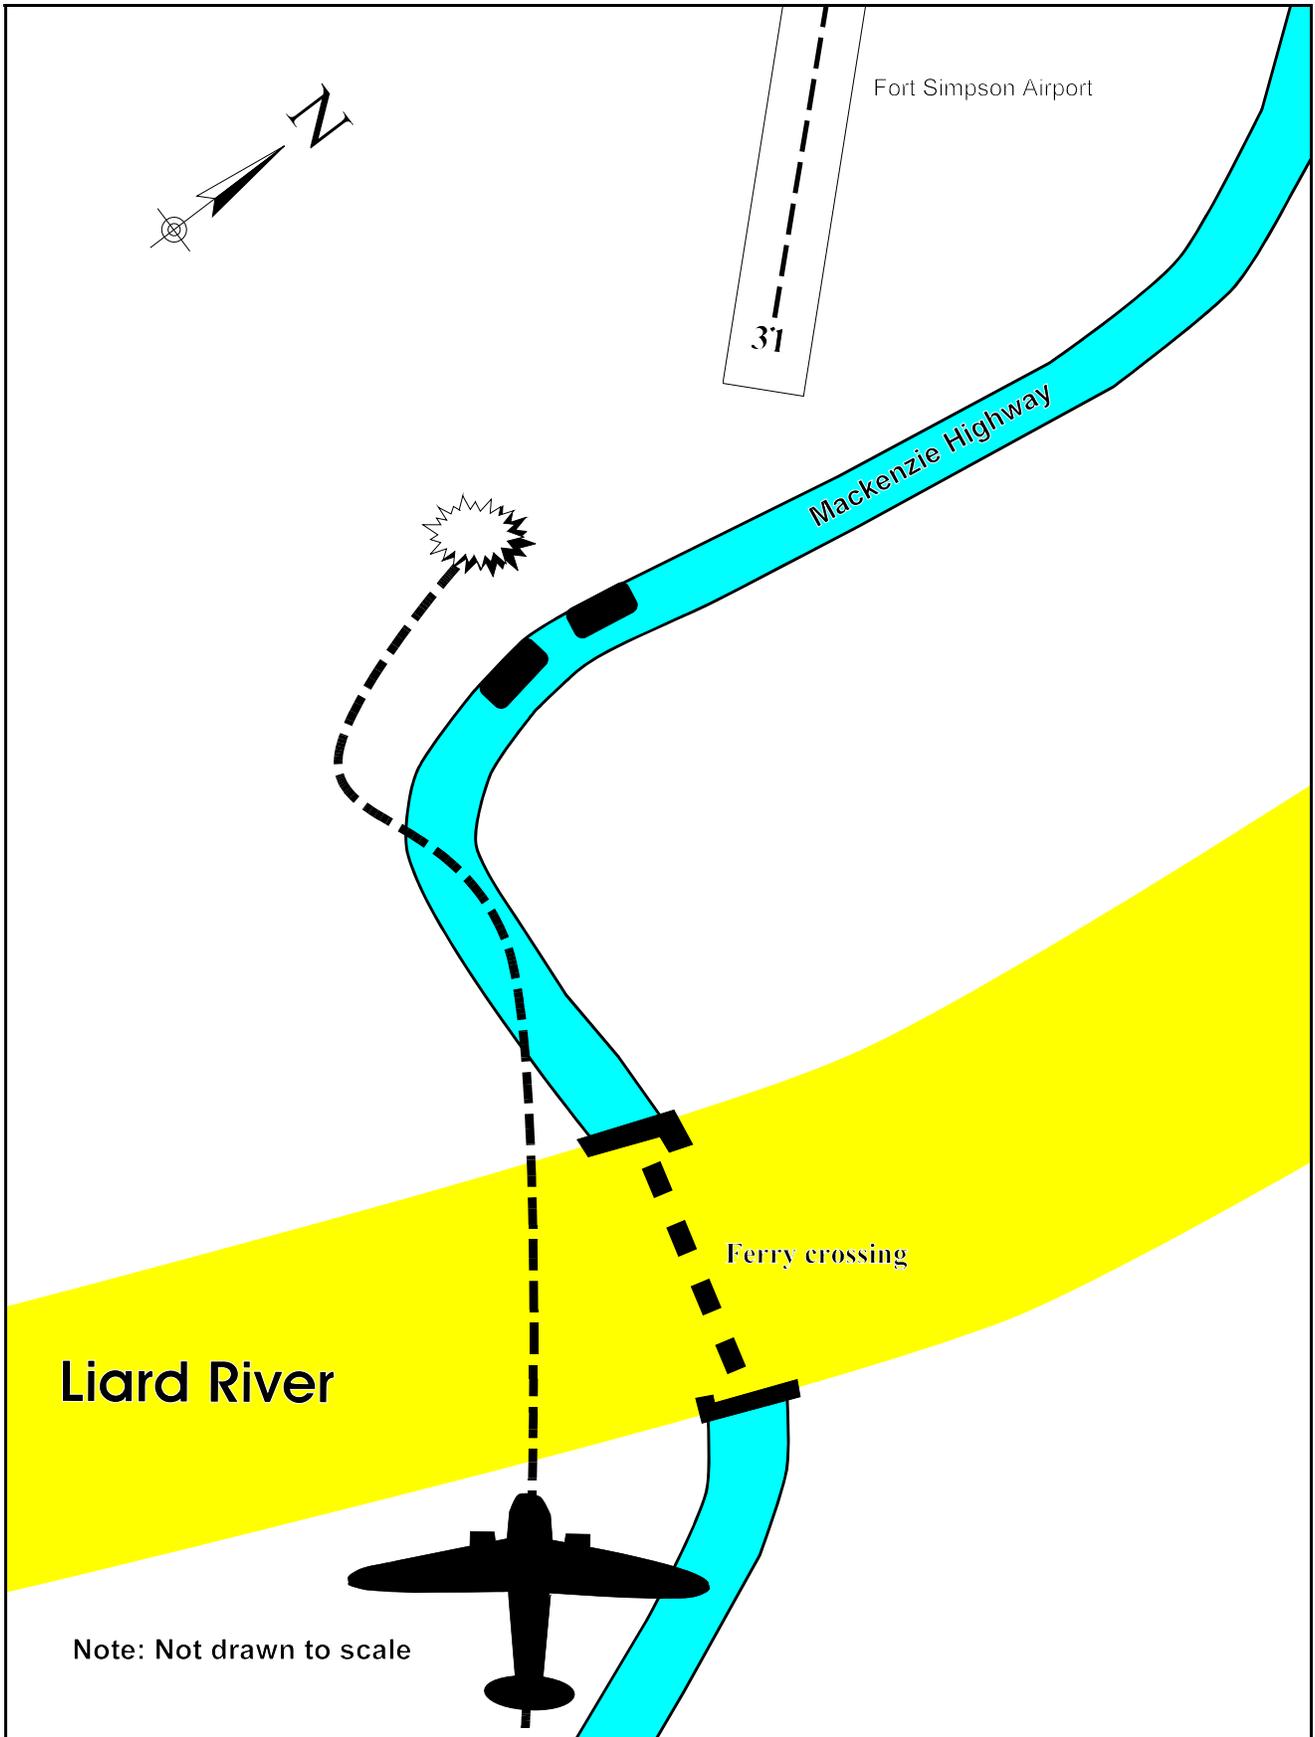
Appendix A - Occurrence Flight Path

Approximately six miles from the airport, at an altitude of about 400 to 500 feet above ground level (agl), the PF advised the PNF that the left engine was losing fuel pressure. Shortly thereafter, the left engine lost power. Immediately, the PNF switched the left fuel boost pump to the ON position, and the left fuel selector from LEFT MAIN to LEFT AUXILIARY tank position. The engine resumed power momentarily, but lost power again. The PNF then switched the left fuel selector to the RIGHT AUXILIARY tank position and the engine regained power; however, it promptly lost power again.

Realizing that the fuel had been depleted in three of the four tanks, the captain took control of the aircraft and headed straight for runway 31. As the captain called for the engine failure check for the left engine, the first officer advised the captain that the right engine was losing power. With a loss of power in both engines, and without sufficient altitude to glide to the airport, the first officer called the Fort Simpson FSS to advise that the flight crew would attempt a landing on the road (Mackenzie Highway) north of the Liard River. However, the approach to the road was

unsuccessful and the aircraft crash-landed into a treed area. (See Appendix A.)
