**Bureau**  
**Enquêtes-Accidents**

**R E P O R T**

*on the accident to Britten Norman  
BN2 B 8P-TAD  
at Bellefontaine (Martinique)  
on July 18 1994*

**8P-D940718**

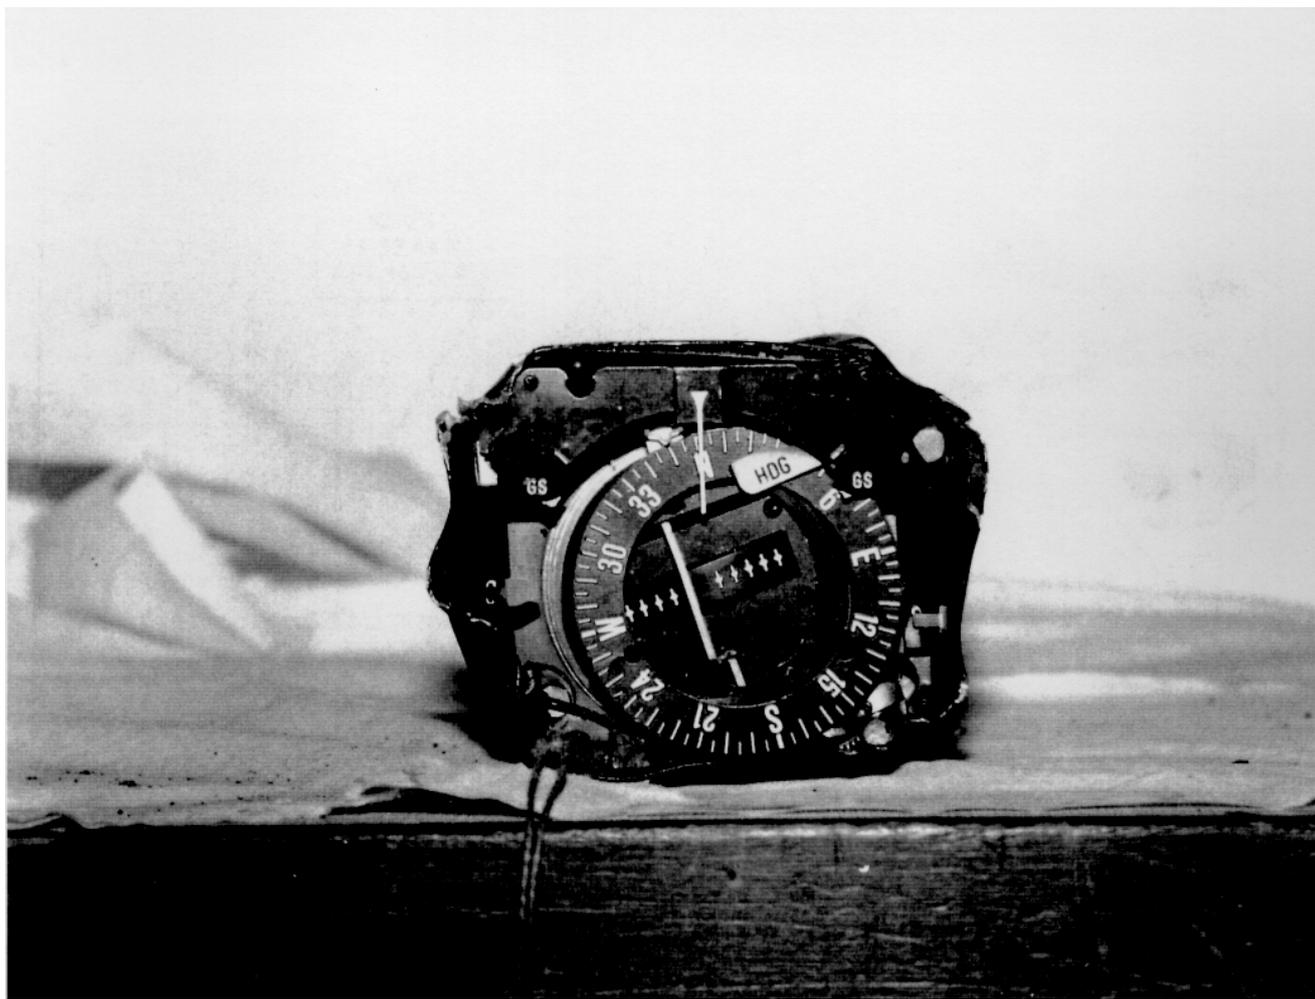
### PLATE 3 (BN2 8P-TAD Crash Site)

The impact occurred eight nautical miles from the airdrome at an altitude of 2700 feet (823 meters). The wreckage was on a bearing of 331 degree from FOF, precisely in line with the extension of its arrival path.

The dispersion of some debris in the trees for one hundred meters fixes the arrival path at 010 degrees magnetic, in level flight with a slight left attitude. The rest of the wreckage was grouped together in the immediate area of the point of impact. The final trajectory was established through broken branches in the vegetation, some of which had been cut off by the propeller blades, indicating that the engines were running on impact.

The airframe was destroyed but no elements of the structure or of the flight control surfaces were missing. The flaps were retracted, indicating the aircraft was in cruise configuration.
