1
PB95-910404
NTSB/AAR-95/04
DCA95MA007

AIRCRAFT ACCIDENT REPORT

CRASH DURING EMERGENCY LANDING
PHOENIX AIR
LEARJET 35A, N521PA
FRESNO, CALIFORNIA
DECEMBER 14, 1994

Abstract: This report explains the accident involving the Phoenix Air Learjet 35A that crashed while attempting an emergency landing at Fresno Air Terminal, Fresno, California, on December 14, 1994. Safety issues in the report focused on maintenance, inspection and quality assurance. Safety recommendations concerning these issues were made to the Federal Aviation Administration, Phoenix Air, and the Department of Defense.

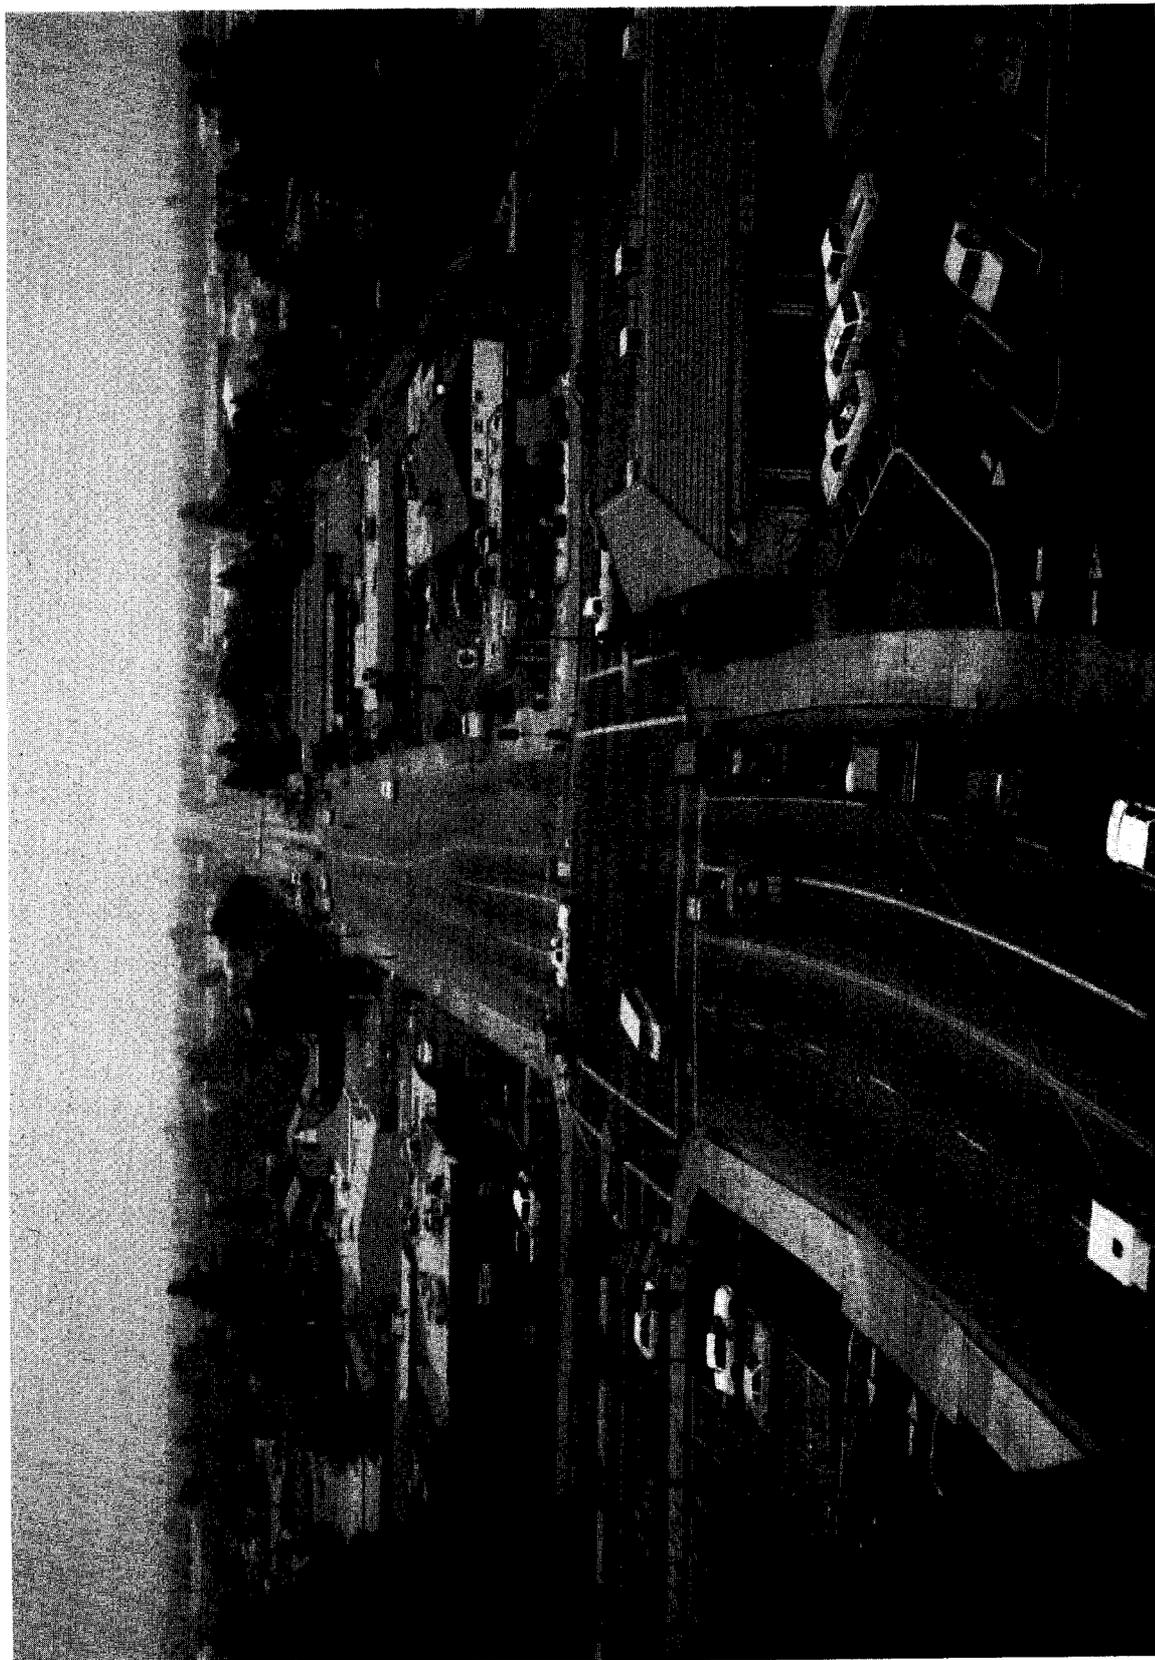
Figure 2a.-- View to the west on E. Olive looking approximately down the final flightpath.

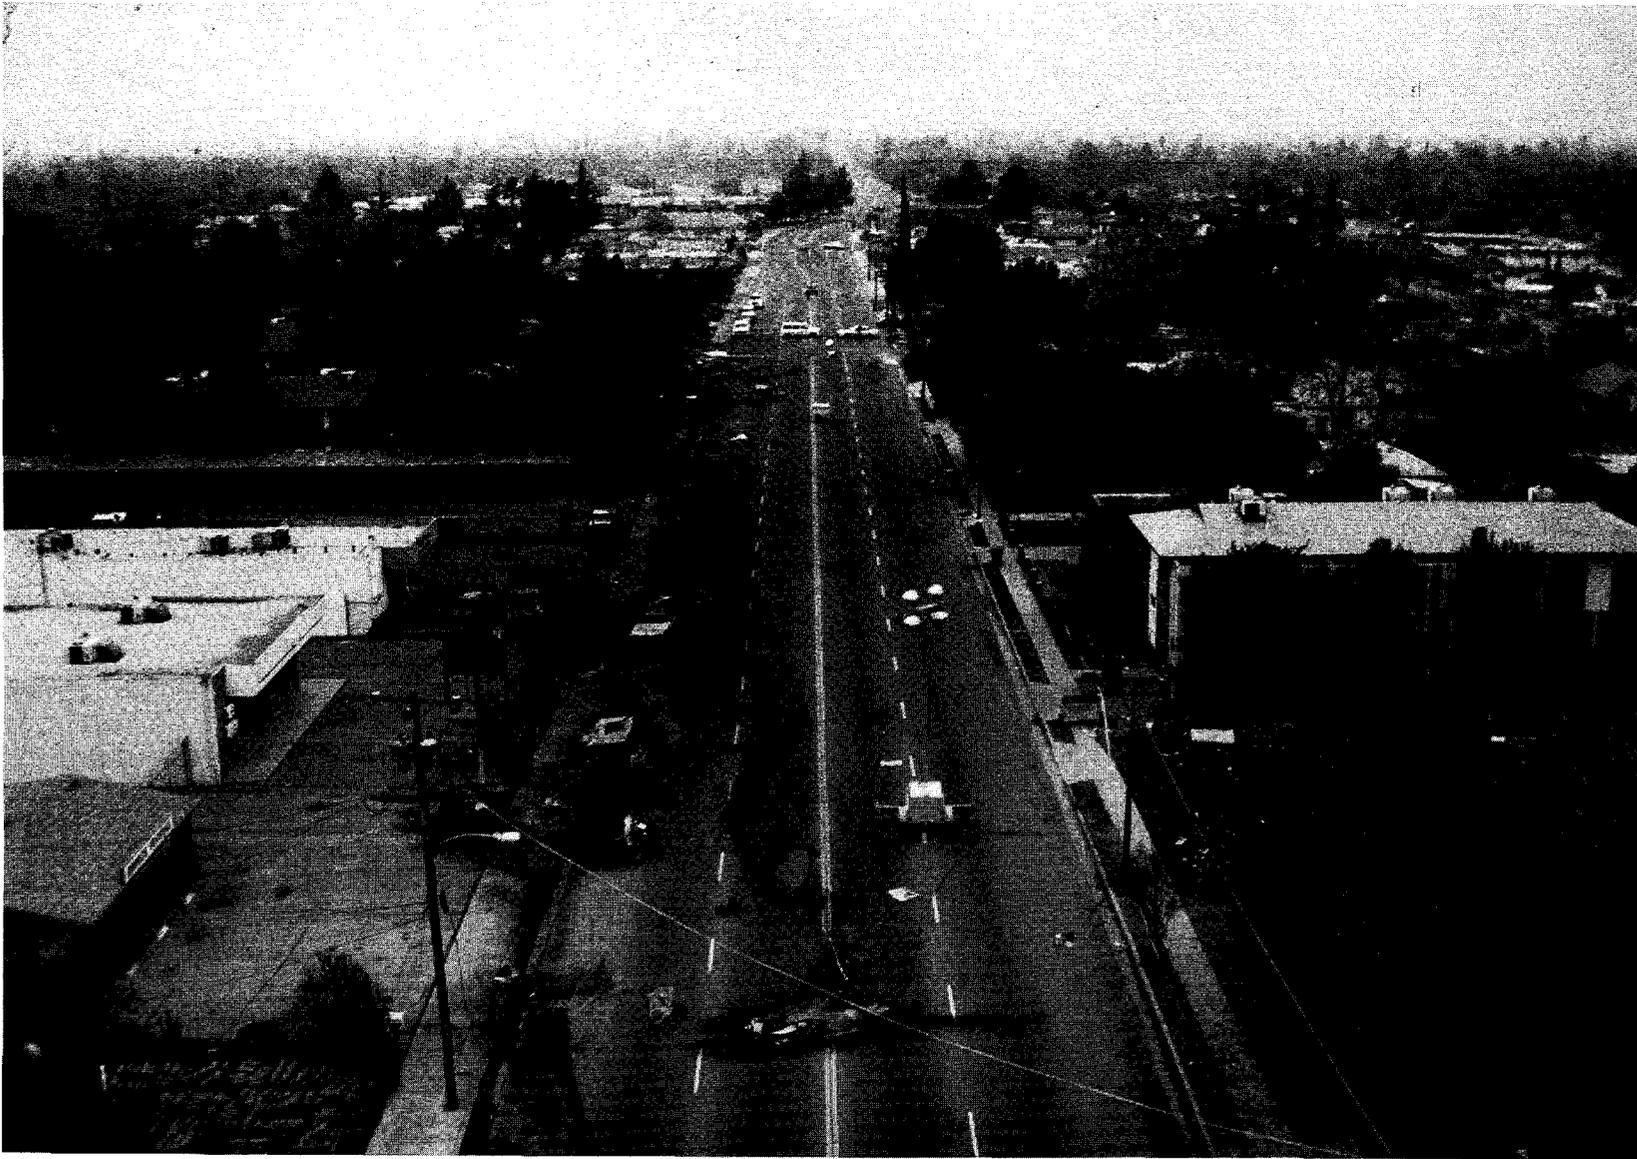
Figures 2b.--View to the east on E. Olive from immediately east of N. Sierra Vista. Last major portions of wreckage in wreckage path are near the bottom of the photograph.

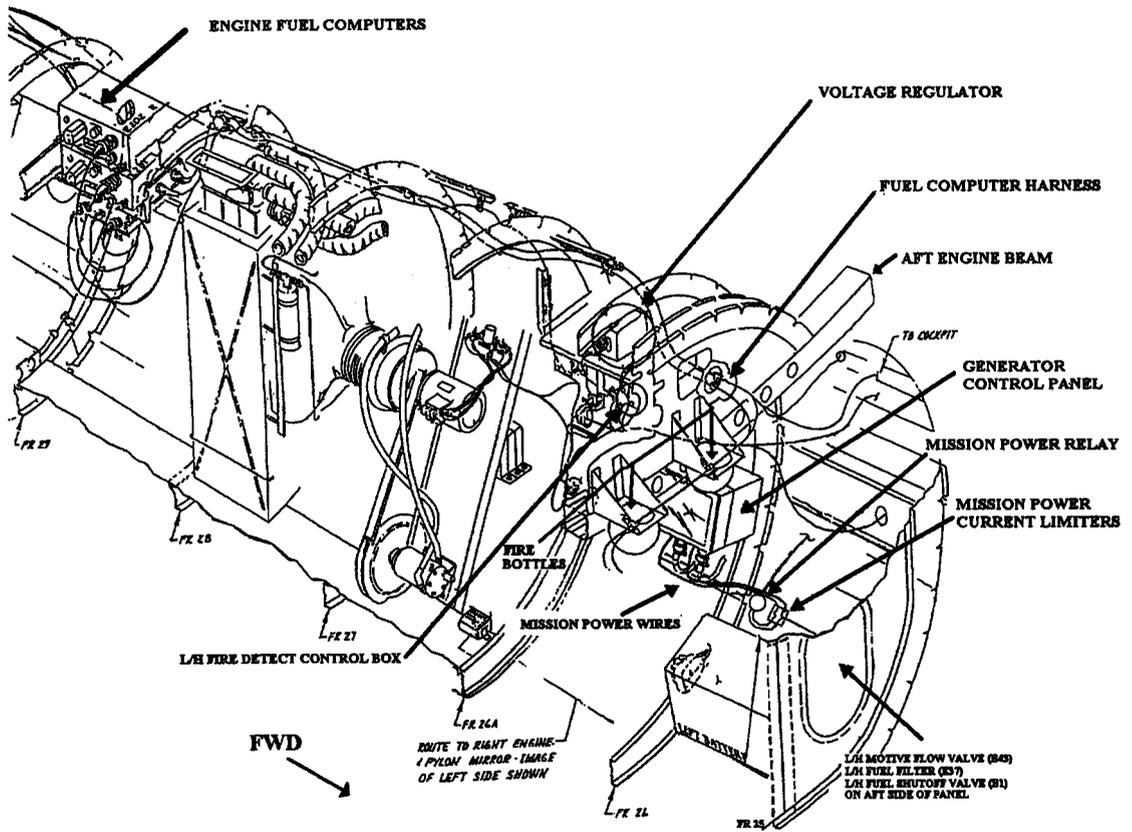
Figure 3a.--Components in tailcone.

The investigation found that in the actual mission equipment wiring of N521PA, the power wires were routed directly to the battery charging bus. (Figure 3a is a drawing of major components in the tailcone. Figure 3b shows the intended versus actual routing of the power wires in N521PA.)

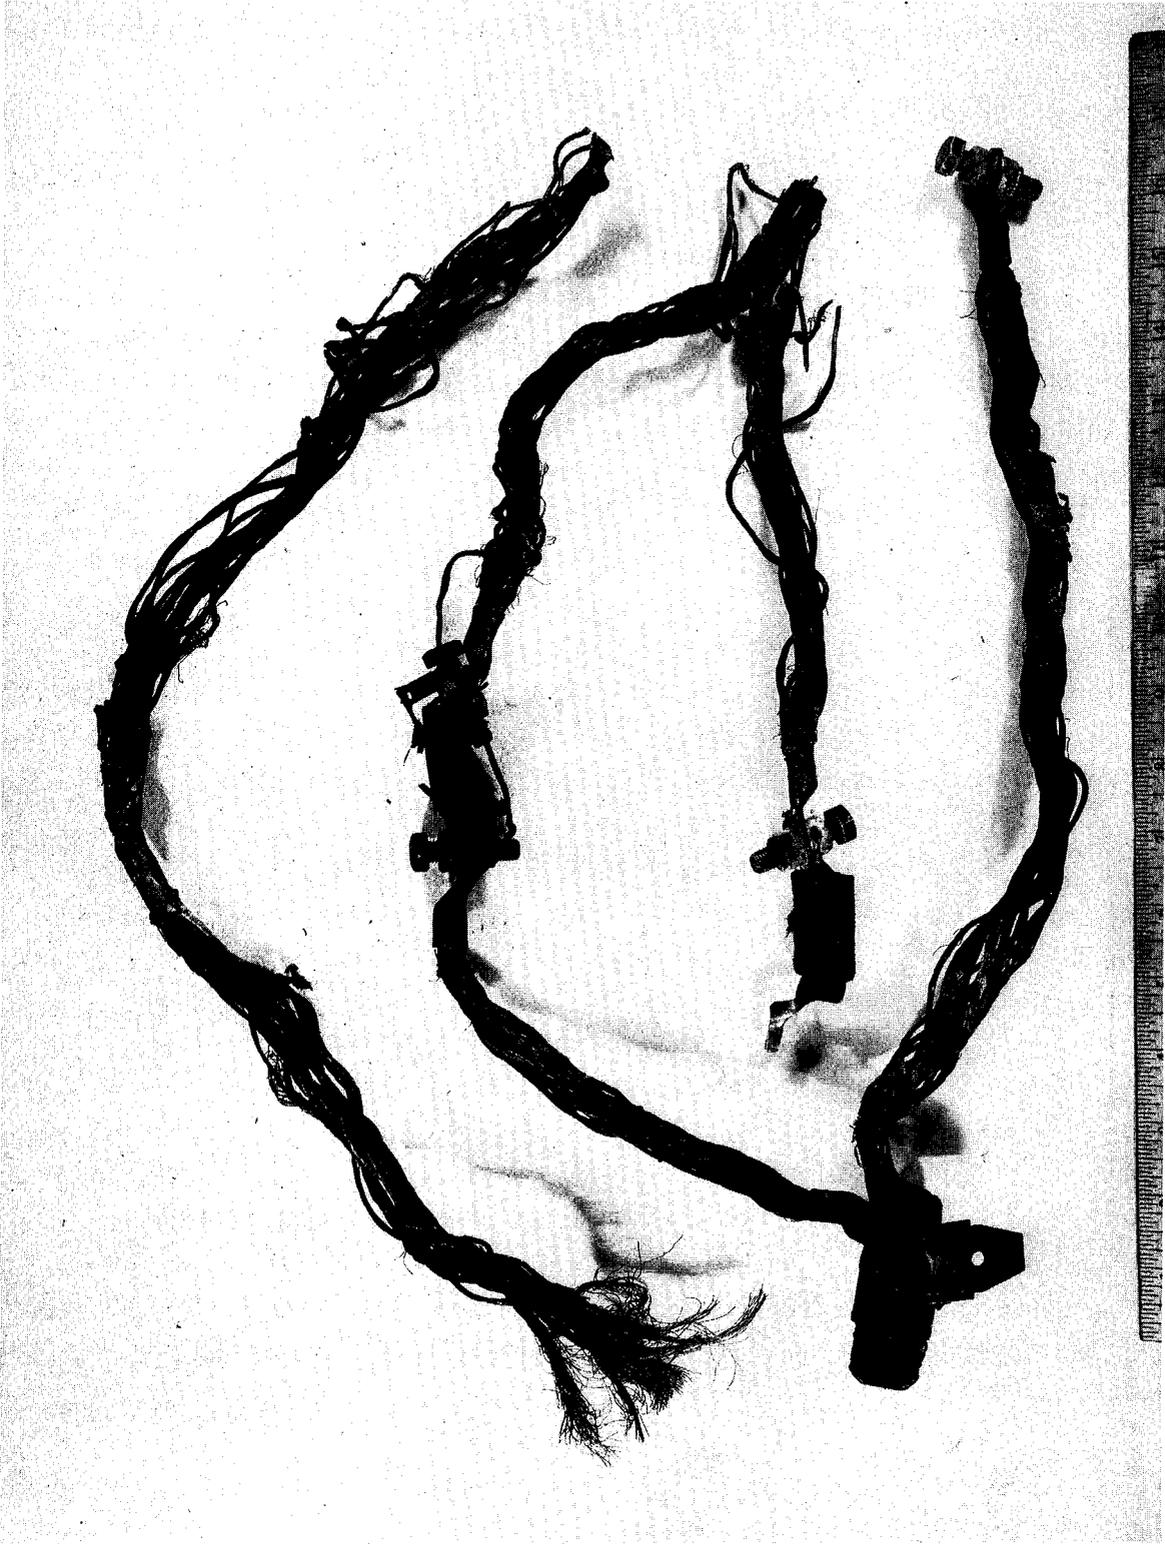
Figure 4.-- View of cables as received for examination.

Portions of the wires, identified as part of the electrical power source for the special mission package, were size No. 0 awg and were found on E. Olive, near the wheel of an unburned vehicle. The wires had evidence of high heating prior to impact, including areas fused together for about 2 inches in length, and individual strands of the wires had a beaded appearance. (See figure 4.) Current limiters (fuses) were found attached to the nonwelded ends of one of the two sets of wires. In subsequent testing, the current limiters were found to provide electrical continuity (in the closed position).
