# NATIONAL TRANSPORTATION SAFETY BOARD

## AIRCRAFT ACCIDENT REPORT

GROUND SPOILER ACTIVATION IN FLIGHT/HARD LANDING  
VALUJET AIRLINES FLIGHT 558  
DOUGLAS DC-9-32, N922VV  
NASHVILLE, TENNESSEE  
JANUARY 7, 1996

**Abstract:** This report explains the ground spoiler activation in flight and subsequent hard landing of ValuJet Airlines flight 558, N922VV, a Douglas DC-9-32 at Nashville International Airport, Nashville, Tennessee. The safety issues discussed in the report include the adequacy of ValuJet's operations and maintenance manuals, specifically winter operations nosegear shock strut servicing procedures; the adequacy of ValuJet's pilot training/crew resource management training programs; flightcrew actions/decisionmaking; the role of communications (flightcrew/flight attendants/operations/dispatch/air traffic control); ValuJet's flightcrew pay schedule; Federal Aviation Administration (FAA) oversight of ValuJet; and the adequacy of cockpit voice recorder (CVR) duration and procedures. Safety recommendations concerning these issues were made to the FAA and ValuJet Airlines.

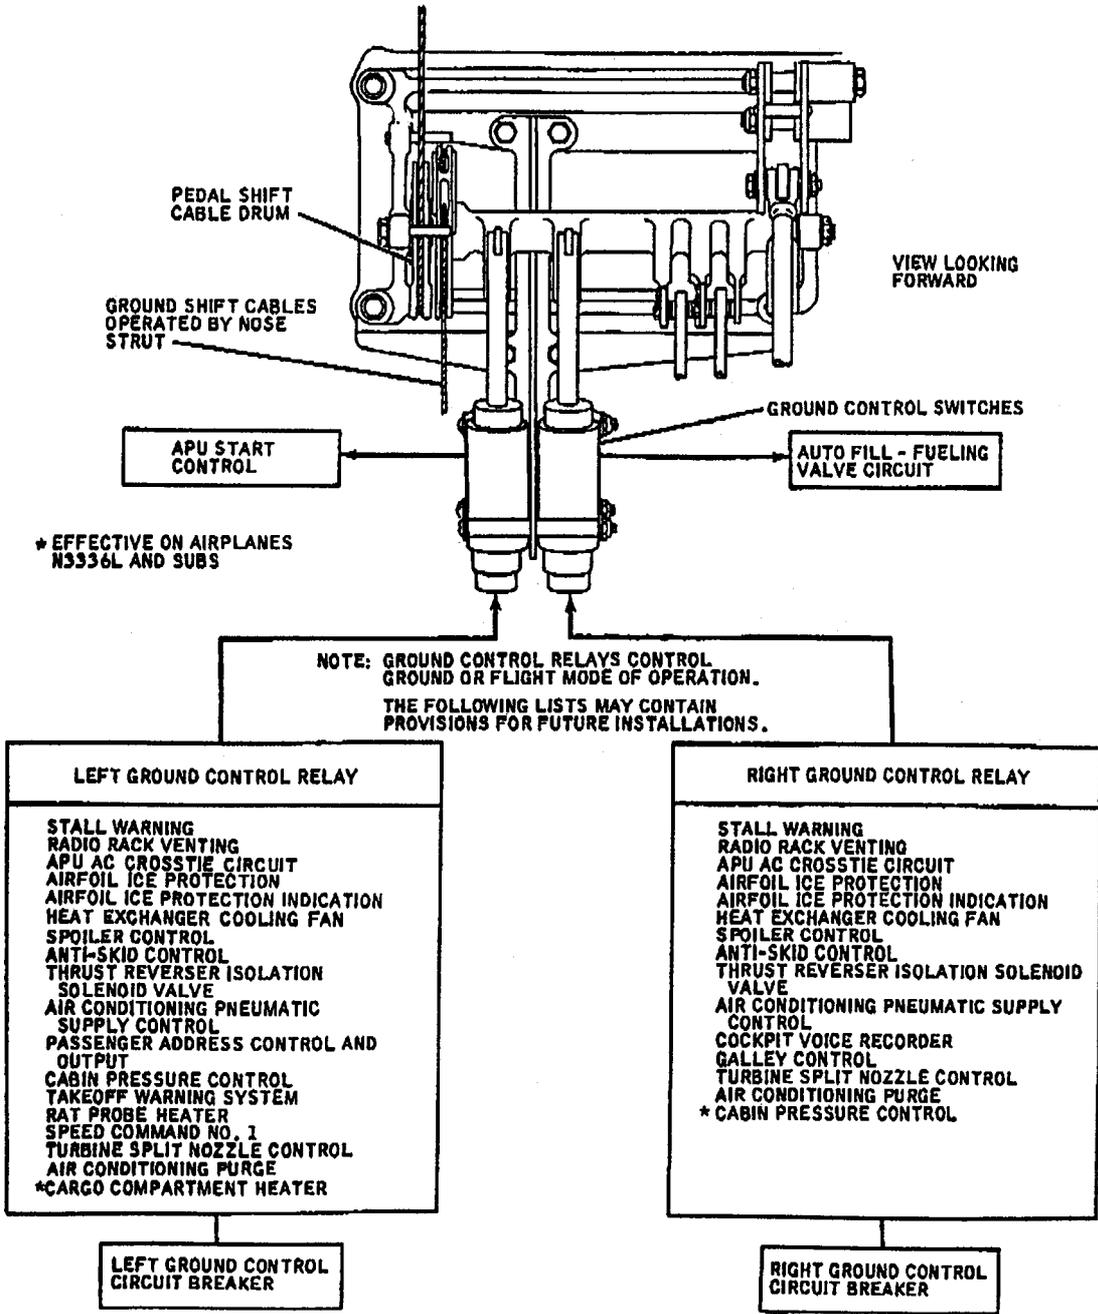
Figure 2—DC-9 Ground Shift Mechanism

The ground shift mechanism, which is actuated by nosegear shock strut extension/compression, controls whether certain aircraft systems operate in the ground or flight mode.<sup>21</sup> When the nosegear shock strut is compressed by the weight of the aircraft, the ground shift mechanism causes those aircraft systems to be operated in the ground mode. When the nosegear shock strut is extended after takeoff, it triggers the ground shift mechanism,

According to Douglas representatives, when the nosegear shock strut is underserviced/underinflated, strut extension after liftoff may not be sufficient to activate the ground shift mechanism to shift the aircraft systems into the flight mode and release the gear lever anti-retraction mechanism. Douglas representatives indicated that this is a commonly reported occurrence during cold weather operations. They stated that Douglas had issued numerous service bulletins (SBs) and all operator letters (AOLs) describing the anomaly and recommending maintenance procedures to avoid underserviced/underinflated nosegear shock struts during cold weather operations.<sup>23</sup>

It is likely that the nosegear shock strut did not extend far enough to actuate the ground shift mechanism because it was underserviced/underinflated for the cold/winter weather conditions. The en route portion of the flight proceeded uneventfully. When the airplane was about 100 feet above the ground during the approach to Nashville, the pilots reset the ground control relay circuit breakers, thereby unintentionally shifting the airplane systems from the flight mode to the ground mode. The ground spoilers subsequently extended in flight, and the airplane descended suddenly, impacting the ground in the runway approach light area.

Accordingly, the Safety Board believes that ValuJet should develop, immediately, a more extensive and accurate winter operations manual, with corresponding adjustments to maintenance procedures, to reflect the manufacturer's cold weather nose gear servicing procedures. Further, because no airline is exempt from encountering a range of weather extremes, the Safety Board believes that the FAA should require all airlines to review their operations and maintenance manuals and, if necessary, adjust or expand these manuals to reflect the manufacturer's recommended cold weather nose gear servicing procedures.
