AIRCRAFT ACCIDENT REPORT

WHEELS-UP LANDING
CONTINENTAL AIRLINES FLIGHT 1943
DOUGLAS DC-9 N10556
HOUSTON, TEXAS
FEBRUARY 19, 1996

**Adopted: February 11, 1997
Notation 6804**

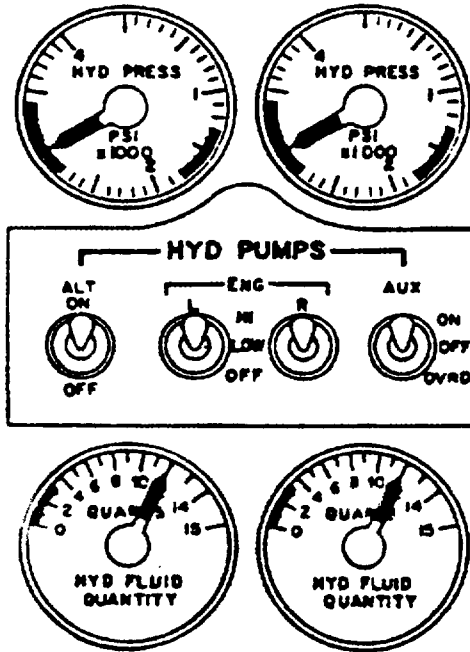
Figure 1 – Hydraulic switch panel.

Upper Illustration - Hydraulic switch panel in high pressure configuration.

Bottom Photo - Photo of accident airplane's hydraulic switch panel in low pressure configuration (see section 1.12).

Examination of the cockpit revealed that the landing gear handle was in the down position and the flap handle was set to 50°. The left and right engine-driven hydraulic pump switches were in the “LOW” position, and the ALT and AUX hydraulic pump switches were in the “OFF” position. The left hydraulic system gauge indicated 1,600 psi, and the right gauge indicated 0 psi (refer to figure 1). The safety wire on the GPWS flap override switch was found broken; however, the switch was not in the “OVRD” position.

The evidence indicates that the airplane's hydraulic system was not configured for landing. Because the hydraulic system remained in the low pressure mode, hydraulic pressure was not available to lower the landing gear and deploy the flaps. The flightcrew failed to detect this configuration error and continued its approach into Houston. Comments on the CVR and postaccident statements by the flightcrew indicate that both pilots recognized that the flaps did not deploy after the flaps were selected to 15°, but the flightcrew did not determine the cause of this problem or execute a go-around.
