AIRCRAFT ACCIDENT REPORT

In-flight Breakup Over the Atlantic Ocean
Trans World Airlines Flight 800
Boeing 747-131, N93119
Near East Moriches, New York
July 17, 1996

**NTSB/AAR-00/03
DCA96MA070
PB2000-910403
Notation 6788G
Adopted August 23, 2000**

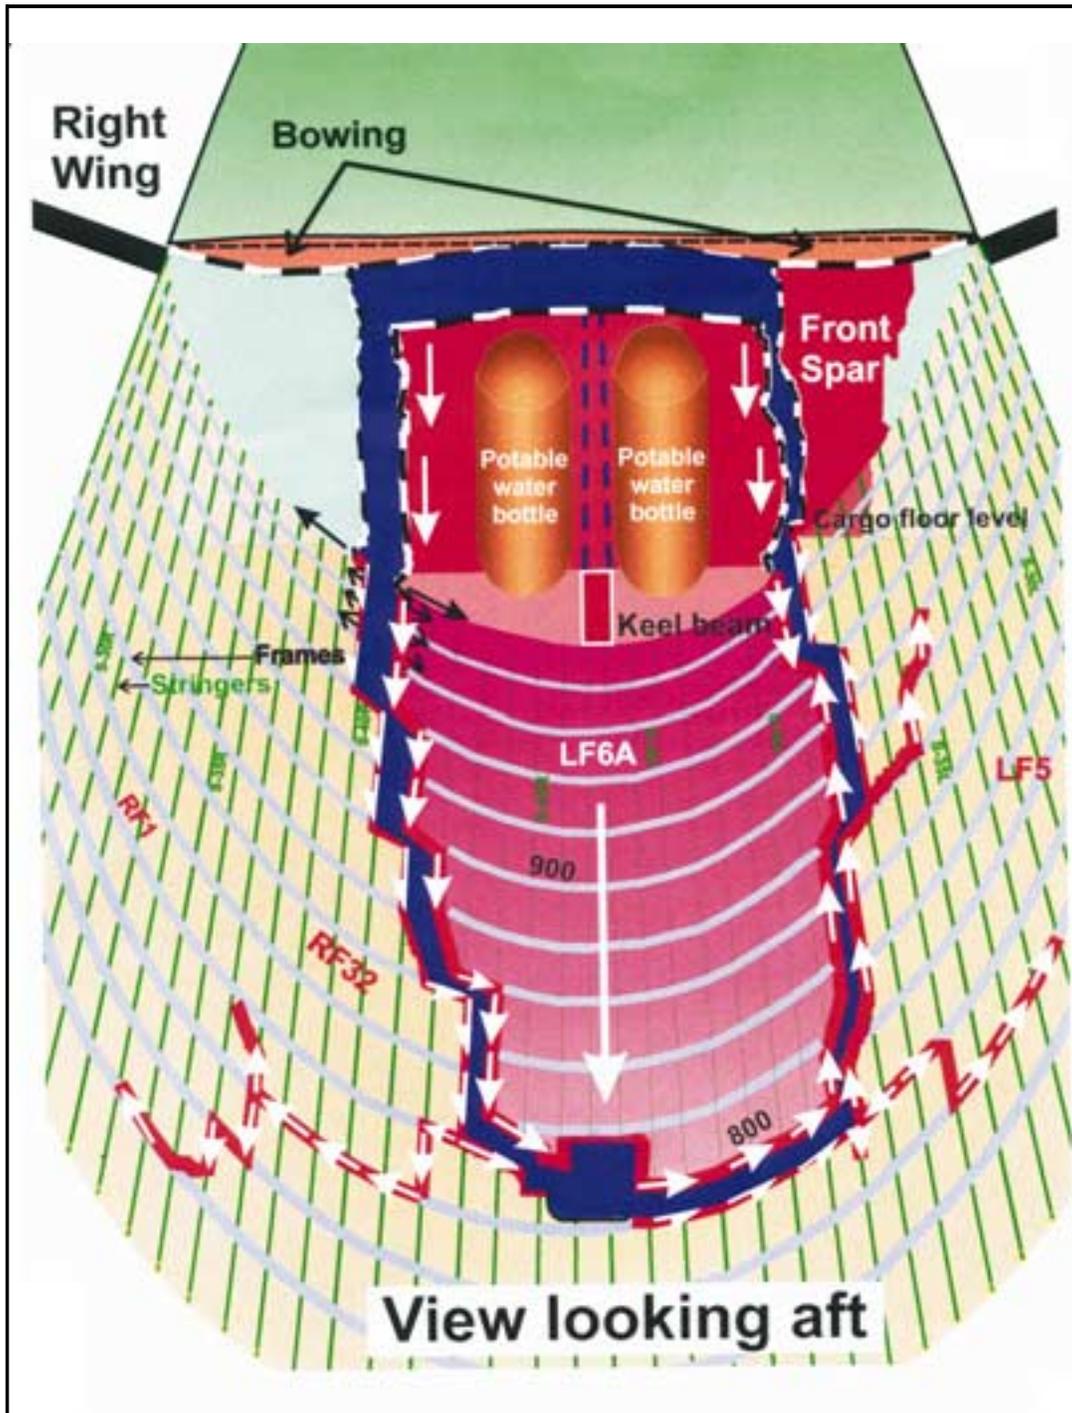
Figure 30. A schematic drawing of the lower portion of the fuselage skin in the area

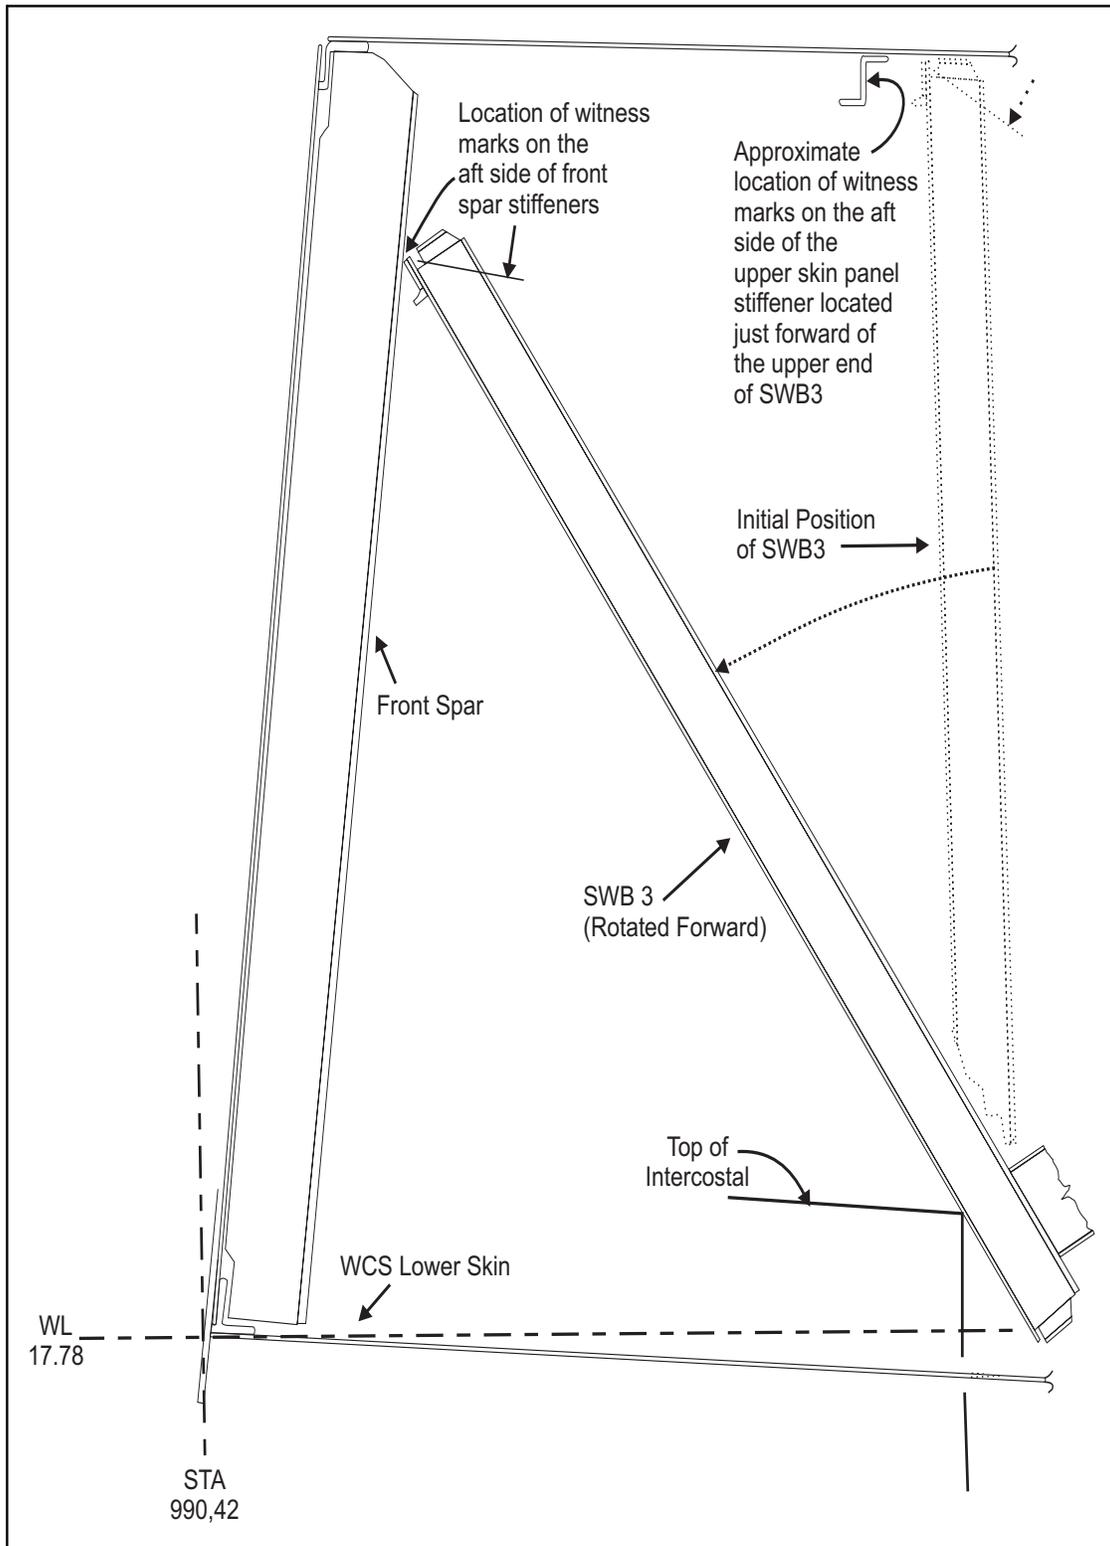
Figure 31. Diagram showing the approximate shape of the upper skin panel stiffener and its location before being struck by SWB3 as the beam rotated forward.
