PB97-910403
NTSB/AAR-97/03
NYC97MA005

AIRCRAFT ACCIDENT REPORT

DESCENT BELOW VISUAL GLIDEPATH
AND COLLISION WITH TERRAIN
DELTA AIR LINES FLIGHT 554
MCDONNELL DOUGLAS MD-88, N914DL
LAGUARDIA AIRPORT, NEW YORK
OCTOBER 19, 1996

**Adopted: August 25, 1997
Notation 6785B**

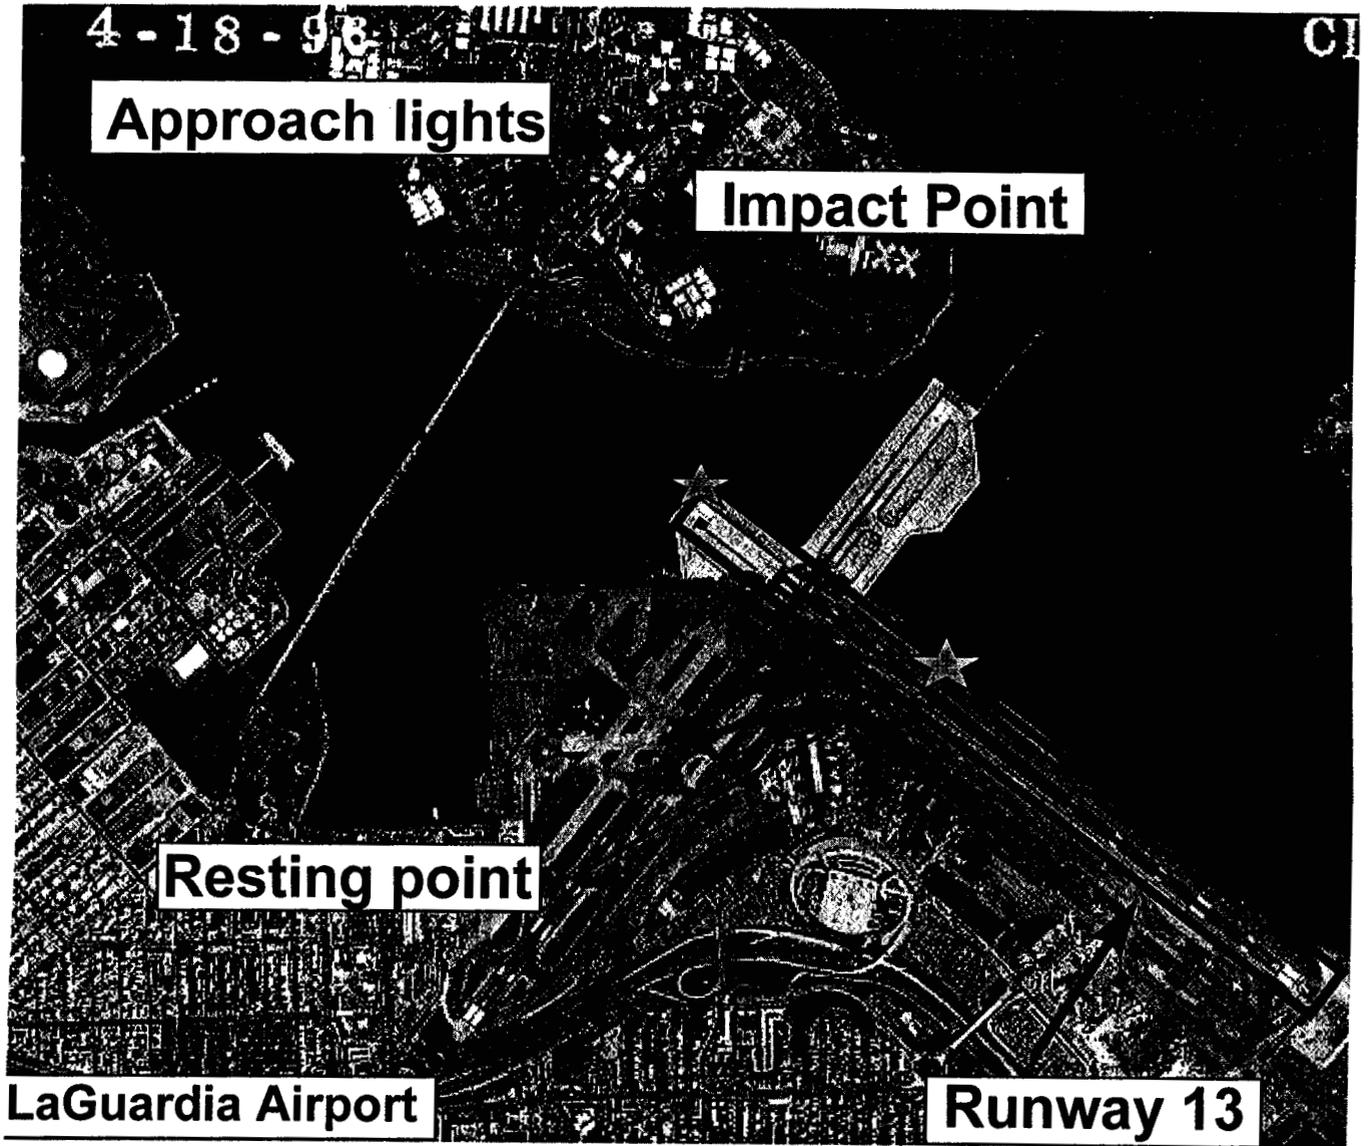
Figure 2—LaGuardia Airport, with runway 13 approach lights, the point of initial impact, and the point where the airplane came to rest on runway 13 depicted

The metal runway approach light structure and the wooden catwalk that accessed it were damaged when the airplane struck the approach light structure. The approach end of the runway deck and the runway/pier support stanchions were also damaged. The estimated cost to repair the damage to airport property was about \$240,000.

Postaccident examination revealed damage to the approach light bars located 203 and 100 feet short of the approach end of the runway deck, the access catwalk structure, the edge of the runway deck, the runway deck support structure, and six runway threshold lights. The plywood on the vertical portion of the runway deck exhibited two main areas of impact damage; both areas of damage extended from the upper surface to a point approximately 3 feet 9 inches below the upper surface of the deck and were approximately 4 feet wide. The approximate midpoints of the damaged areas were located 11 feet and 27½ feet left of the extended runway centerline.³⁷ In addition, debris from the approach light structure and the access catwalk was found embedded in the plywood at the end of the runway deck.

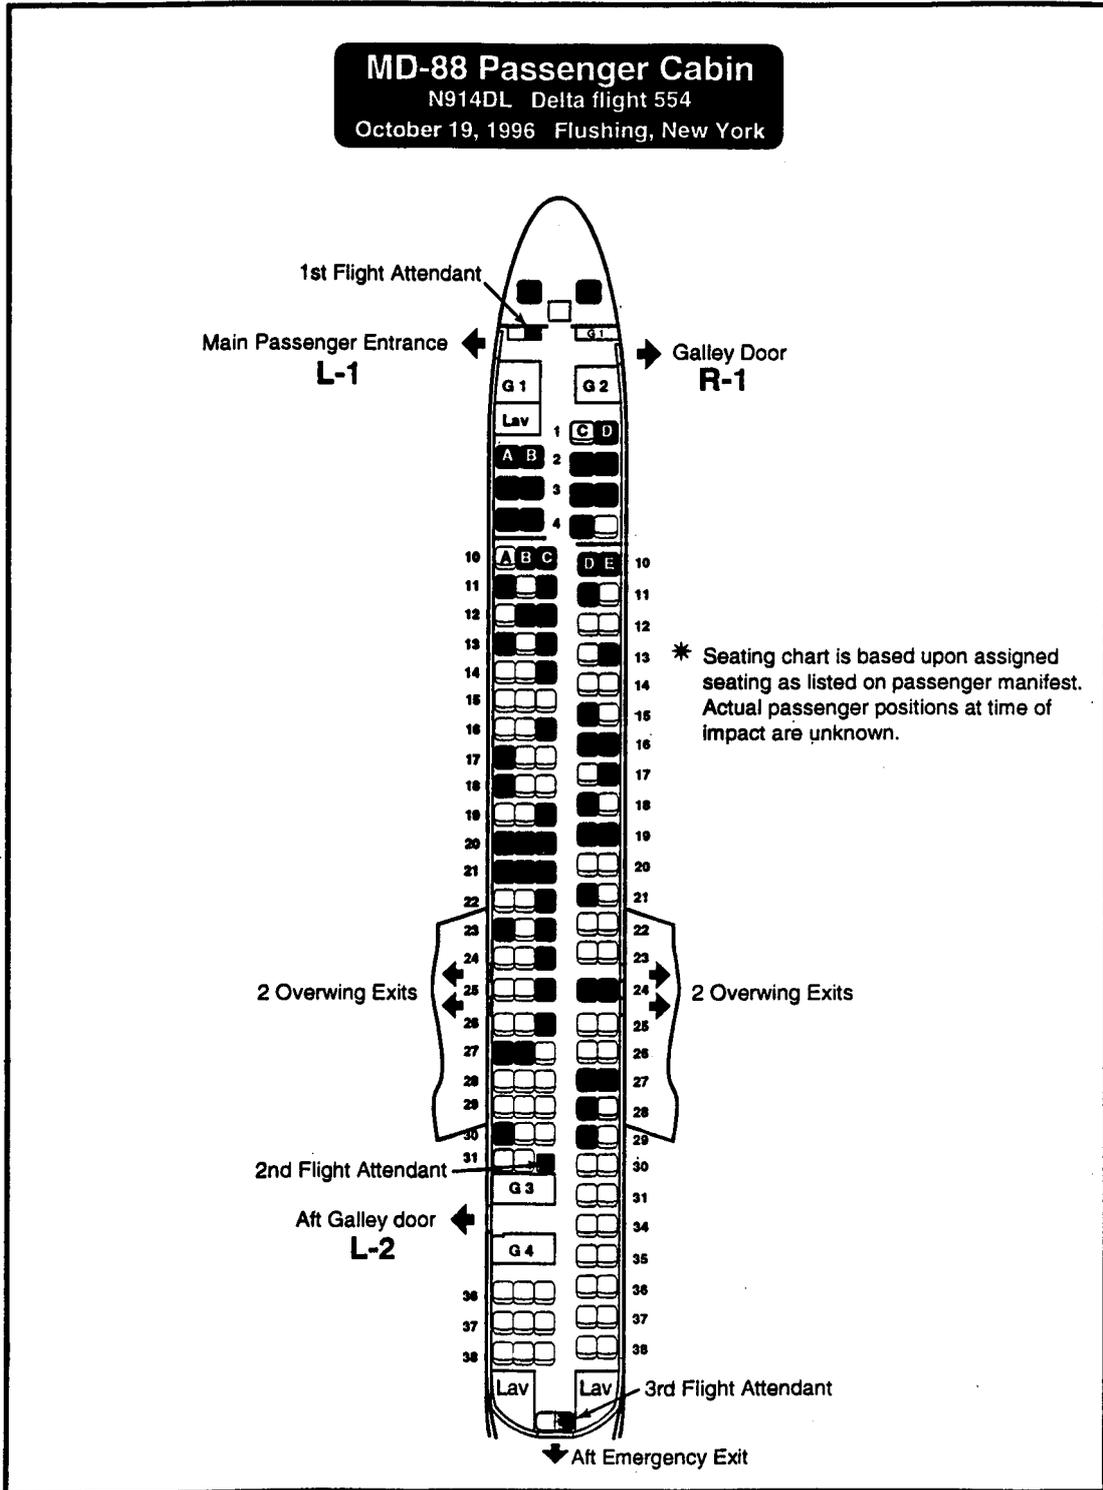
Figure 4—Airplane diagram and seating chart

Although no serious or fatal injuries occurred in this accident, the Safety Board examined the flight and cabin crew decisions and procedures during the emergency evacuation. The airplane was configured with 142 passenger seats, 58 of which were occupied on the accident flight. Two floor-level exits were located in the forward cabin; four overwing exits were located at seat rows 20 and 21; one floor-level exit was located in the aft galley, on the left side of the cabin; and a tailcone exit was located at the rear of the cabin. According to the flight attendants and dispatch documentation, most of the passengers were seated forward of the overwing exits. All airplane occupants were evacuated safely through the forward left (L-1) door. See figure 4 for an airplane diagram and seating chart.

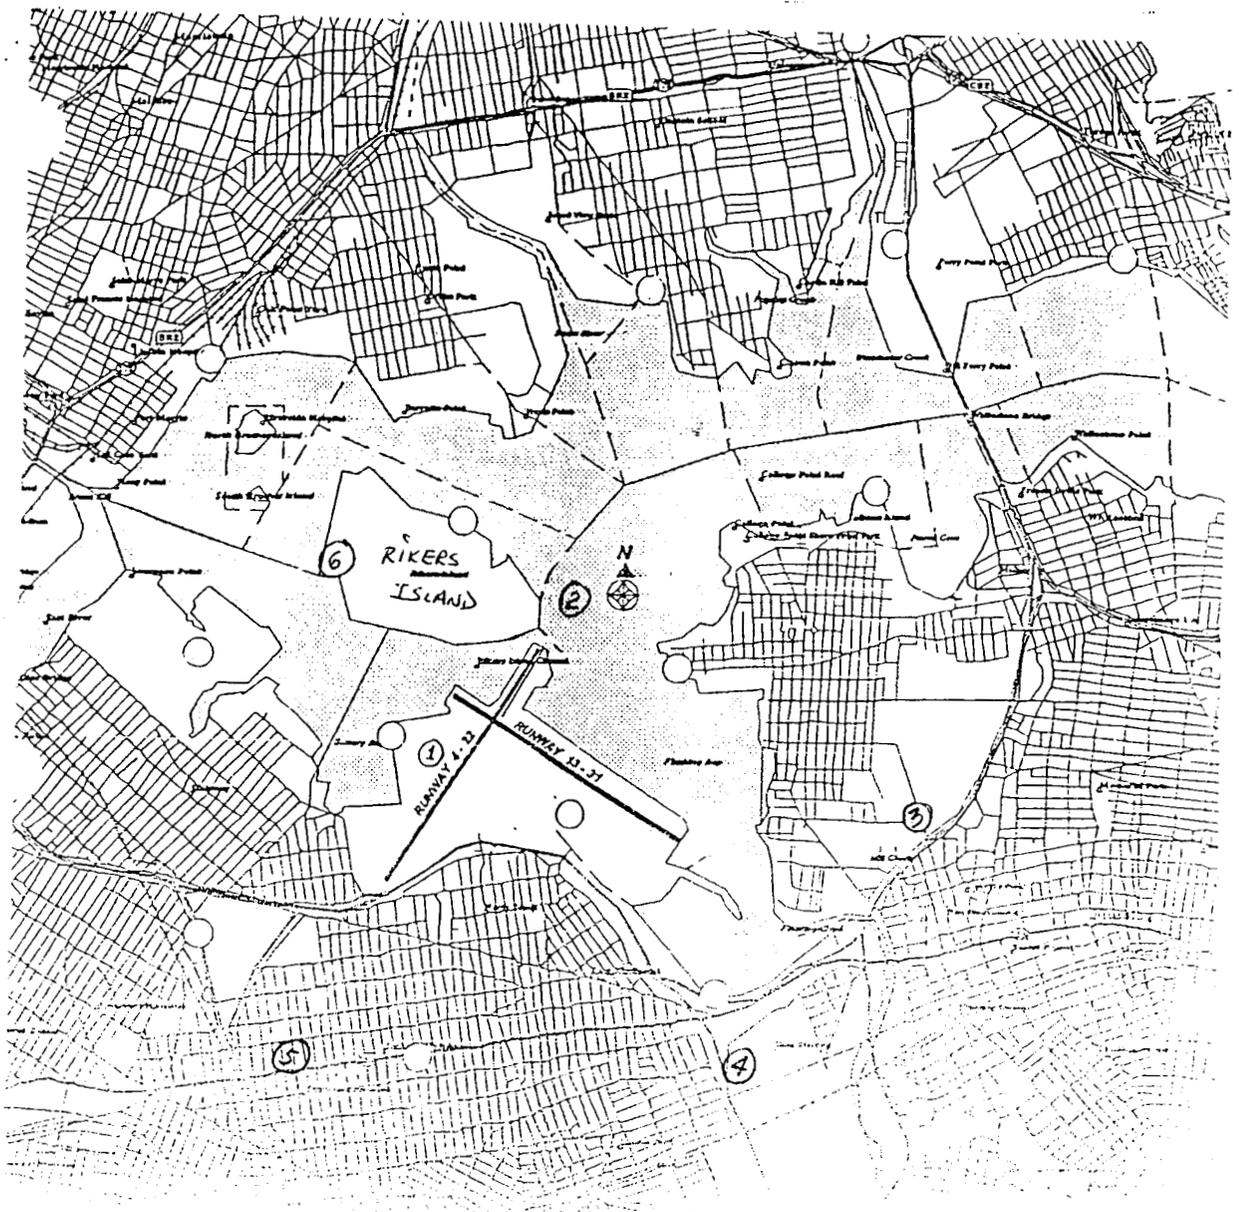
LLUAS Sensor Locations

After the accident, the FAA performed a site performance evaluation system of the LLWAS archived data. The examination revealed that three of the six sensors (sensors 3, 4, and 5) appeared to have problems. According to the FAA, the sensor problems might have resulted in the system's failure to detect existing windshears, or the system producing false windshear warnings.
