## FINAL REPORT

**AAIU Report No: 2004-023**

<b>Operator:</b>	Air Zimbabwe
<b>Manufacturer:</b>	Boeing
<b>Model:</b>	707-330B
<b>Nationality:</b>	Zimbabwe
<b>Registration:</b>	Z-WKU
<b>Location:</b>	Shannon Airport, Ireland
<b>Date/Time (UTC):</b>	10 March 1997, 23.15 hrs

### **SYNOPSIS**

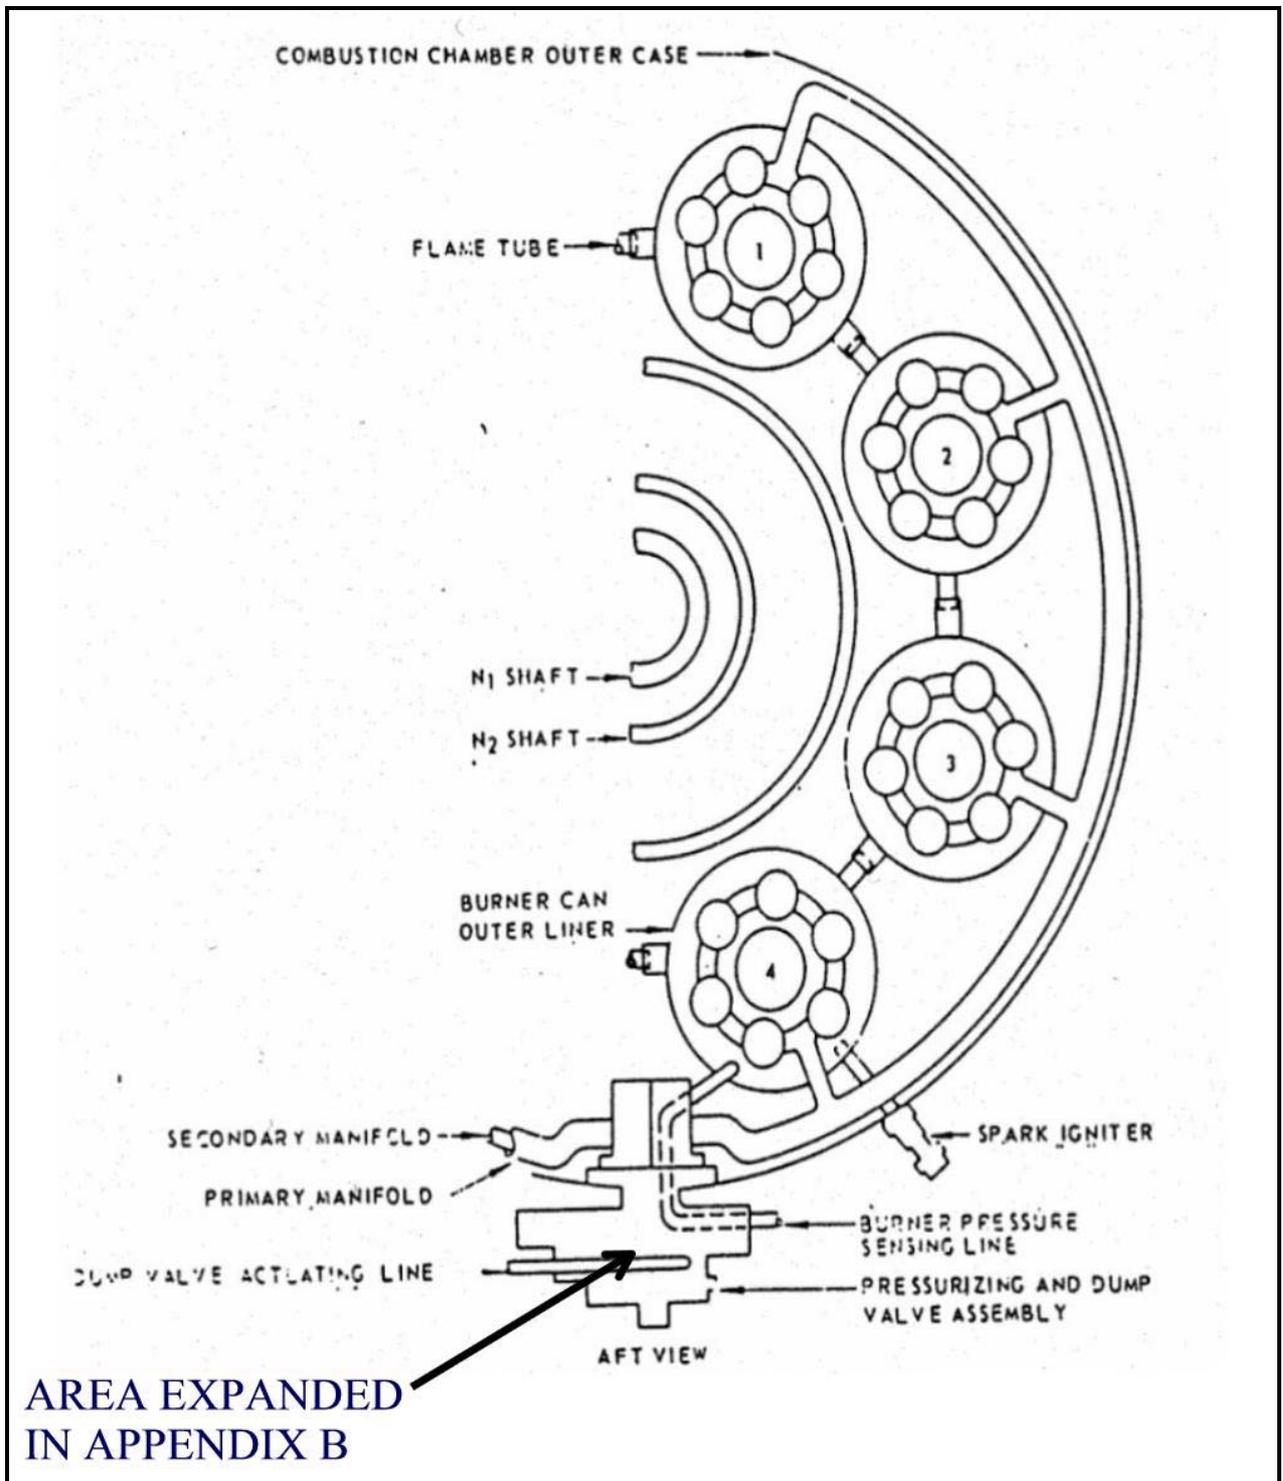
Appendix A

The manifolds consist of 2 semi-circular rings, with nozzles located on various points, from which fuel is sprayed into the combustion cans. Each manifold has four nozzle clusters, each cluster comprising of six nozzles. Each nozzle has two jets; the inner being the primary fuel jet while the outer co-axial jet is for the secondary fuel. The primary fuel path supplies fuel continuously, whereas the secondary fuel path only supplies fuel when the fuel flow rate reaches 2,000 lbs per hour. This equates to an engine speed of about 75% (7,300 RPM) N2 or higher, which is approximately off-idle power or higher. The general layout of these components is shown in **Appendix A**

VIEW OF THE FUEL MANIFOLD ASSEMBLY

THE P&D VALVE IS AT THE BOTTOM OF THE DIAGRAM

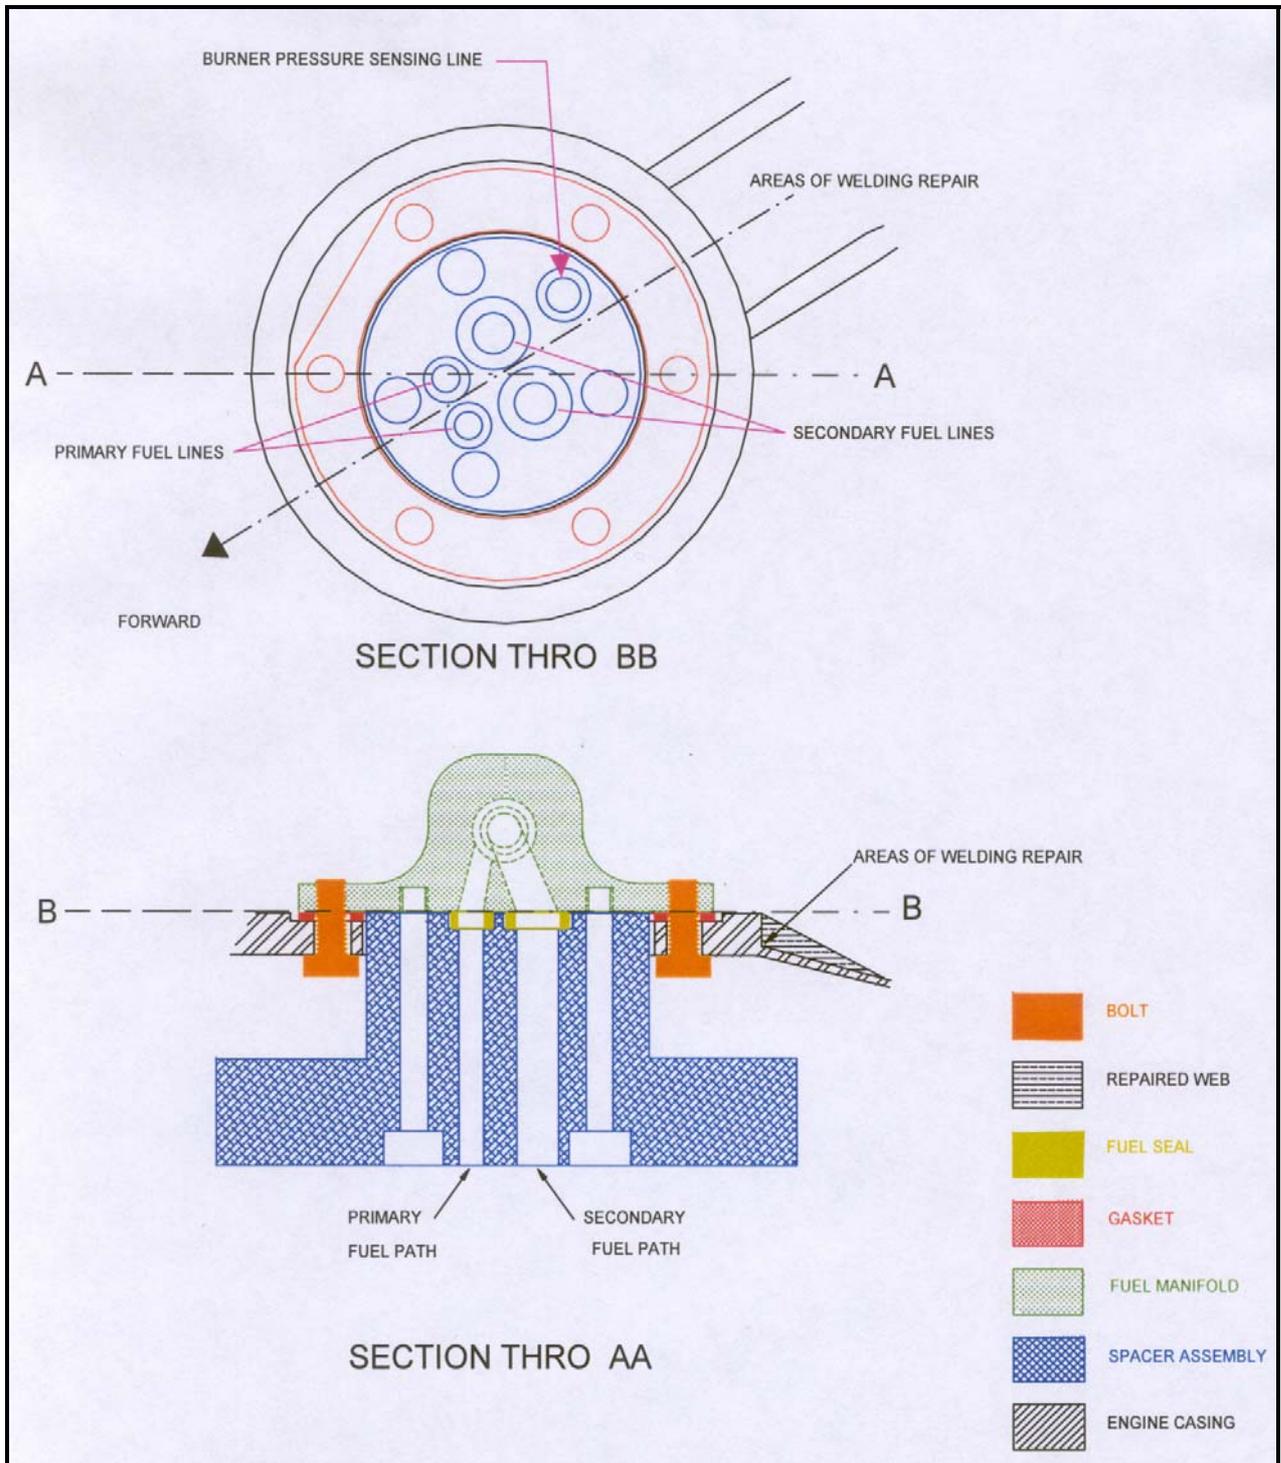
## Appendix B

**1.6.4.2** The attachment of the P&D Valve Assembly is shown in **Appendix B**. The fuel manifold comprises of a right hand section and a left hand section, and is clamped to a flat bearing surface, known as the mounting-boss, on the inside of the diffuser casing. Three 12-point bolts secure each section. A copper gasket seals this joint. A spacer assembly is fitted through a hole in the diffuser casing, located directly underneath the manifold assembly. The spacer assembly is secured to the manifold assembly by means of four socket head cap screw bolts. There are four fuel paths through the spacer assembly, into the manifolds. The front two paths supply primary fuel to the left and right fuel manifolds respectively, and the rear two paths supply secondary fuel, again one to each of the left and the right fuel manifolds. Each of these four fuel paths is sealed by a metal seal at the spacer/manifold interface. The P&D valve is then bolted, underneath, to the spacer assembly.

SKETCH OF THE P&D VALVE MOUNT LAYOUT

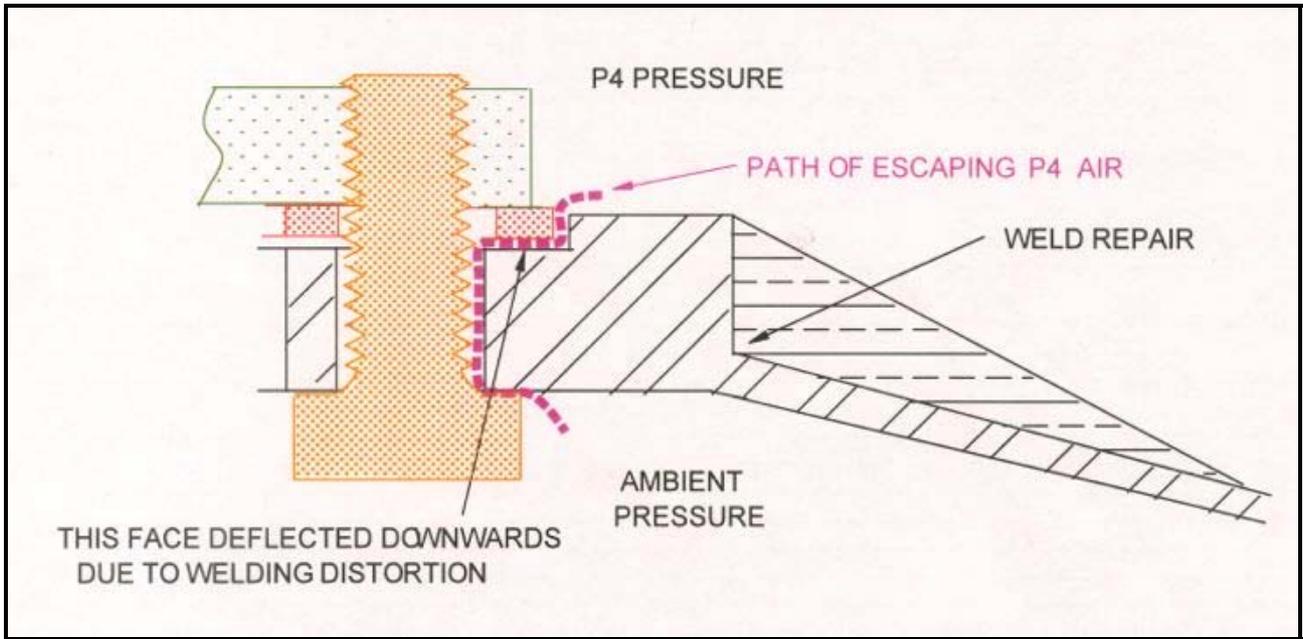
Appendix C

- 2.1.4** The distortion of the mounting face for the P&D valve allowed P4 air, at a pressure of up to 175 PSI above ambient atmospheric pressure, to leak past the copper gasket, into the bolt hole in the diffuser casing and to escape under the bolt head. Furthermore, the distorted mounting face and the distortion of the boss would have exacerbated the possibility of a leak under the bolt head. Initially this leak would have been extremely small. The initial path of this leak is shown in **Appendix C**.

ENLARGED VIEW OF THE BOLT AREA  
SHOWING THE PROBABLE PATH OF  
THE INITIAL LEAK

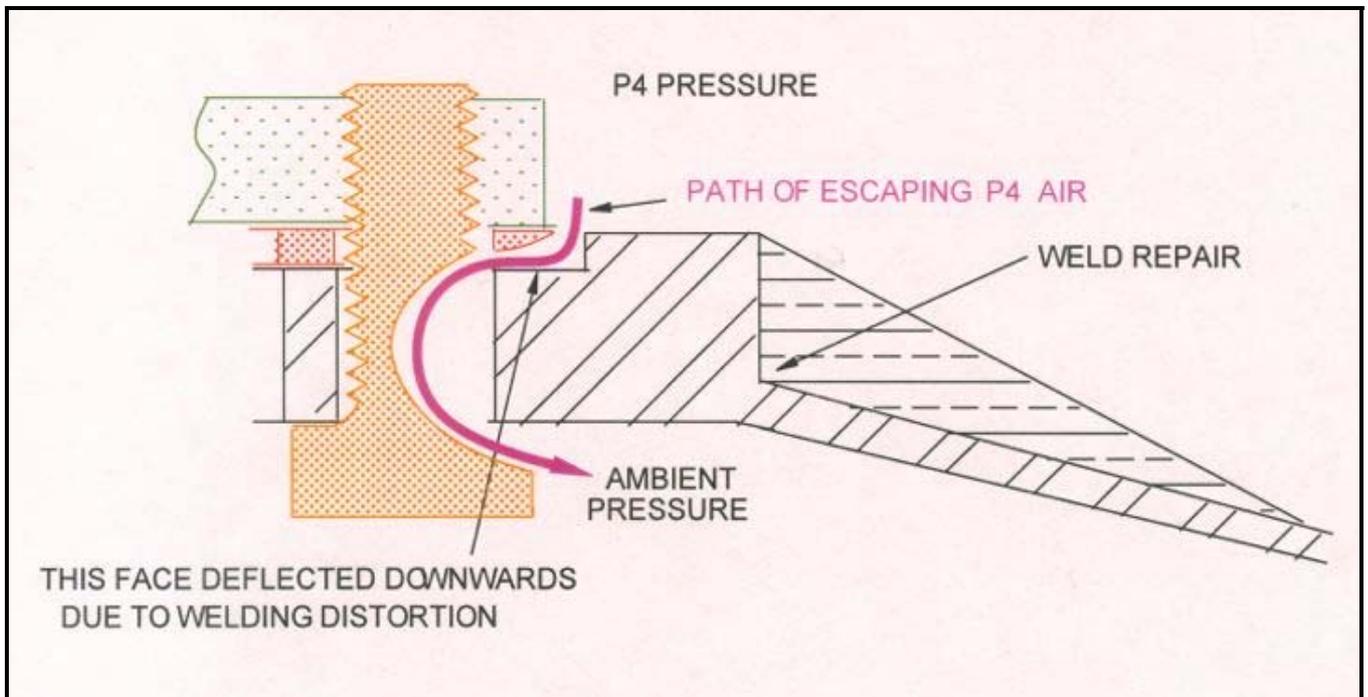
Appendix D

- 2.1.5** Over an extended period of operation this air leak, mixed with fuel, gradually eroded portions of the bolt, the bolt hole in the diffuser casing and the fuel manifold, producing a larger hole, and thereby increasing the rate of erosion. This situation is shown in **Appendix D**. The extent of the bolt erosion is shown in **Appendix F, Photo 1**.

ENLARGED VIEW OF THE BOLT AREA  
SHOWING THE EROSION OF THE BOLT  
CAUSED BY THE LEAK

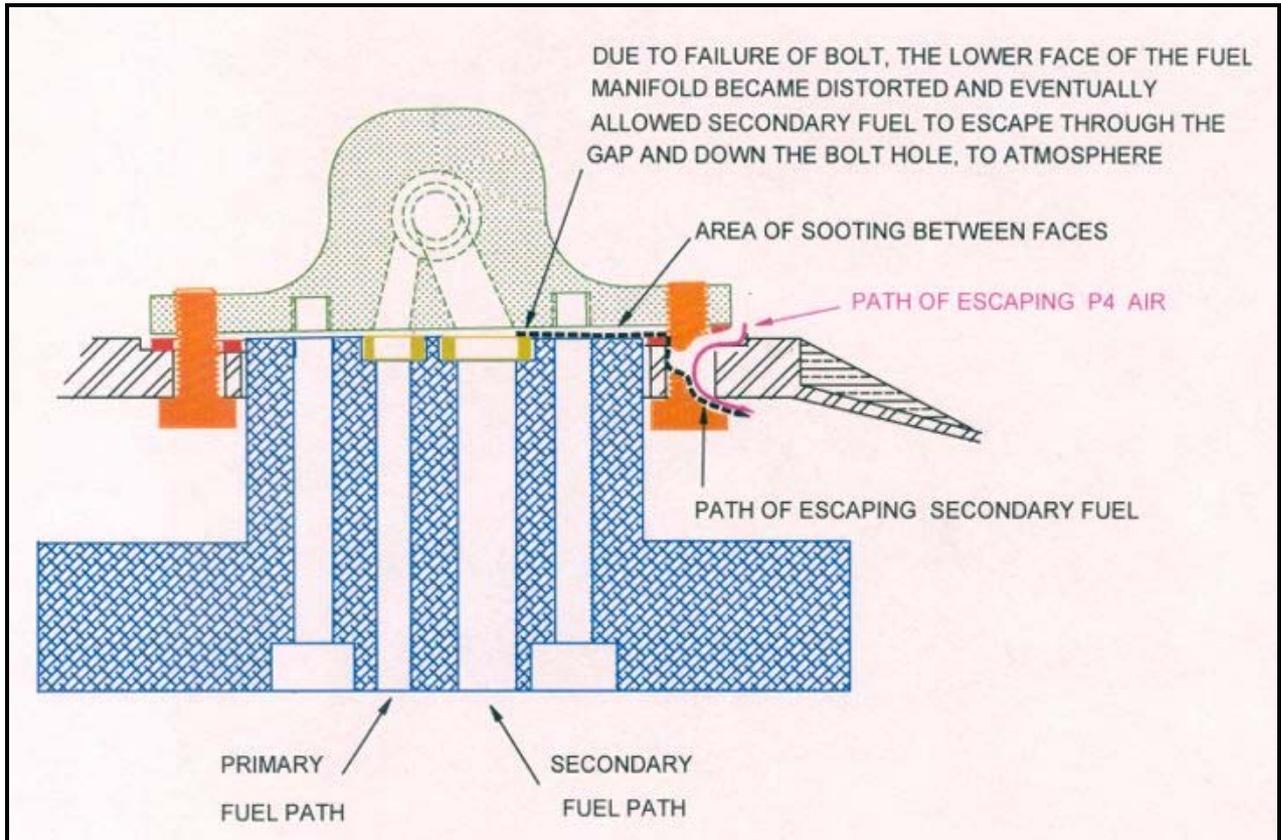
## Appendix E

- 2.1.6** Ultimately the cross-sectional area of the bolt was reduced by P4 air/fuel erosion to such an extent that it failed in tension. This allowed the corner of the base of the fuel manifold to distort away from the P&D valve spacer assembly. This distortion would have been exacerbated by thermal stresses but also by the pressure of the secondary fuel; that is when the secondary fuel supply was activated, the fuel pressure assisted in opening up a gap between the fuel manifold face and the spacer, through which secondary fuel was able to escape. The burning on the surface of the manifold heat shield would have increased the normal thermal stresses on the manifold area. This burning was probably caused by a faulty fuel nozzle allowing fuel to drip onto the manifold which would have ignited and burned on the hot surface of the shield. The path of the fuel leak is shown in **Appendix E**.

ENLARGED VIEW OF THE P&D VALVE ASSEMBLY  
SHOWING THE SITUATION  
AFTER THE FAILURE OF THE BOLT

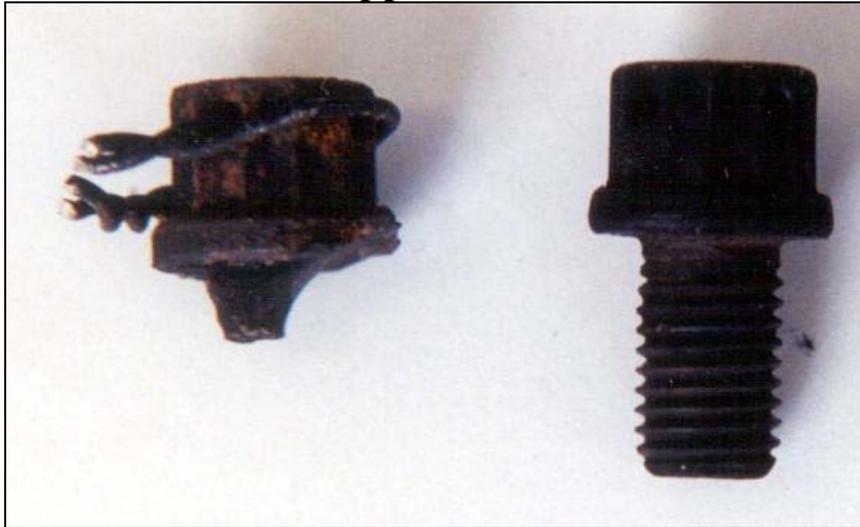
**PHOTO 1**

1.16.5 The fuel manifold was found to have suffered erosion type damage in the area surrounding the bolt-hole, which corresponded to the failed bolt. The hole in the diffuser casing, through which this bolt passed, had eroded in an elliptical pattern. The major and minor diameters of the worn hole were 3/8" by 5/8". The correct size of the hole should be nominal 5/16". Both the failed bolt head and the portion of the bolt threads that remained in the fuel manifold showed evidence of severe erosion. The condition of the failed bolt is shown in **Appendix F, Photo 1**. Measurements of the bearing face on the P&D valve mounting-boss on the inside of the diffuser casing, to which the fuel manifold was bolted, showed that the bearing face was not flat but distorted to the extent that the bearing area surrounding the failed bolt was, in places, up to .008", below the general level of the bearing face.

**VIEW OF THE ERODED BOLT (LEFT)  
AND AN UNDAMAGED BOLT (RIGHT)**

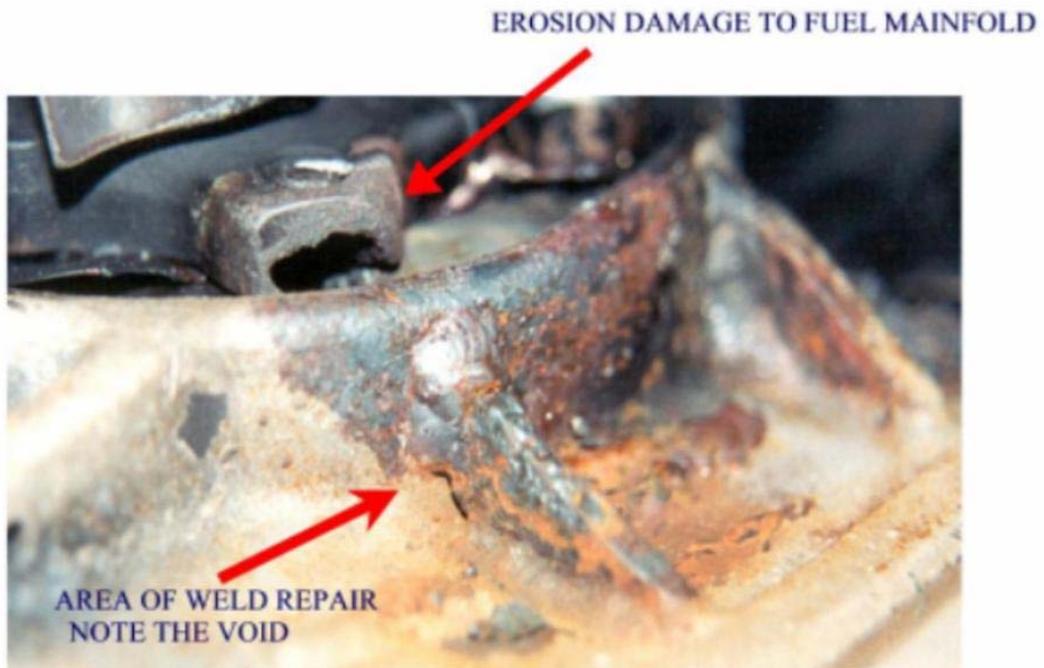
**PHOTO 2**

- 1.16.6** It was observed that a welding repair had been performed on the engine casing close to the area of the failed bolt. The repair consisted of the replacement/repair of two webs, which support the diffuser casing immediately to the rear of the fuel manifold boss. The repair weld showed evidence of abnormally high heating and failure to continuously fill the weld line, particularly close to the failed bolt. Inspection of the engines records failed to determine where and when this repair was performed. The repair of these webs is an approved P&W repair scheme.

- 2.1.13** The records of the diffuser casing do not show when the welding repair to the boss support was done. However, during the course of the pressuring and leak testing of the case following the repairs in September 1995, it would have been necessary to remove the P&D valve support. If the air leak had been present at that time, it is probable that erosion of the bolt and the bolt-hole would have been found. This would indicate that the welding repair to the supports did not pre-date September 1995. The repair area is shown in **Appendix F, Photo 2**.

**3.1.2** The diffuser casing had undergone a welding repair in the area of the supports to the flanges of the P&D Valve Support Boss. This repair was poorly executed and caused distortion of the boss.

**PHOTOGRAPH OF THE INTERIOR OF THE DIFFUSER CASE SHOWING  
THE P&D VALVE MOUNTING-BOSS& DETAILING THE EROSION  
DAMAGE TO THE FUEL MANIFOLD AND THE DEFECTIVE WELD REPAIR**
