Aircraft Accident Report

SILKAIR FLIGHT MI 185

BOEING B737-300

19 DECEMBER 1997

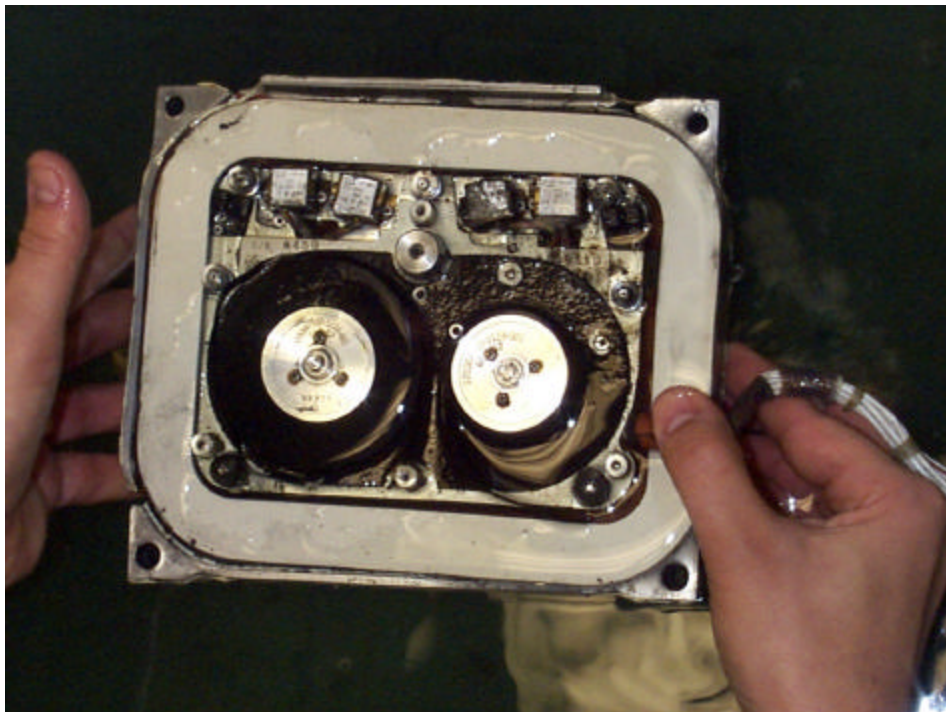
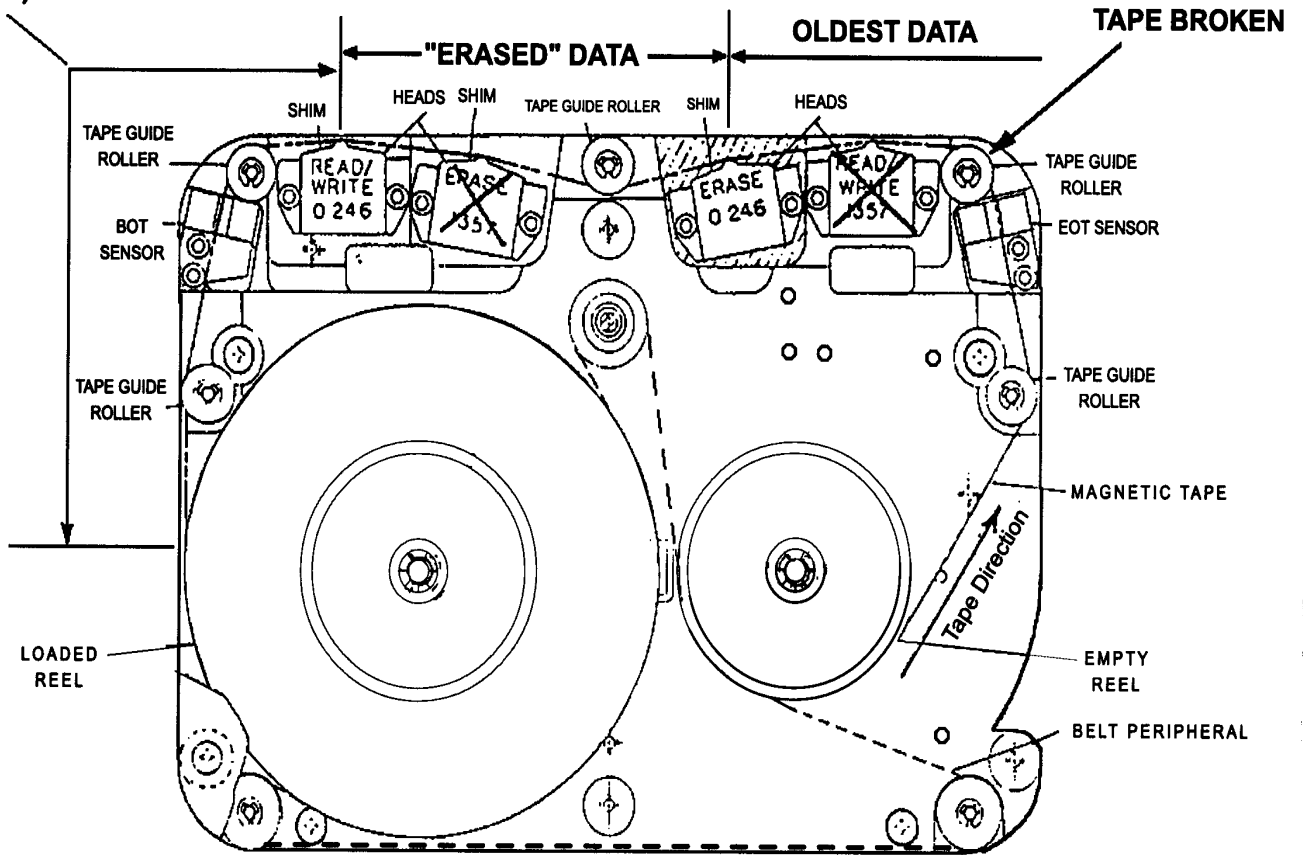
Figure 4.b The tape inside FDR

The FDR module was recovered by divers on 24 December 1997. The FDR's underwater locator beacon (ULB) was found detached from the FDR at the accident site. Two of the enclosure's four retaining bolts were broken. The enclosure was partially opened (Figure 4.a). The partial opening exposed the tape between the two tape reels, near the write and erase heads, see Figure 4.b and c.

The data on the FDR tape was able to be read except from the short length of the exposed tape mentioned above. By examining the physical position of the tape as it was found when the casing was opened, it was determined that approximately 8 cm (3.15 inches) of the exposed tape contained data of the accident flight. The data (about 6.3 seconds) were not recovered because of damage to the exposed part of the tape.

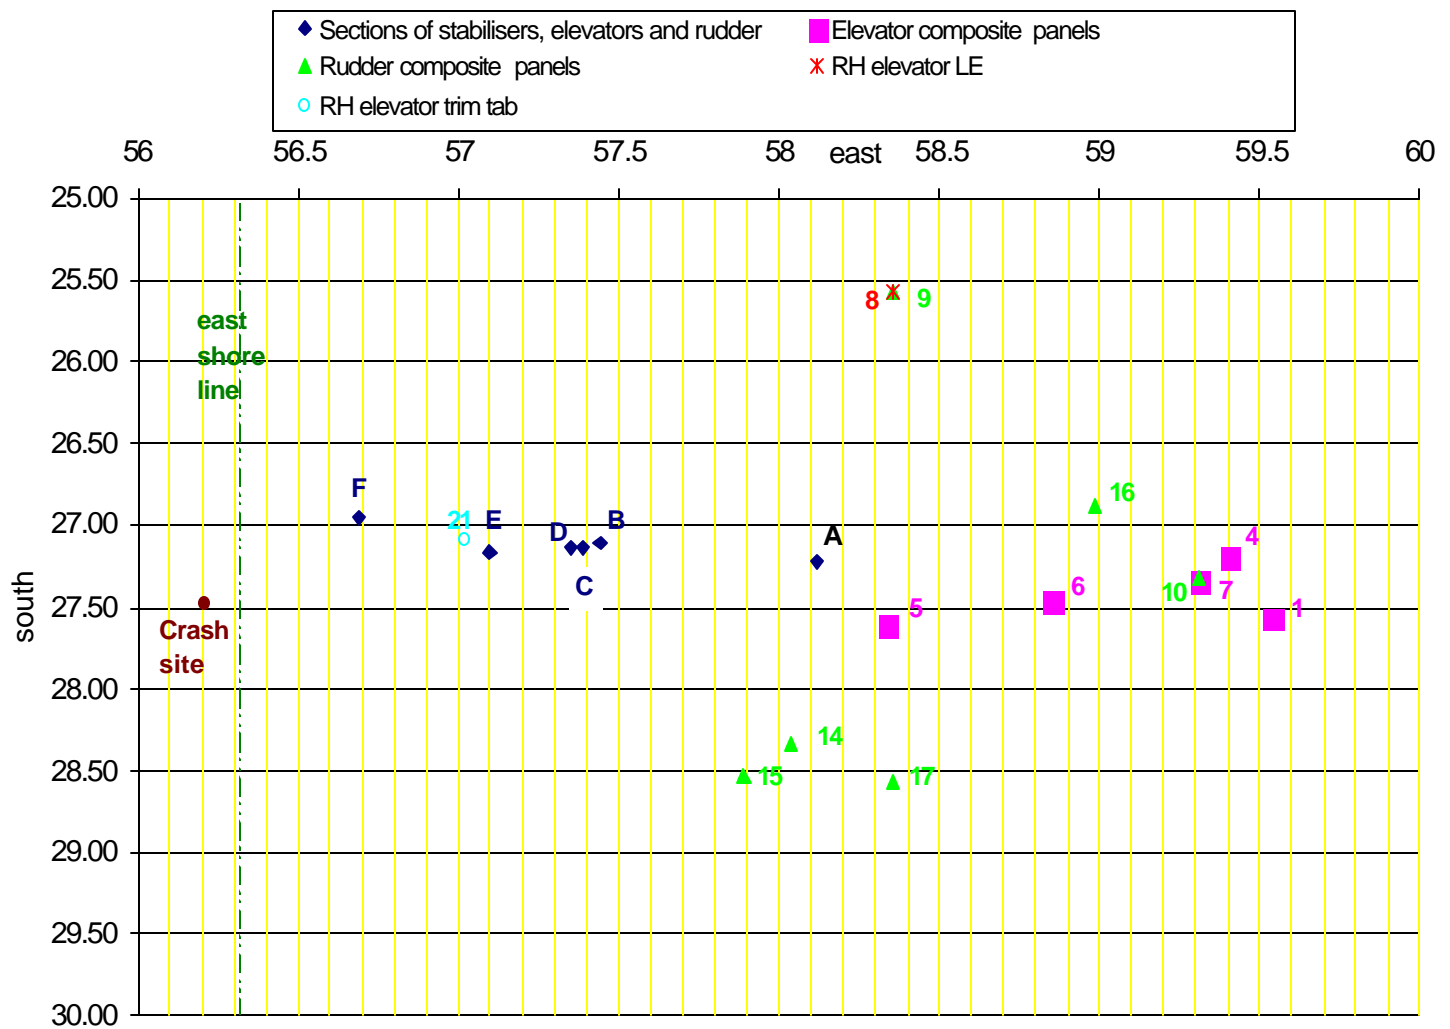
Figure 7 Sketch of the wreckage pieces found on land

Parts of the empennage were found on land. They comprised the outboard sections of the right hand and left hand horizontal stabilizers, sections of the elevators, elevator tabs, rudder upper balance weight and honeycomb skin pieces. These pieces were found generally in an easterly direction from the impact site. The wreckage distribution, as determined by a hand-held GPS (Global Positioning System) unit, is shown in Figure 7. The right hand elevator tip was found about four kilometres to the east of the crash site. This was the furthest location where the wreckage pieces were found. The left hand elevator tip was found about 200 metres from the east river bank (or 700 metres from the location of the wreckage). This was the nearest location to the crash site among the wreckage pieces found on land. Lighter panels (composite materials) from skin of rudder and elevators were also found on land. These were picked up by local residents and handed over to the police and search and rescue helicopter pilots. The exact locations where the lighter panels were originally found could not be determined.

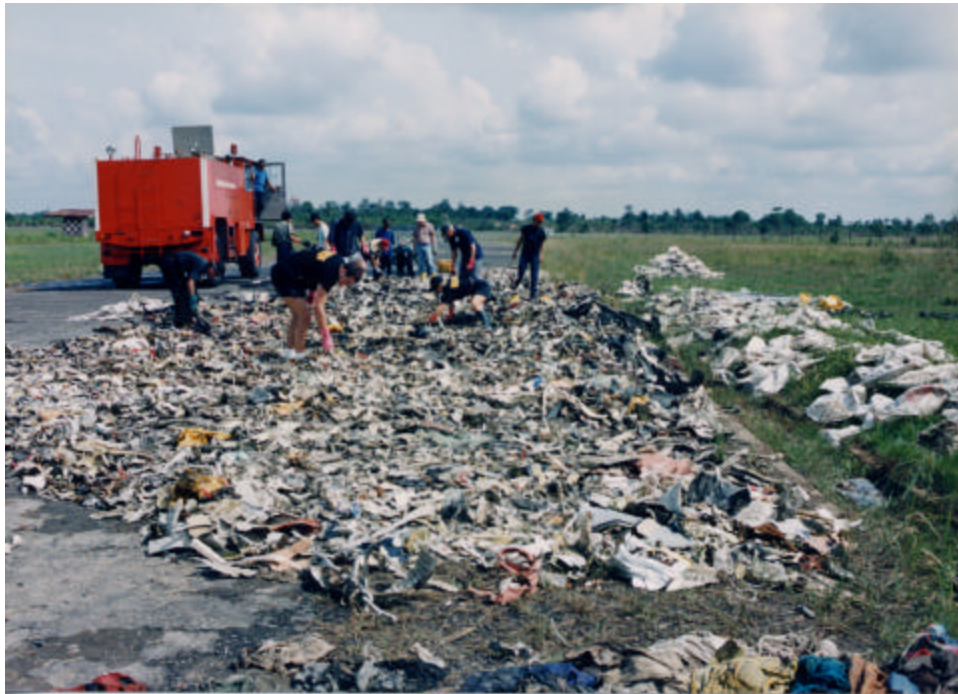
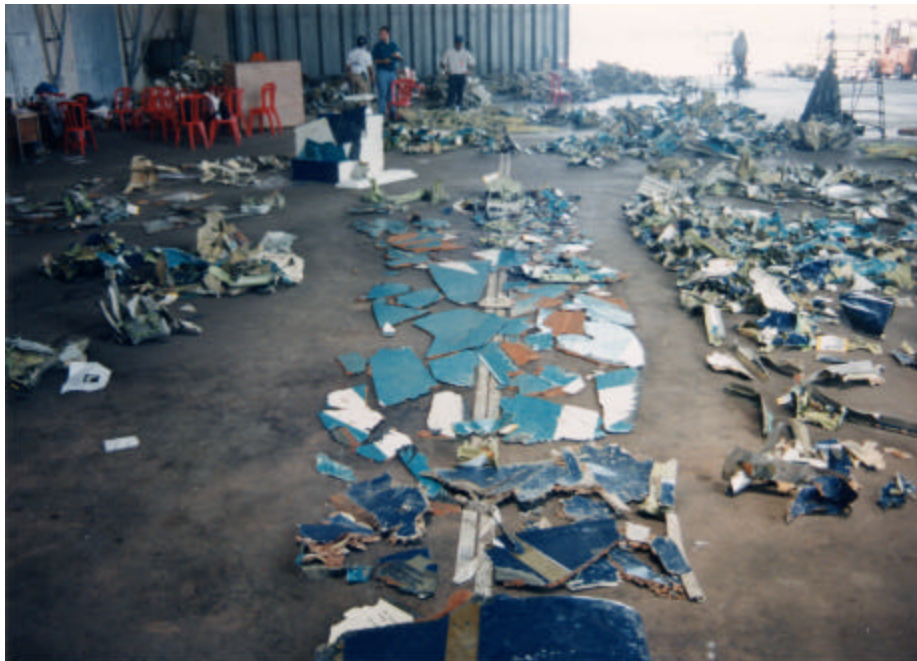
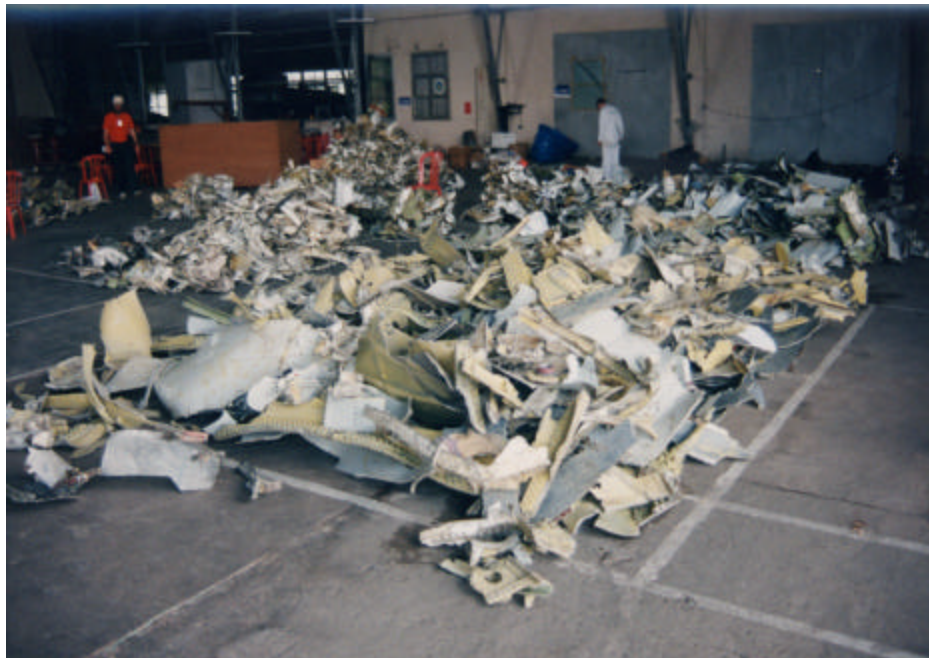
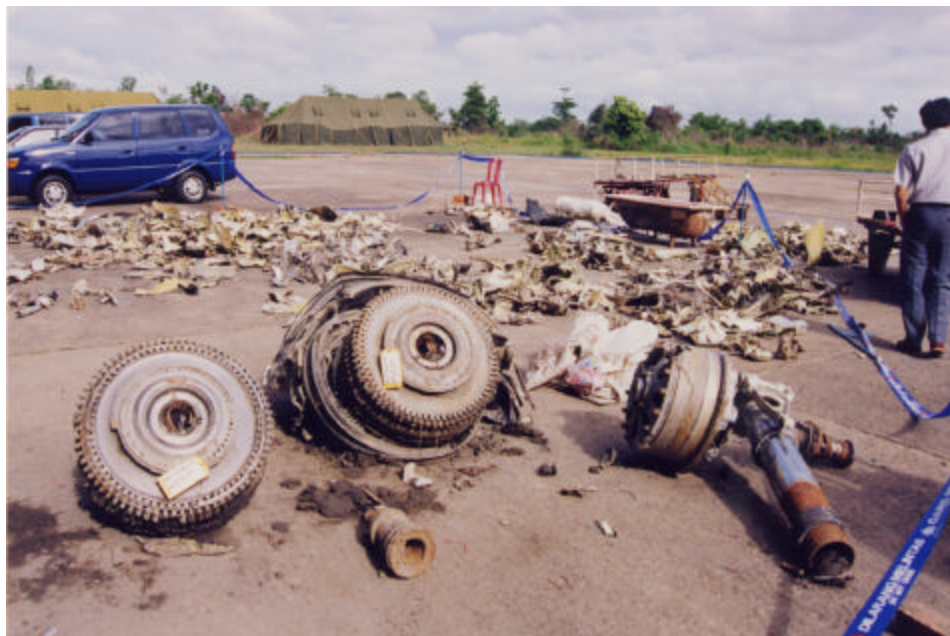
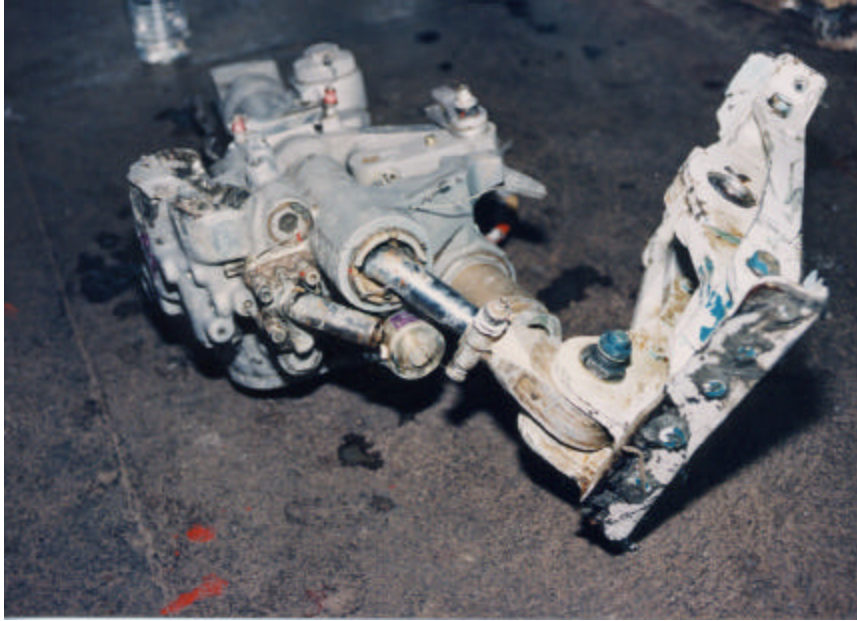
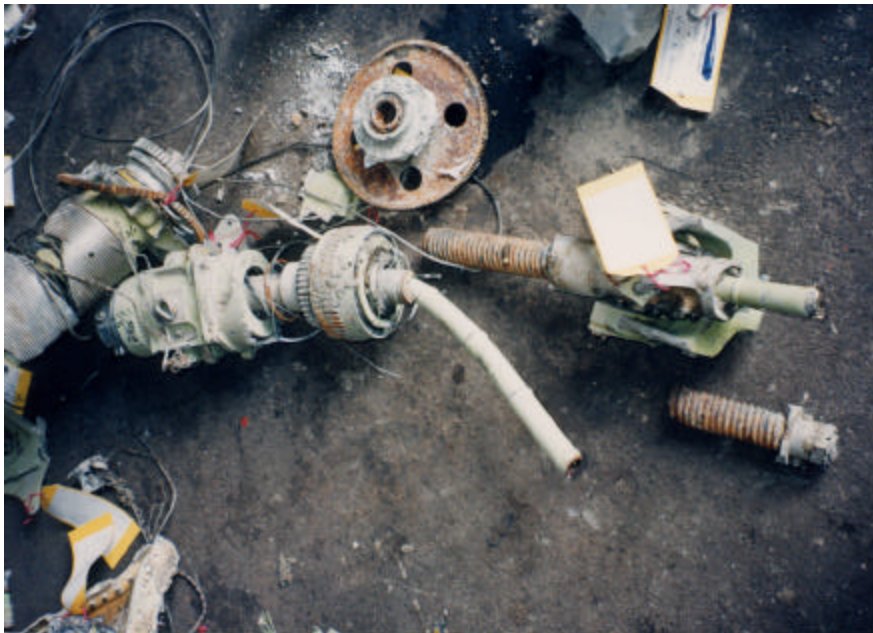
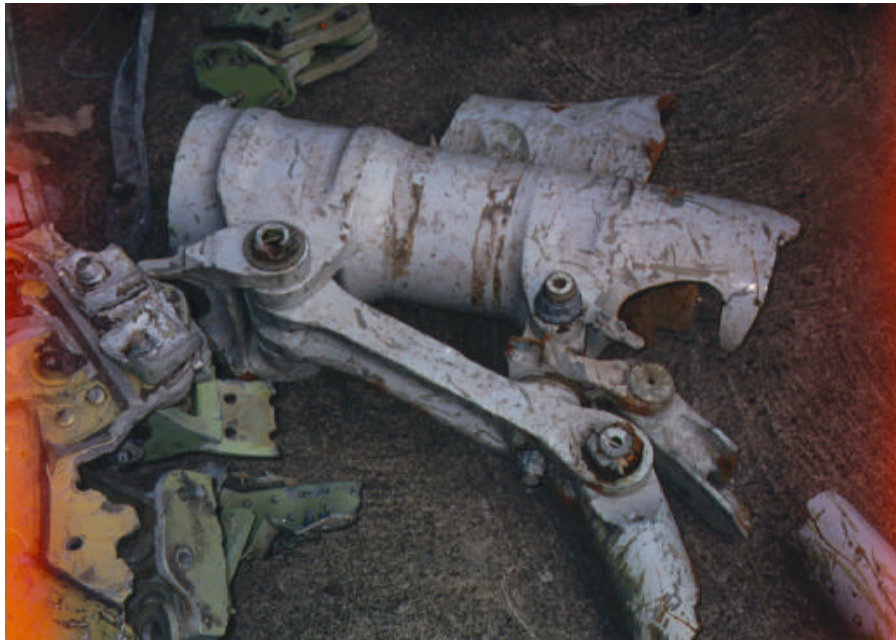
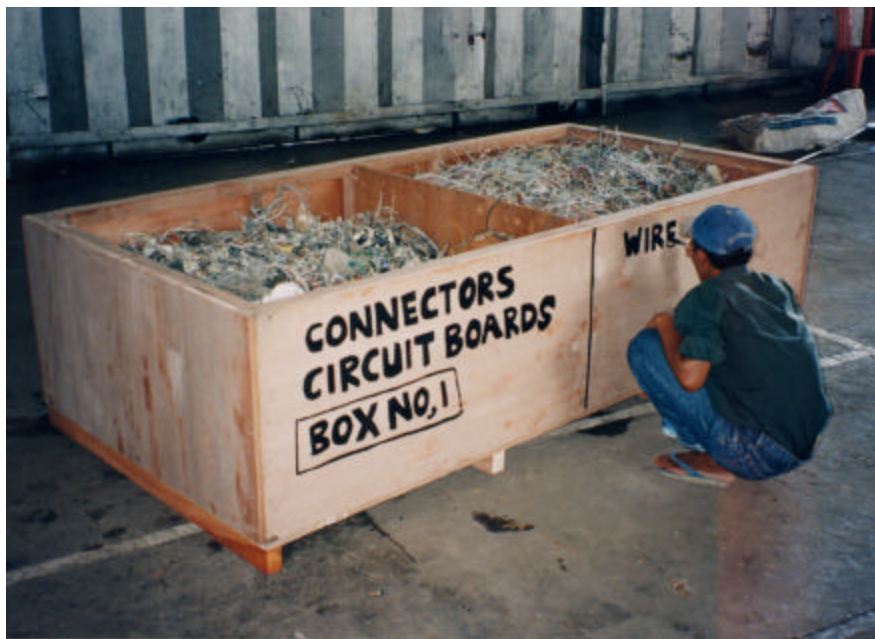
Figure 8 Picture of the wreckage recovered from the river

The aircraft parts found in the river were highly fragmented and mangled on impact, see Figure 8. As a result, all parts of the aircraft were mixed together on recovery, making sorting and identification of the many small pieces difficult. Particular attention was paid to finding parts of the control surfaces, actuators, electronic and avionics systems, engines, Section 48 (rear fuselage including aft pressure bulkhead) and the empennage (see Figure 10). The cockpit instrumental panel and circuit breakers panel were not recovered. The wing flaps, spoilers, ailerons, and leading edge slats and their supporting tracks, carriages and actuation systems were also accounted for. Cabin items such as seat structures, cushions, oxygen generators, etc. were also recovered and examined. Parts and components recovered were contaminated, stained and showing accelerated corrosion. River water and mud samples were taken to determine their effect on the condition of the recovered parts and components. Following cleaning, the parts were marked with the date and method of recovery (by diver or dredge). Where possible, parts were identified, part numbers noted and components were laid out in groups by sub-assembly, for example, wings, landing gears, etc. Empennage parts were laid out on the hangar floor in their approximate respective positions. Reconstruction was limited due to the degree of destruction of the aircraft.

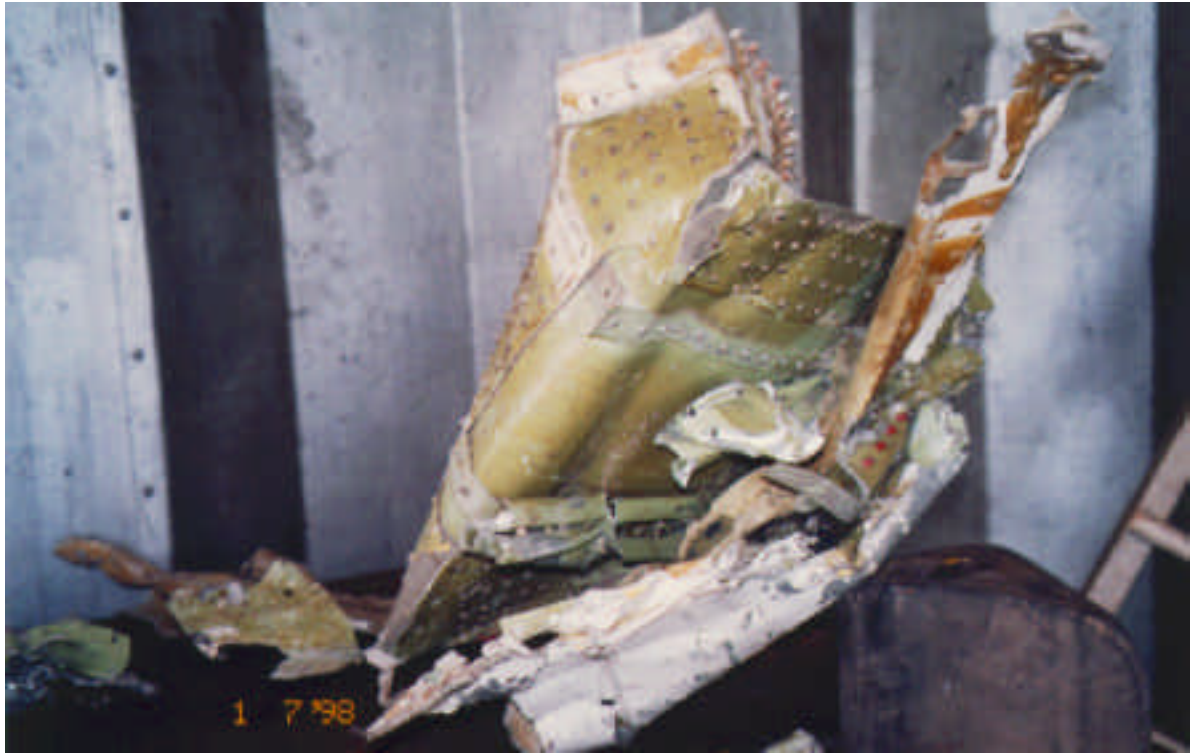
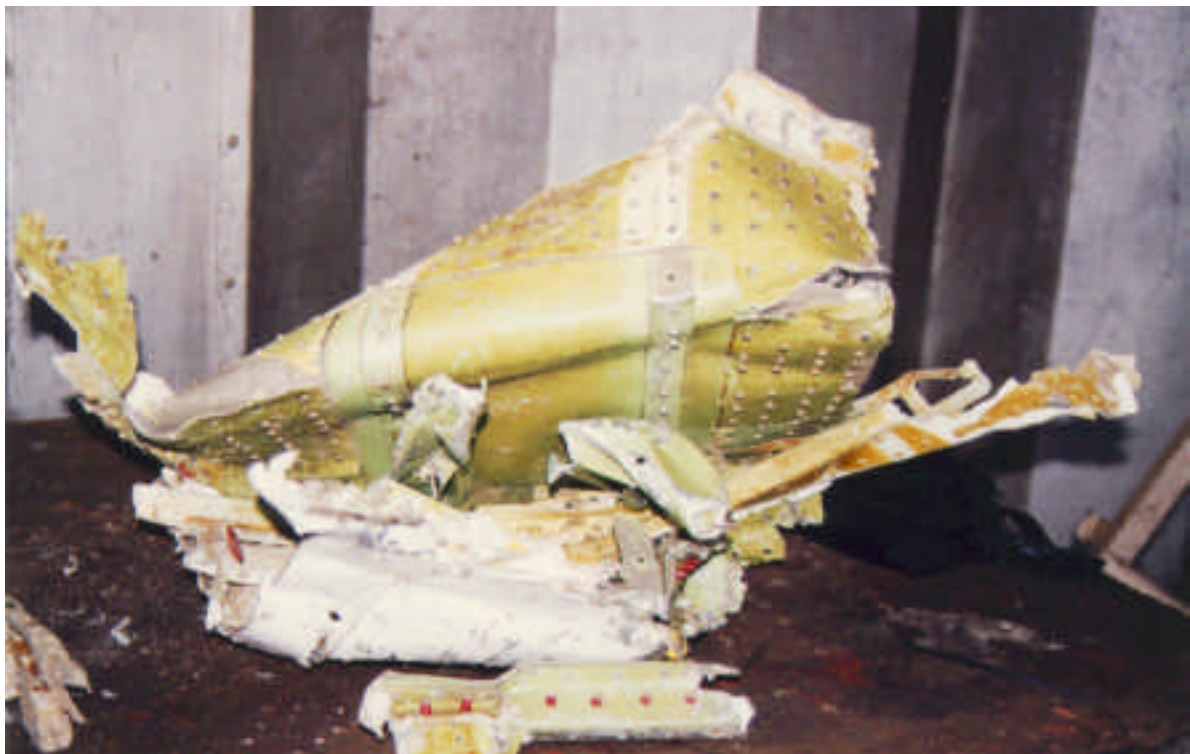
Figure 9 Picture of wreckage of the fuselage skin patch repair

A maintenance document showed that a fuselage patch repair was carried out on the aircraft on 28 April 1997. The repair was carried out by SIA Engineering Company in accordance with the Boeing 737 Structural Repair Manual 53-00-01, [References 6 and 7].

The patch repair was just above the floor level and forward of the left hand aft passenger door between station 867 and station 907 and between stringer 14L and stringer 17L. The entire patch was found intact and was still attached to the surrounding skin, see Figure 9.

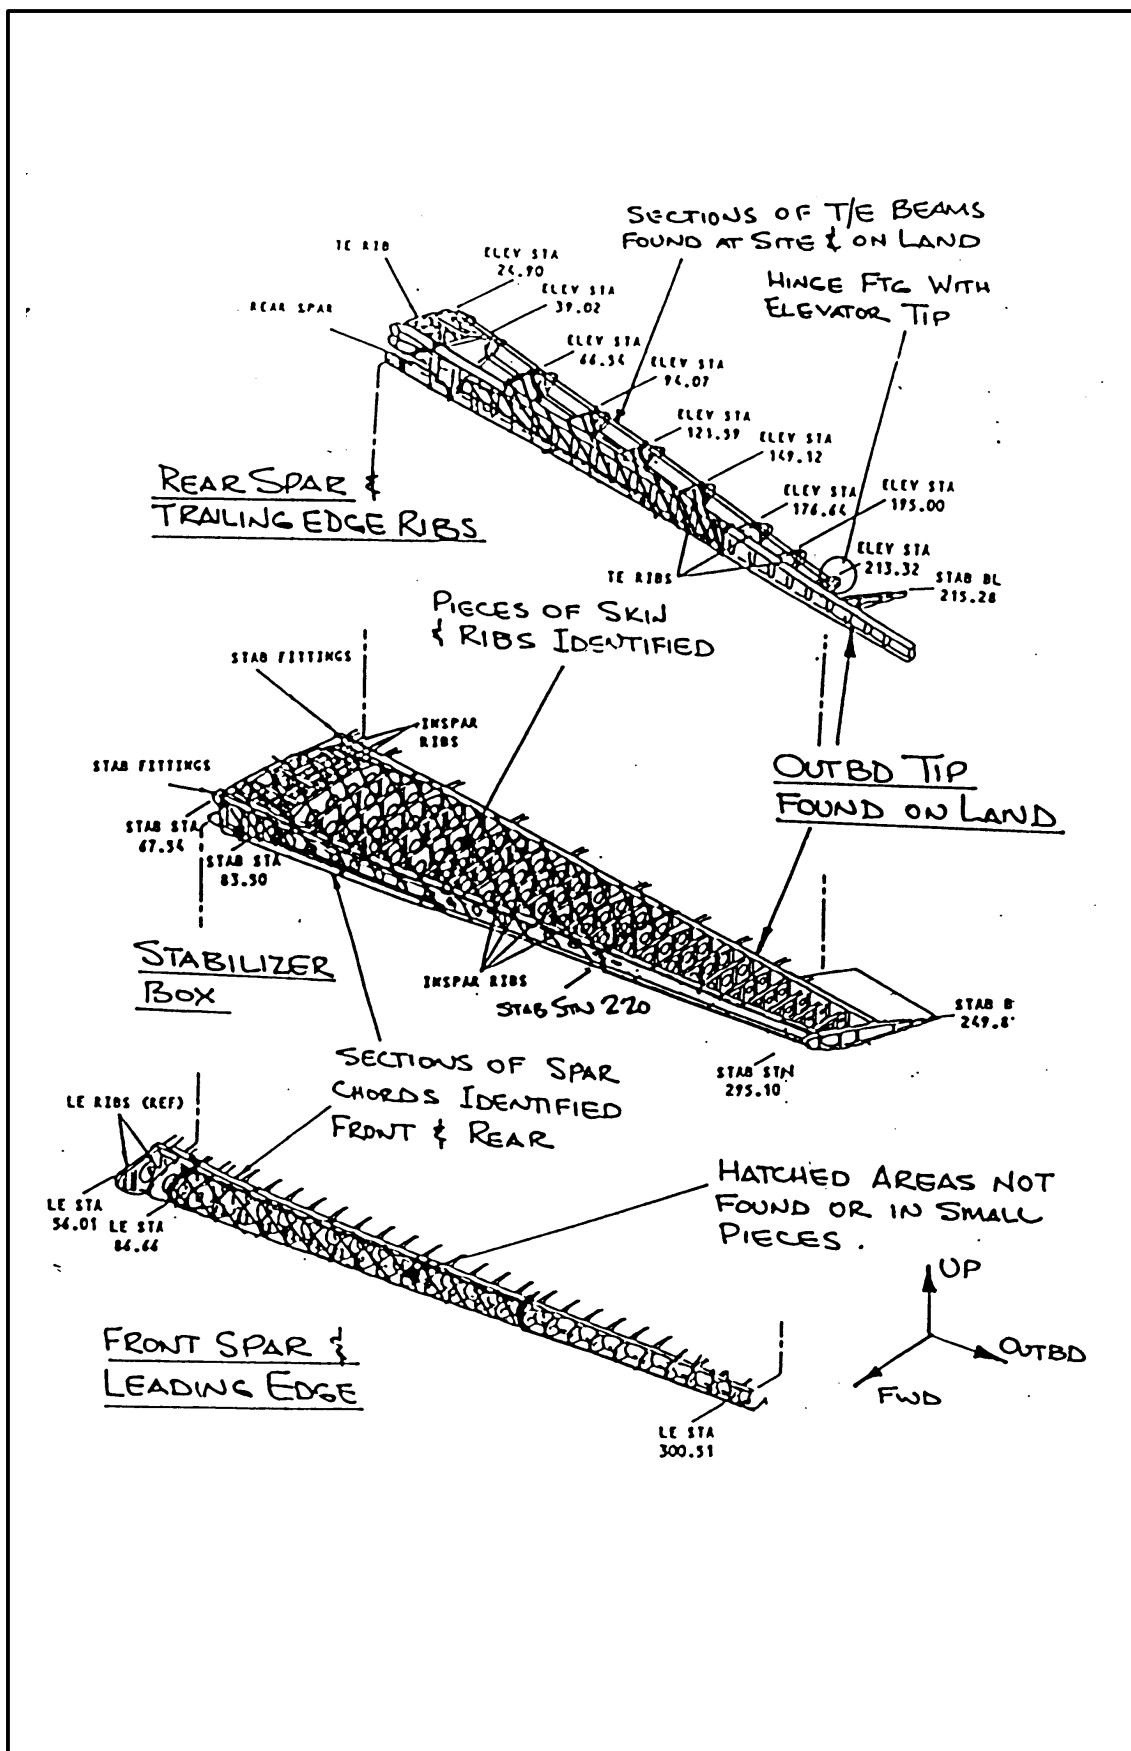
Figure 10.b Horizontal Stabilizer L.H. Side

Left hand horizontal stabilizer (Figure 10.b) - No impact marks were found or observed on the leading edge of this section. Both the front spar (upper and lower chords) and the rear spar upper chord were bent up near their fracture locations. The lower chord fracture was indicative of tensile failure but little deformation was observed. The rear spar web was crushed upward near the fracture location. The upper skin near the fracture was bent up. The upper skin of the leading edge and the interspar areas exhibited wrinkles. The rear spar web of the outboard left hand horizontal stabilizer section contained diagonal tension wrinkles, distortions and paint failures at several locations similar to the right hand horizontal stabilizer outboard sections. As on the right hand horizontal stabilizer, the

damage observed on the outboard left hand horizontal stabilizer section was consistent with high vertical and torsional loading. It is noted that the right hand horizontal stabilizer was severely deformed in the same approximate location as the left-hand horizontal stabilizer chord-wise break near station 221. The stabilizer front spar outboard of station 221 is a solid web, but inboard of this location, the front spar contains flanged lightening holes.

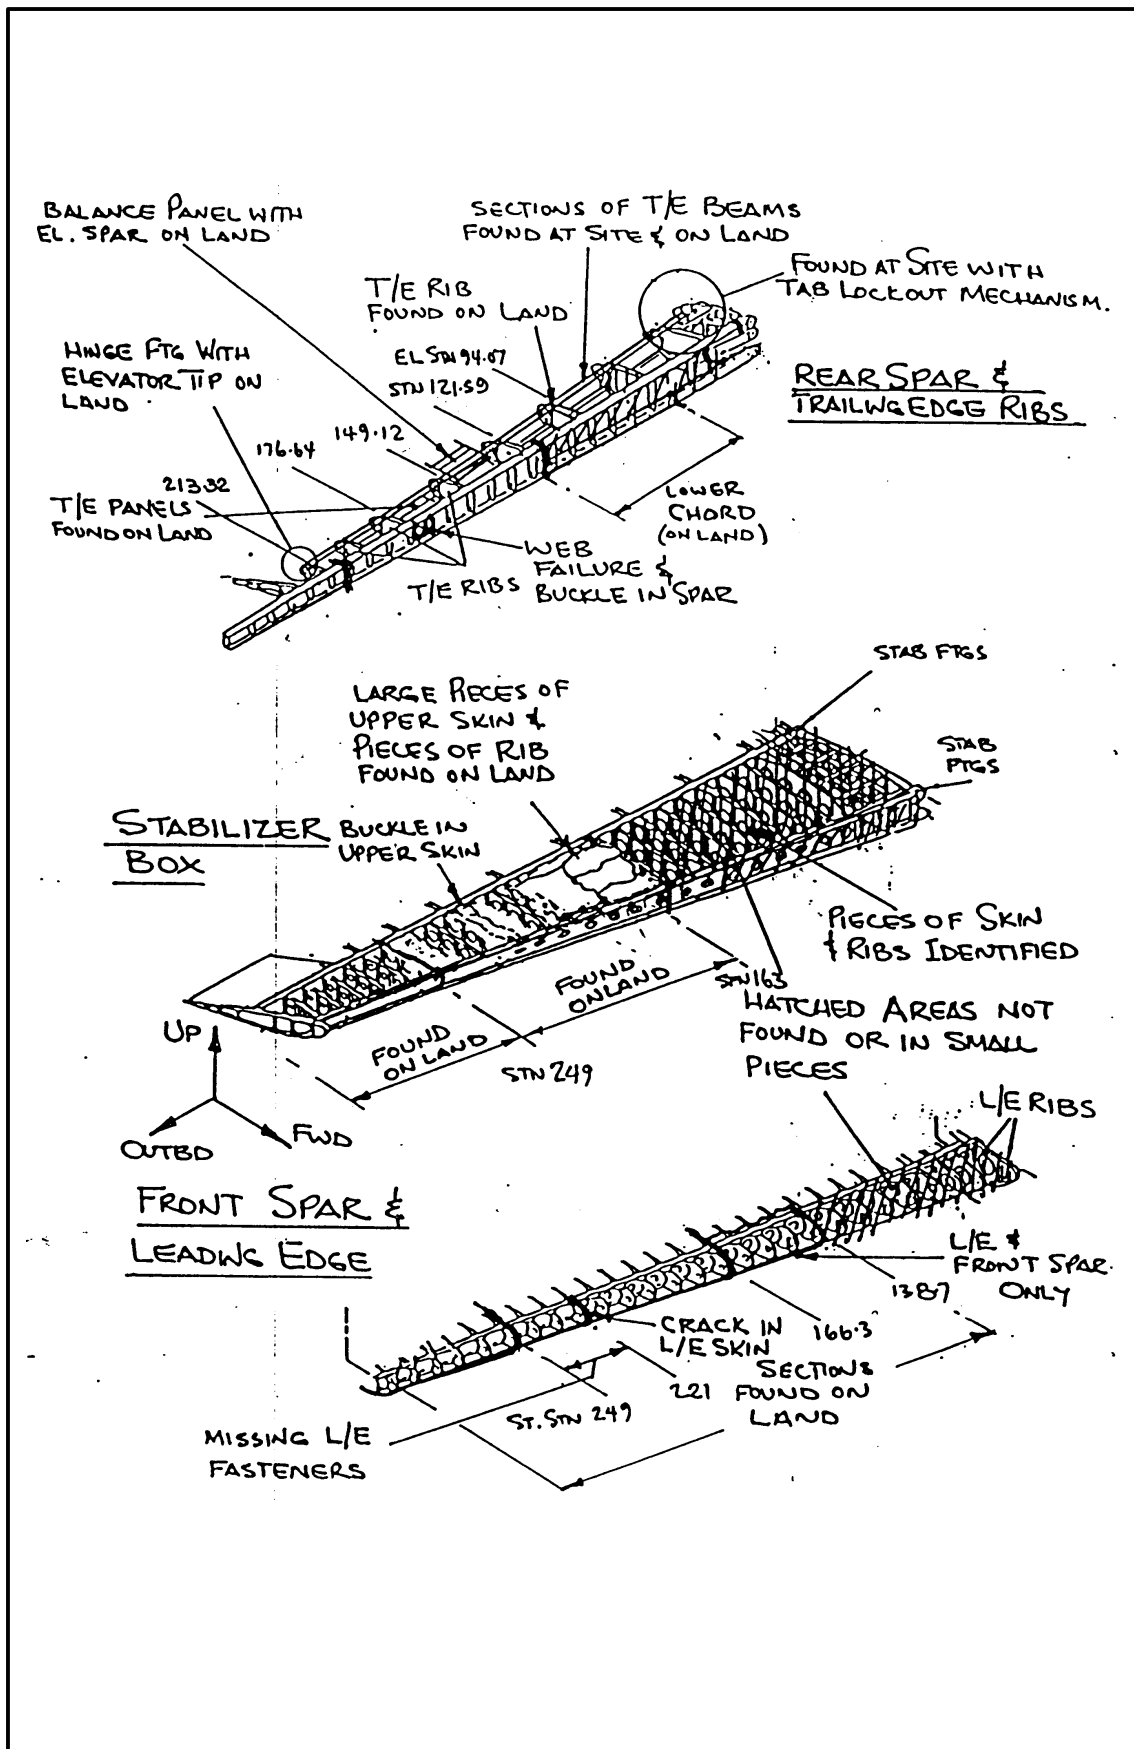
Figure 10.d Horizontal Stabilizer R.H. Side

Right hand horizontal stabilizer (Figure 10.d) - The leading edge of the two right hand horizontal stabilizer sections showed no impact marks. Distortion and wrinkles were noted in the outboard areas of the horizontal stabilizer leading edge and interspar ribs and skin.

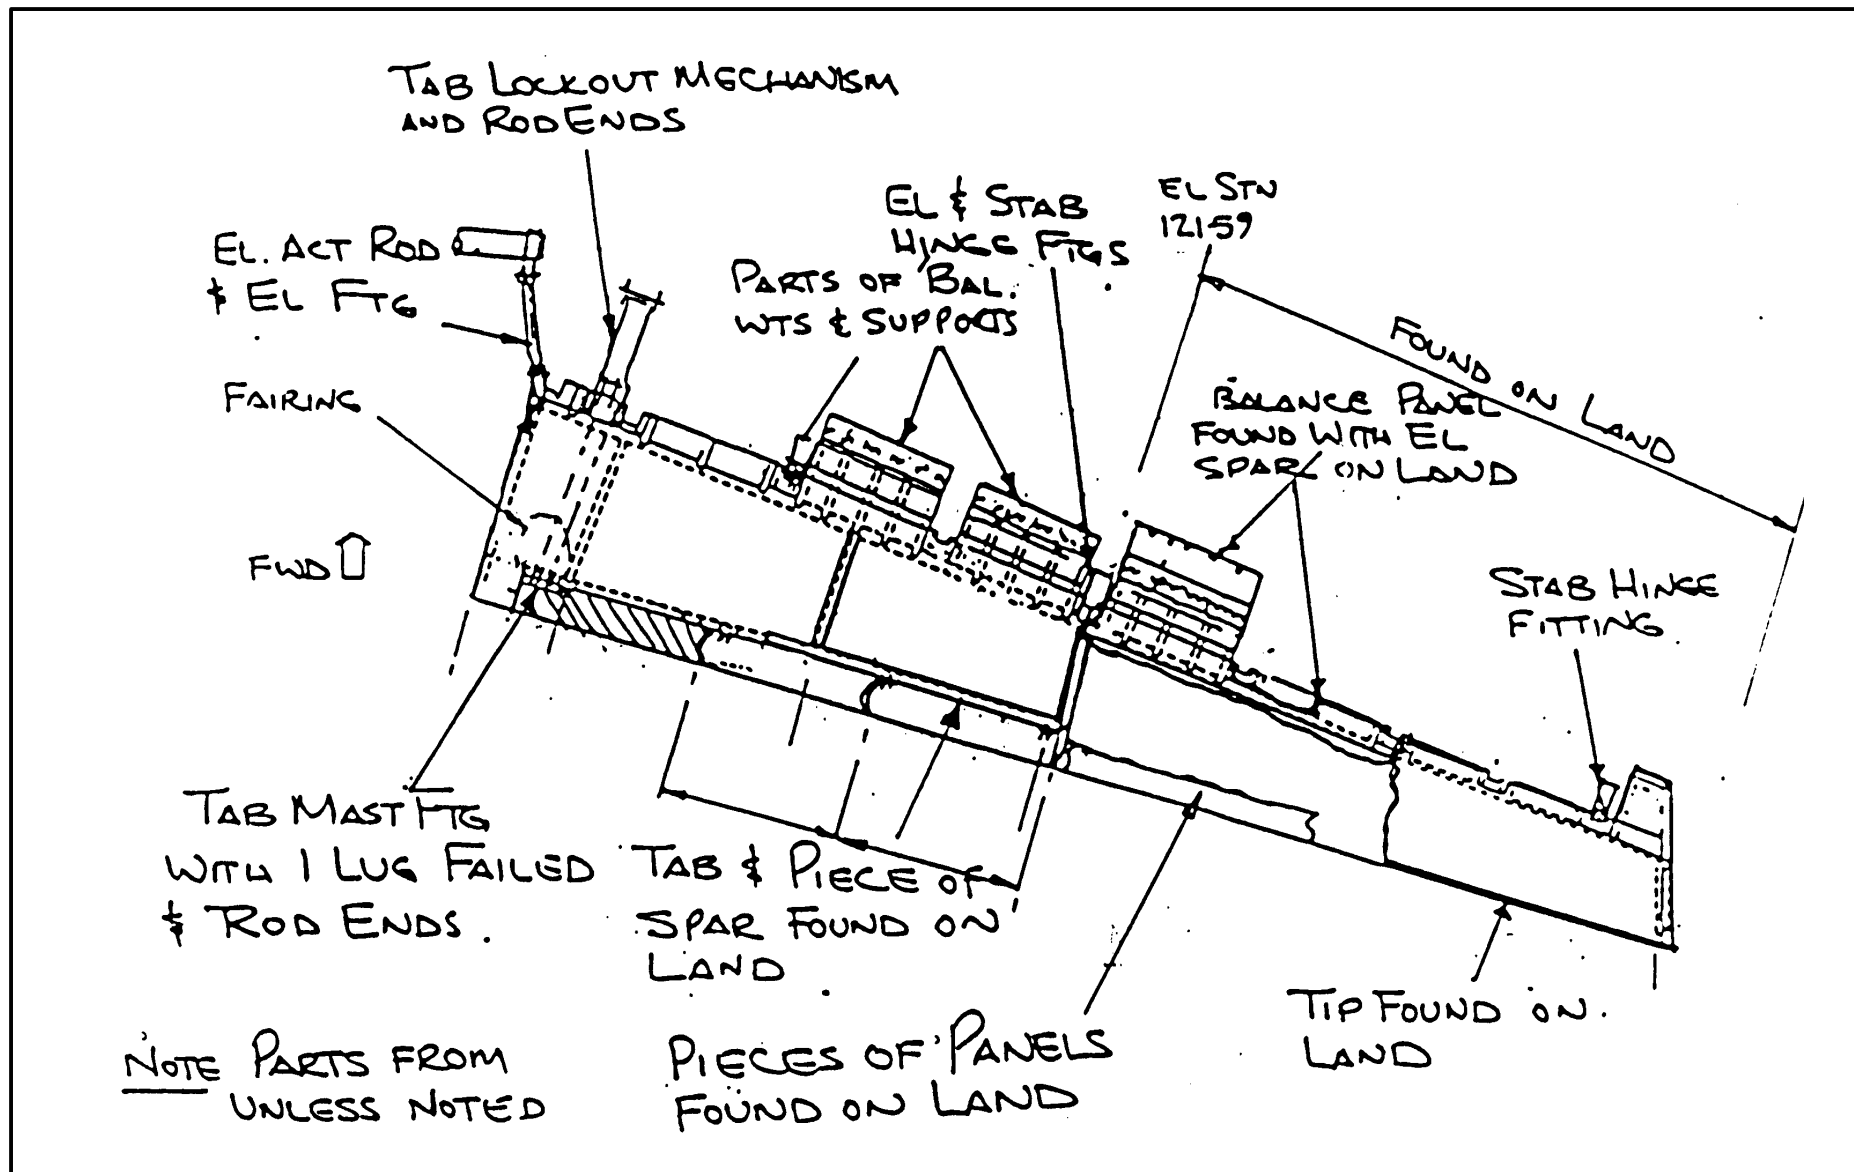
Figure 10.e R.H. Side Elevator

Right hand elevator (Figure 10.e) - All of the control tab pieces were identified except for the portion inboard of elevator station 66. The largest piece of the right hand elevator was the portion from the tip to elevator station 176, including the tip balance weight and elevator station 213 hinge fitting. All six elevator hinge fittings were identified. The hinges located at elevator station 121 and outboard were found on land. The elevator hinges and surrounding area at elevator stations 213 and 176 contained evidence of elevator over-travel in the up and down directions and twisting of the bearings or hinge plates. The bearing and the bearing plates of the elevator hinge at elevator station 195 were twisted as if the elevator outboard end moved upward relative to the horizontal stabilizer. Although the lower bolt was not found, evidence indicated that the bolt was present during the separation of the elevator. The balance weights in the balance bay and support structure were recovered from the crash site. The right hand elevator control tab rods were identified. Deformation of the rods at the right hand elevator showed that they

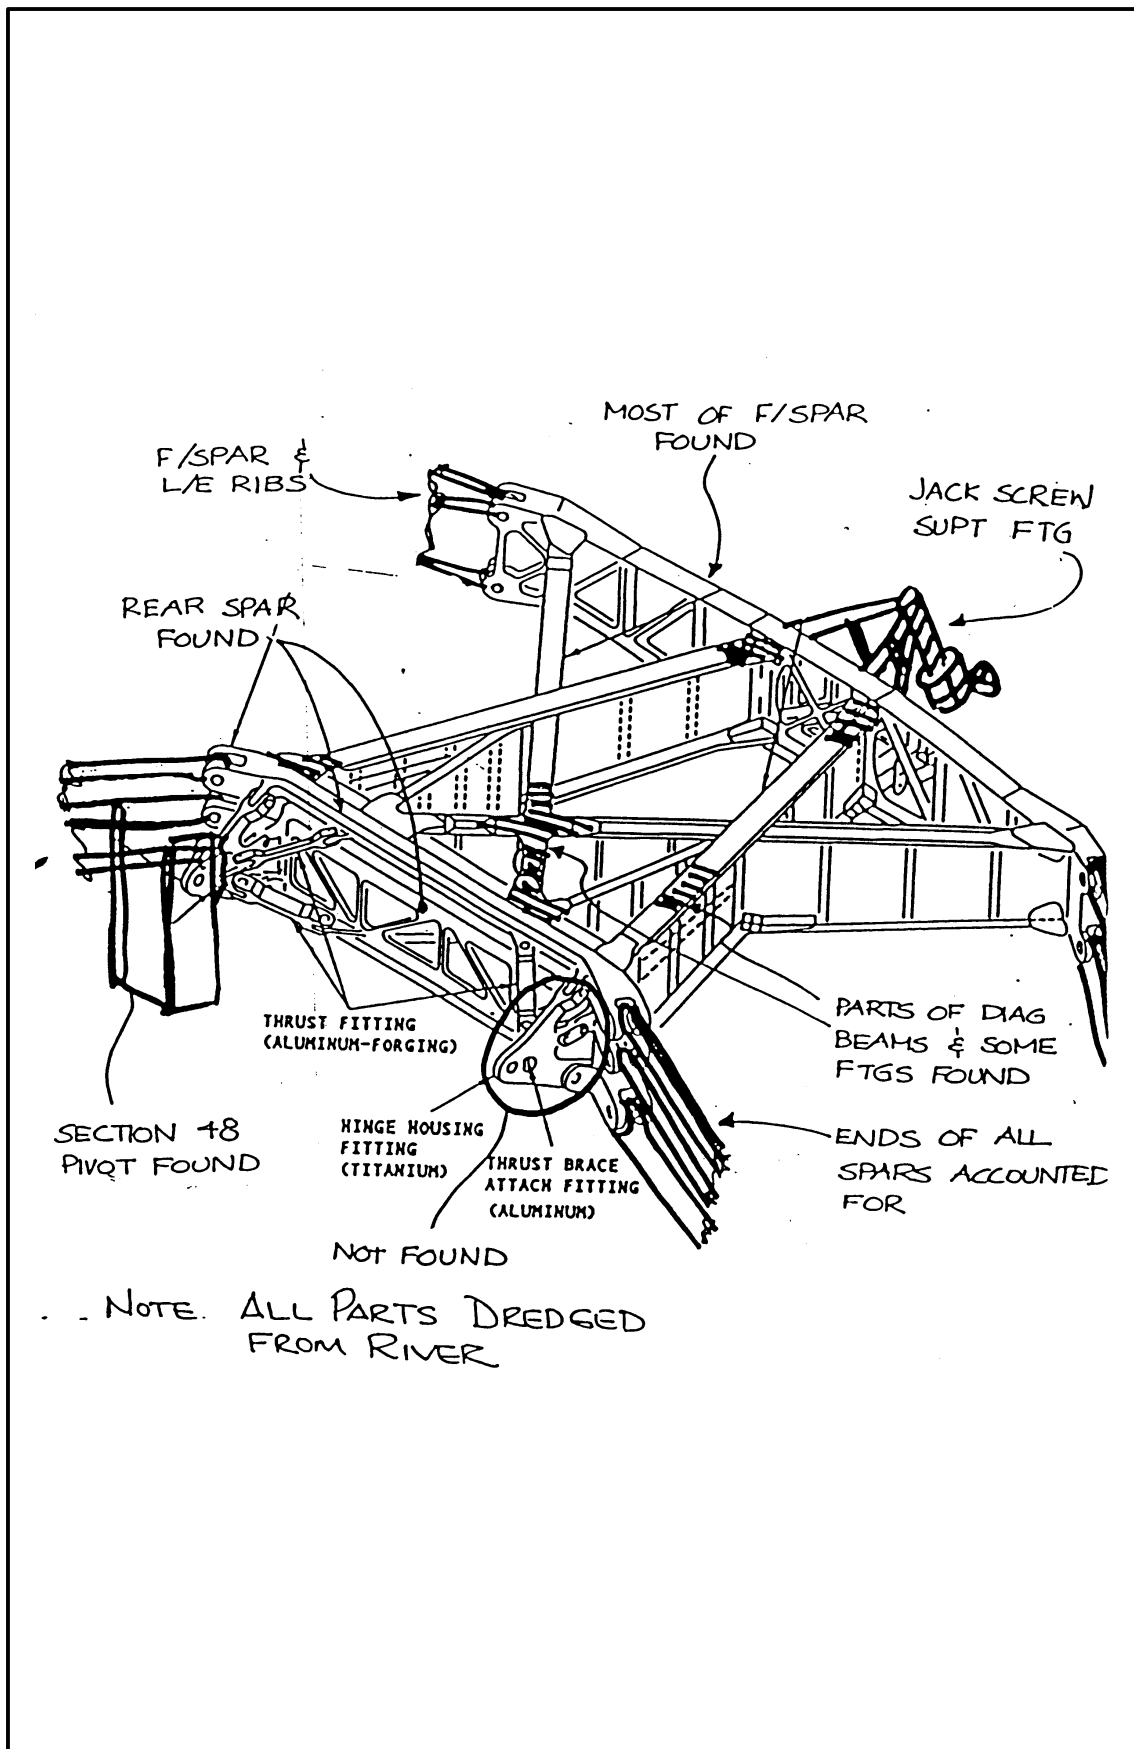
Figure 10.f Horizontal Stabilizer Center Section

The horizontal stabilizer center section (the so-called "Texas Star") structure and the horizontal stabilizer jackscrew were recovered from the crash site in the river. The majority of the front and rear spars were found and identified. The horizontal stabilizer center section has two hinge supports at the rear end about which the horizontal stabilizer is pivoted. The front end of the Texas Star structure is connected to a ball-nut on the jackscrew which is used to move the horizontal stabilizer (Figure 10.f).

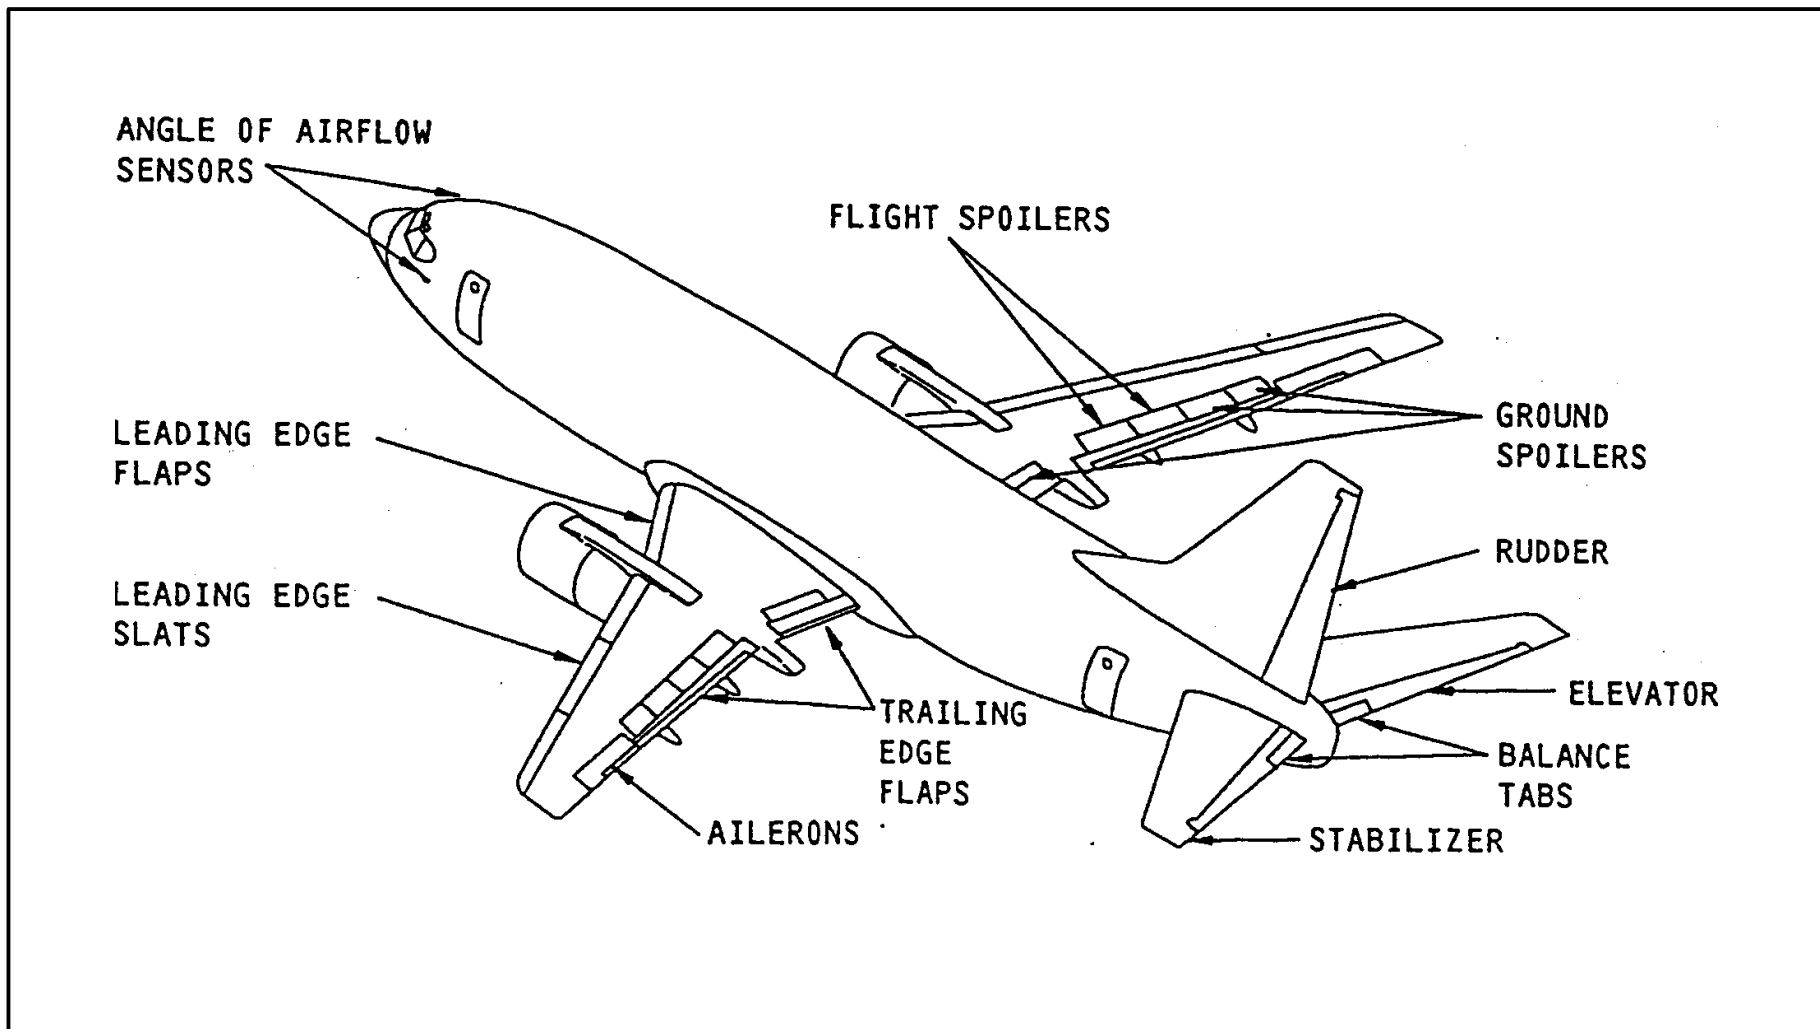
Figure 18 Flight Control Surfaces Location

Flight spoiler actuators – four units per aircraft: (*Items 7, 8, 9 & 10 in Appendix E*) All four flight spoiler actuators were recovered and examined. The actuators were found to be in the fully retracted position (see Figure 18).
