AAIU Report No. 2000/001
AAIU File No. 19990006
Published 31/07/2000

Aircraft Type and Registration: Lockheed Electra L-188C N-285F

Location: Shannon Airport, Ireland

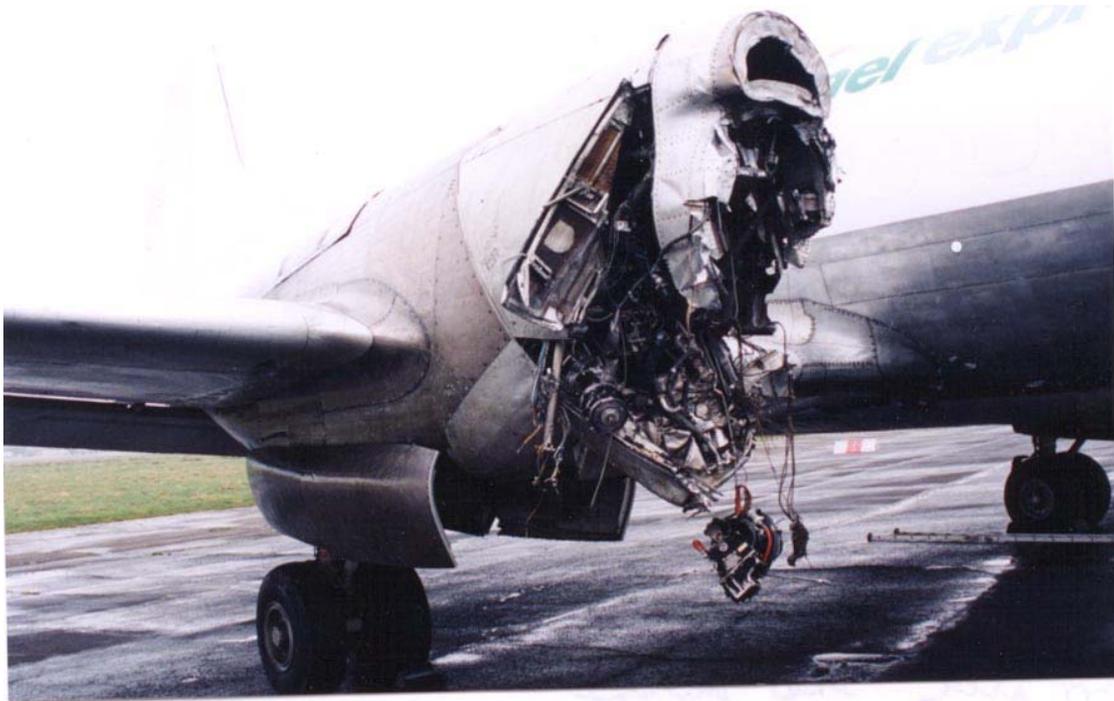
The aircraft was inspected by AAIU inspectors who found that the forward part of engine No 3 back to the diffuser casing was missing. The engine starter and oil pump assembly were found hanging by electrical cables from the engine. All propeller blades from engines No 2 & 4 were found damaged. Pieces from No 3 engine assembly had struck No 4 engine and penetrated the cowlings of that engine. There was slight skin abrasion to the rear underneath fuselage section, indicating a tail scrape. There was no evidence of fire.

**Top – Propeller assembly and part of engine missing from No.3 power plant.
Bottom—Damage to No.4 engine inflicted by parts of No.3 propeller**
