Investigation Report of the Aircraft Accident Investigation Bureau

to the Saab 340B aircraft, registration HB-AKK

of Crossair flight CRX 498

on 10 January 2000

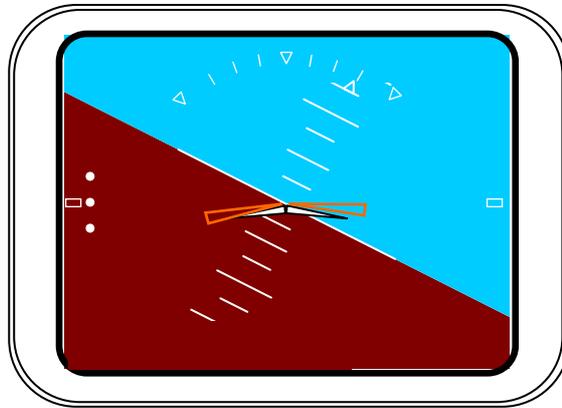
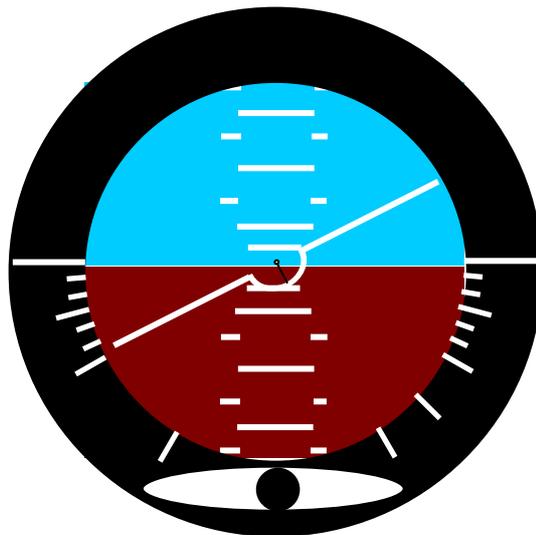
In addition to the inverse representation of roll, mention should also be made of the decoupled representation of roll and pitch in the Russian instrument compared with the combined representation in the western type.

In Russia, the risk of confusion when interpreting the artificial horizon display and when reading off the roll angle is well known since the introduction of the western type horizon on a number of aircraft types (TU-154, all western types). Several accidents have been caused by this.

Illustration: comparison of western and Russian horizon, left bank angle 27°, pitch 1° ANU

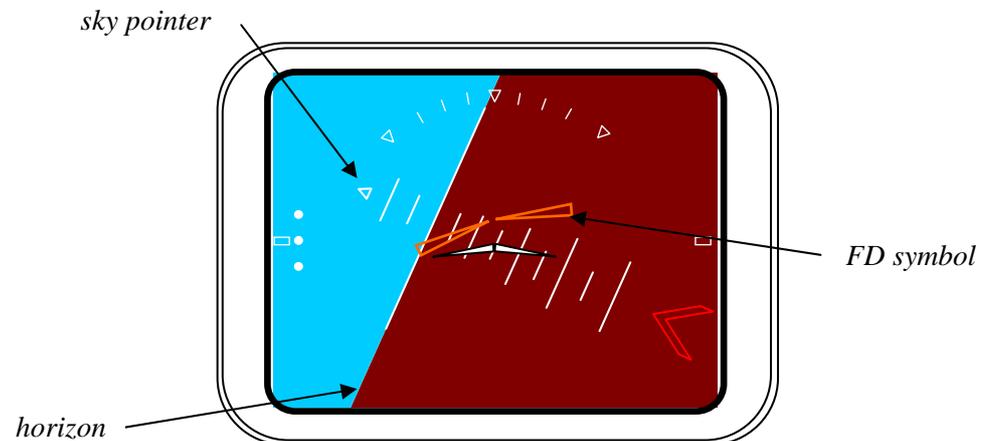
The EADI display was now already difficult to interpret. The combined representation of two parameters (bank attitude and pitch) made it essential to perform mental extrication. This applies especially in comparison with the Russian-type horizon with a decoupled representation where attitude and pitch can always be read independently of each other. The bank angle was shown in the angle of the horizon line (blue-brown dividing line) of the EADI compared with the instrument case. With the dominant display of the brown element and the slipping of the horizon line to the top left corner, this became increasingly difficult. The sky pointer had exceeded the scaling limit at 60° bank angle. The pitch display was now no longer represented as the position of the horizon line in vertical reference to the neutral line of the instrument. With vertical bank, for instance, a change in pitch caused a lateral movement of the horizon line.

Illustration: representation of the EADI with FD symbol for a right bank angle of 65° and a pitch of 15° AND

It is conceivable that in this period the commander's confusion about the current attitude dominated his perceptions and that he was having trouble interpreting the EADI display at all and reconciling it with his mental picture of flight path and attitude. Once again, an enhanced effect due to the medication cannot be excluded.

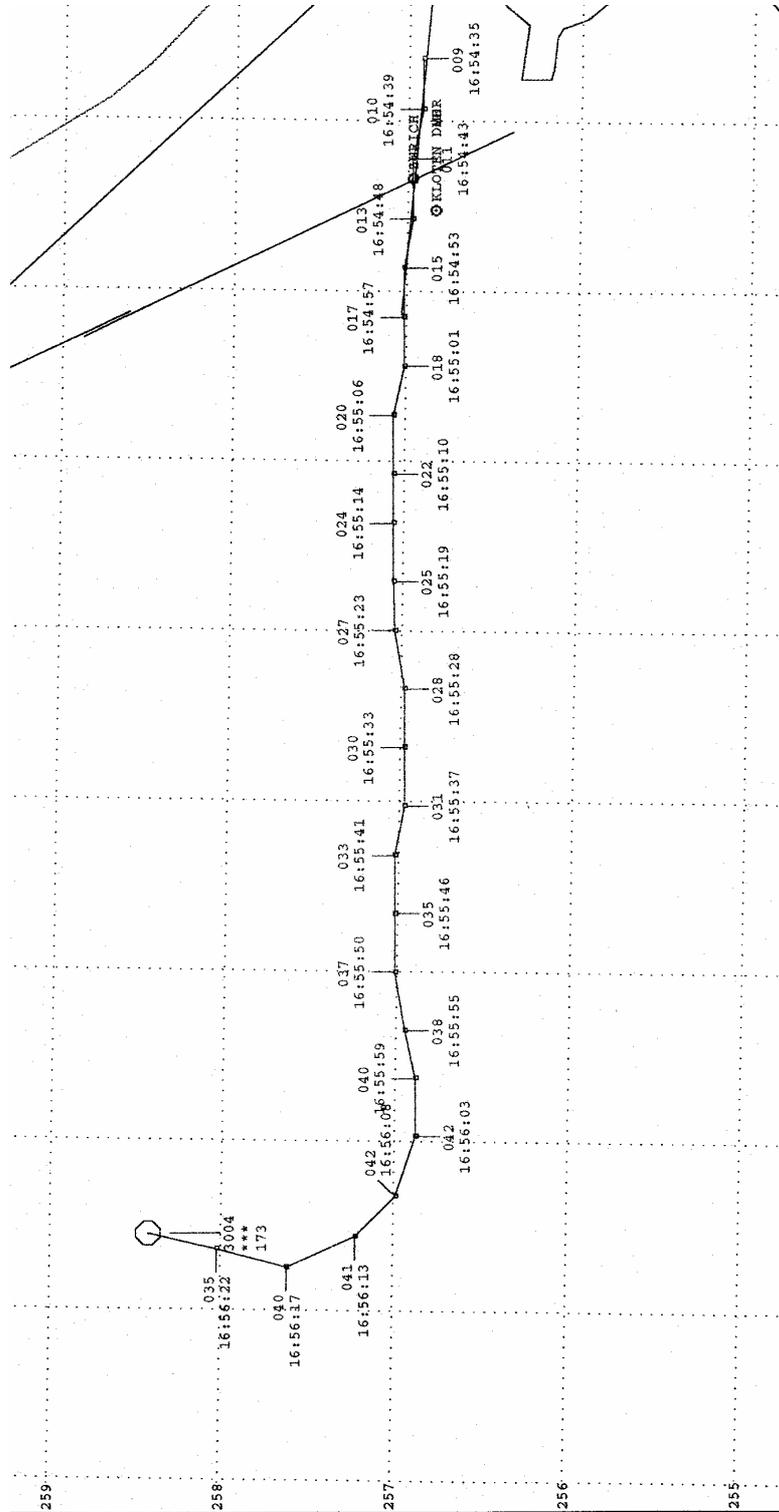
Annex 2

Radarplot of flight CRX 498

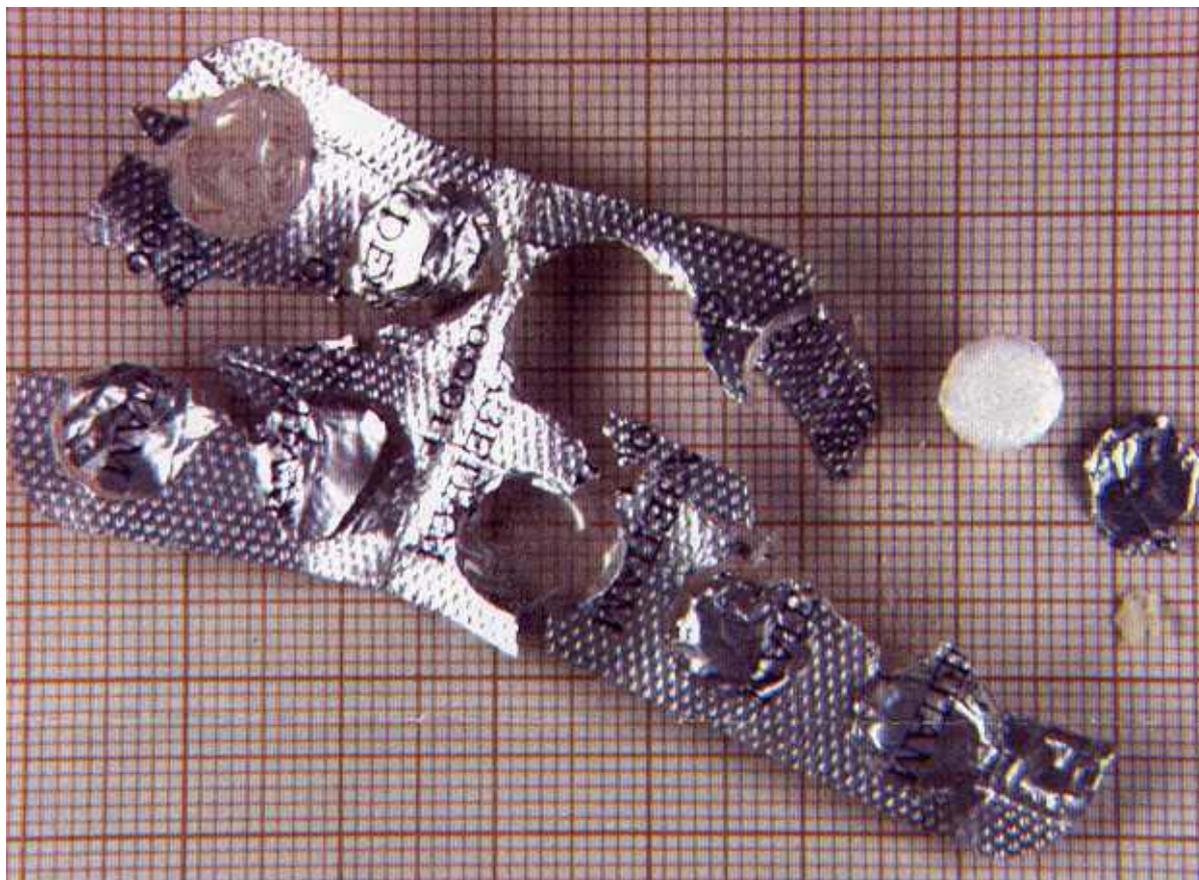
Annex 4

Pack of Phenazepam, found in the commander's crew bag

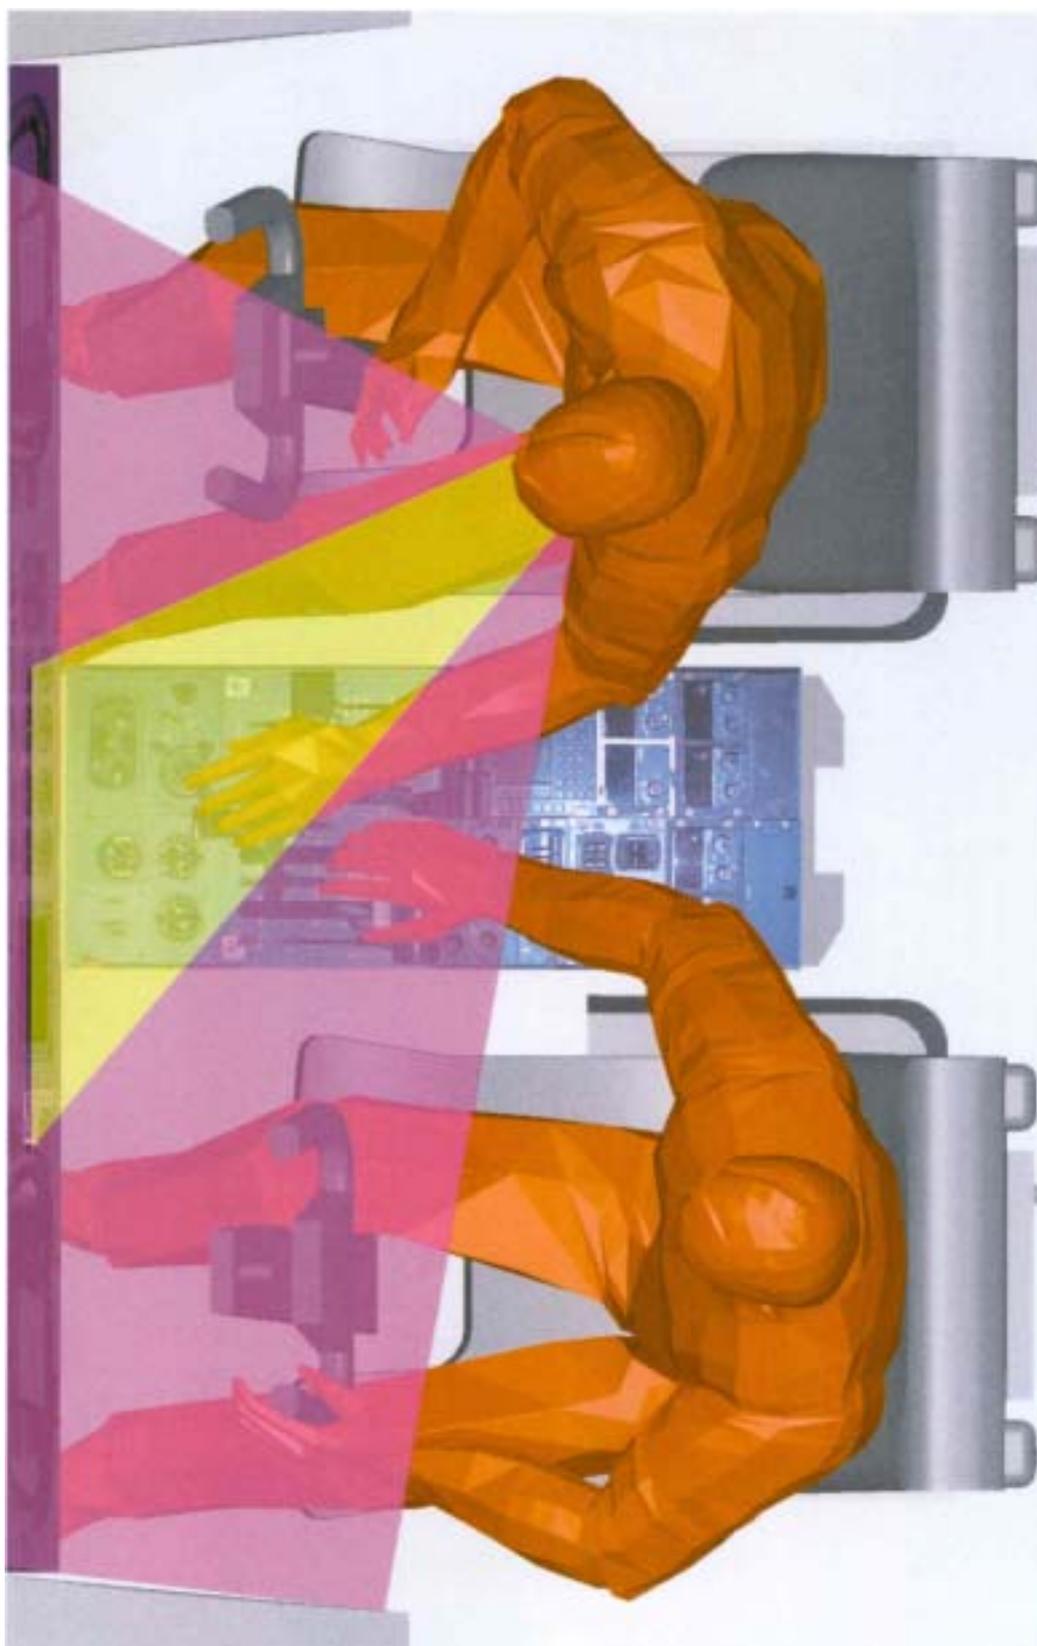
Annex 5

First officer's field of view – plan form

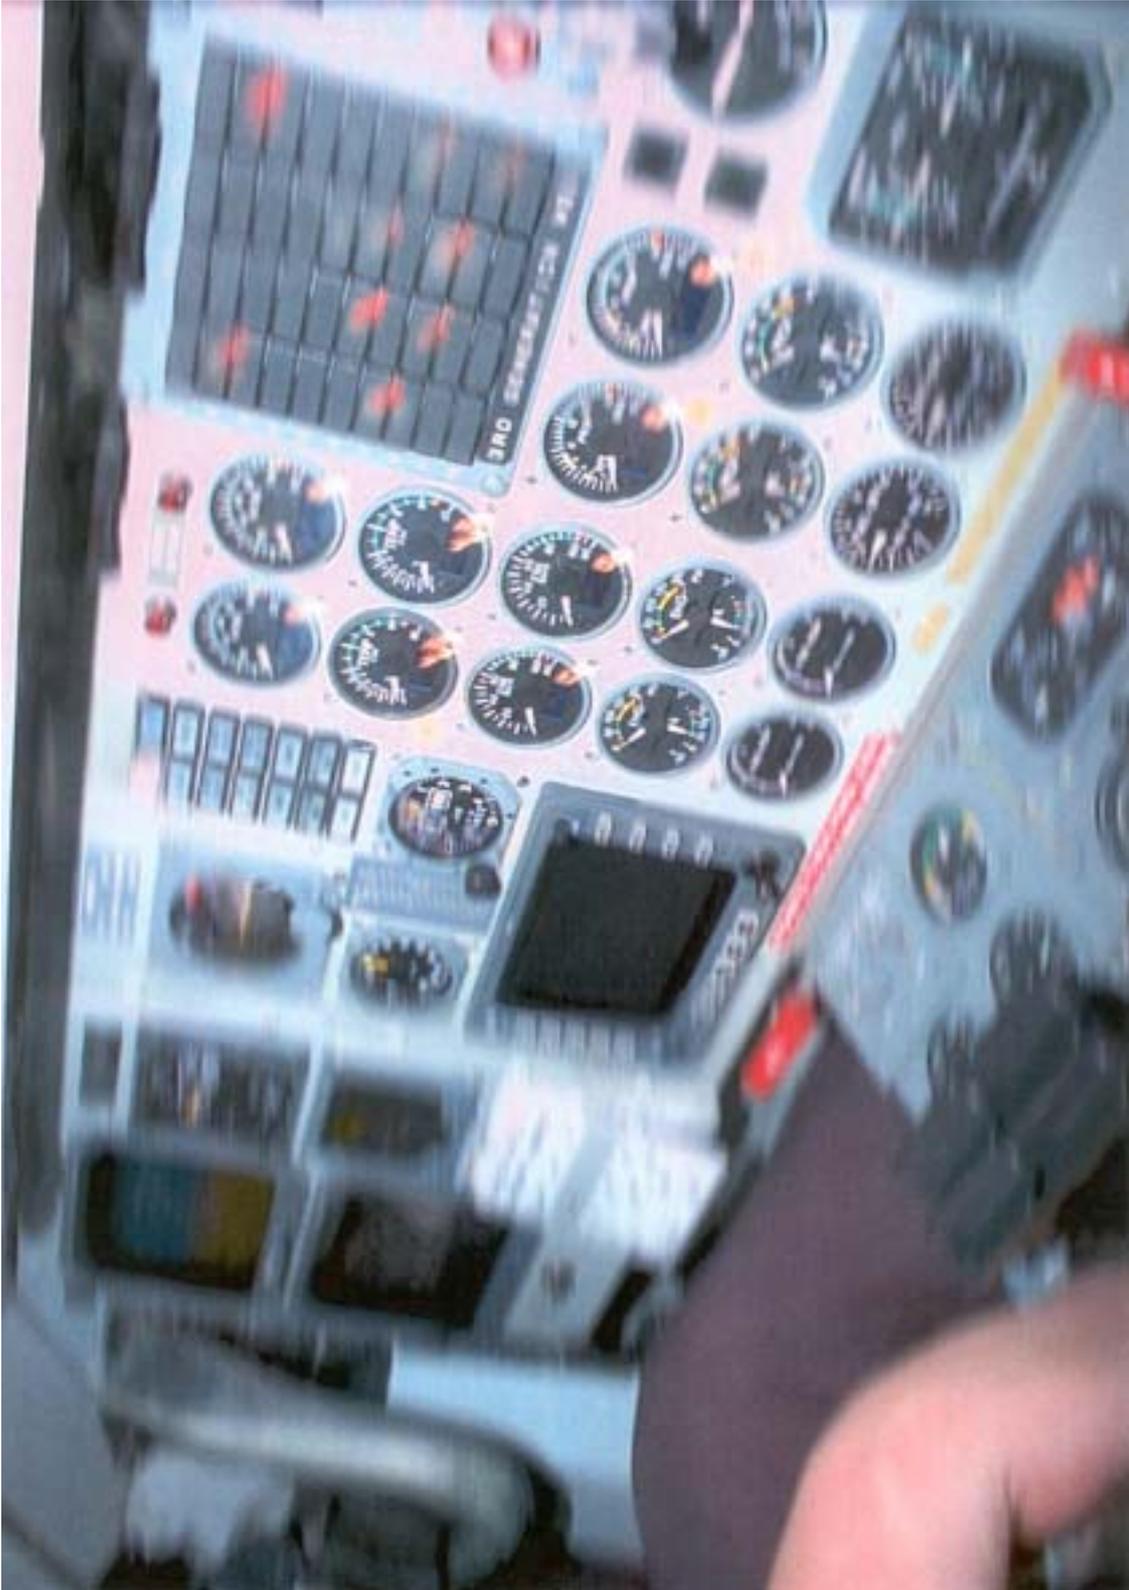
First officer's field of view – simulation

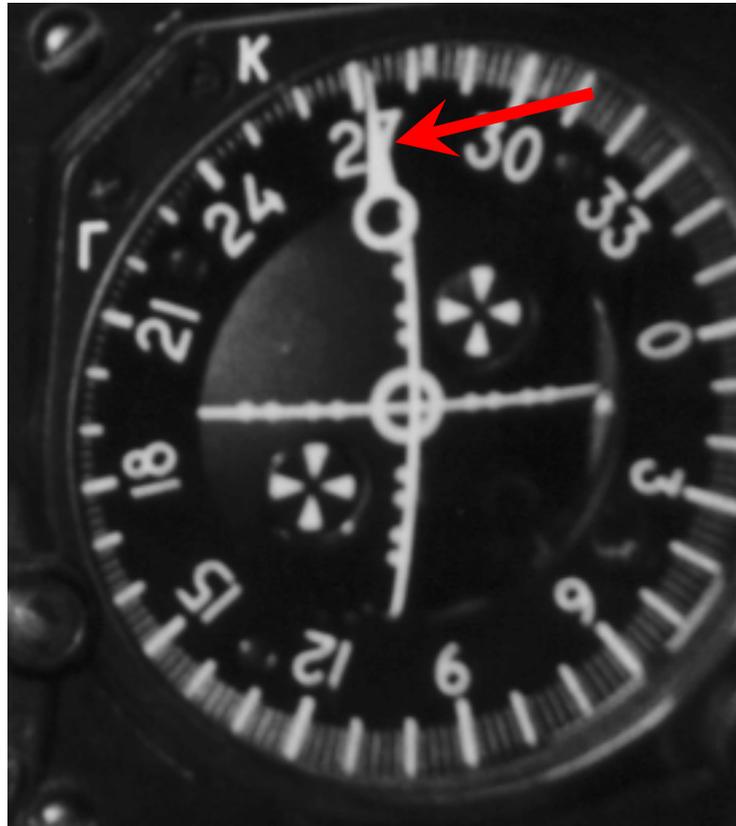
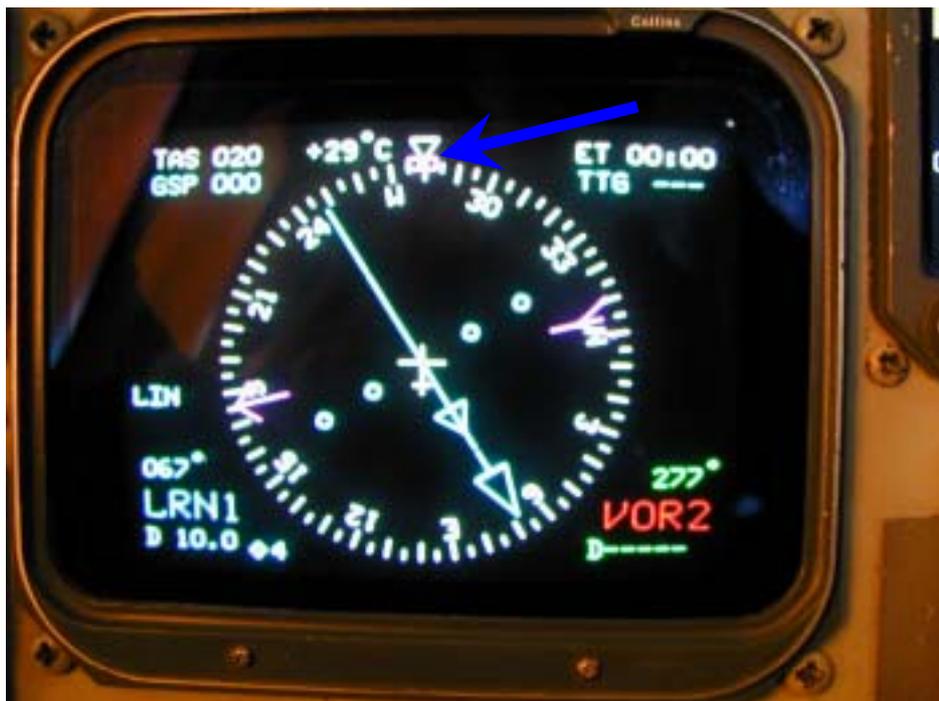
Annex 6

Gyro compass of russian design (above) in comparison with the EHSI of the SF-340 B (below). The pointer (red arrow) rotates with respect to the fixed scale, whereas on instruments of western type, the heading bug (blue arrow) is fixed with respect to the rotating compass card.

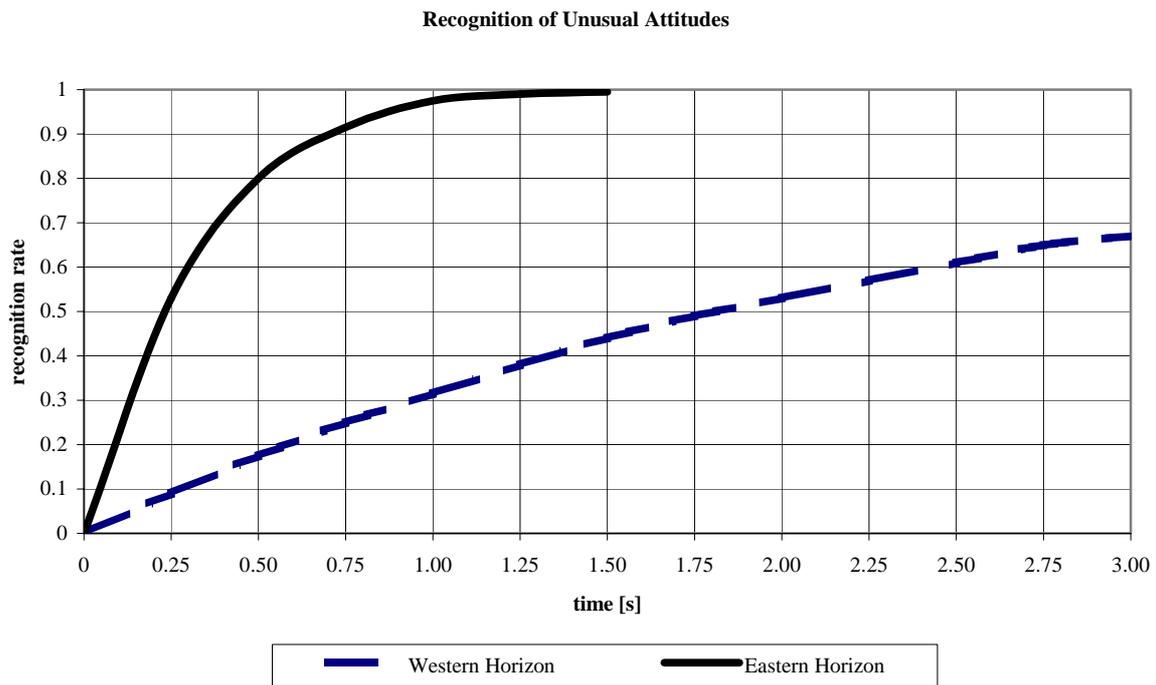
Annex 7

The diagram below shows the results of a study which registered the time needed by pilots trained on eastern horizons to detect an attitude with certainty. The rigid curve represents the situation in which eastern horizons were used, the dotted curve represents the one, when artificial horizons of western make were used.

For instance after one second, 98% of pilots were able to interpret the attitude, if it was represented by eastern horizons. But only 32% of the same pilots could reliably determine attitude after one second on western instruments.

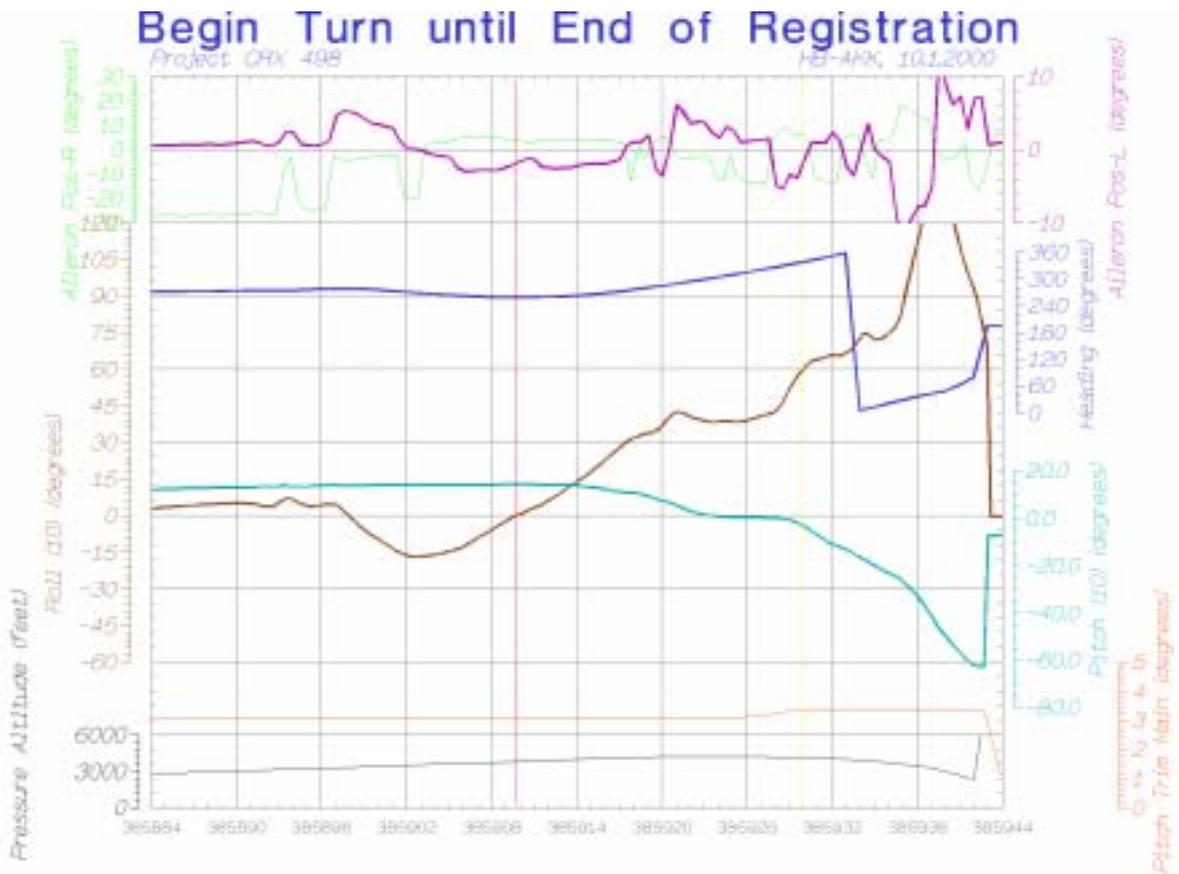
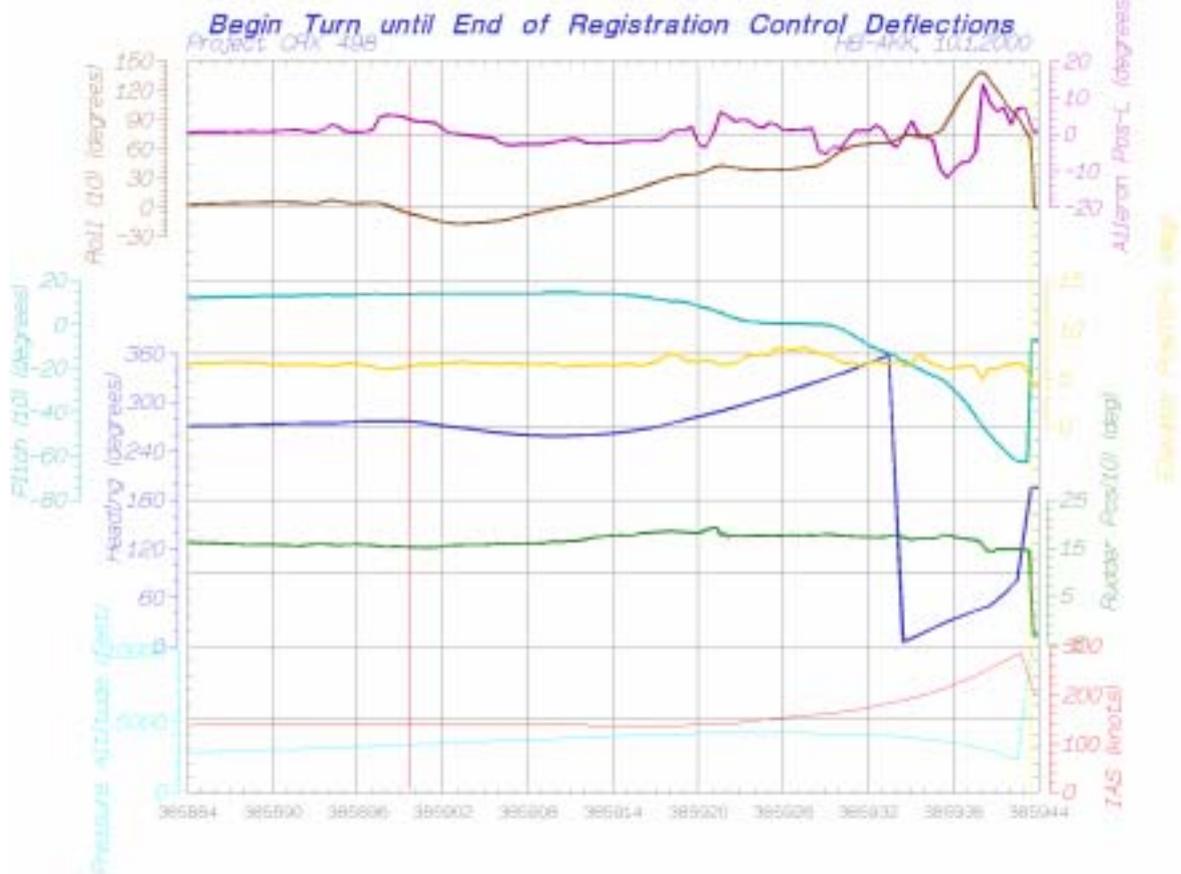
Annex 9

Excerpts from the recordings of the *digital flight data recorder (DFDR)*.
