Aircraft Accident Report

**Loss of Control and Impact with Pacific
Ocean Alaska Airlines Flight 261
McDonnell Douglas MD-83, N963AS
About 2.7 Miles North of
Anacapa Island, California
January 31, 2000**

**NTSB/AAR-02/01
PB2002-910401
Notation 7263E
Adopted December 30, 2002**

The National Transportation Safety Board determines that the probable cause of this accident was a loss of airplane pitch control resulting from the in-flight failure of the horizontal stabilizer trim system jackscrew assembly's acme nut threads. The thread failure was caused by excessive wear resulting from Alaska Airlines' insufficient lubrication of the jackscrew assembly.

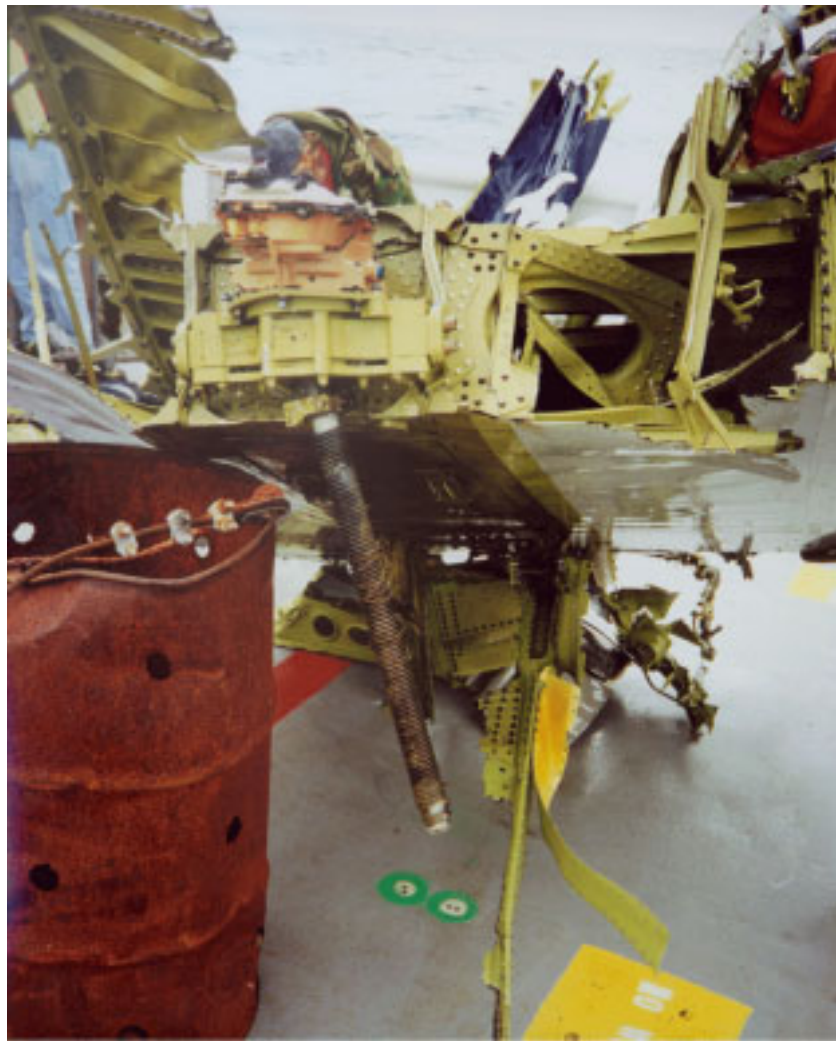
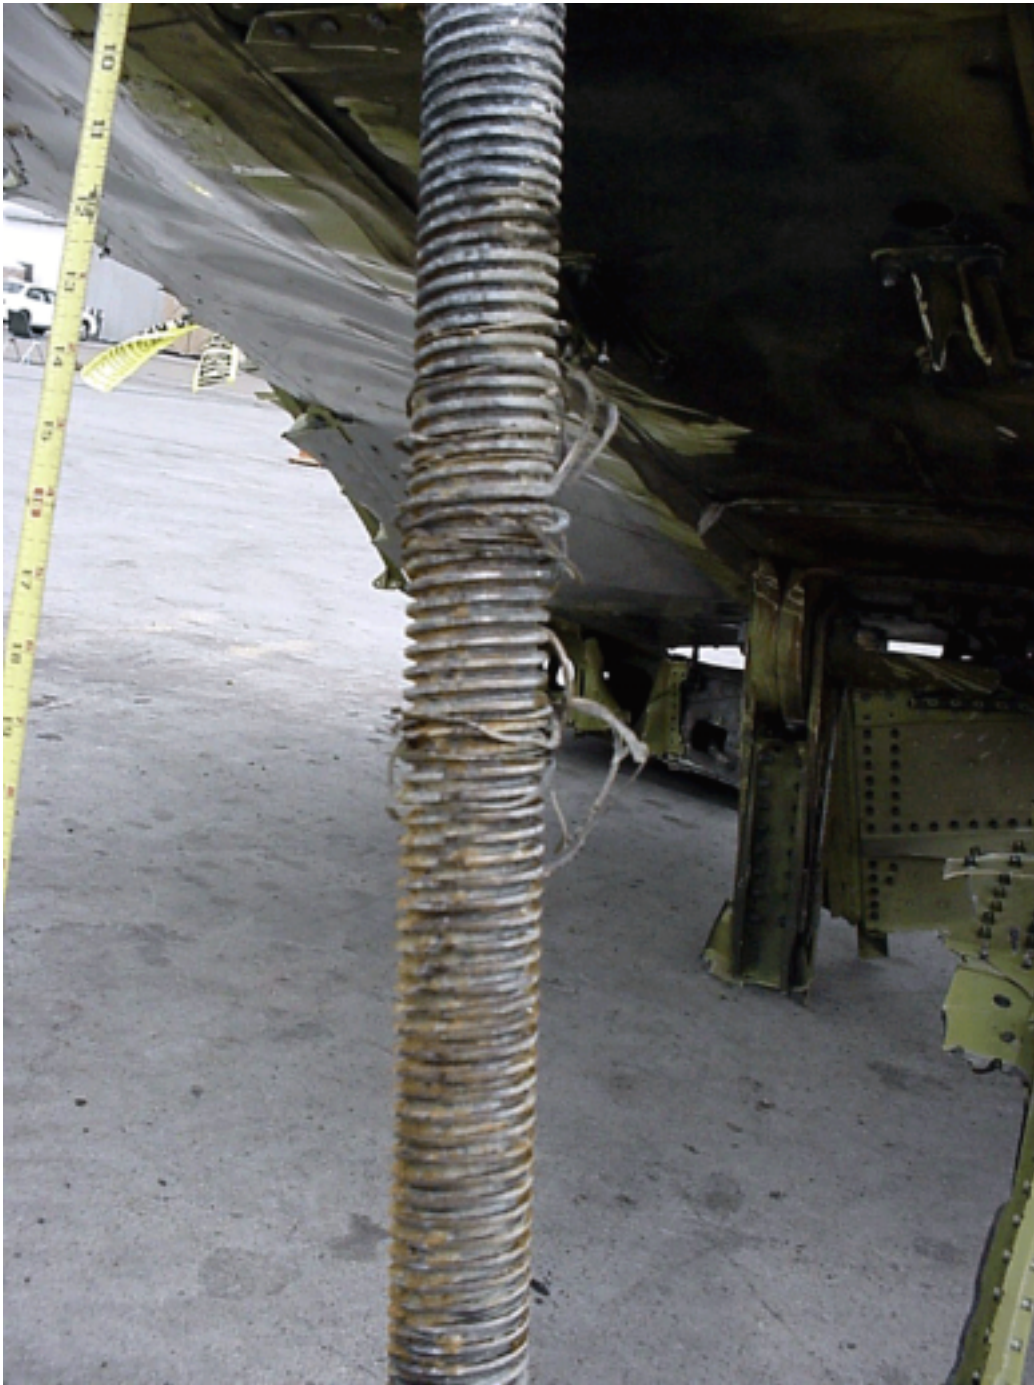
wrapped around the central part of the acme screw.¹¹⁶ (Figures 12a and 12b show the acme screw immediately after it was brought on board the recovery ship and immediately after it was brought to shore, respectively; figure 12c shows the acme screw during initial inspection.) The acme screw was rinsed with fresh water immediately after its recovery by directing the water from a hose similar to a garden hose over the gearbox and allowing the water to flow down over the screw. To preserve the acme screw and the thread remnants wrapped around the screw in their as-recovered condition, the stream of water used to rinse the screw was not directly sprayed on it. The acme screw might have been rinsed again with a garden-type hose after it was brought to shore.

Figure 12a. The acme screw immediately after it was brought on board the recovery ship.

Figure 12b. The acme screw immediately after it was brought to shore.

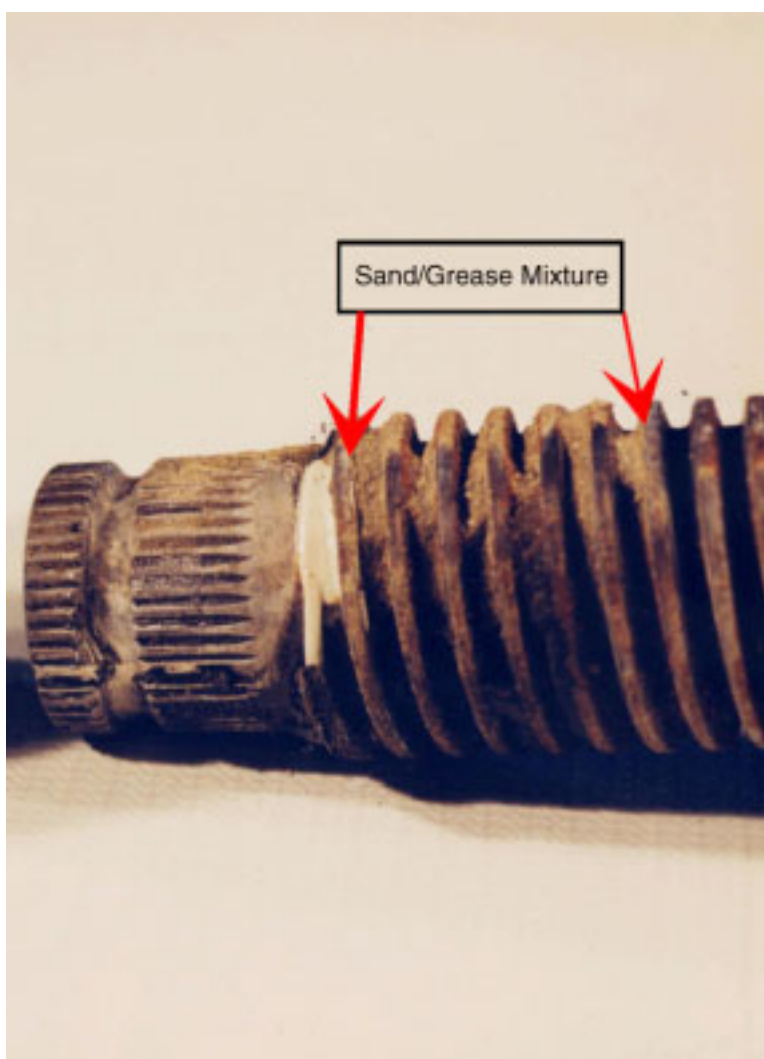
On-scene visual and tactile inspections by Safety Board metallurgists of the acme screw's threaded areas found no evidence of grease in any condition, either semi-fluid (that is, fresh) or solid/dry (that is, old or degraded), or other lubricants in the central "working region" of the screw threads.¹²⁹ Laboratory examinations found small flakes of dried and hardened grease attached to some of the thread remnants in this region. The acme screw's lower threads (which are outside of the working region) were found partially packed with a mixture consistent with sand and grease. (Figure 14 shows the sand/grease mixture packed between the acme screw's lower threads.) Parts of the acme screw's upper six to eight threads had an oily sheen, and small deposits of greaselike material were found between the threads.

Figure 14. A photograph of the sand/grease mixture packed between the acme screw's lower threads.

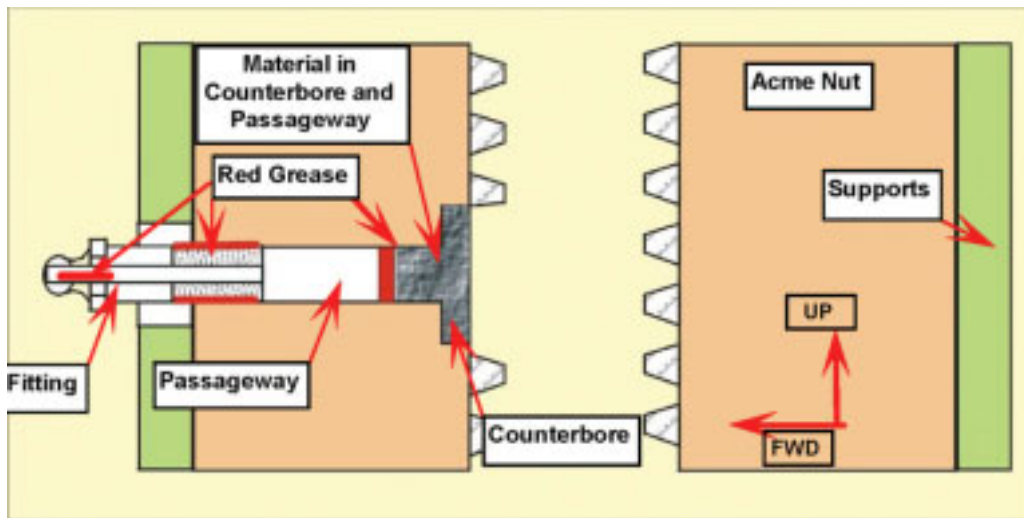
The acme nut has a grease fitting on the forward, upper side of the nut through which grease can be applied to the acme nut threads. A solid, black, claylike, dry residue coated with white, powdery material was found in the internal counterbore of the acme nut's grease passageway where it intersected the inside surface of the nut, as well as in the smaller diameter grease passageway behind the counterbore. When the grease fitting was

removed to allow collection of material samples from the grease passageway, translucent, reddish grease consistent with the appearance of Mobilgrease 28 was observed on the fitting's external threads. (Figure 17 shows a cross-section through the acme nut's grease passageway and fitting.) Traces of translucent, reddish grease were also found inside the grease passageway in the acme nut and in the bore of the grease fitting, a section distinct from the grease passageway. (Figure 18 shows the grease passageway and counterbore after the acme nut was sectioned.) Microscopic examination determined that the sample from the counterbore consisted mostly of black powdery material, larger chunks of black and white material, and particles of copper-colored metallic debris identified as acme nut material.

Figure 17. A diagram of a cross-section through the acme nut's grease passageway and fitting. Red areas denote the locations where red grease was found, and gray areas denote the location where the dry residue was found.
