Report 00-006

Fairchild SA227-AC Metro III

ZK-RCA

undercarriage failure and subsequent wheels-up landing

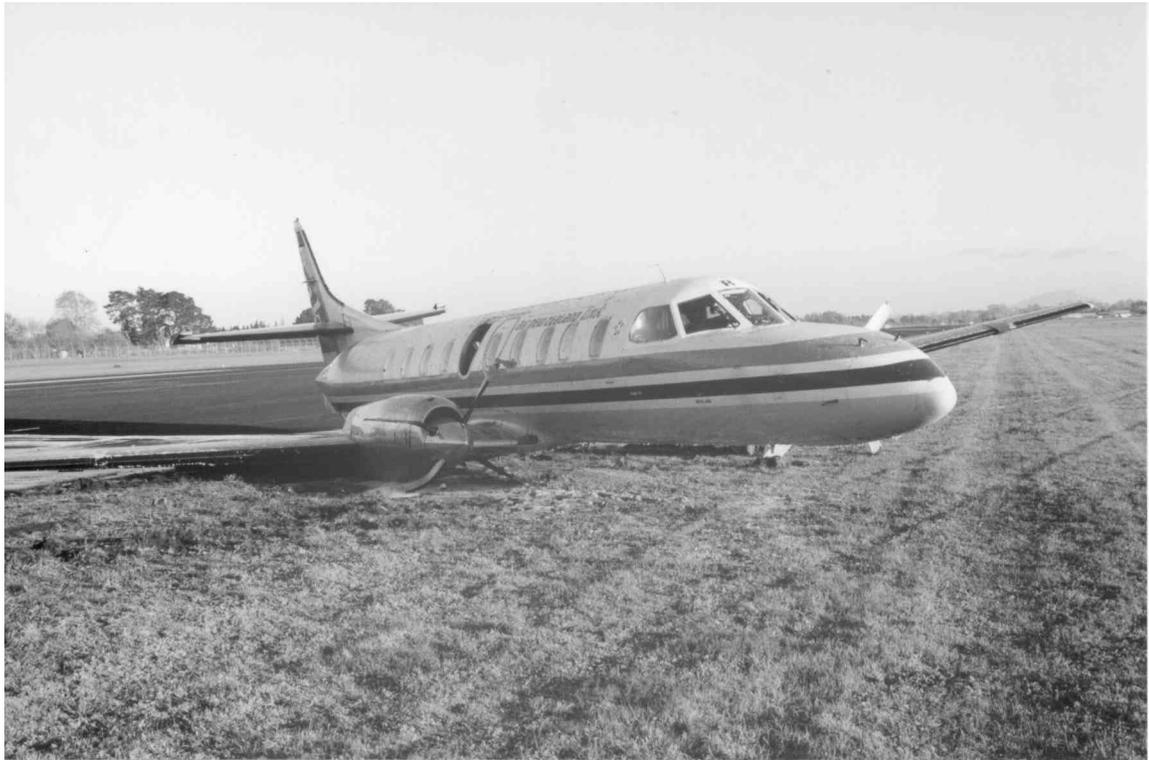
ZK-RCA Metro III
After the wheels-up landing

- 1.3.1 The left propeller blade tips had struck the runway on landing at Gisborne Aerodrome after the left undercarriage collapsed, resulting in significant damage to each of the 4 propeller blade tips. The pilots were unaware of the propeller strike and did not detect any in-flight engine or propeller vibration. Both engine propellers were feathered before the landing at Hamilton Aerodrome but they were destroyed from bending and abrasion during the landing.

- 1.3.2 The engines were removed for overhaul following the accident. There was substantial abrasion damage to the trailing edge of the right flap and rear fuselage. The right undercarriage doors on the bottom of the right engine nacelle were abraded and bent. The left undercarriage doors below the left engine nacelle and left flap were undamaged where the partially extended left undercarriage absorbed the landing forces. Impact damage to the fairing aft of the left undercarriage occurred when the undercarriage collapsed rearwards. The right engine nacelle showed evidence of some torsional and compression buckling. The left engine nacelle showed no evidence of any torsional or compression buckling.

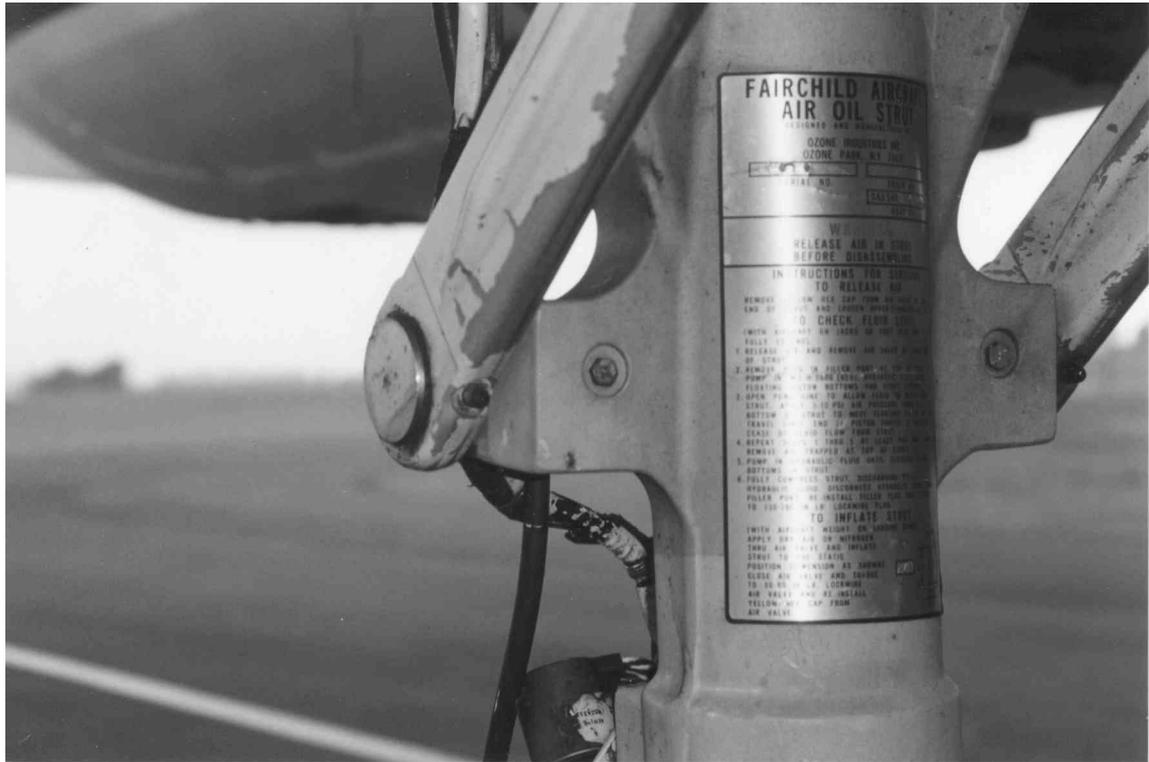
Figure 1
Metro undercarriage leg showing inboard and outboard lower drag braces

- 1.3.3 Both lower left undercarriage drag braces failed near their respective attachment points on each side of the undercarriage leg, through a recess machined to accommodate a grease fitting. The fracture surfaces on the matching end of each drag brace were abraded from scraping on the runways. The broken end piece of the outboard drag brace remained attached to the undercarriage leg. The inboard broken end piece was later found at Gisborne Aerodrome. The 2 undercarriage hydraulic actuator arms for the left undercarriage had bent around the undercarriage leg attachment points when the undercarriage leg collapsed rearwards. The arms were bent upwards about 20 degrees approximately 5 cm from the end of each arm and prevented the left undercarriage from retracting fully into the left engine nacelle. Some structural damage occurred near the left undercarriage drag brace upper attachment area. The left undercarriage down lock bellcrank bearing shattered when the undercarriage collapsed rearwards.

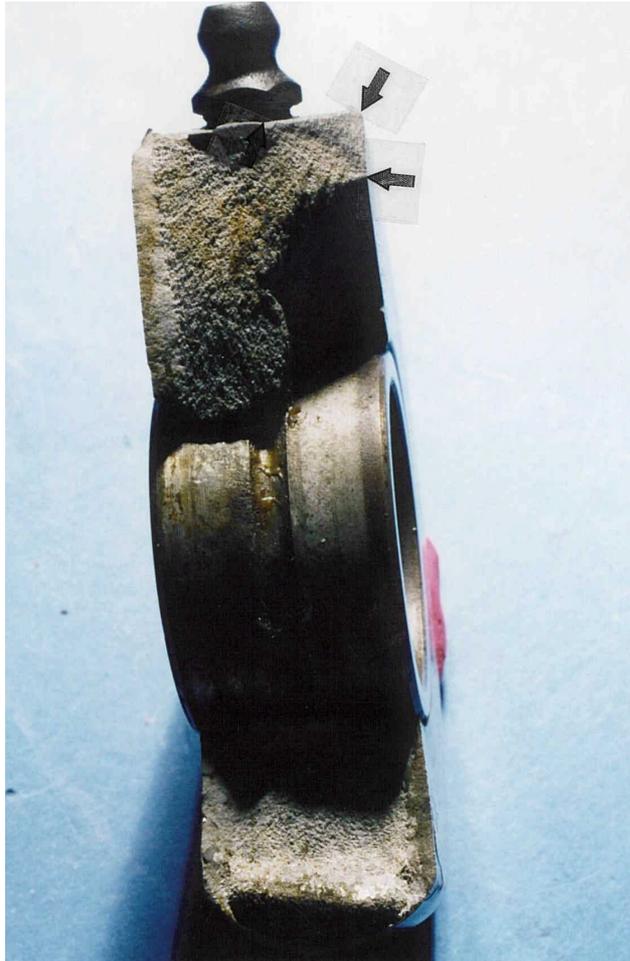
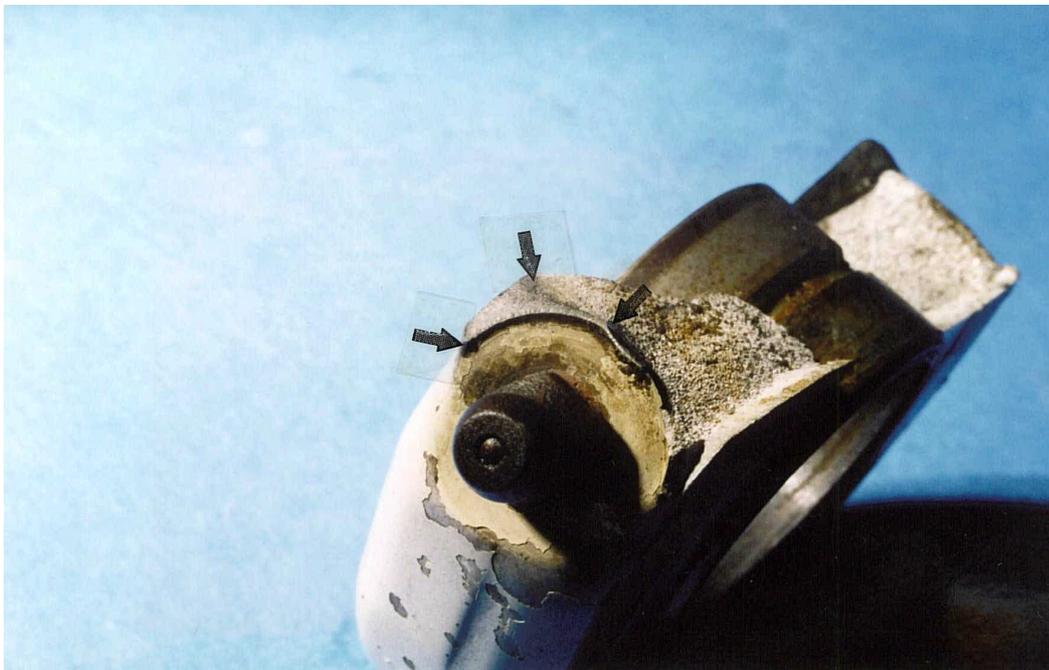
- in the failed outboard lower drag brace a fatigue crack had started and propagated from the edge of the machined bolting face at the top of the grease fitting hole (see Figure 2)

- the fatigue crack was multi-originated (this was indicative of a relatively high stress failure)
 - the fatigue crack surface was slightly polished and darker in colour than the remainder of the fracture surface

- the fatigue crack surface was relatively rough (this was indicative of a low cycle fatigue failure rather than a high cycle fatigue failure)
 - the fatigue crack had started around the change in section. The crack had propagated at the surface over a length of about 10 mm and to a maximum depth of 8 mm, from the outer corner where the crack met the side of the brace

- away from the area of fatigue, the fracture was typical of overload
 - the edge of the machined area had been formed with a square-edged cutter. There had been no attempt to radius the corner during manufacture

Figure 2
The broken outboard drag brace end piece from ZK-RCA showing the fatigue crack (arrowed)

- 2.4 During the landing at Gisborne the left undercarriage outboard lower drag brace failed because a fatigue crack had started and propagated in the machined grease fitting recess until overload occurred. The failure occurred near the point where the drag brace attached to the undercarriage leg. Once the outboard lower drag brace failed the load was transferred to the inboard drag brace, which then failed in overload in a similar manner through its grease fitting recess.

- 2.10 The recesses machined in the drag braces to accommodate the grease fittings had square edges, which will have acted as significant stress concentrators. If the recesses had been machined with smooth radiused corners they would not have acted as stress concentrators and cracking probably would not have occurred.

- 4.1 On 23 June 2000 the aircraft manufacturer issued Service Bulletins, number 226-32-068 for the Fairchild SA226 series aircraft, and number 227-32-043 for the Fairchild SA227 series aircraft with Ozone Industries 14 500 pound (6578 kg) maximum gross take-off weight, part number OAS5453-5 main landing gear assemblies. The bulletins were essentially the same and called for the main landing gear drag brace links to be routinely checked for cracks in the area of the grease fitting recesses using dye penetrant.
- 4.2 The manufacturer highly recommended compliance with the Service Bulletin. Initial inspection was to be accomplished within 50 hours, time in service from receipt of the bulletin. The bulletin detailed the checking requirements, the ongoing checks necessary and the criteria for replacement of the drag brace assemblies.

- 4.3 On 31 July 2000 the New Zealand CAA issued Airworthiness Directive DCA/SA226/41, effective from 3 August 2000, applicable for all New Zealand registered Fairchild SA227 series aircraft with Ozone Industries 14 500 pound (6578 kg) maximum gross take-off weight, part number OAS5453-5 main landing gear assemblies. The directive was issued to prevent failure of the drag brace assemblies and required the assemblies to be inspected per the manufacturer's Service Bulletin.

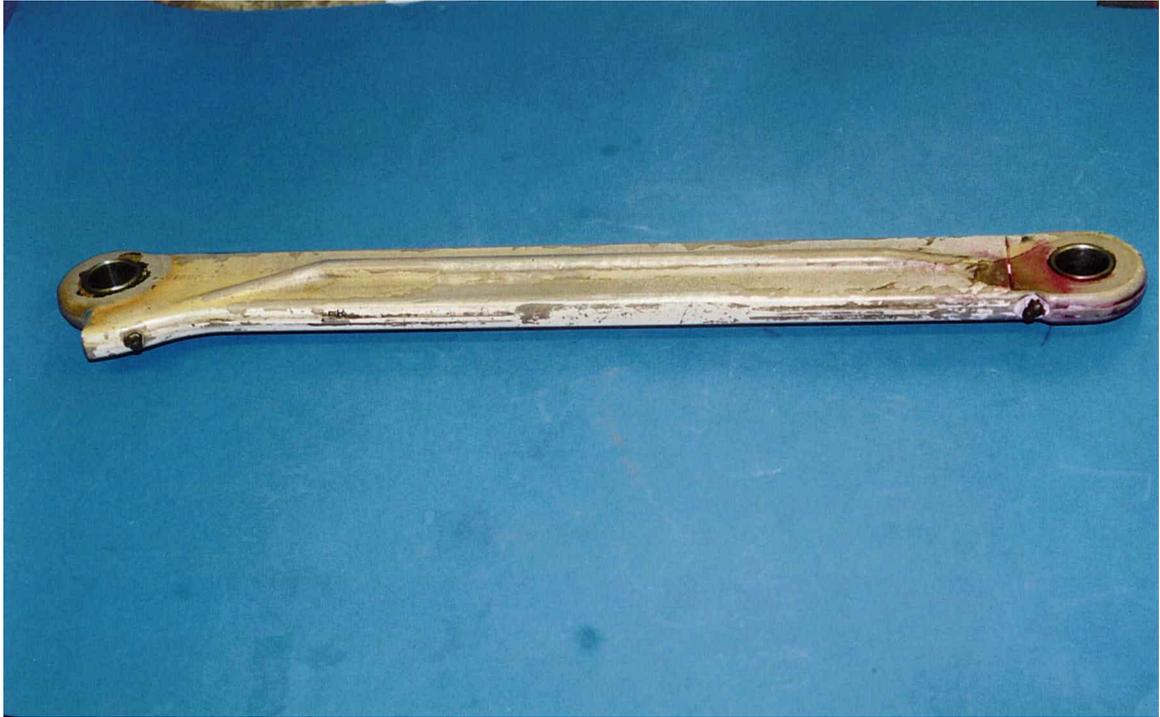
- some corrosion was present in the outboard drag brace end bushing.
- 1.10.4 The intact drag brace from ZK-OAA (see Figure 3) was mounted in a tensile testing machine and loaded between pins placed in the end attachment holes. At a load of 13 525 kg one of the pins holding the drag brace fractured. Examination of the drag brace after the test revealed that the crack had become visible to the naked eye. The drag brace was reloaded in the testing machine between high tensile bolts. The lower end of the drag brace failed at a load of 20 000 kg. Based on the cross-sectional width of the bulk of the brace this was estimated to equate to a tensile strength of 290 MPa (megapascals).

1.10.5 The lower end of the drag brace failed in a near identical manner to the inboard drag brace from ZK-RCA. Examination of the fracture revealed that:

Figure 3
The complete but cracked lower drag brace from ZK-OAA

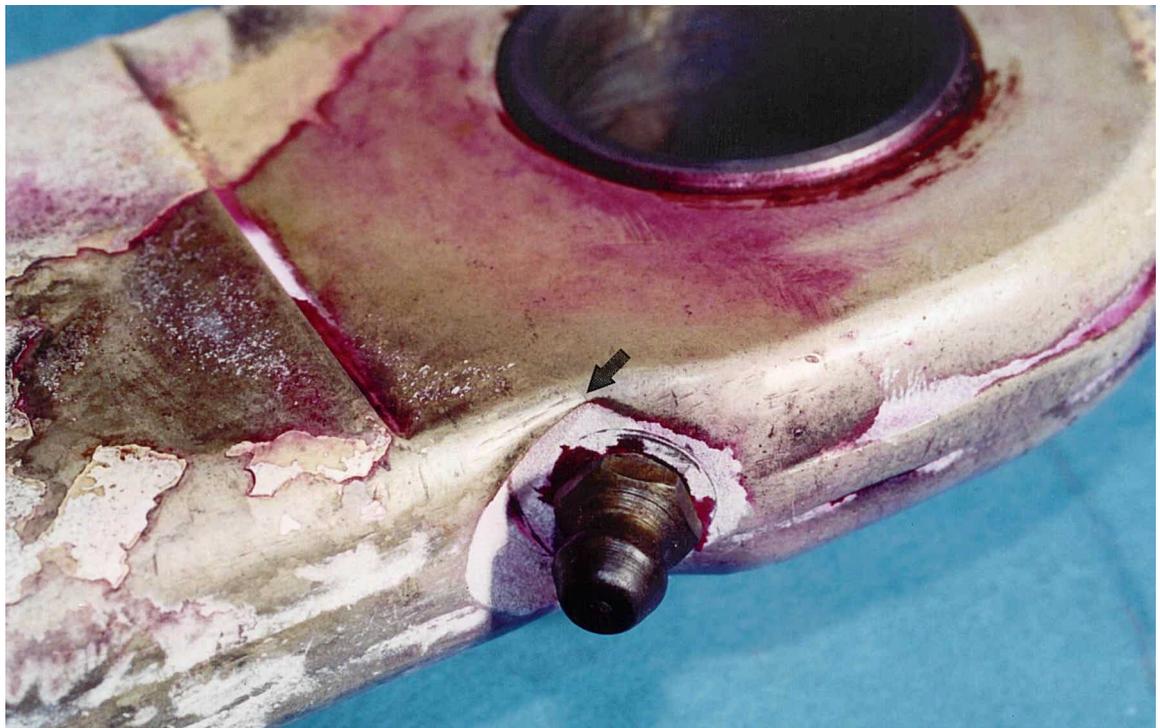
- a small fatigue crack had been present at the end of the edge of the machined region in a similar location to the fatigue crack seen in the outboard drag brace from ZK-RCA, except that it ran towards the left rather than the right of the fracture
- the fatigue crack was about 0.8 mm deep and ran around the change in section for about 4 mm (see Figure 4).

Figure 4
The fatigue crack in the lower drag brace from ZK-OAA
(arrowed)

- 2.13 The crack in the drag brace from ZK-OAA had started in a similar location to that in ZK-RCA. The presence of this crack and the cracks in the other Metro drag braces detected indicated that the fatigue cracking was a design and inspection problem potentially common to all the same type of aircraft.
- 2.14 The crew's decision to fly ZK-RCA to Hamilton for the wheels-up landing was prudent because the runway distance used during the landing exceeded the available runway length at Gisborne Aerodrome.
