AVIATION INVESTIGATION REPORT

A0000199

FAN COWL SEPARATION

AIRBUS A320-232 C-GTDC

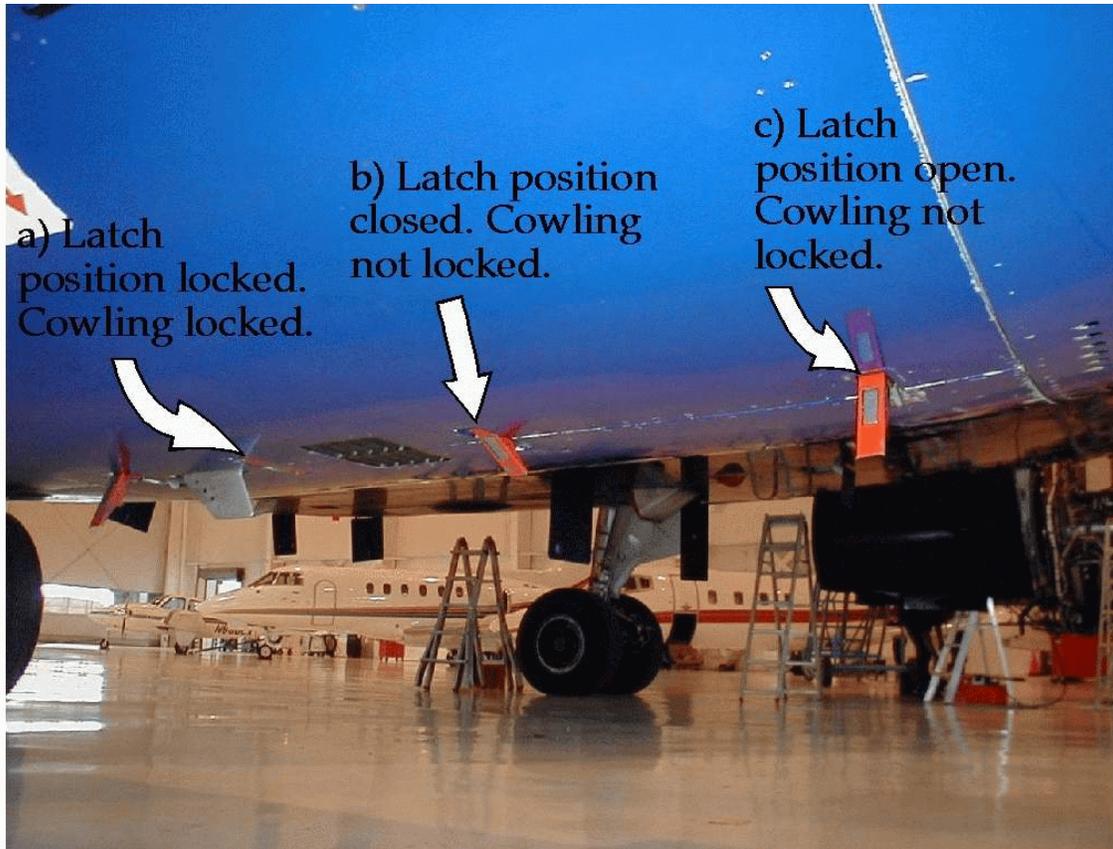
Appendix A - Latch Position

The fan cowling has four latches that connect at the bottom of the engine. The fan cowling doors are heavy and designed such that, when hanging unsupported, they fair flush, giving the appearance of being locked, even if they are not latched. Normally, the latches can be in three possible conditions (see Appendix A):

- a) latches fully locked and will appear flush with the cowling;
- b) latches closed, but cowling not locked. In this condition, they will protrude about one inch underneath the cowling. This is the normal condition of the latches after maintenance opens the cowling, until the latches are re-locked; and
- c) latches fully open and cowling unlocked. This is considered a temporary condition after unlocking the cowls. According to industry standard, the latches are immediately closed because the fully unlocked latch presents a personal injury risk to maintenance engineers. Fully unlocked latches protrude down about four inches from the bottom of the cowling.

Because of the circumference of the engines and their proximity to the ground, a proper visual inspection of the latches requires an individual to get on hands and knees, go underneath the nacelle, and look up at the latches. The latches are out of view to a person standing within about 10 feet of the engine, and difficult to see from a greater distance because they are relatively small and inconspicuous.

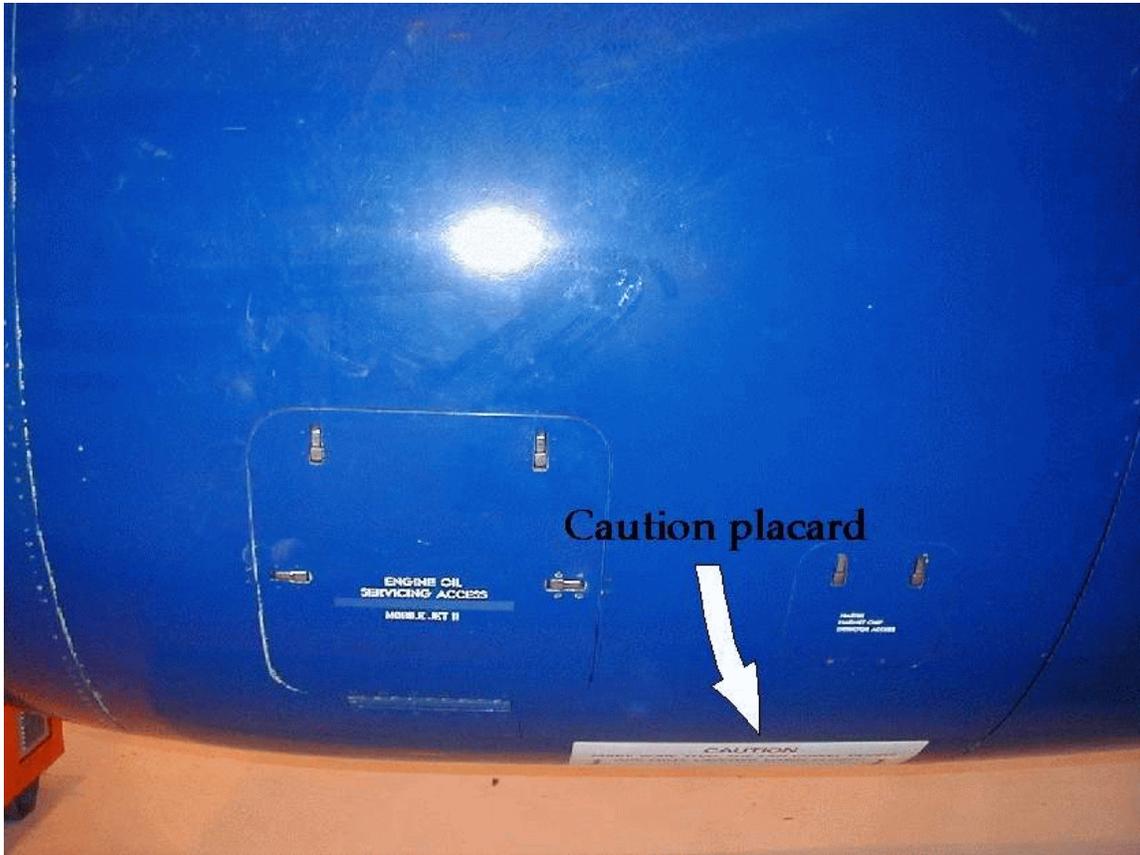
Appendix B - Caution Placard

The aircraft modification issued by the engine manufacturer to apply instructions to the fan cowl doors: "Caution Make Sure That The Fan Cowl Doors Are Fully Latched When Closed," was ineffective. The service bulletin requires the placard to be placed low, on both sides of the fan cowling. This increases the visibility of the placard when the fan cowlings are open and supported. However, when the fan cowlings are closed, the low placement of the instructions and the wide circumference of the fan cowlings decrease the visibility of the instructions, reducing the likelihood of drawing attention to the latches (see Appendix B). Additionally, none of the personnel associated with the aircraft before departure could identify either the number or locations of these placards.
