AIRCRAFT ACCIDENT REPORT
ASC-AAR-02-04-001

**CRASHED ON A PARTIALLY
CLOSED RUNWAY DURING TAKEOFF
SINGAPORE AIRLINES FLIGHT 006
BOEING 747-400, 9V-SPK
CKS AIRPORT, TAOYUAN, TAIWAN
OCTOBER 31, 2000**

AVIATION SAFETY COUNCIL

Crashed on a Partially Closed Runway during Takeoff, Singapore Airlines Flight 006,
Boeing 747-400, 9V-SPK, CKS Airport, Taoyuan, Taiwan, October 31, 2000

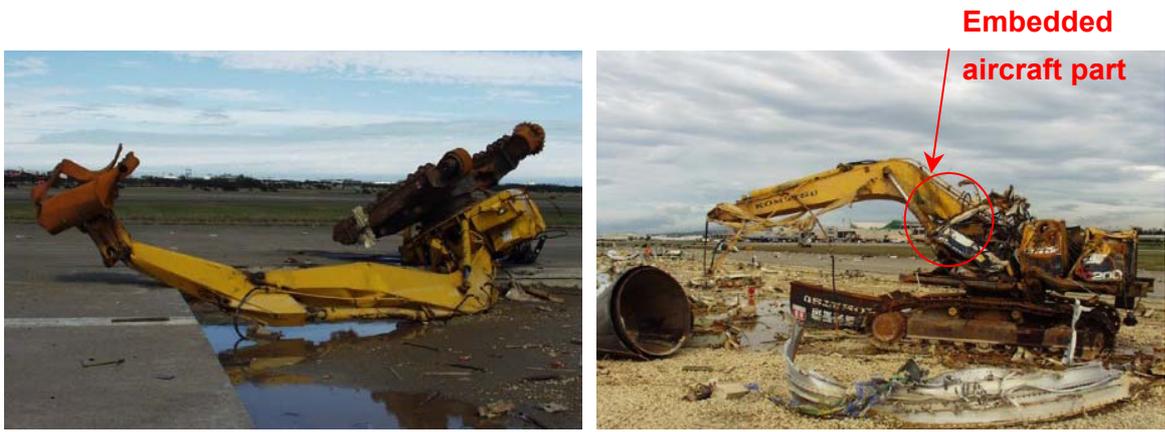
Figure 1.4-1 The excavator in No.5 pit (left) and the excavator in No.11 pit (right)

The construction crew had left six units of ground equipment on Runway 05R, specifically two excavators (Figures 1.4-1), two vibrating rollers (Figures 1.4-2), one small bulldozer (Figure 1.4-3) and one air compressor. All six units suffered serious impact damage. There were 11 pits at the construction site. With the exception of one excavator and the bulldozer, the rest of the units were scattered during the impact from their original positions in the various pits.

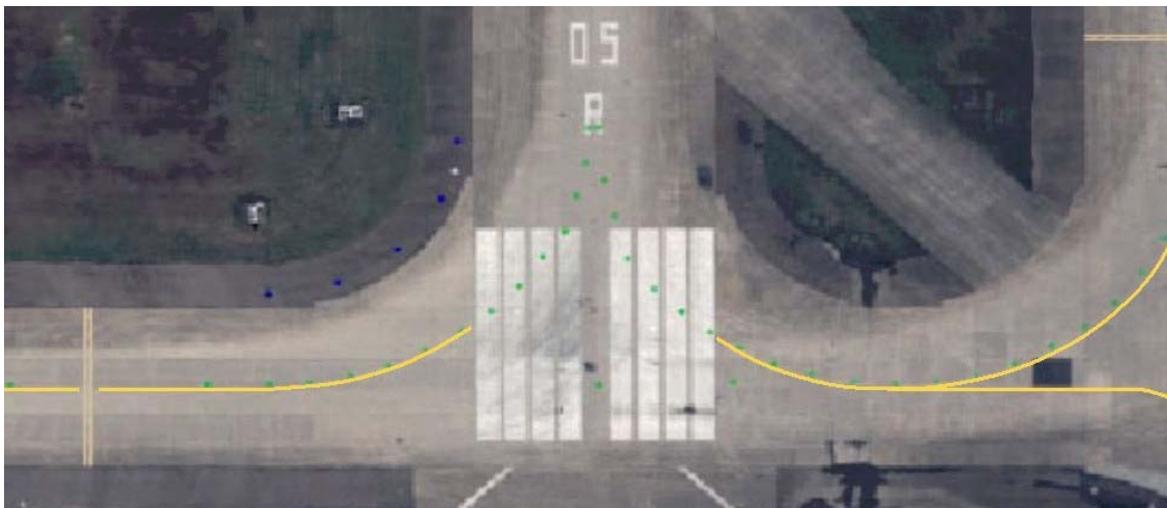
Figure 1.10-6 Taxiway centerline marking near the threshold areas of Runway 05R

The yellow taxiway centerline marking at CKS Airport was generally 20 centimeters wide and located on all pavement segments designated as a taxiway. The single-line taxiway centerline marking on N1 extended in a continuous arc from Taxiway NP to the approximate centerline entry point of Runway 05R. Further, there was an opposing, single-line, arcing taxiway centerline that extended from the approximate centerline of Runway 05R to N1 with its termination point at the runway edge line of Runway 05L, as shown in Figure 1.10-6. Part of the taxiway centerline marking on N1 that extended from NP to the south edge of Runway 05R and then from the north side of Runways 05R to 05L was not present.

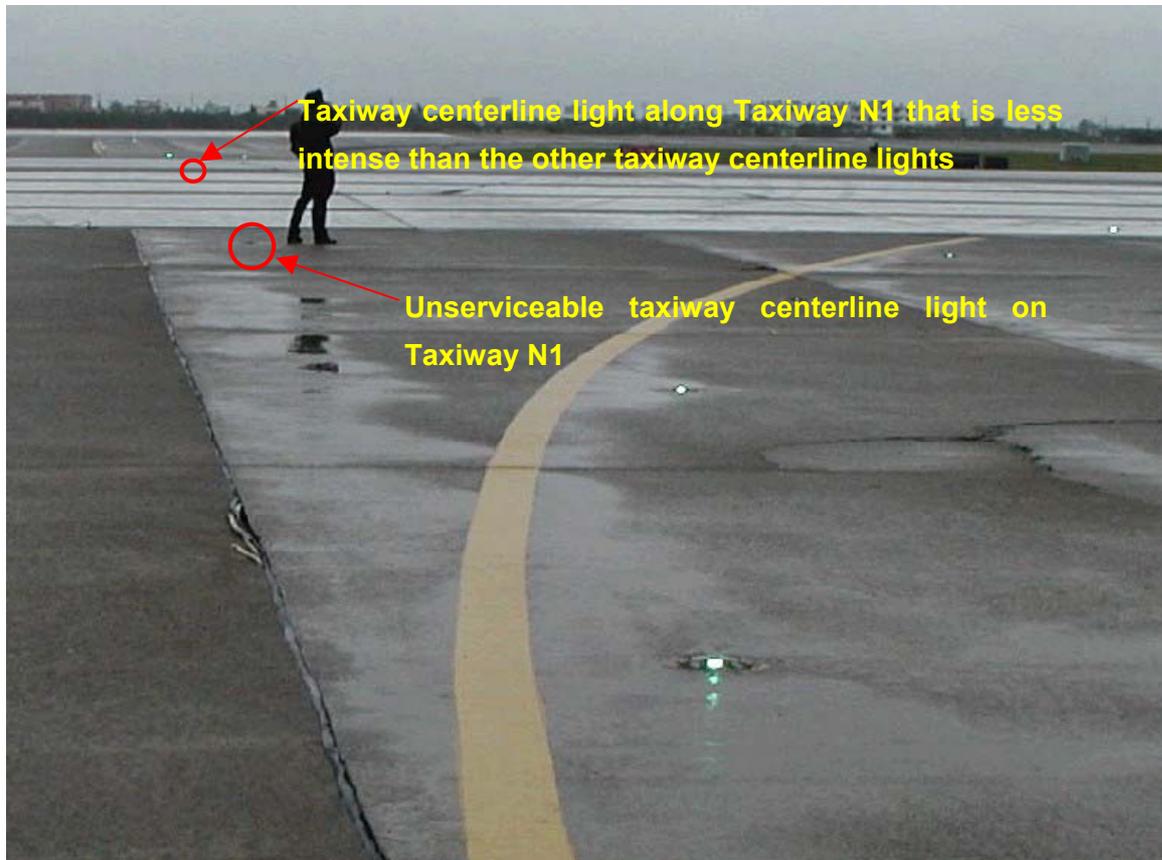
Figure 1.10-10 Status of Taxiway N1 centerline lights close to the threshold of Runway 05R (picture taken on November 4, 2000)

- Four days after the accident, the investigation team found that a green centerline light immediately after the Runway 05R entry point along Taxiway N1 leading to Runway 05L was un-serviceable and the following light was dim. It could not be determined what the status of those lights was on the night of the accident. (1.10.3.2.4; 2.3.1.2.3)

During the site survey (on November 4, 2000), it was noted that the first taxiway centerline light after the point of tangency was unserviceable while the second light was less intense than the other lights. (See Figure 1.10-10)

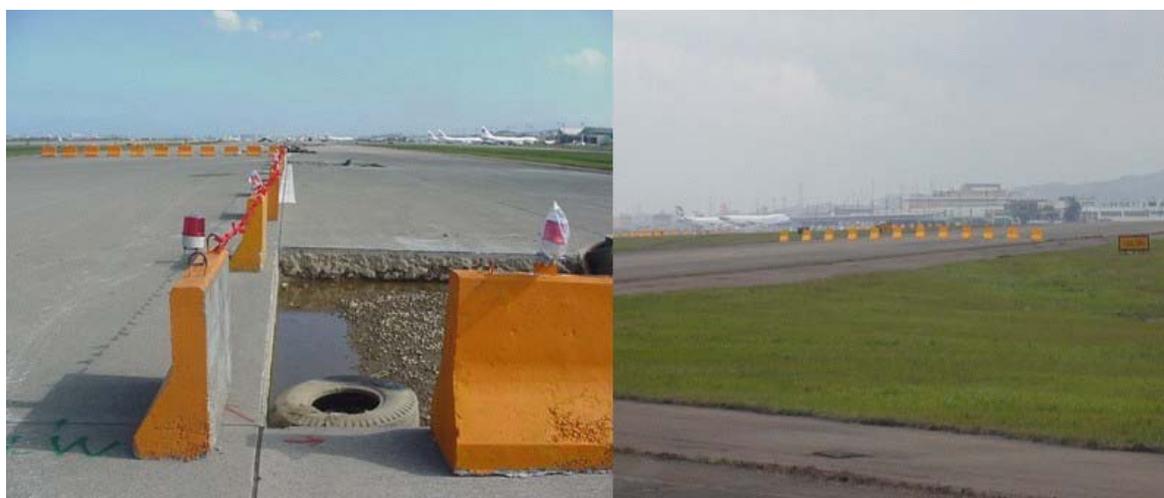
Figure 1.10-11 Closed working area along Runway 05R/23L and Taxiway viewed from Runway 05L/23R

According to information provided by the CKS Airport, due to the high wind conditions and heavy rain associated with Typhoons at CKS Airport, the light plastic, frangible markers with red obstruction light markers may be either washed away or blown away, therefore posing a risk of foreign object damage (FOD) to aircraft. To prevent such occurrences, CKS Airport used concrete jersey barriers, about 0.8 meters high, and 1 meter long, placed in close proximity to construction zones. The blocks were painted yellow, orange, or a combination of yellow and black stripes. Battery-powered, flashing red warning lights spaced at a distance of two to five meters were installed on top of the blocks for night time use (See Figure 1.10-11).

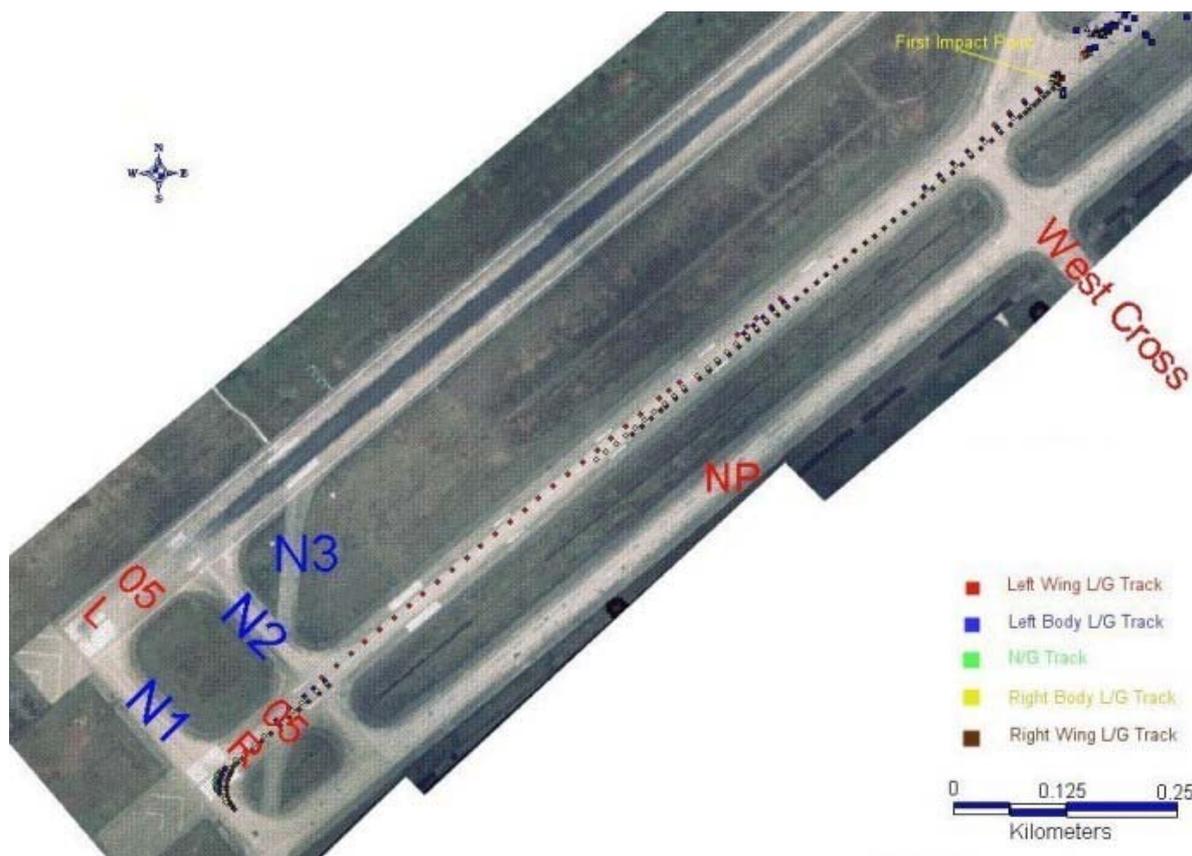
Figure 1.12-1 Tire marks map from site survey data

Ground survey of the wreckage field, including aircraft wreckage and ground marks was conducted from Taxiway N1 through N8 along Runway 05R. The landing gear tire mark from the beginning of Taxiway N1 to the initial impact point was also documented. The tire marks were visible in the damp early morning but not visible in drier afternoon or when the runway was wet. (Figure 1.12-1)

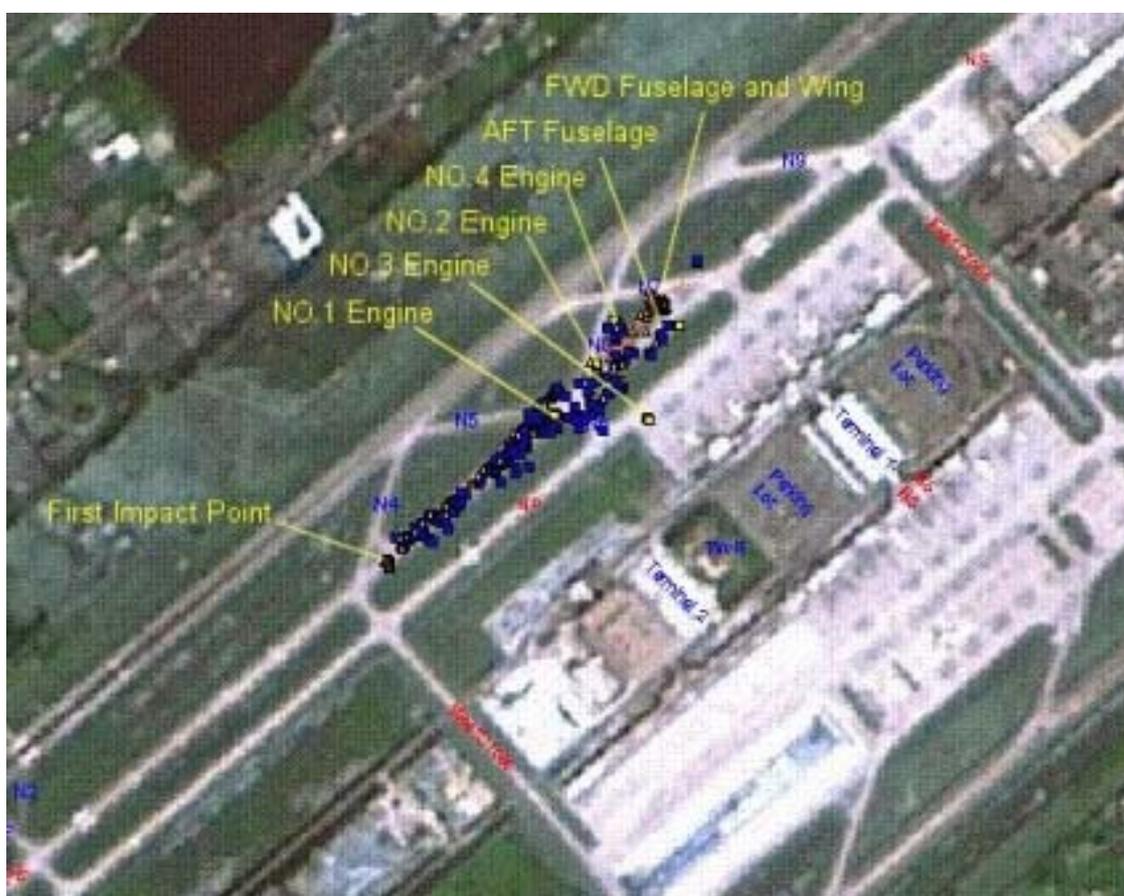
Figure 1.12-2 Related location of the wreckage and the airport

The aircraft wreckage was distributed along Runway 05R (Figure 1.12-2), beginning at the initial impact point (Figure 1.12-3) about 4,080 feet from the runway threshold. The aircraft broke into two main sections about fuselage Body Station 1560¹⁸ and came to rest about 6,840 feet from the runway threshold. The left and right wings remained attached to the forward fuselage section, which came to rest on a heading of about 085°. The tail section (aft of Body Station 1560) was found upright on a heading of approximately 040degrees. It was reported that this section had been moved by the rescue personnel and high winds, and that the original orientation was on a heading of approximately 130 degrees resting on its left side (Figure 1.12-4~5). The rest of the major components were scattered along Runway 05R (Figure 1.12-2).

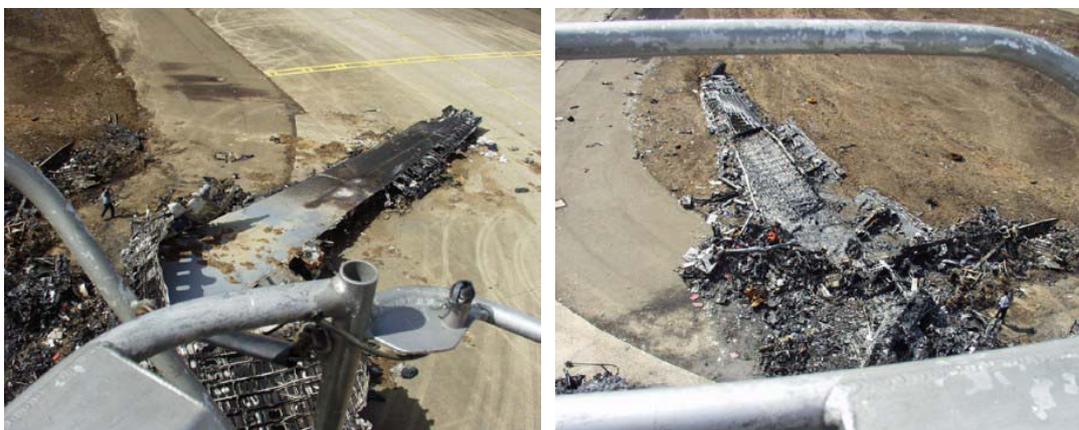
Figure 1.12-7 The left and right wings of the aircraft

The profile of the left side wing was still visible with most of the fire damage occurring on the outer portion. The outboard portion of the left side wing outboard of Wing Station 1360 had broken off. (Figure 1.12-7).

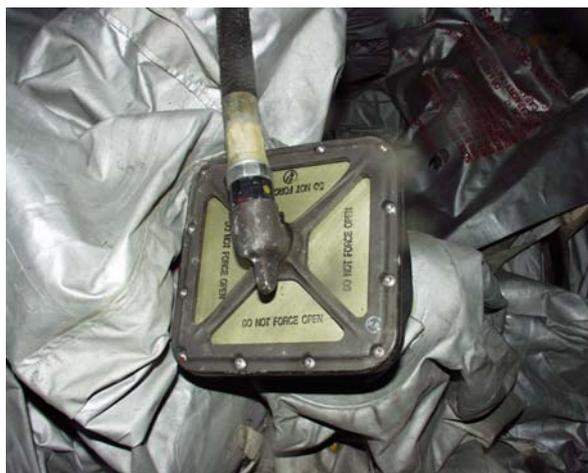
Figure 1.12-10 The aspirator of Door 2L slide

Door 2L was found intact and in the “open” position. Its mode selection lever was in “Automatic” (Armed) position. The slide was found partially deployed outside the aircraft. The fuse pins remained connected near the base of the girt skirts preventing the slide from fully deploying. There was significant fire burn damage to the slide and it had burnt away from the girt bar. No soot or fire damage was found at the inlet of the slide aspirators. See Figure 1.12-10 below.

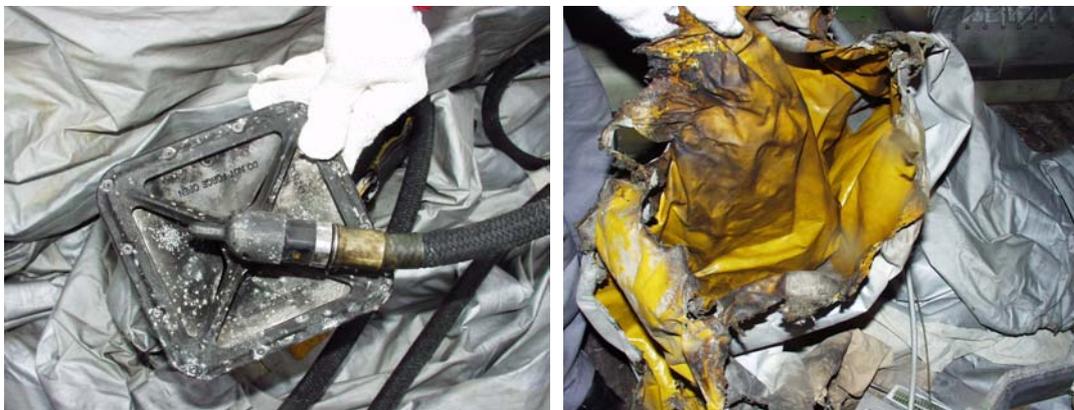
Figure 1.12-11 The aspirator inlet (left) and the inner fire damage of 4R slide (right)

Door 4R remained intact and was not opened. Its mode selection lever was found in “Automatic” (i.e. Armed) position. The slide was deployed (deflated) inside the aircraft and it extended laterally through the cabin to Door 4L. Soot and fire burn damage were found on the slide skin at the inlet of the slide aspirators. See Figure 1.12-11.

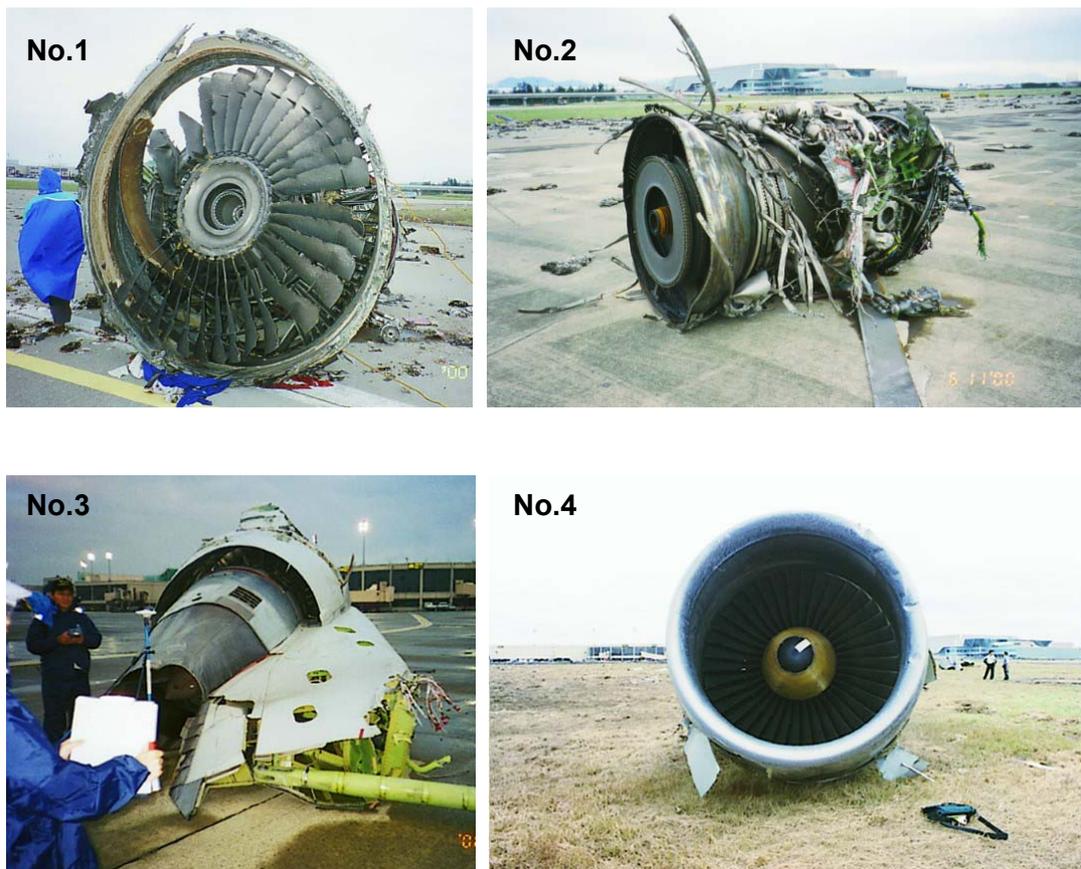
Figure 1.12-12 The four engines

All four engines had separated from the aircraft during the impact sequence. None of the four engines exhibited any indication of an uncontained disk/blade separation, or of fire prior to impact. (See Figure 1.12-12)

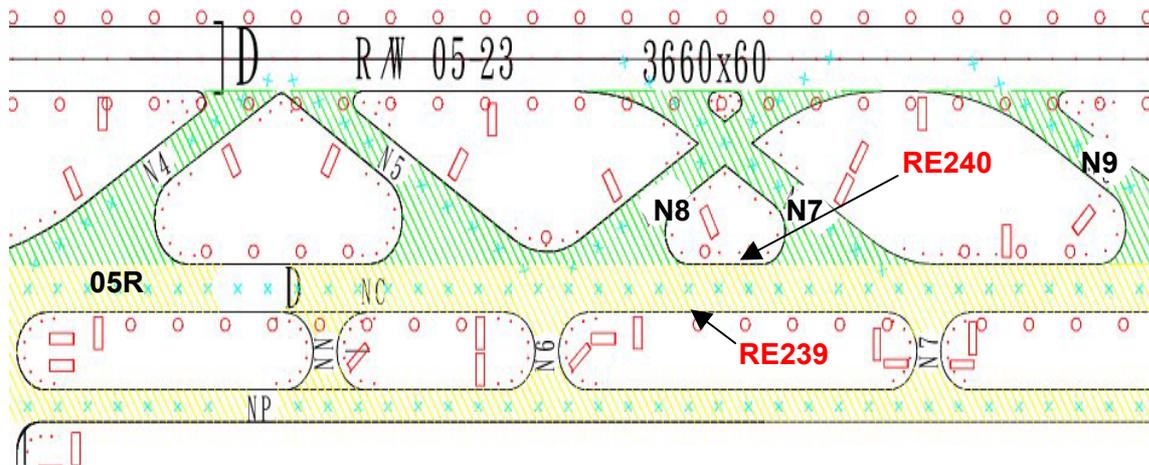
Figure 1.12-13 The positions of RE239 and RE240 on the runway

Figure 1.12-13. Near the location of RE240, tire tracks from ground vehicles and wreckage pieces are shown in Figure 1.12-14.

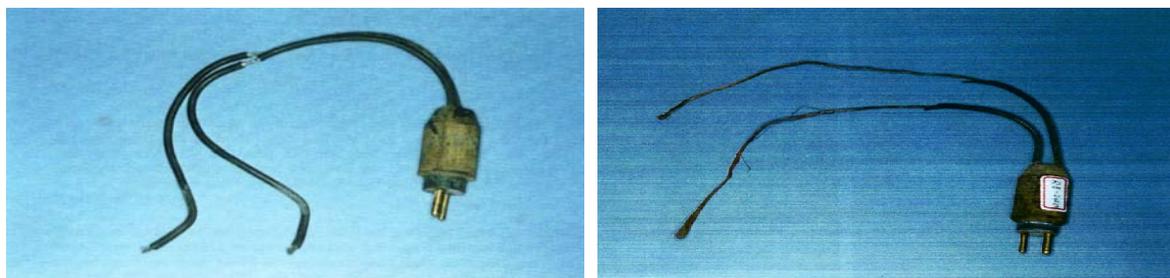
Figure 1.12-15 RE239 (left) and RE240 (right)

remained bolted in place, but the upper portion was not located. No fragments of metal or glass were found in the immediate area. Two wires were observed protruding approximately 5 to 15 cm from the remaining portion of the light base. When the wires were lifted, the plug was found still connected to the mating receptacle under the ground. The wire was disconnected and tagged for identification purposes (Figure 1.12-15).

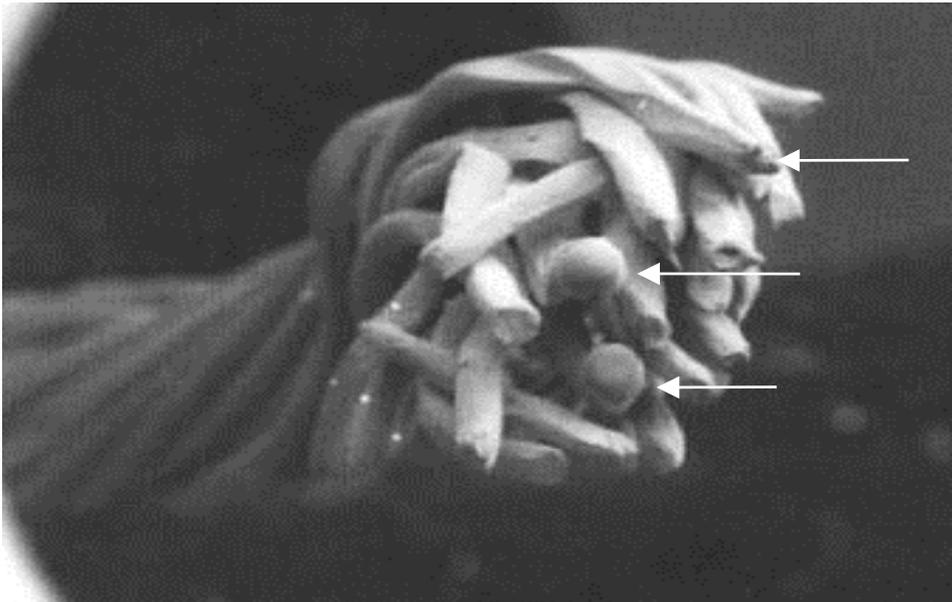
Figure 1.16-4 Three beads on the RE240-1

Three beads were found on the RE240-1 strand ends (Figure 1.16-4). According to the CSIST report, these beads indicate that local melting occurred, which was most likely the result of electrical arcing. The CSIST report also mentions that SEM/EDS analysis of the contaminative deposition on the strand ends indicates that the three beads were formed after all of the other strand ends had been contaminated. There was a "crater" on the surface of the melted bead of the RE240-1 wire end which was cleaner than the fracture surfaces of the strands without localized melting (Figure 1.16-5).

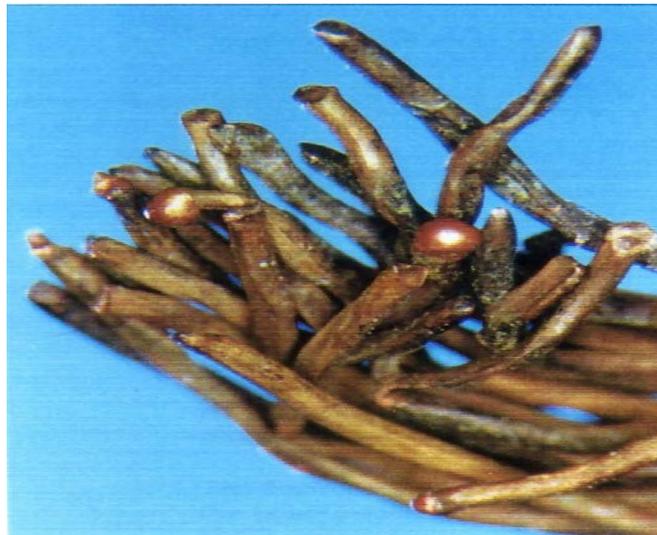
Figure 1.16-6 RE240-1, some of the melting beads formed at wire ends.

The ATSB report identified localized melting indicative of electrical arcing at the RE240 wire strand ends and about 9.5 cm from the end of the plug moulding, near the remnants of the insulation (Figure 1.16-7), but there was no arcing (melting) evidence found on the wire strands of RE239.
